Environmental Review Team Report

D.B.S. Subdivision Canterbury, Connecticut

Environmental Review Team
Report
on

March 1979

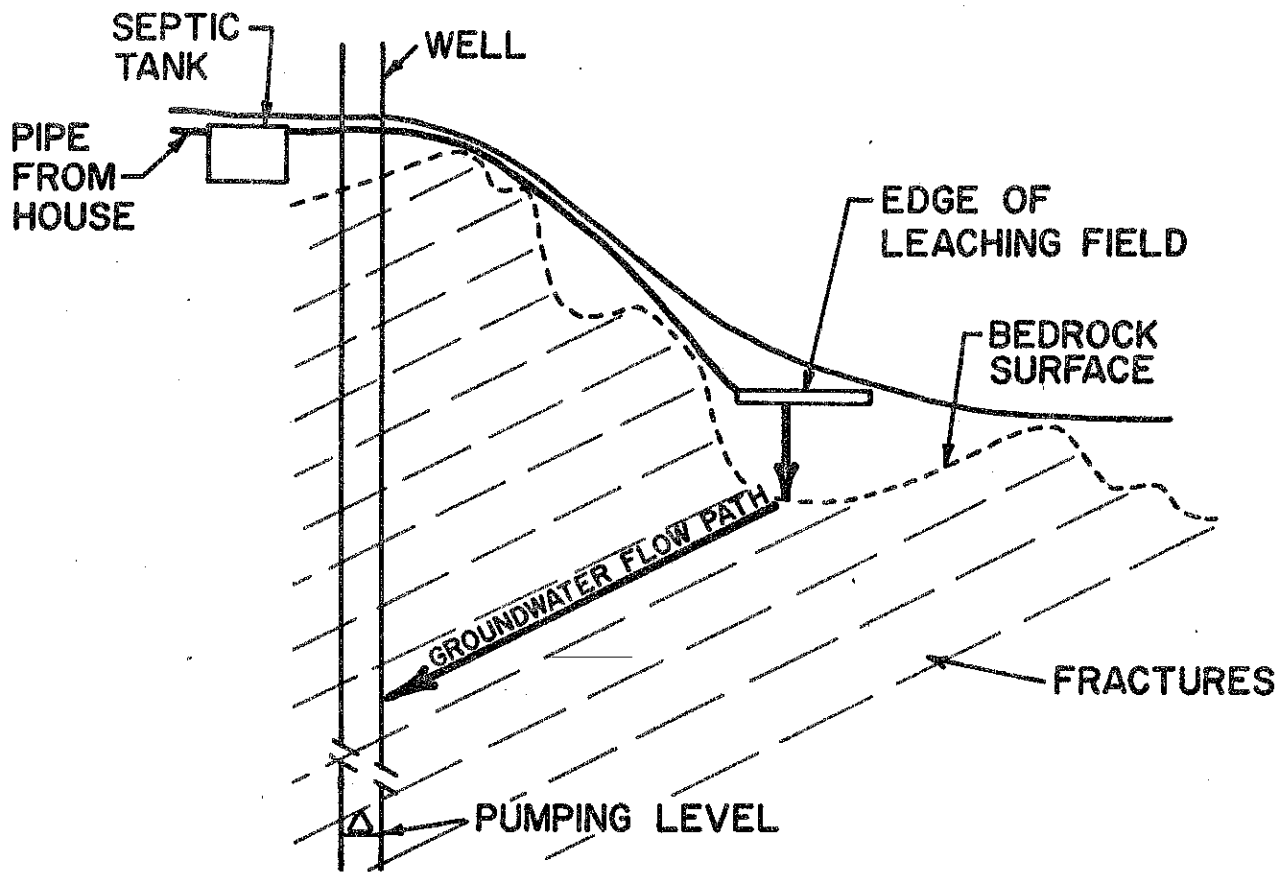
ANTICIPATED PATH OF SEPTIC SYSTEM EFFLUENT

A more pressing concern is the operation of septic systems in the subdivision. Much of the property is shallow-to-bedrock, although deep pockets of till exist in several areas. Even if the wells are drilled uphill of the leaching fields, the dip of the most prominent fractures virtually assures that wastewater ultimately will be recycled to the wells. Hence, it is urgent to provide adequate filtration of the effluent in the overburden. Judicious site selection, coupled with appropriate engineering measures, is needed to assure suitable depths and areas of soil in order to avoid serious water-quality problems in the future.
