**MEETING HOUSE HILL
SCHOOL BALLFIELDS
NEW FAIRFIELD,
CONNECTICUT**

Environmental Review Team Report

MARCH 1988

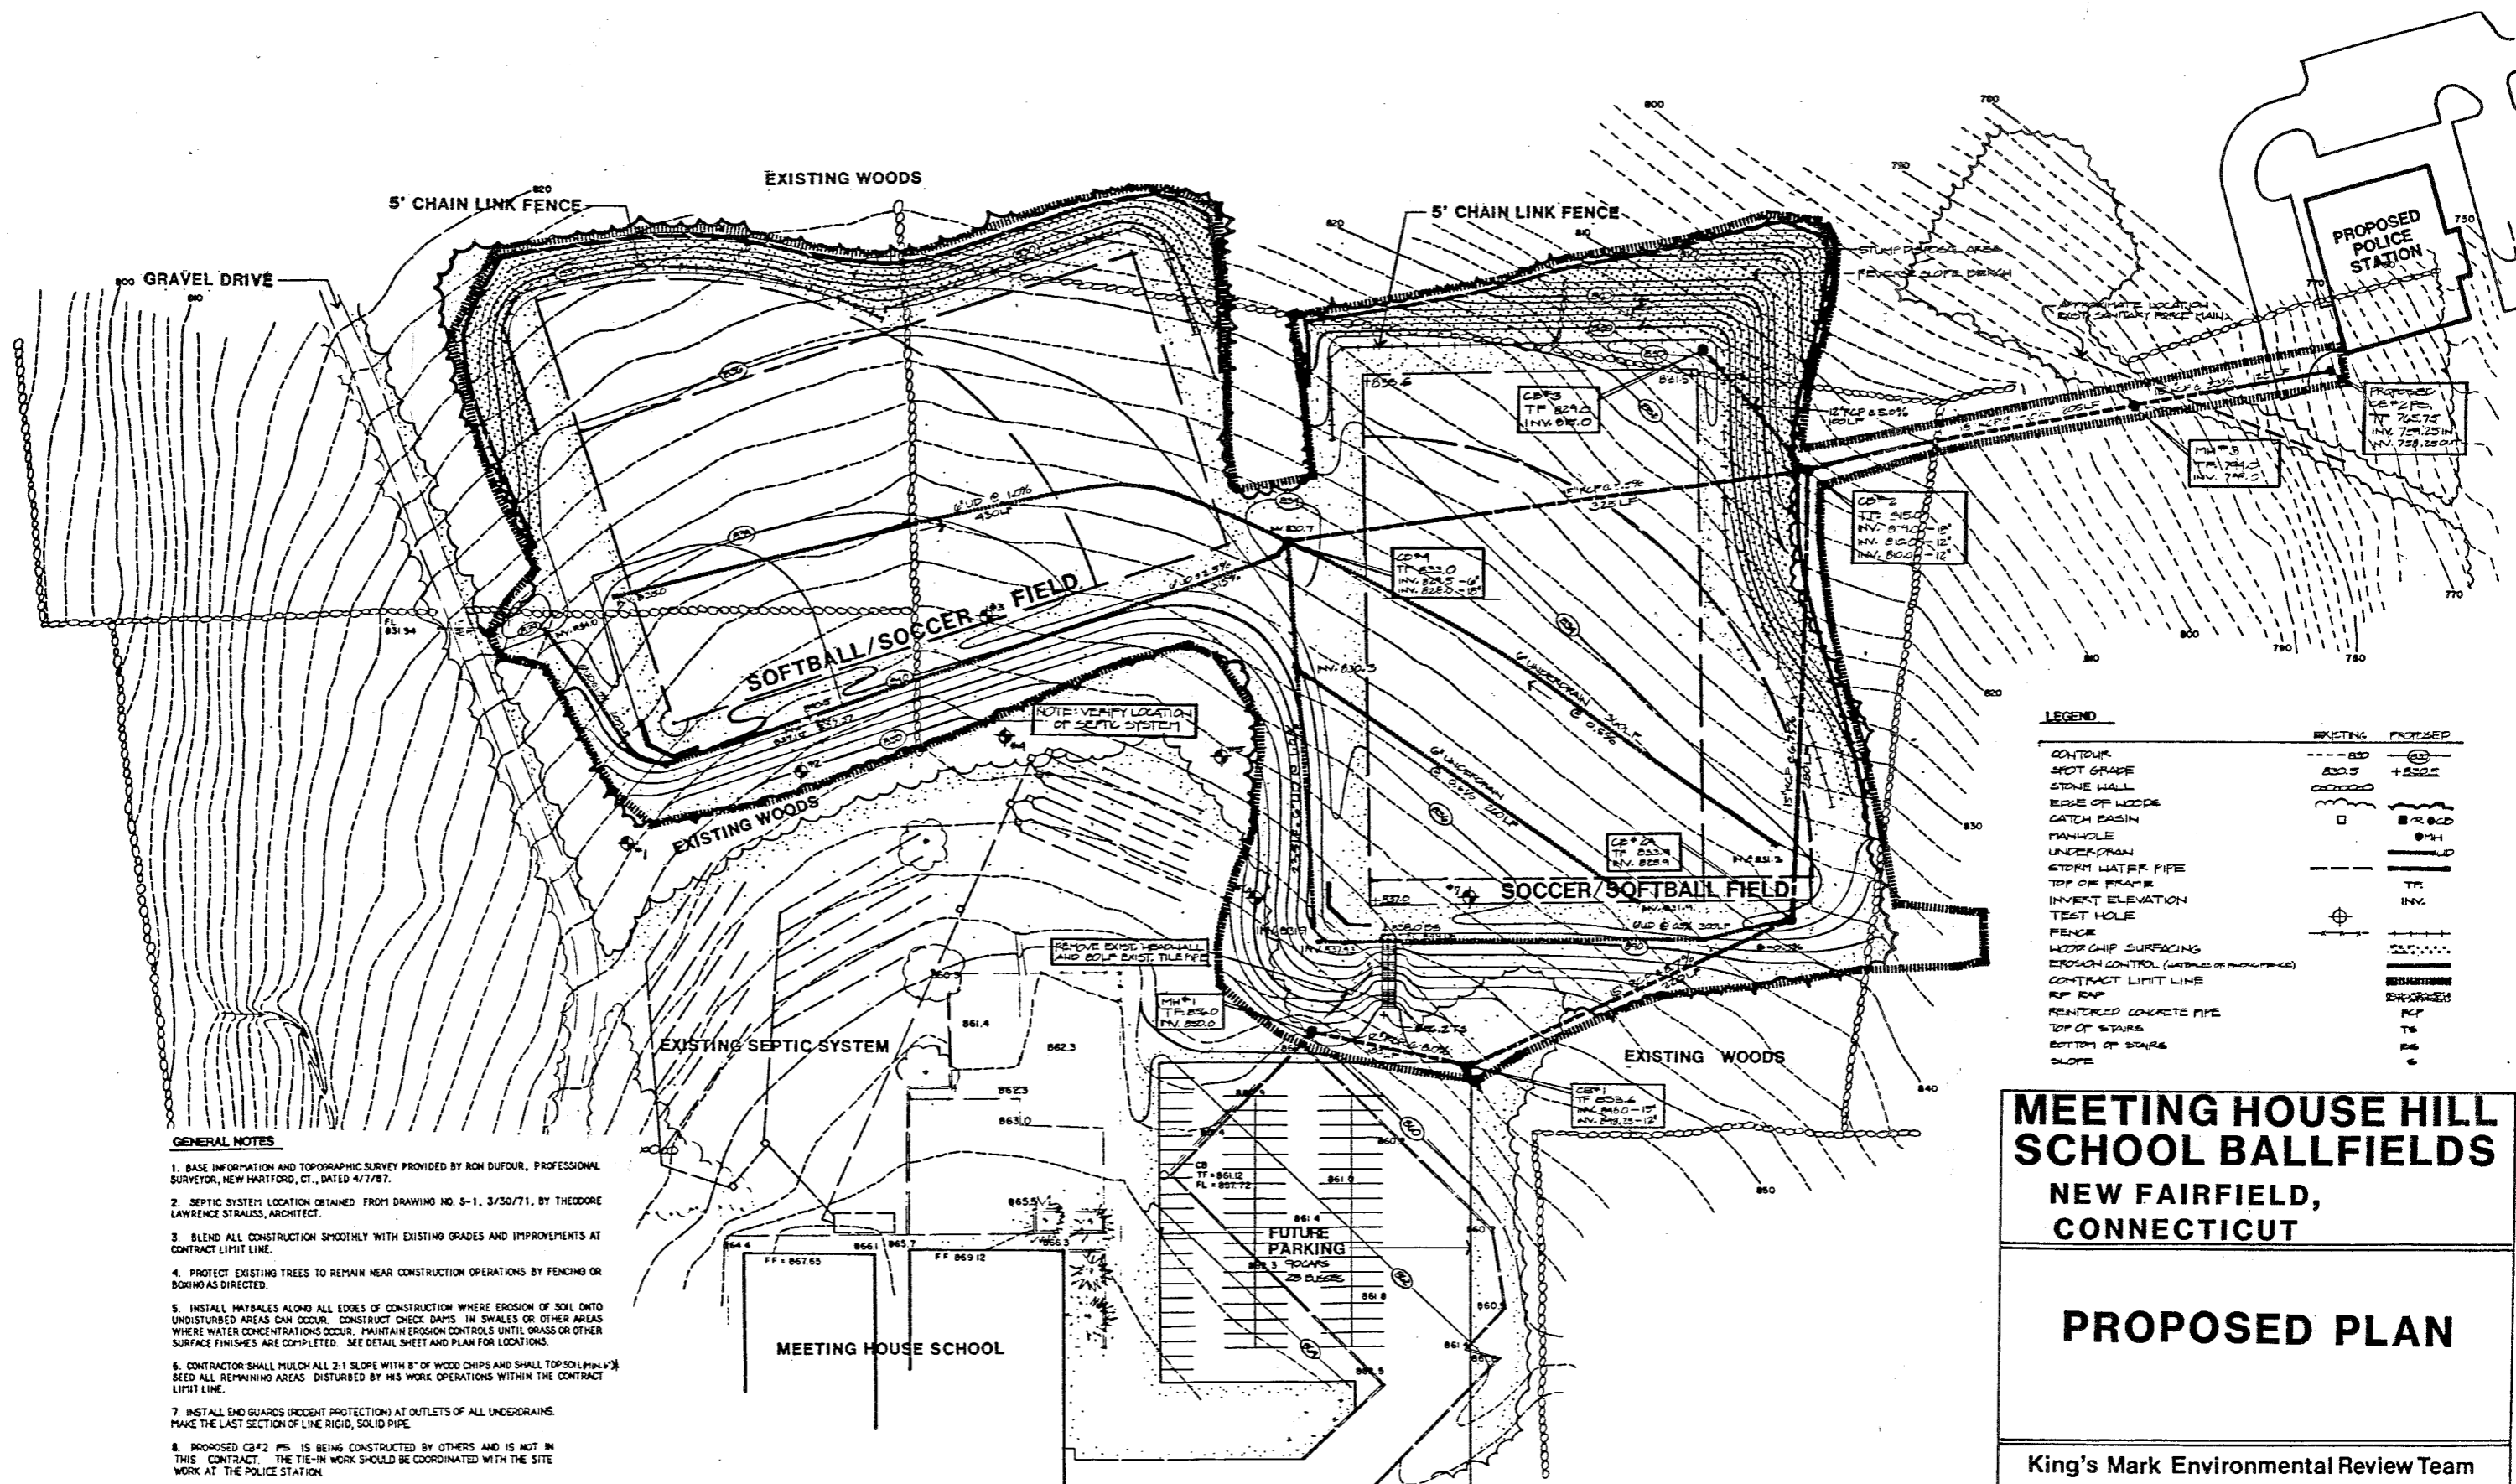
Figure 2

6 feet to 11.5 feet below ground surface (see Figure 2). It would be wise to conduct a few borings in the ballfield area to determine if the bedrock surface will be encountered during field construction. If the bedrock surface was encountered during the construction of ballfields, blasting would probably be required. Blasting activity can be difficult, especially in developed areas, and very costly.

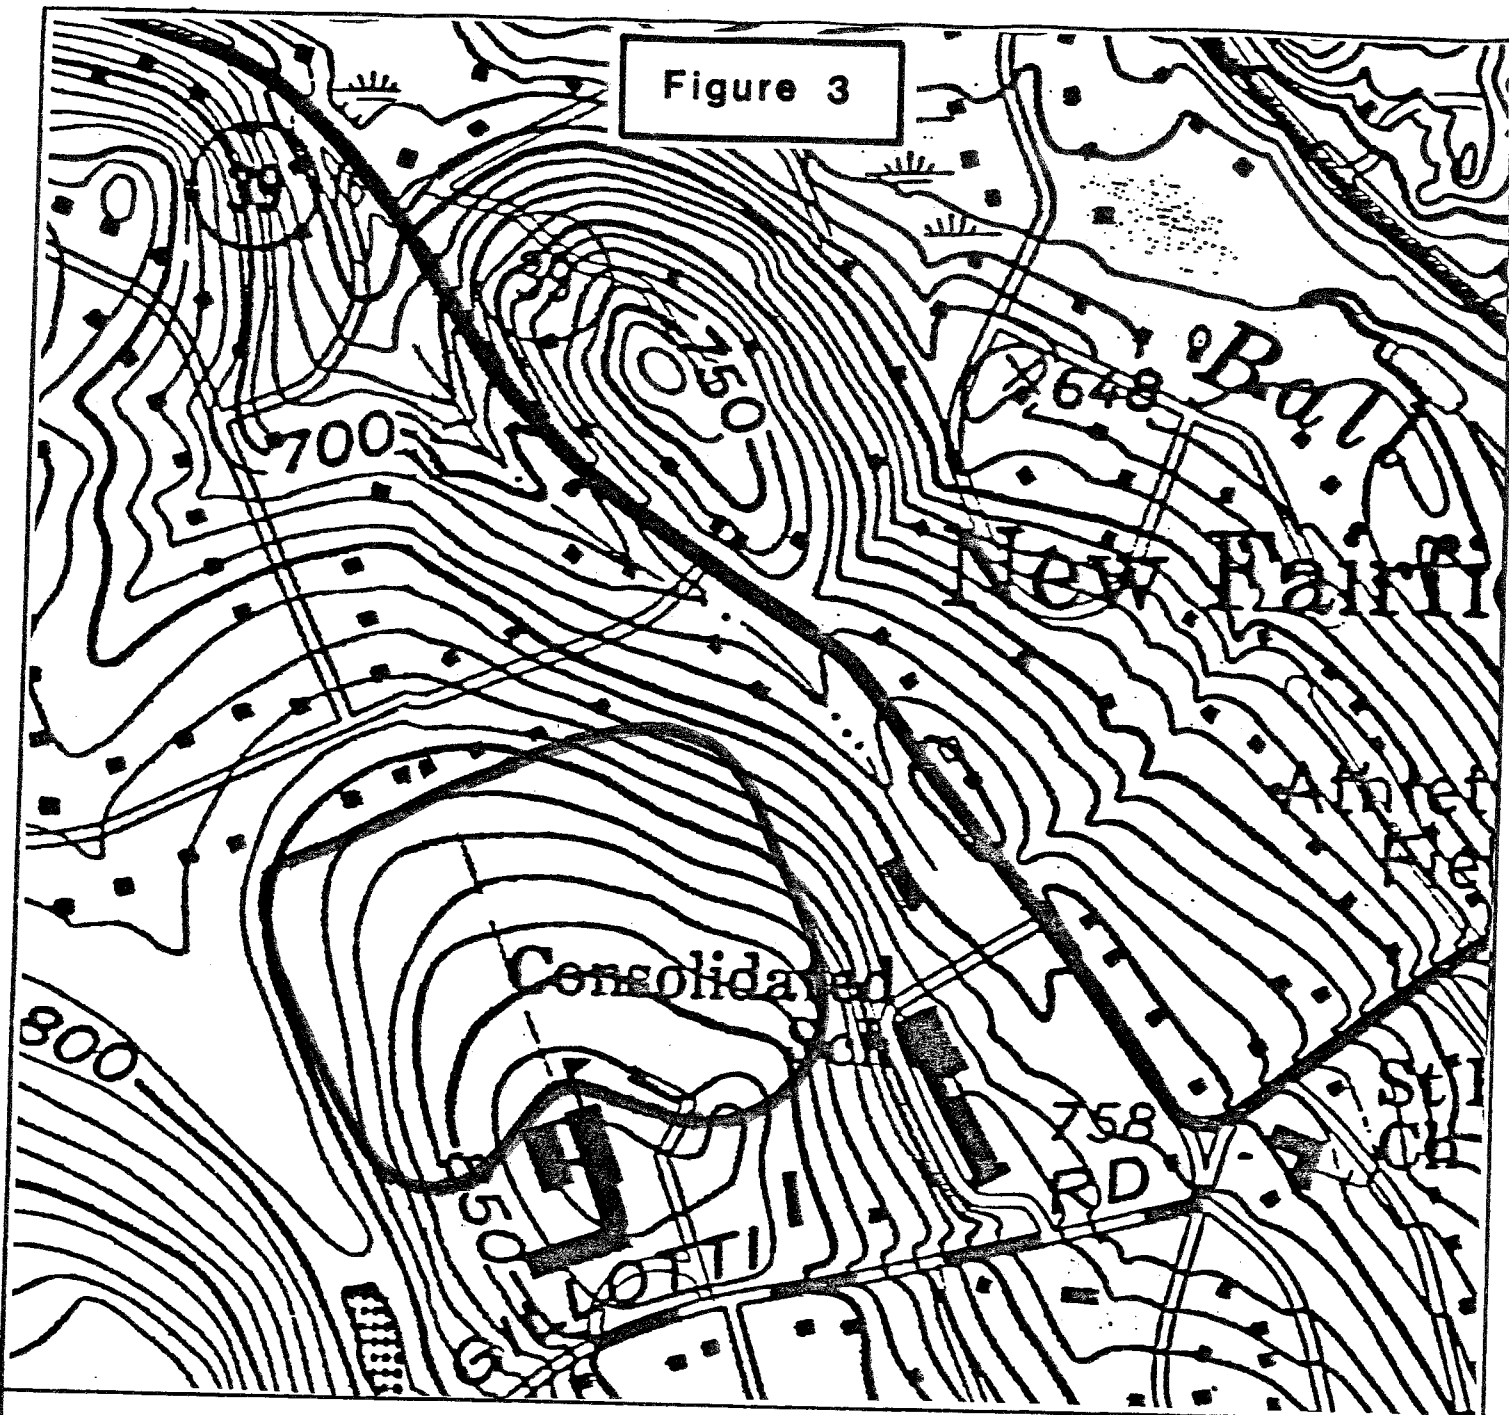
Figure 3

The hill slopes gently then more moderately north/northeastward towards Rita Drive and Route 39 (see Figure 3). No major watercourses were observed in the area of the proposed ballfields. Surface water flows downslope to road drainage on Rita Drive or is intercepted by an intermittent stream that parallels Route 39. It ultimately flows into Ball Pond Brook (see Figure 4). In order to construct the ballfields on an acceptable grade, cutting and filling activity will be required on the site (see Hydrogeology/Geologic Development Concerns).

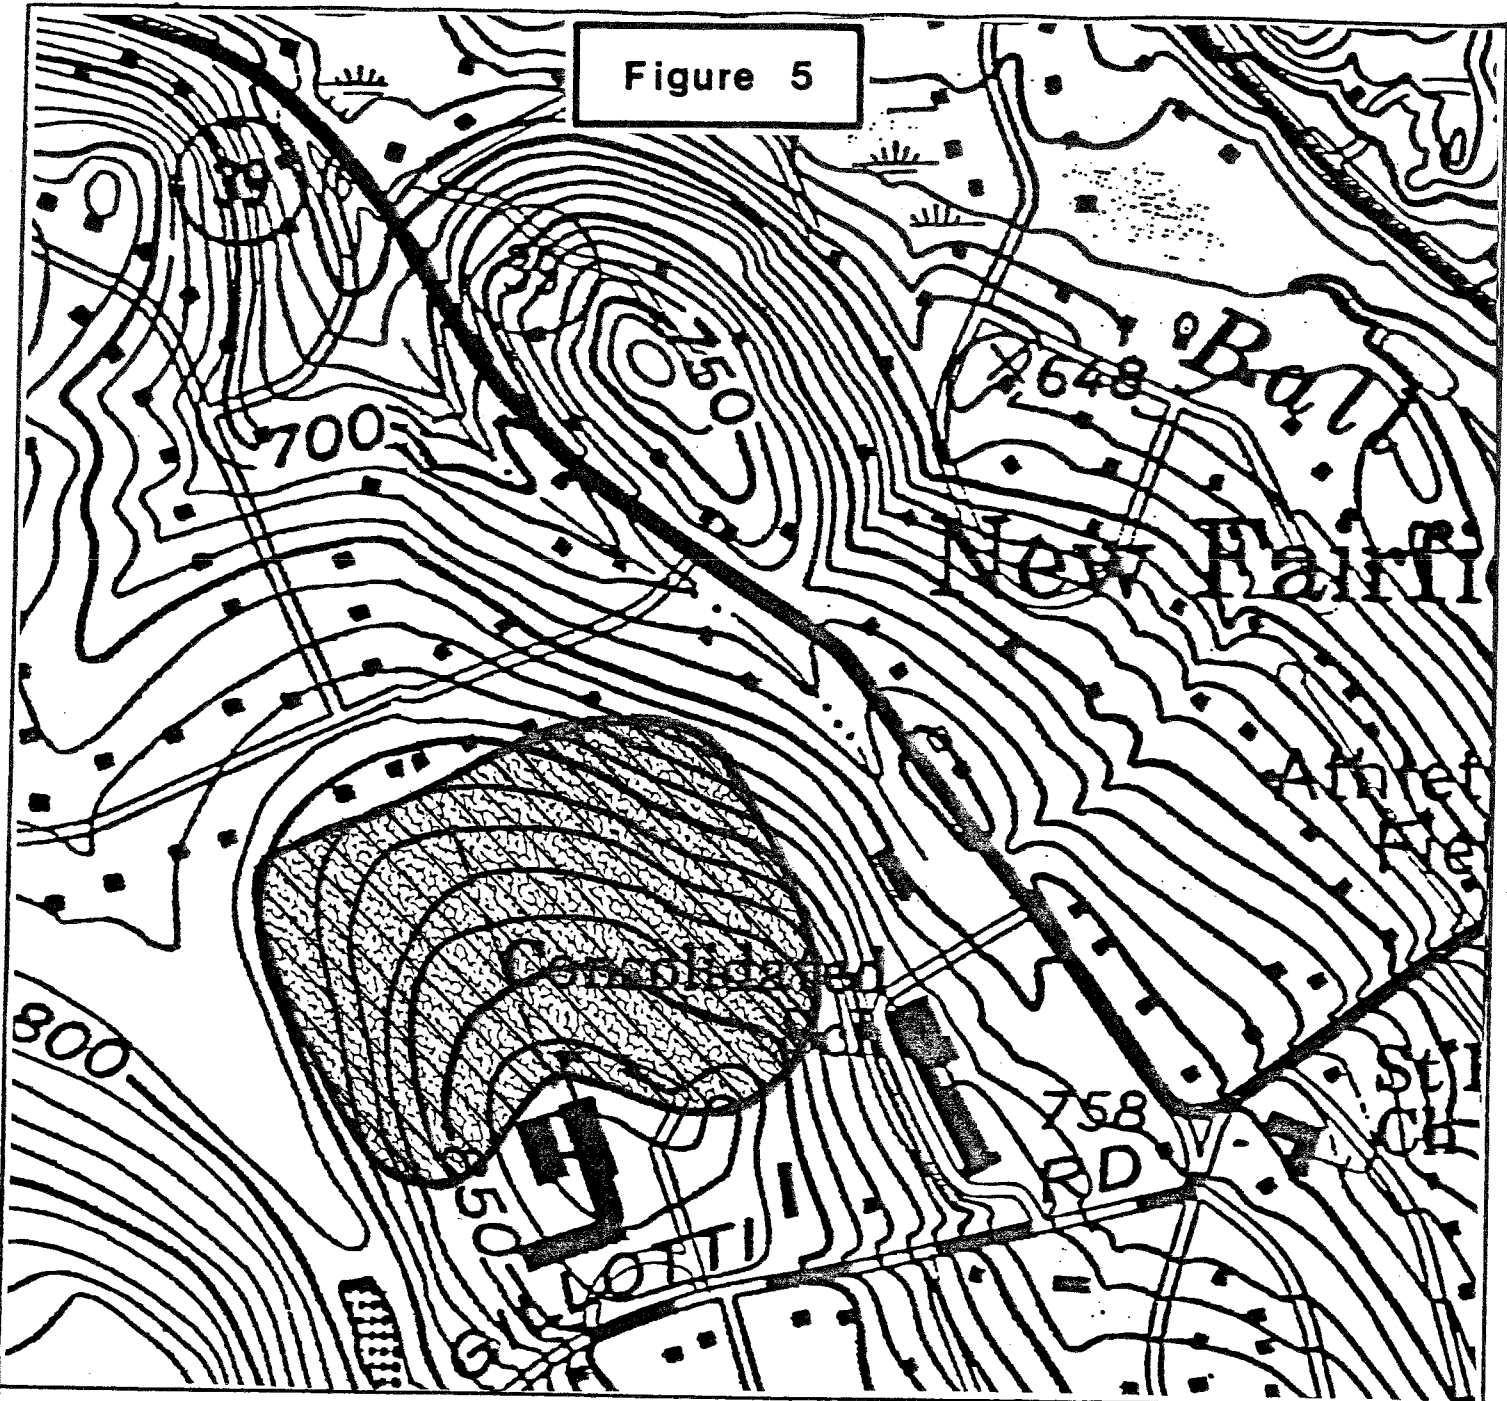
Figure 5

The bedrock that forms the core of Meeting House Hill is described as pink granitic gneisses (see Figure 5). The major mineral components include feldspar and quartz. Geologists believe that the rock mass formed from molten material (magma), which was subsequently metamorphosed (geologically altered by great heat and pressure). These rocks are believed to be the oldest rocks in Connecticut, about 1.1 billion years old. The term "gneiss" used above refers to the rock's texture; these rocks characteristically include thin bands of elongate or flaky minerals that alternate with layers of granular minerals. This gives the rock a banded appearance.

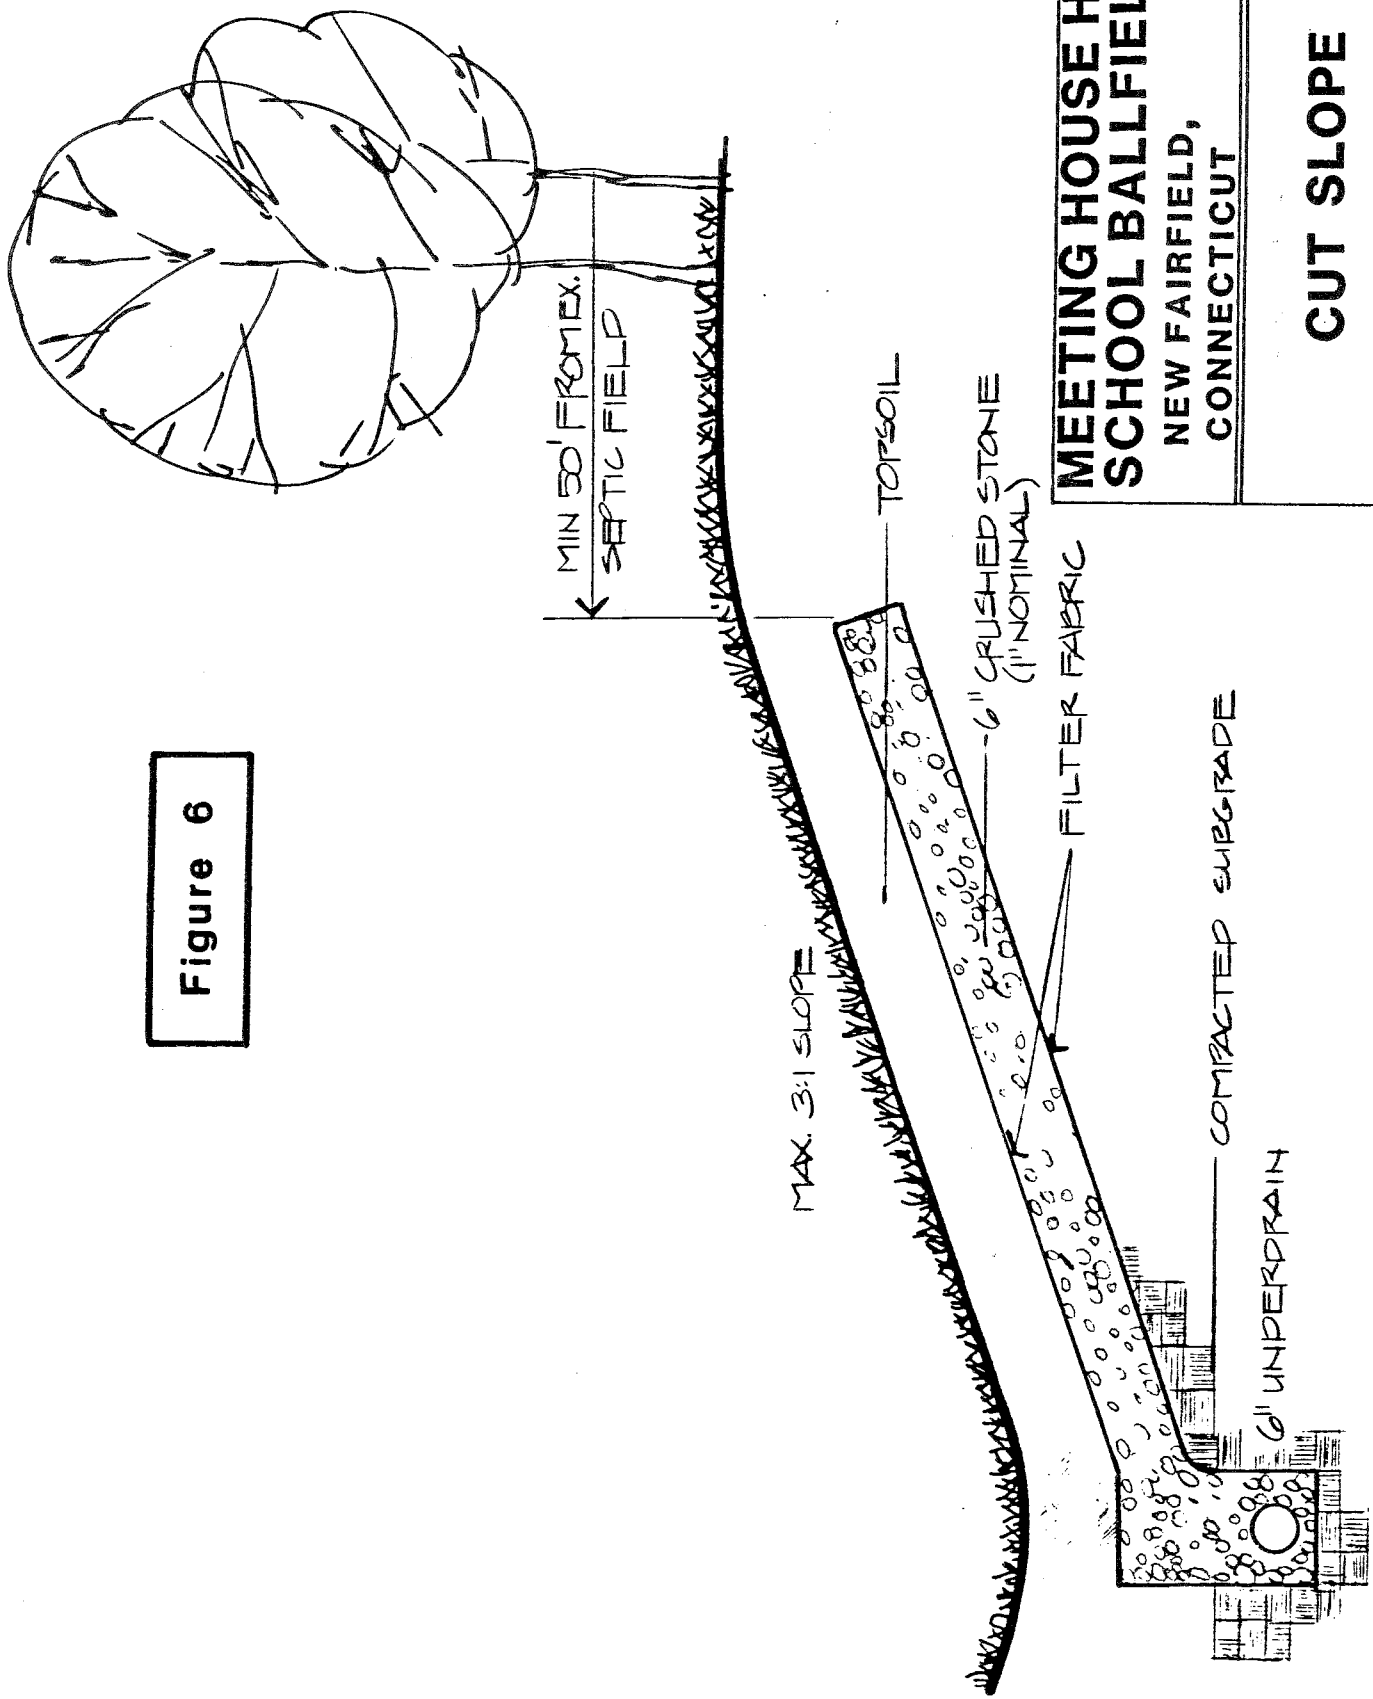
Figure 6

The stone-filled envelope slope drainage proposal for cut slopes will protect these slopes from falling (see Figure 6). It must, however, be installed at the correct depth to intercept the subsurface flow line. This depth may vary across the slope; accuracy in placement is crucial. It is unavoidable that effluent from the existing leaching field will be picked up in a portion of the slope drain. Should the additional leaching field be installed as planned, a serious incompatibility would exist.
