MORNING THORPE SUBDIVISION OXFORD, CONNECTICUT

KING'S MARK ENVIRONMENTAL REVIEW TEAM REPORT

MORNING THORPE SUBDIVISION OXFORD, CONNECTICUT DECEMBER 1976

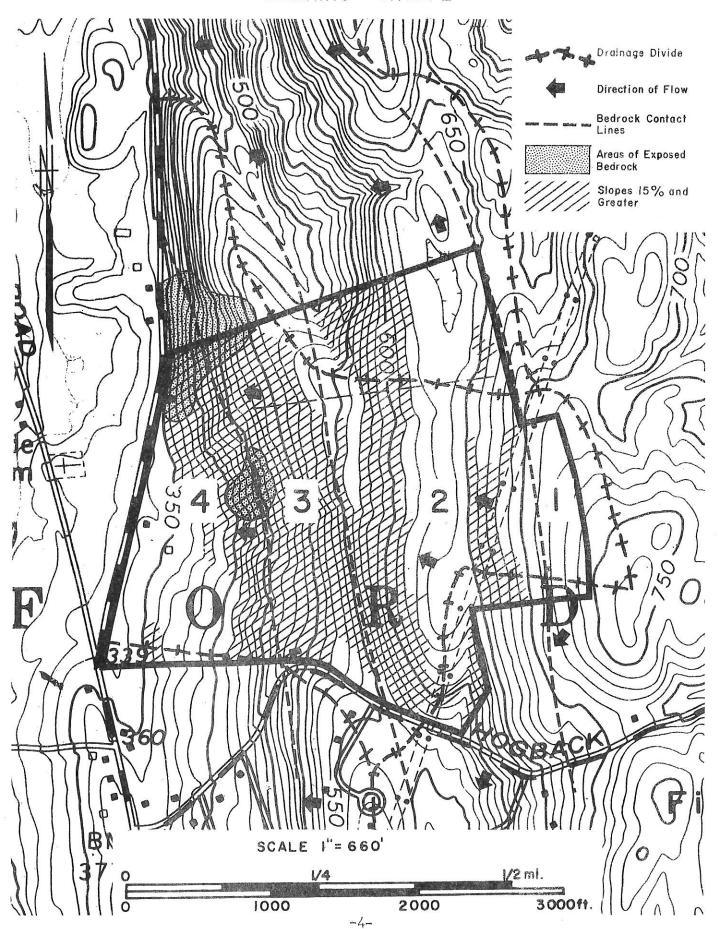
TOPOGRAPHIC MAP

When man accelerates water movement through these delicate areas by disrupting and paving over the land surface, the risk of dangerous situations developing increases. It would appear only two locations on this property may have the potential for this type of problem; these are in those areas delineated as bedrock exposures on the Topographic Map.

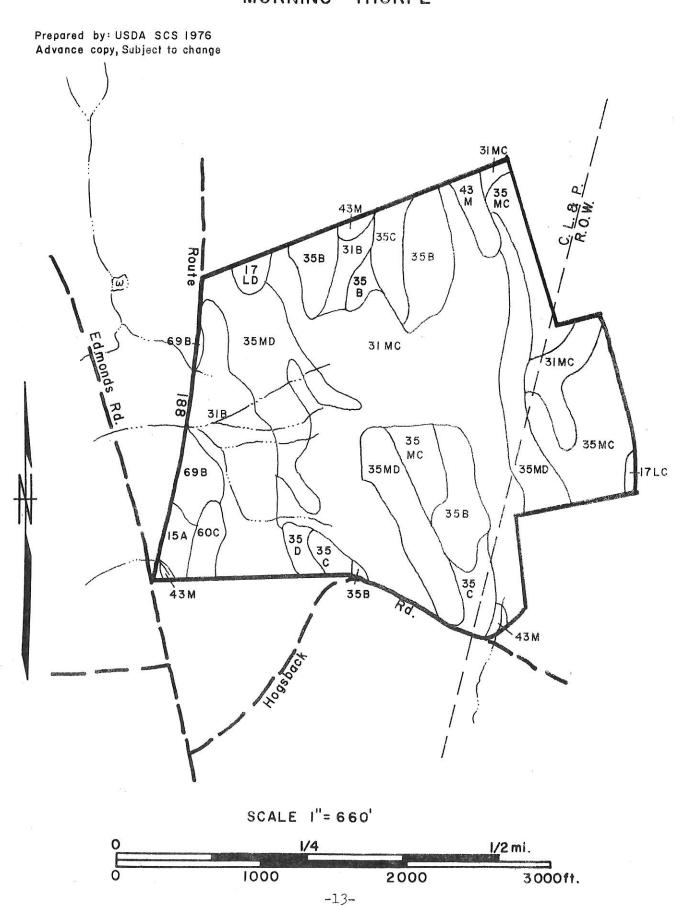
SOIL MAP MORNING THORPE

With the examination of the Soil Map and accompanying Chart, a correlation between the soils and surficial geology can be seen. The property is composed of soils in Natural Soil Groups A, B, C, and D. Soils in Natural Soil Groups B, C, and D are all upland soils that were formed in areas of till. These soils that have developed on glacial till comprise the majority of the site. Soils in Natural Soil Group A are the only exception and these are terrace soils underlain by water deposited beds of sand and gravel (stratified drift). They normally occur above flood plains in river and stream valleys. On the site they are found along Route 188.

Most of the property (90.9 percent) is composed of soils in Natural Soil Group C. Group C soils are upland soils which have developed over compact glacial till (hardpan). These soils are often stony and have formed with a slowly or very slowly permeable hardpan or fragipan at a depth of 16 to 36 inches below the soil surface. Permeability above the hardpan is moderate but the pan drastically reduces percolation and restricts the downward movement of water in the soil. Excess water from heavy rains, spring thaws or septage effluent absorption fields will move laterally downslope over the surface of the pan. At times, a temporary perched water table may form above the hardpan in wet seasons and after heavy rains. For example, soils types 31B and 31MC have a seasonal high water table that remains within 15 to 20 inches of the surface from fall through spring. During the review these soils were found to have a water table at approximately 18 inches below the surface in most places examined. Seep spots or wet spots are also quite common with hardpan soils. These occur seasonally on slopes as water moves laterally downslope above the hardpan and comes to the surface on the more concave portions of the landscape. In many cases seep spots form minor inland wetlands (see below).

There is only one soil type found on the site in Natural Soil Group B, 43M. (Group B soils are generally found in thicker deposits of till occurring on hillsides.) Soil type 43M is an inland wetland soil as defined under Public Act 155. Small narrow areas of this soil type occur along most of the natural drainageways found on the site with the largest area just west of the power lines. The Soil Map does not indicate all of these areas because they were impractical to map separately at the scale of mapping used. It should also be noted that small areas of other poorly drained inland wetland soils (mostly Ridgebury fine sandy loam - Natural Soil Group C-3a) exist on the site that do not appear on the Soil Map. They exist along the lower part of the slopes throughout the site. They range up to about an acre in size with most being less than one-half acre. They are essentially seep spots, and are wet from fall through spring and after heavy rains during the summer. During the field review, many of these poorly and very poorly drained soils were observed to have water within a few inches of the surface.

Soils in Natural Soil Group D comprise a very small portion of the site. Group D soils occur mostly in the rougher areas of the uplands. They may occupy narrow ridge tops but most often are on steep side slopes. These soils are underlain by hard bedrock with areas containing barren rock outcrops. In most places hard rock is less than 20 inches below the soil surface. Areas on the site where bedrock is at or near the land surface have already been described (see Topographic Map). It should be noted that bedrock is within a few feet of the surface in a few small areas of the 35MD soil type delineation in the northwestern portion of the site. (35MD belongs in Natural Soil Group C.)
