KEACH POND VIEW SUBDIVISION WOODSTOCK, CONNECTICUT

EASTERN CONNECTICUT ENVIRONMENTAL REVIEW TEAM REPORT

ENVIRONMENTAL REVIEW TEAM REPORT

REPORT #616

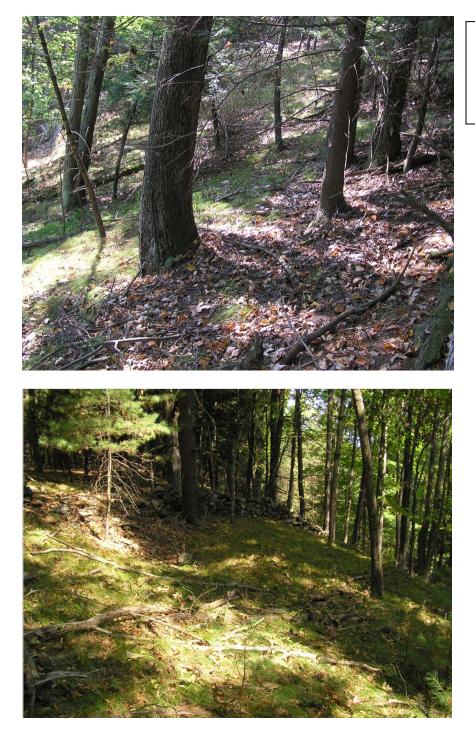
The steep slope has an uneven, slightly rilled topography that suggests to this reviewer that it may have been unstable in the recent past and experienced down-slope mass movement of the soil. Today the slopes are subject to very slow soil creep in places. This is evidenced by slight bends in some of the tree trunks on the slope. (Figure 2). If the land is left undisturbed this should not be a hazard. In this reviewer's opinion, care should be taken when making cuts into the base of the slope, even the minor cut for the driveway on proposed lot #6. Possibly a retaining wall could be considered for that cut.

Evidence for past landslide activity includes the remnant of a head scarp at the top of the slope on proposed lot #5 (or #4?). (Figure 3) and a roll-over toe observed in several places near parcel A at the base of the slope. (Figure 4) Past down-slope movement may have occurred when the land was clear-cut.

Figure 2. Deformed tree trunks indicate slow active soil creep near top of slope (proposed lots \$4 or #5).

Figure 3. Crescentic depression at top of slope on proposed lot #5 (or #4?) suggests headscarp at top of currently inactive slump.

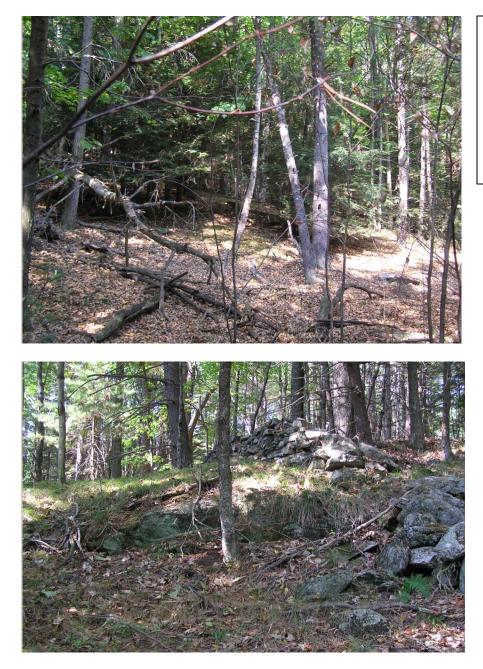
The outcrop observed during the ERT field review was poorly fractured (Figure 5). Foliation parallel fractures dip into the hillside, away from Keach Pond. If groundwater recharge occurs beneath the soils, it would flow away from Keach pond in the foliationparallel fractures. In addition, Pease (1972) shows south-dipping east-west fractures at numerous places on his map (one at an outcrop immediately south of the proposed subdivision). These cross-cutting fractures are important. If groundwater recharge to the bedrock occurs beneath the soils on this parcel, the east-west oriented fractures will allow that water access to Keach Pond.

Figure 4. Flat area near base of slope adjacent to parcel A. Although not shown, slope is very steep uphill slope (on the left). Note that slope again steepens downhill. This is interpreted as the toe of an inactive slump.

Figure 5. Low outcrop of calc-silicate gneiss of Bigelow Brook Formation exposed near rear of proposed lot #4. Out crop is 2-3' high. Note lack of apparent fractures in outcrop.

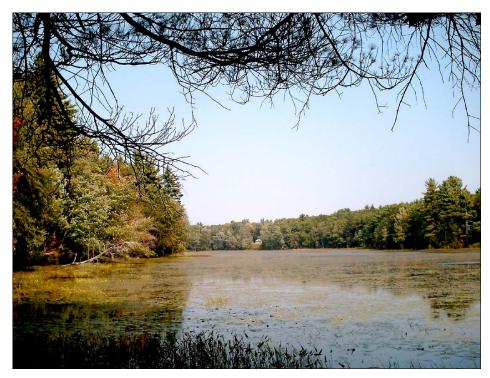
This view of the pond from the top of the dam looking north shows the surface water of the pond at the time of the ERT visit to be green with floating vegetation.
