**The Hoppers -
Birge Pond
Property**

**King's Mark
Environmental
Review Team
Report**

September 2003

Report No. 320

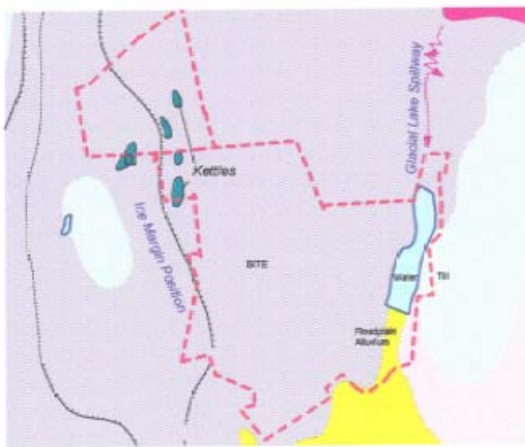
Figure 3- Kettles in Geologic Context

To summarize from prior reports, the Hoppers portion of the property was formed during the last glacial retreat. Receding glacial meltwaters deposited stratified (layered) sands, silts, and gravel into an ice-dammed glacial lake that was bounded by the Chippens Hill drumlin to the northwest and a massive ice dam to the southwest. (See **Figure 2**) The glacial lake was not part of the much larger Glacial Lake Hitchcock, but was directly southwest of it, and formed under similar conditions. The ice dam that formed the lake melted to successively lower levels over time, leaving behind a “step-like, sloping, or irregular quality” to the kame terraces and knolls of the site. The site's kettles (colloquially known as “hoppers”) were formed by buried glacial ice that did not carry much debris. When the ice melted, large holes were left. “Sinuous elongate” esker ridge-forms

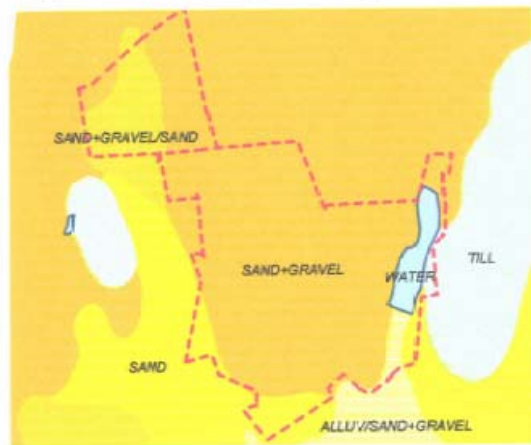
Figure 4- Surficial Materials Left by Glaciers at Site

About 90% of the property is made up of stratified sands and gravels of glacial origins. (See **Figure 4**) Bristol is laced with such “surficial” deposits, in places where there were glacial lakes and ponds. (See **Figure 5**, and compare to **Figure 2**) The sand and gravel are often less than 20” below the soil surface. As would be expected, soils associated with underlying sand and gravel have low moisture-holding capacity, rapid permeability, and low natural fertility. In the Hoppers these factors have led to the somewhat meager forest cover, which is also prone to summer fires because of droughty conditions.

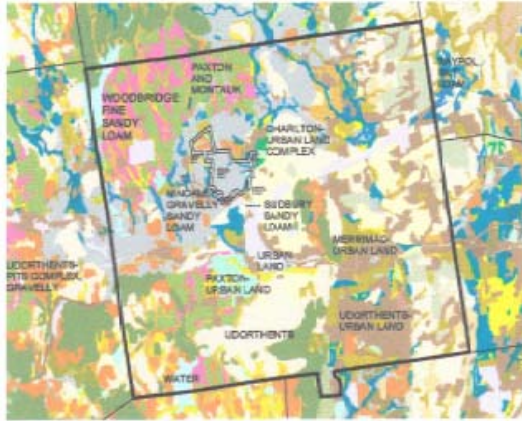
Figure 7- Soil Types in Bristol

- Hinckley Gravelly Sandy Loam Soils (previously called Terrace Escarpment soils in 1954 Soil Survey) Found on almost all of the Hoppers area. **Figure 7** shows the Hoppers containing the largest block of Hinckley terrace soils in Bristol.

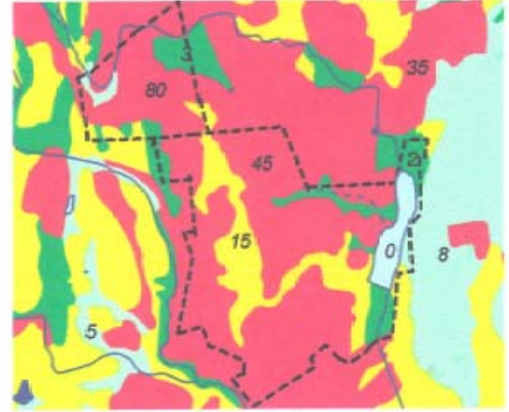
Figure 8- Maximum Slopes at Site (Percent Slope in Numbers; Flatter to Steeper: Green to Yellow to Red)

so many, in fact, that the USGS topographic map seems an inadequate guide to the terrain. (See Figure 8 for Slope Analysis of the USGS data currently available.) Sometimes it almost appears that precarious-looking piles of sandy material have been placed along ridges by mechanical means, when, in fact, the material was left by glacial activity and has somehow still persisted into the present. One or two trails on very narrow esker ridges between major kettles seem almost designed as viewing areas into the kettles, when in fact these ridges are thin walls of sandy material left by glacial meltwaters that flowed between the ice masses that molded the kettles.

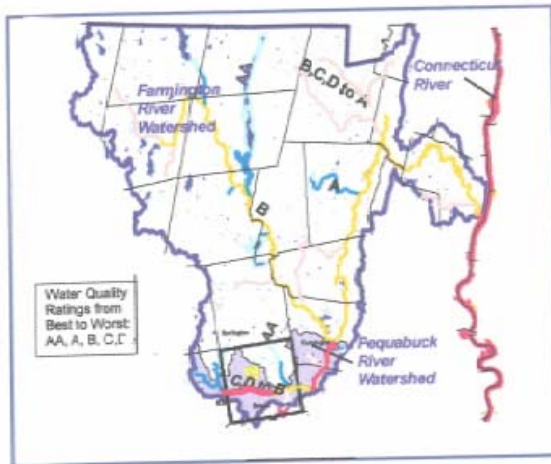
Figure 13- Water Quality in Farmington River Watershed

commercial/industrial uses. (See Figures 13 and 14 for most recent EPA water quality ratings). Since, as has been stated in all cited reports, water quality in the large tributary of Birge Brook has been consistently degraded by erosion and stormwater runoff from mining and from the 30+ years of subdivision development, it is likely that water quality of the Pequabeck River is affected.

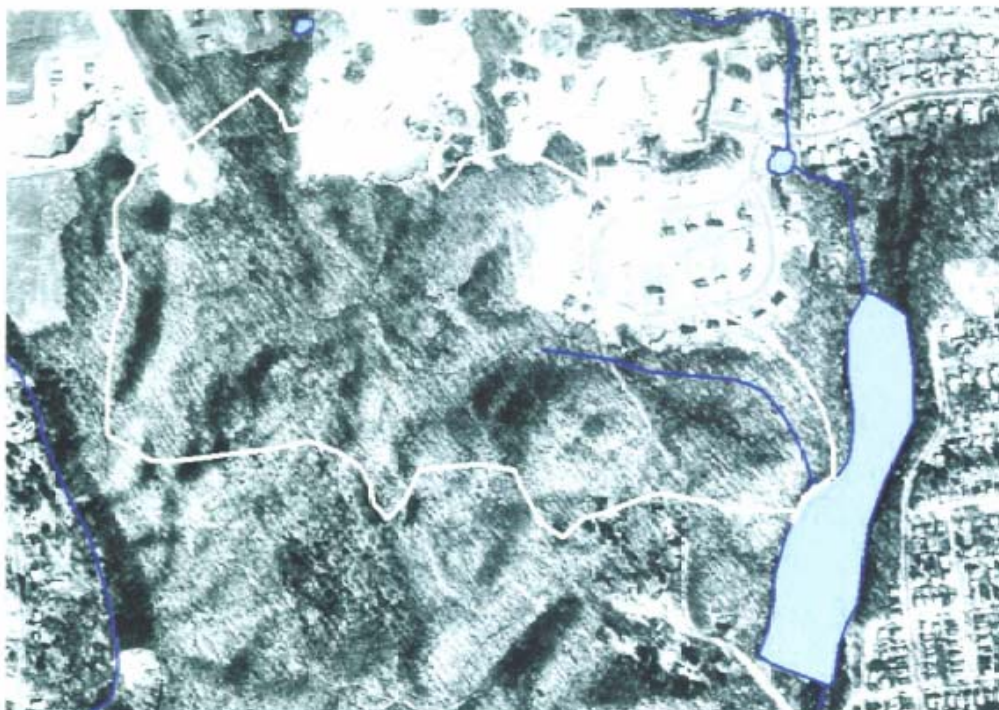
- There were many concerns specifically regarding degradation of wetlands due to sedimentation. It is clear and the comparative aerial photos show there has been land building, or accretion, due to sedimentation over the years. But to remedy this, the city will have to make a concerted effort to ease the Brook's sediment loading within the pond's watershed since most

The outline of the "special" watershed west-north-west of the pond. The photo is from 1990.

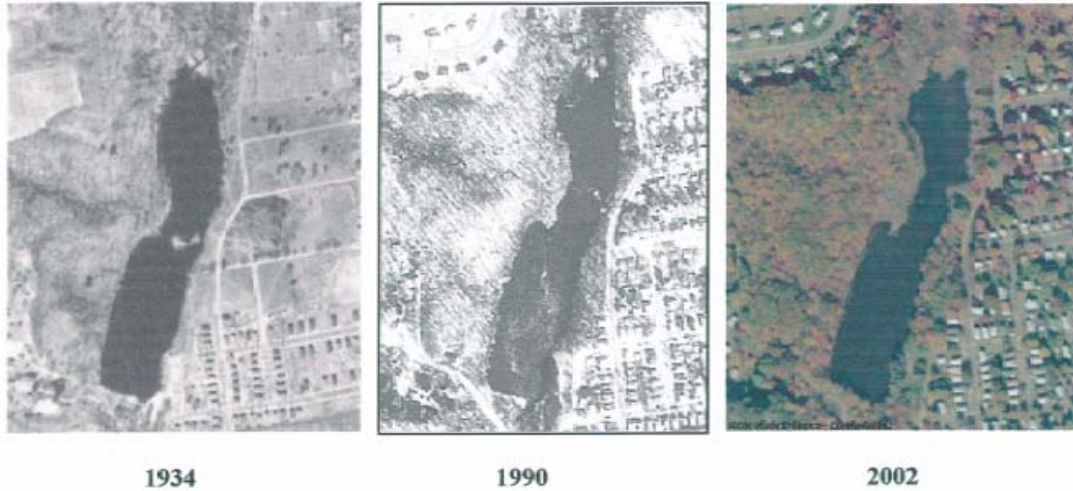
There were questions about the sedimentation of the Birge Pond due to stream-carried road sediments. The three photos below show the changes in the pond shoreline over two spans of years. The two left-hand photos were taken 56 years apart. Twelve years separates the changes between 1990 on the center photo and 2002 on the right (Courtesy of MapQuest). Noticeable delta building areas, (i.e., accretion of sediments) can be distinctly seen in three locations on the most recent photo. The first location is at the north end of the pond near the location of Birge Pond Brook's inflow. Especially in these past 12 years the delta building is noticeable, possibly due to reasons mentioned above.

In addition, the land is "growing" in the east-north-east with the addition of an almost pointy triangle of land apparent just in the last twelve years. Other areas have changed as well. Review of the photographs provides a large visual statement.

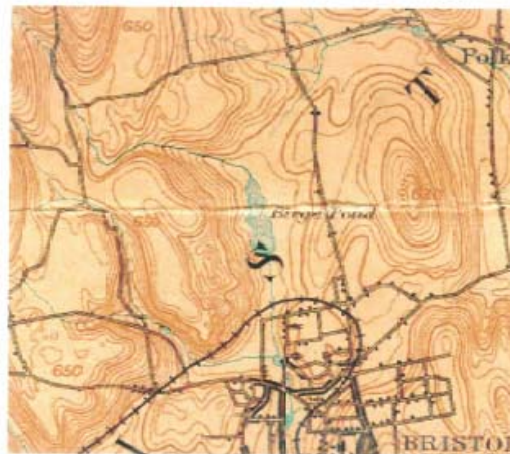
Below is the 1893 USGS topographic map for the area. The map was surveyed in 1889-1890; more than 110 years ago. Notice the neighboring land use of the Pond and the use of the land in the watershed at the time.
