Jinny Hill Road Relocation

Cheshire, Connecticut

KING'S MARK ENVIRONMENTAL REVIEW TEAM REPORT

Environmental Review Team Report

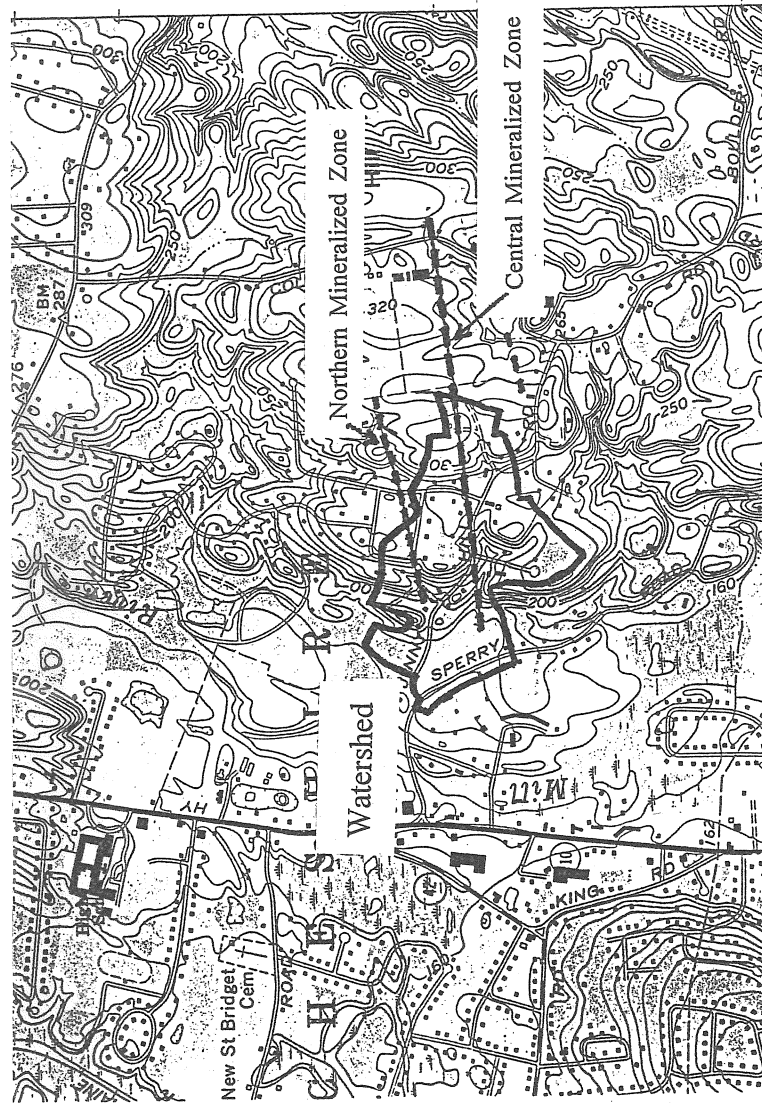
**AREA DRAINED BY THE SEASONAL STREAM
CROSSING JINNY HILL ROAD NEAR ITS
INTERSECTION WITH SPERRY ROAD**

The apparent surface watershed of the small seasonal stream that drains the project site through a small culvert under Jinny Hill Road covers approximately 100 acres (see Figure 2). An additional area about 20 acres in extent, can be expected to contribute water to the wetlands via the mine workings. Fritts (1962) speculates that the Jinny Hill mine workings extend along the Central vein from its main adit in the gully at the head of the wetlands all the way to Coleman Road. The interconnected tunnels and stopes, even if collapsed, can act as a “storm sewer” and carry water from outside the surface watershed directly to the project area.

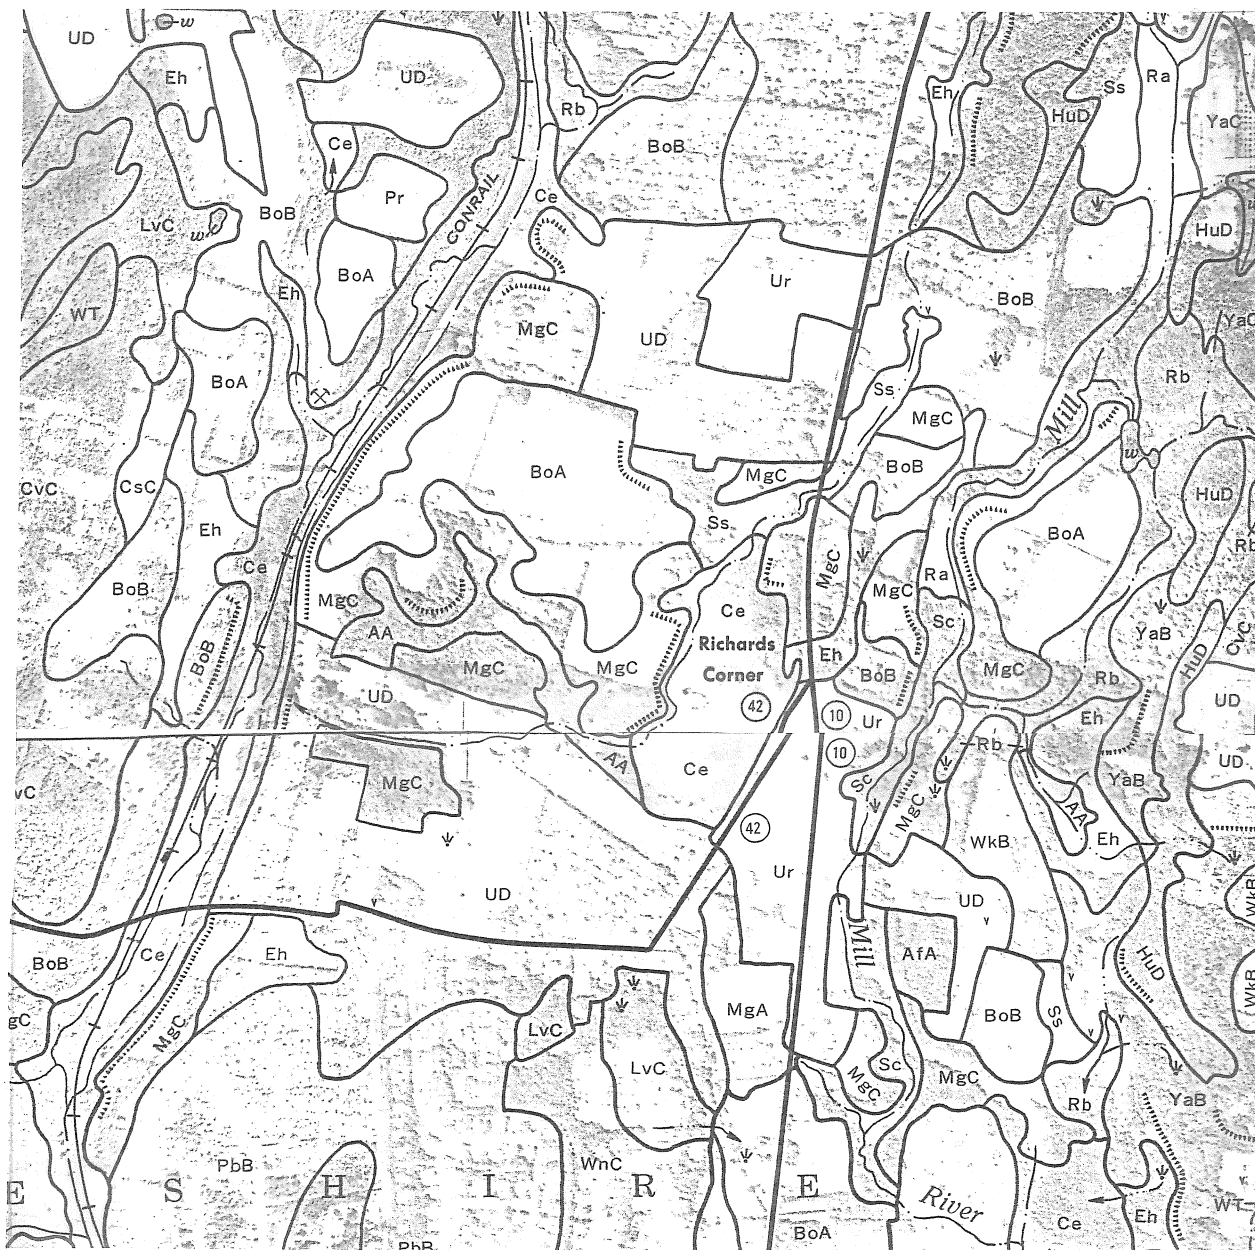
SOILS MAP

Scale 1" = 1667'

Brief, non-technical soils descriptions of on-site soils are presented in Table 1, and the limitations of such soils for use as roadfill and for local roads and streets are described in Table 2. Please refer to the published New Haven Soil Survey for more thorough discussion of land use limitations.

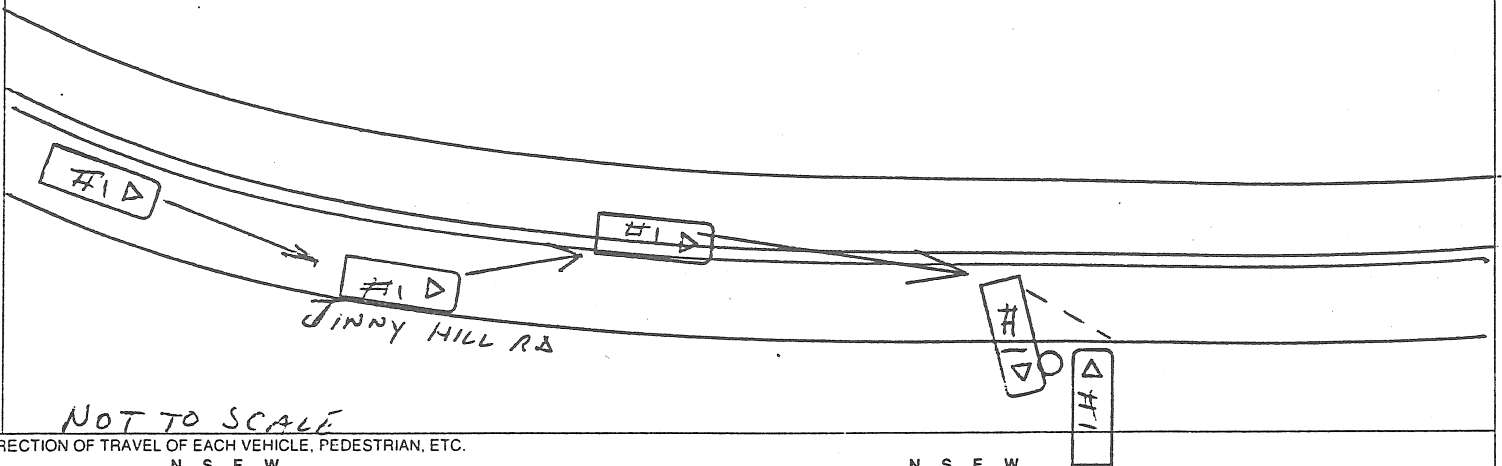
DIAGRAM SECTION

VEH#1 WAS W/B ON JINNY HILL RD. AS VEH#1 WAS W/B IT MOVED TO THE NORTH PART OF THE W/B LANE. VEH#1 TRAVELED THROUGH LOOSE SAND. OP#1 BEGAN TO LOOSE CONTROL OF THE VEHICLE. VEH#1 CROSSED THE DOUBLE YELLOW LINES. VEH#1 THEN LEFT THE TRAVELED PORTION ON THE NORTH SIDE OF THE ROAD. VEH#1 STRUCK A TREE AND CAME TO REST OFF OF THE ROADWAY. OP#1 STATED THAT PRIOR TO LOOSING CONTROL HE AVOIDED AN E/B VEHICLE WHICH WAS TRAVELING NEAR THE CENTER LINES
