# Laurel Grove

East Hampton, Connecticut

ENVIRONMENTAL

REVIEW TEAM

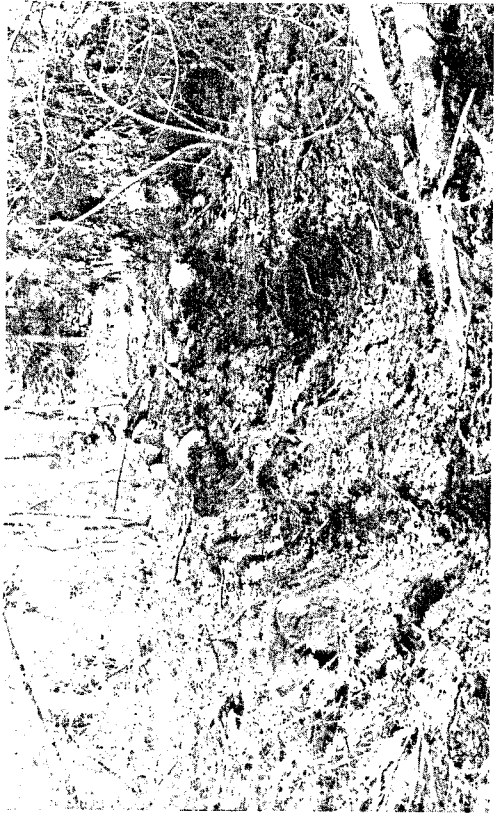
STEEP SLOPES

Skid trails and logging roads should avoid slopes exceeding twenty percent, except for short distances. (A skidder will coast on slopes of five - ten percent; logs will roll on slopes steeper than fifteen percent.)

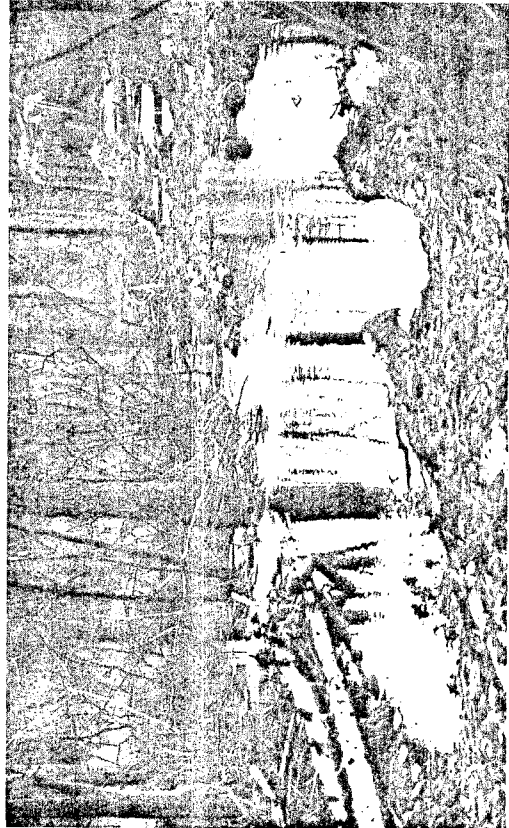
FLATS OR NO SLOPE

Avoid wet flats (less than two percent slope), swales, benches or other areas where water cannot be drained away, or log these sections when frozen or dry. Side hill locations with slope sufficient for controlled drainage are preferred for skid trail routes.

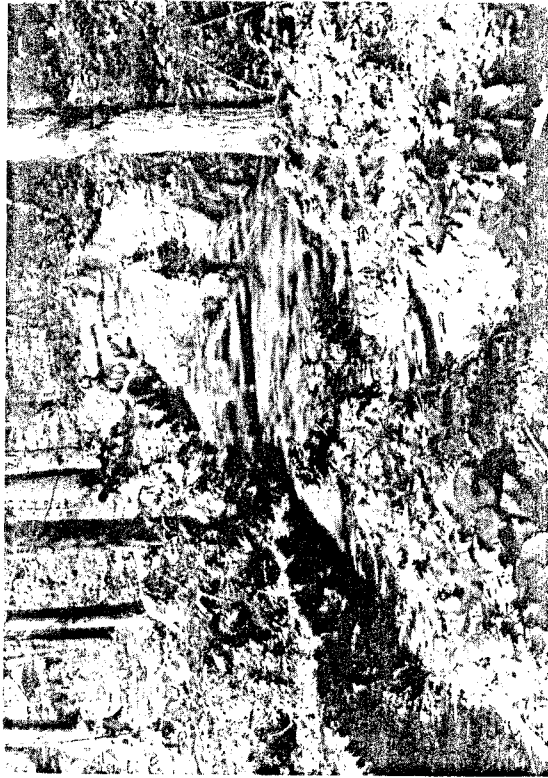
### POOR LOCATION

This poorly-located crossing will continue to cause water quality problems long after the logging is completed.

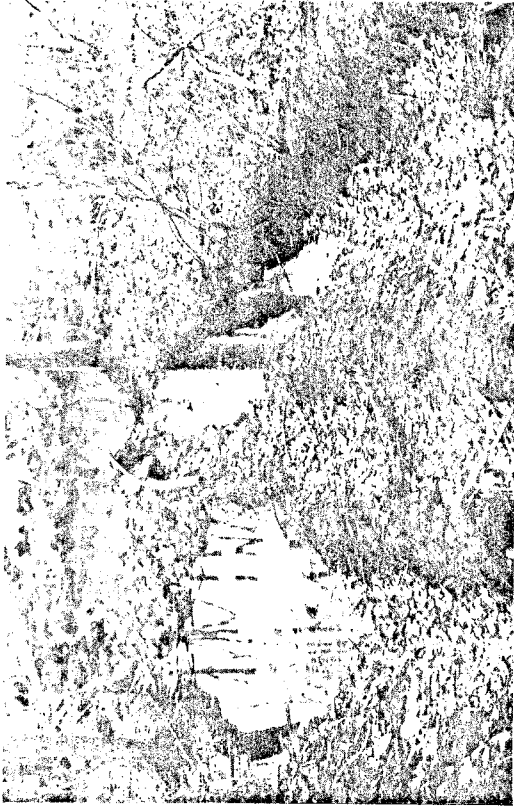
NATURAL DRAIN - INCORRECT

The area shown above could have been improved greatly if the natural drain pattern was kept open. Unless water is removed, a mud hole will only get worse.

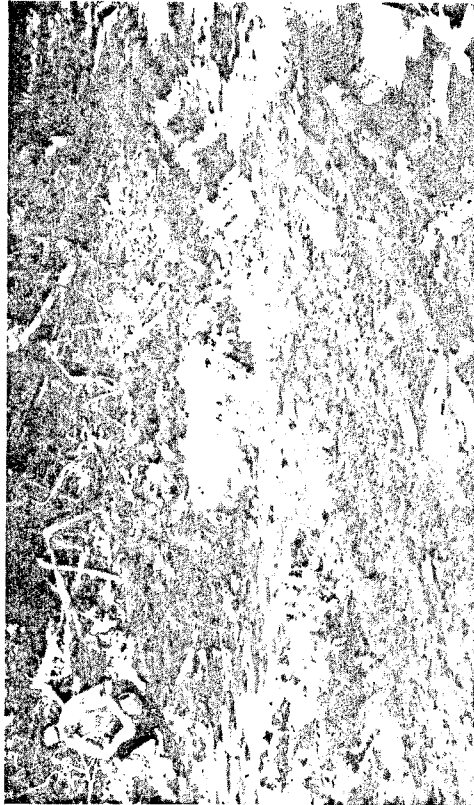
NATURAL DRAIN - CORRECT

Periodic cleaning of debris and mud kept this natural drain open and prevented the development of impassable conditions.
