EASTERN CONNECTICUT ENVIRONMENTAL REVIEW TEAM REPORT

Sleepy Hollow Extension Subdivision East Lyme, Connecticut

Review Date: October 22, 1990

Report Date: December 1990

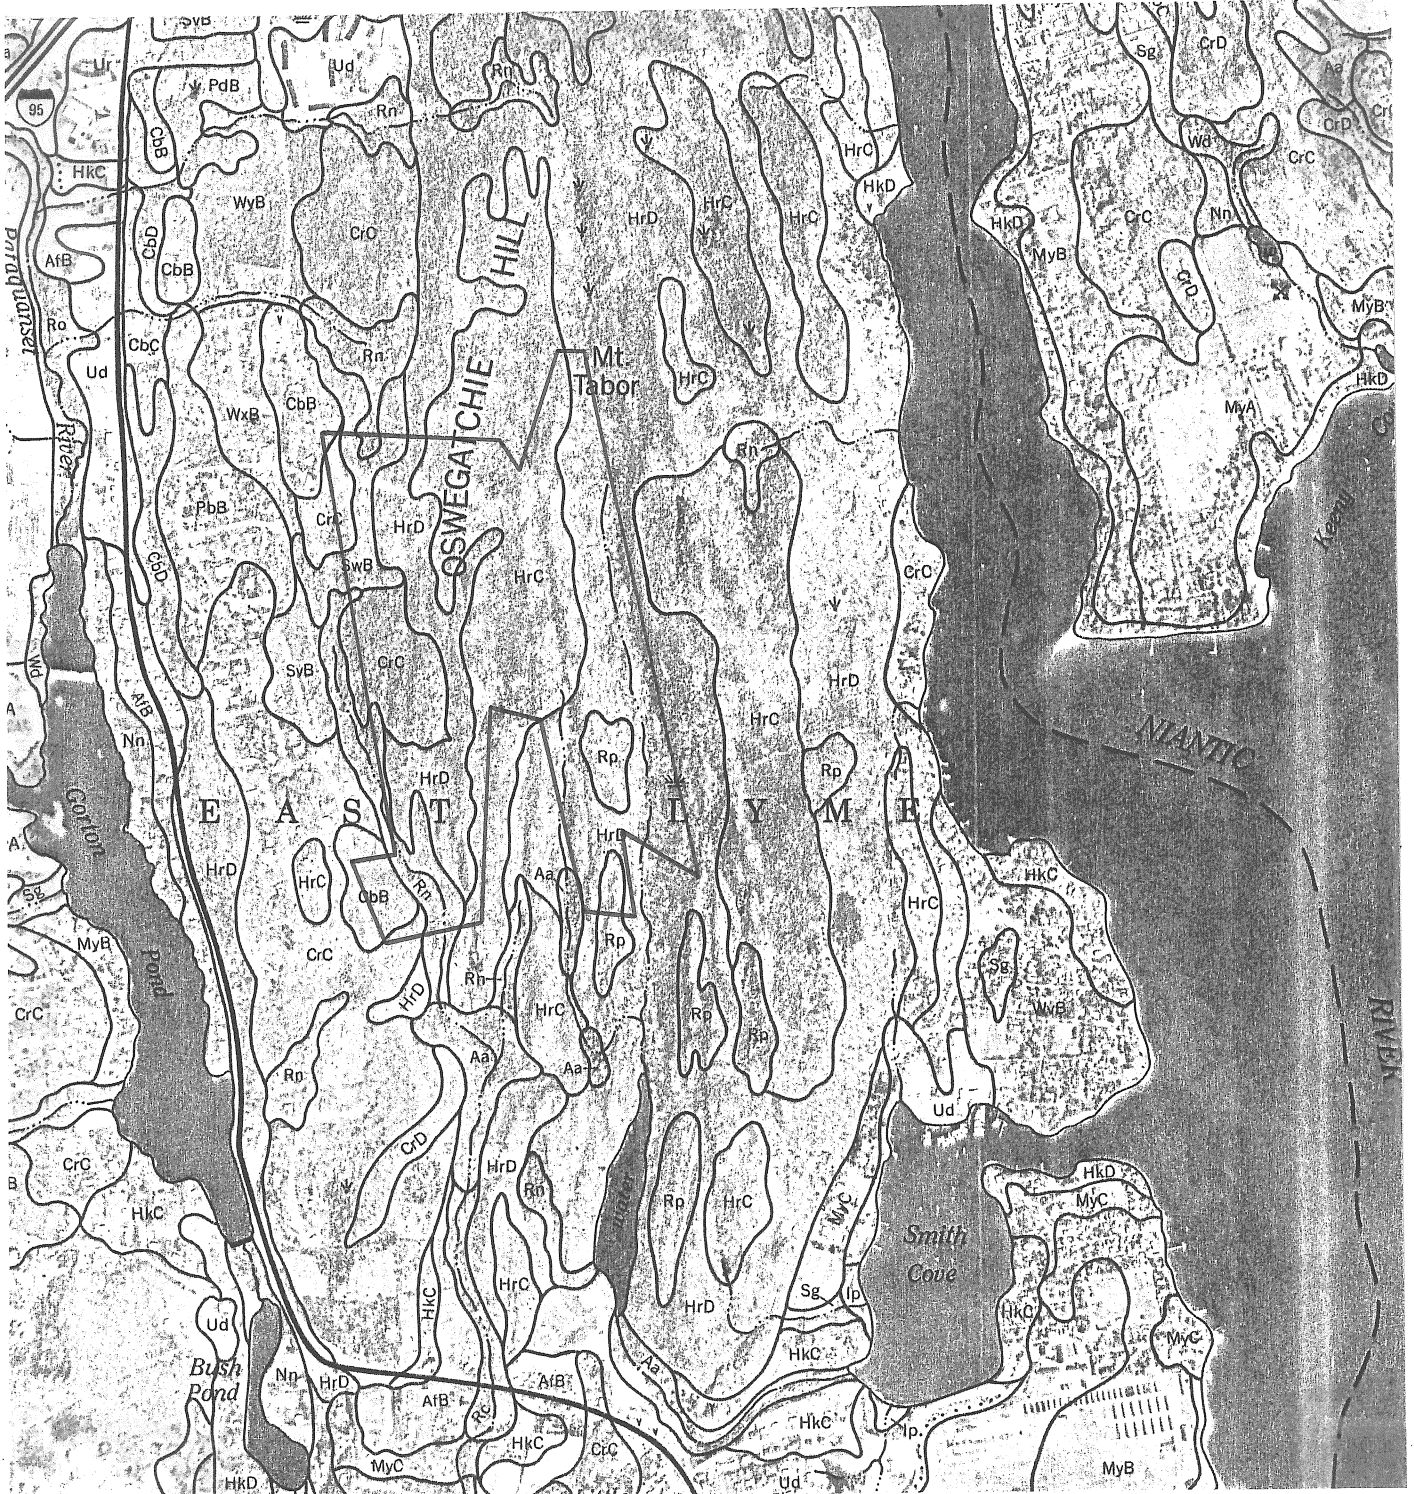
SOILS MAP

— Approximate Site Boundary

The soils on the site are very rocky Charlton-Hollis and Hollis-Charlton rock outcrop complexes. The slopes are steep and the hazard for erosion is severe. Bedrock is also a limiting factor for excavation and septic system design. Increasing the area of investigation to utilize the deepest soils for septic system design and an engineered system will be necessary. The soils in phase I are mainly (CbB) Canton-Charlton and (Rn) Ridgebury Leicester and Whitman extremely stony. The CbB soil mapping units are generally favorable to site development. The terrain becomes less desirable in phase II.
