FAIRFIELD OPEN SPACES

Springer Glen, Millspaugh, Drake Lane, Flower House Drive, Riverfield

Environmental Review Team Report

OCTOBER 1988

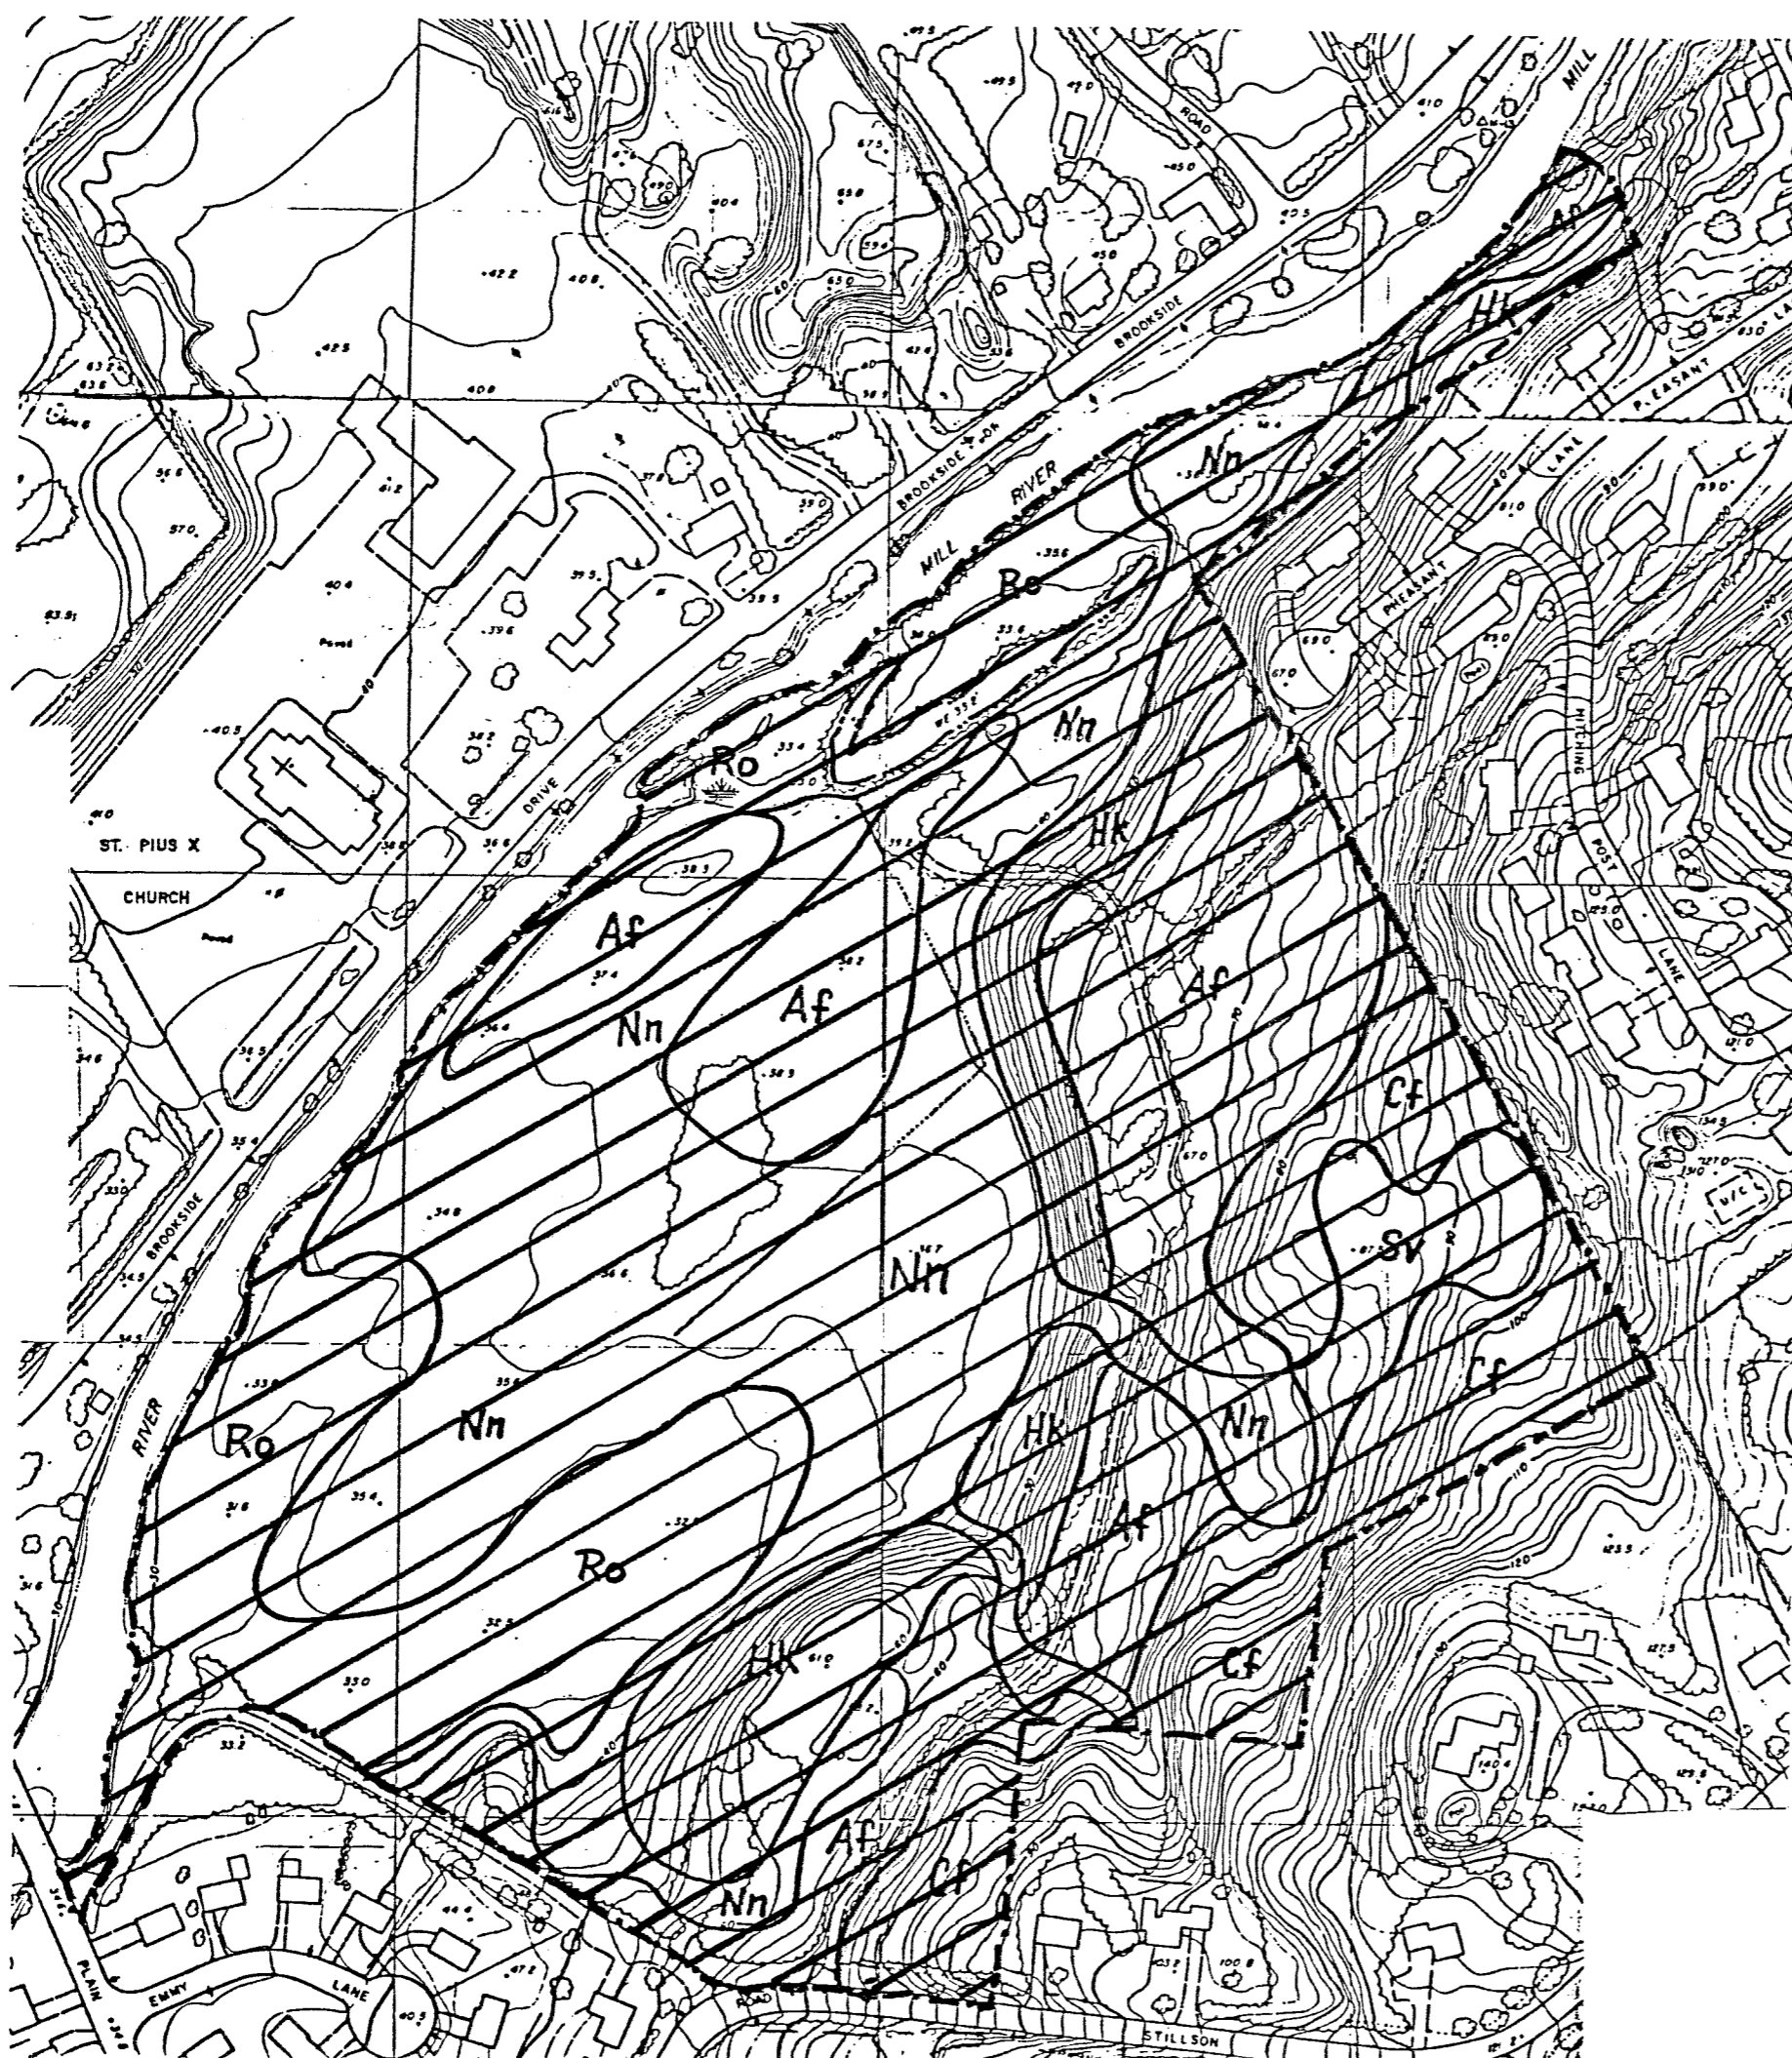
Figure 6

Trap Falls Formation

Bedrock does not appear to be exposed on the site. According to the Bedrock Geological Map of Connecticut (Rodgers, 1985), bedrock underlying the site is classified as the Trap Falls Formation (see Figure 6). It is described as a gray to silvery, partly rusty-weathering, medium grained schist.

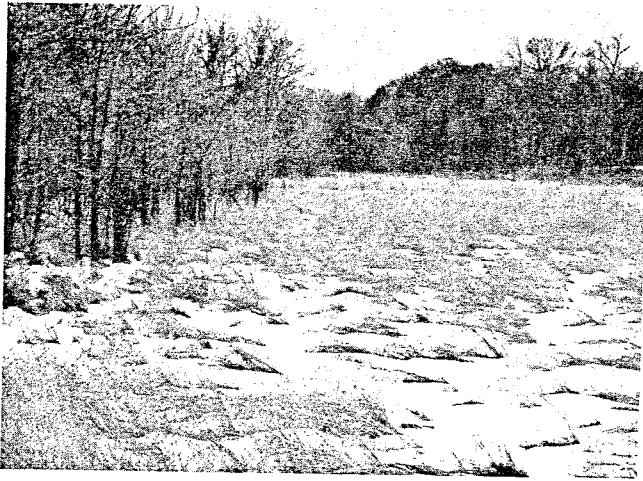
PLATE 28

A boggy field at Riverfield Park. Note the abrupt transition between it and the red maple swamp on the left.

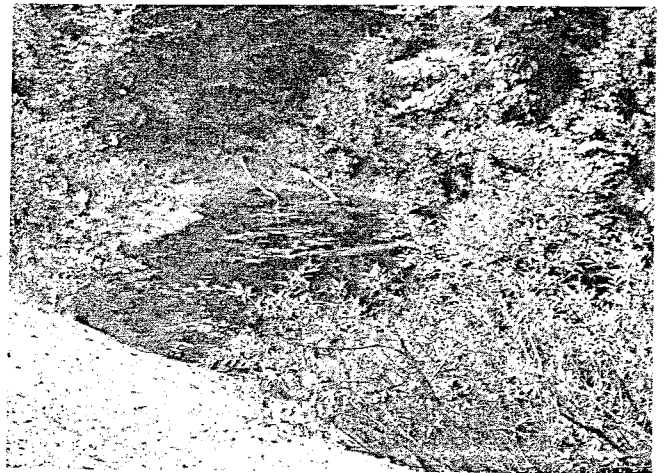
PLATE 29

One of two small pools lying only a few feet from the river in Riverfield Park. Willows and other shrubs are taking hold on the disturbed area.

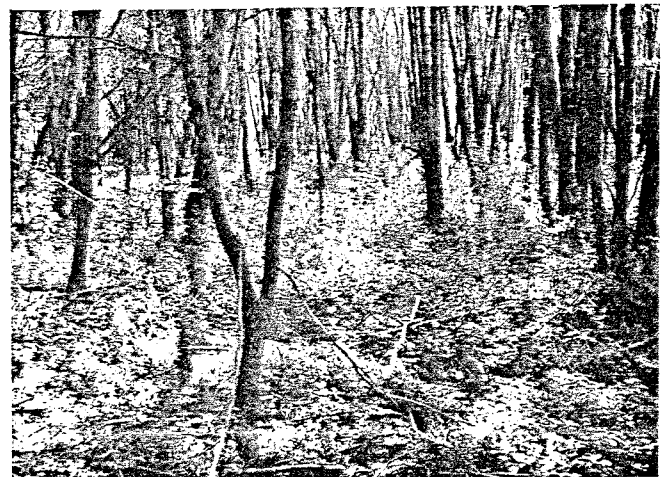
PLATE 30

This open red maple woods at Millspaugh Drive is partly in public open space (foreground) and partly in private ownership (rear).

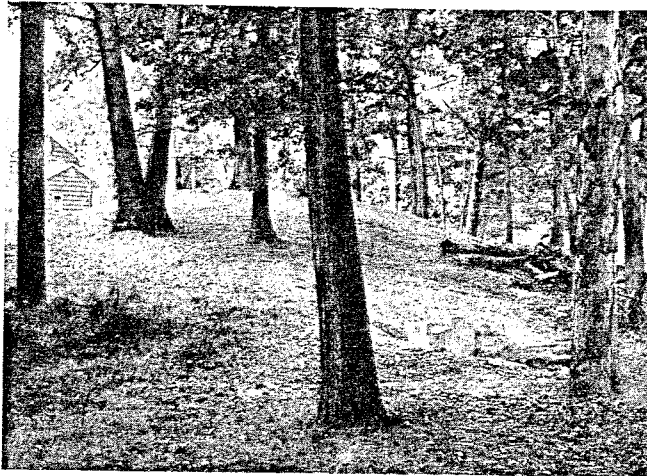
PLATE 31

Old, second-growth oak dominates this area lying west of the river in the Millspaugh Drive tract.

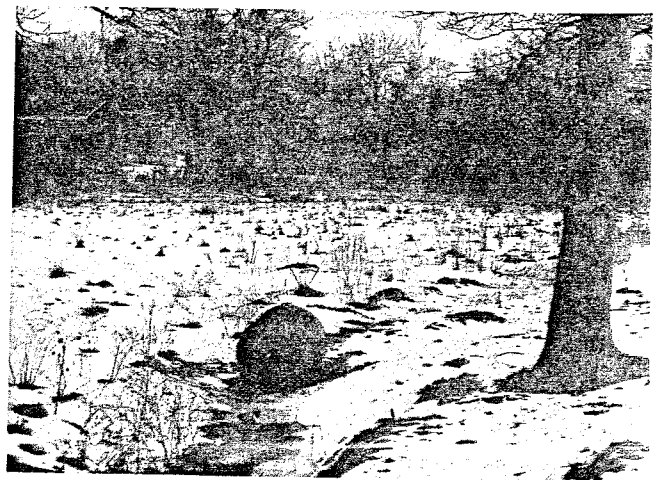
PLATE 32

A small ball field or playground would be well suited to this open area at the Millspaugh Drive tract. The river is beyond tree line in background.

2. Construct a ball field in the dry field of the tract (Fig. 1, section proposed for intensive use). While many of the Town's open space tracts along the Mill River are best suited to uses that are as important to the whole Town as to the immediate communities, we believe that this part of the Millspaugh Drive tract is better suited to active recreation for local residents. A moderate amount of earth fill at the river (or downhill) end of the field would level the field, help drain it, and enable it to support short grasses. Retention of a shrub and tree layer between the river and the field would help confine play to the field itself.
