Hartford's
Camp Courant
Nature Trail/
Outdoor Classroom

Farmington, Connecticut

Eastern Connecticut
Environmental Review Team
Report

March 2000

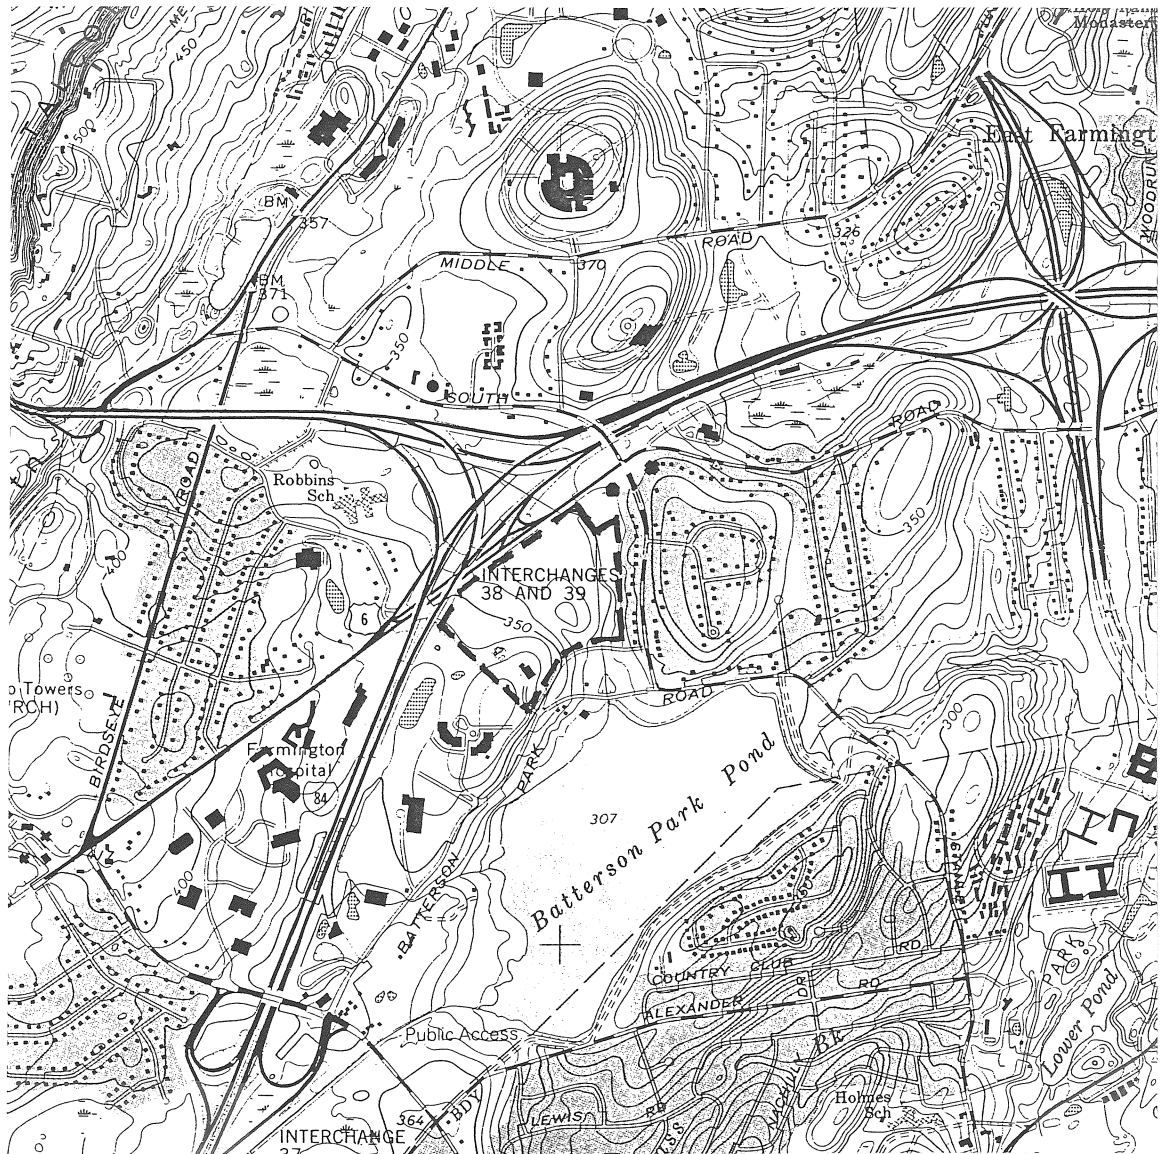
Figure 1.

Location and Topographic Map

Scale 1" = 2000'

The Hartford City Manager has requested assistance from the Eastern Connecticut Environmental Review Team in conducting an environmental review of the proposed outdoor classroom/nature trail at Camp Courant in Farmington. (Figure 1)

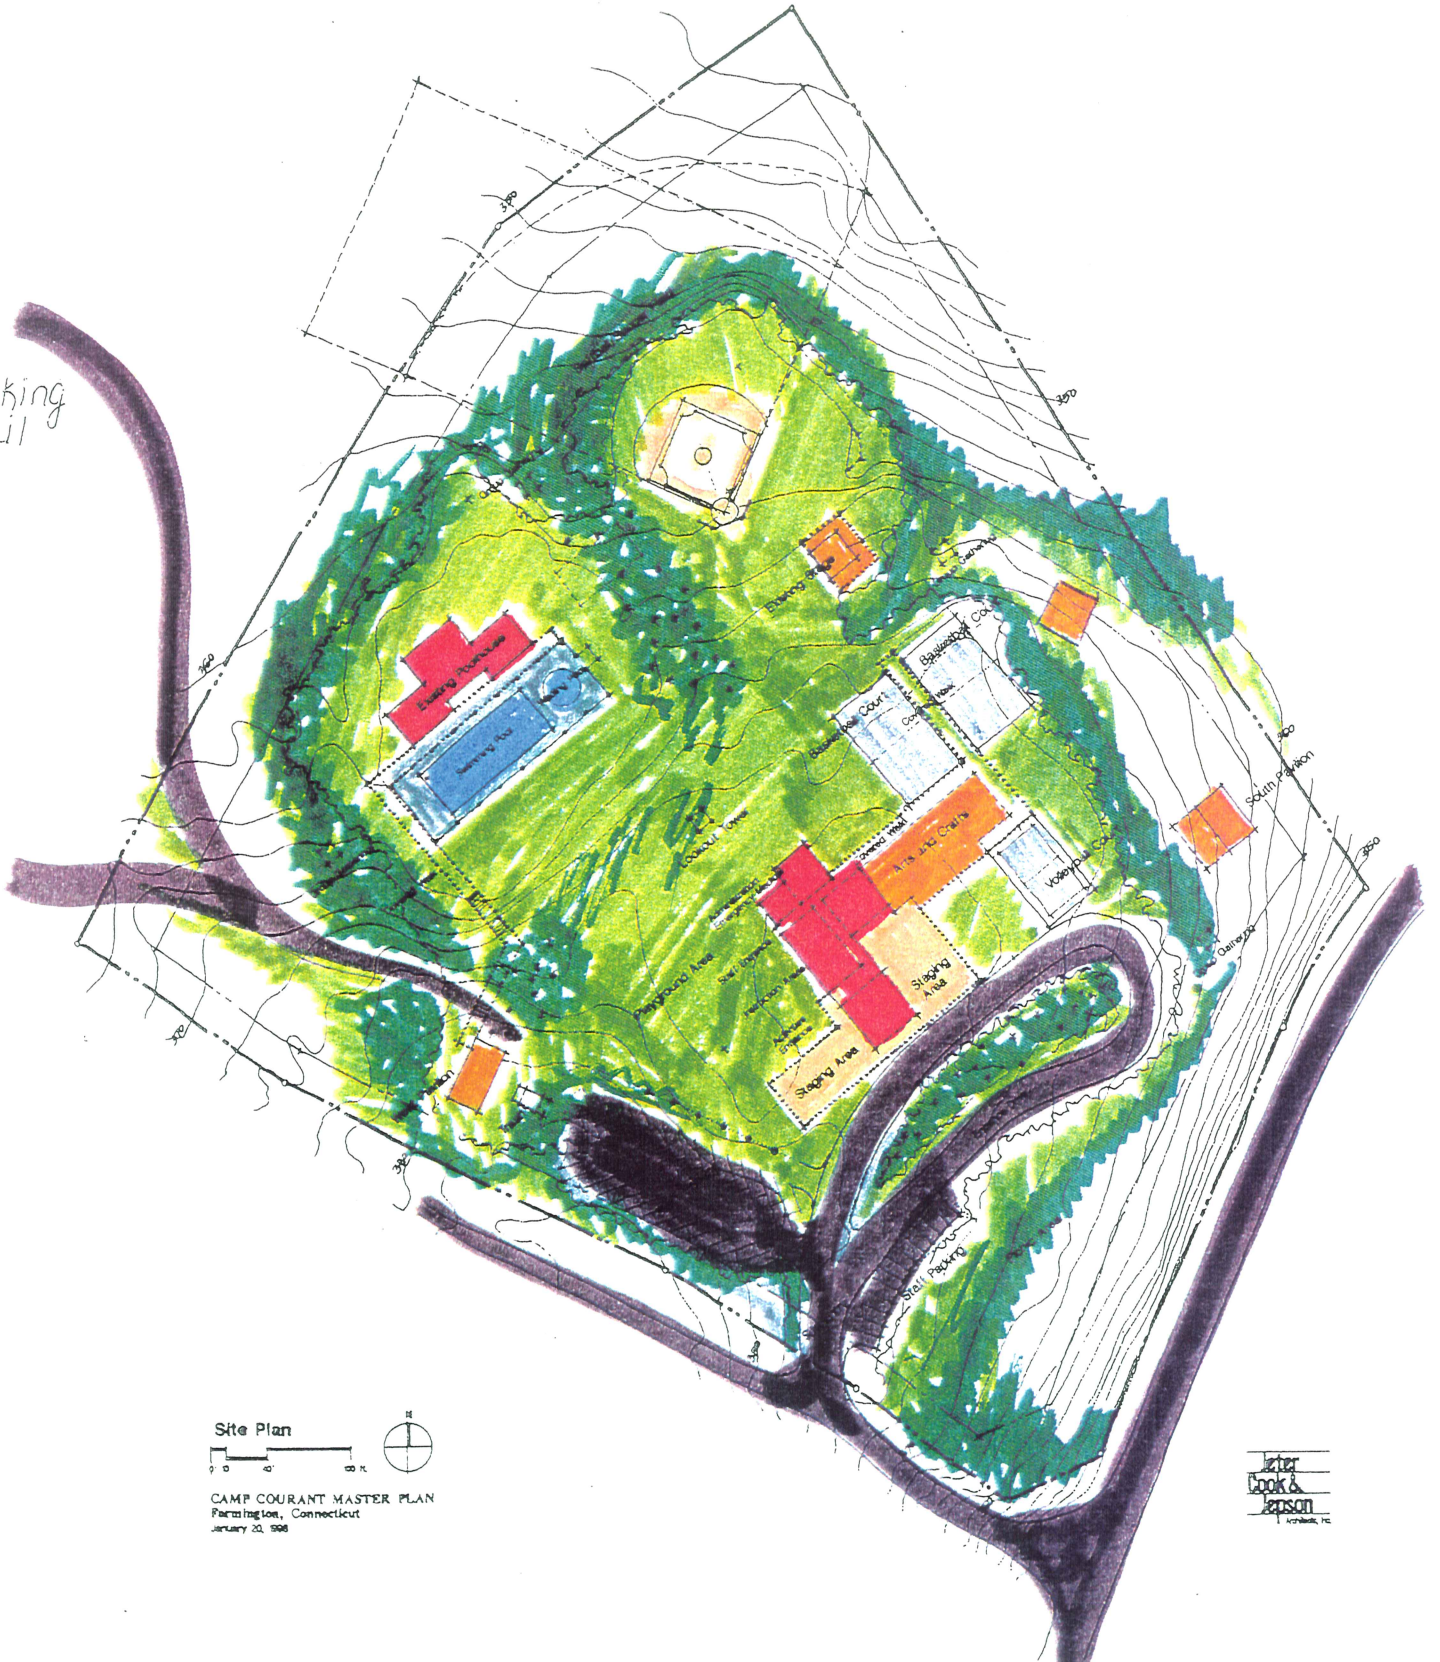
Figure 2.

Camp Courant Master Plan Map
13 acre current program area

Site Plan
0 40 80 ft
CAMP COURANT MASTER PLAN
Farmington, Connecticut
January 20, 1968

Camp Courant is located on 36 acres on Batterson Park Road across from Batterson Park in Farmington. The property is owned by the City of Hartford and leased to Camp Courant. The camp is operated as a free summer day camp for city children. The camp serves approximately 2500 children during a seven week season. The children range in age from five to 12. The camp currently uses 13 acres for program space and buildings. Current activities include athletics, a low ropes challenge course, computer laboratory, creative arts, special programs and an early learning program. (Figure 2)

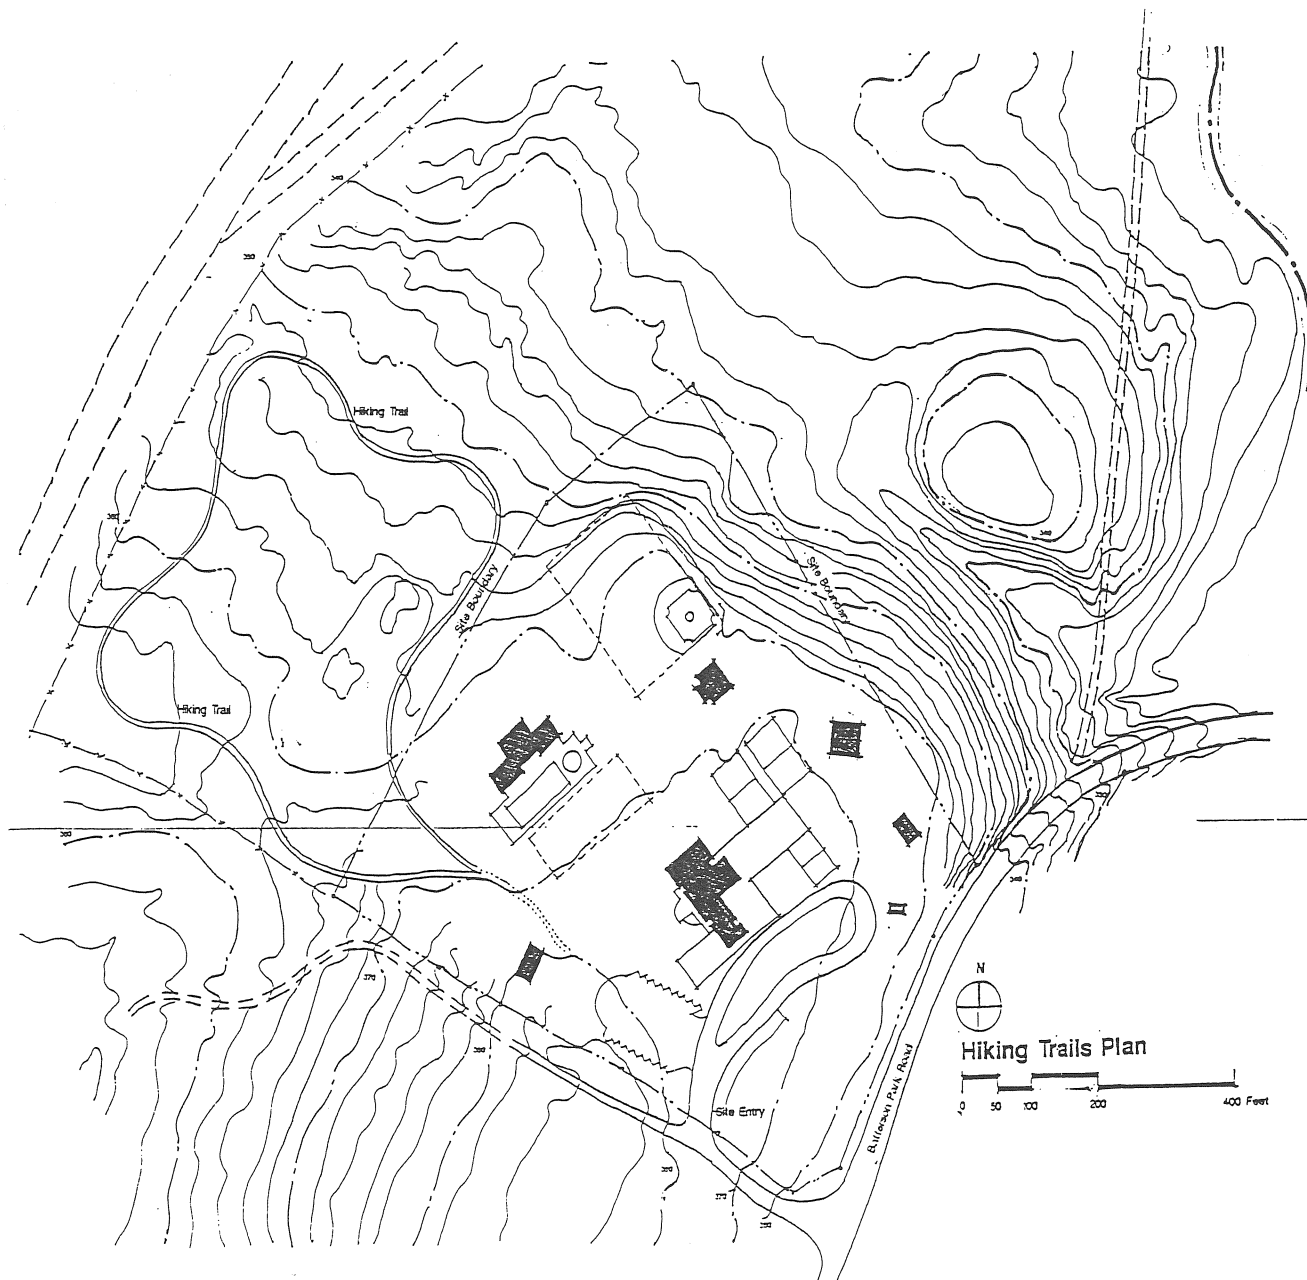
Figure 3.

Hiking Trails Concept Plan Given to Team Members

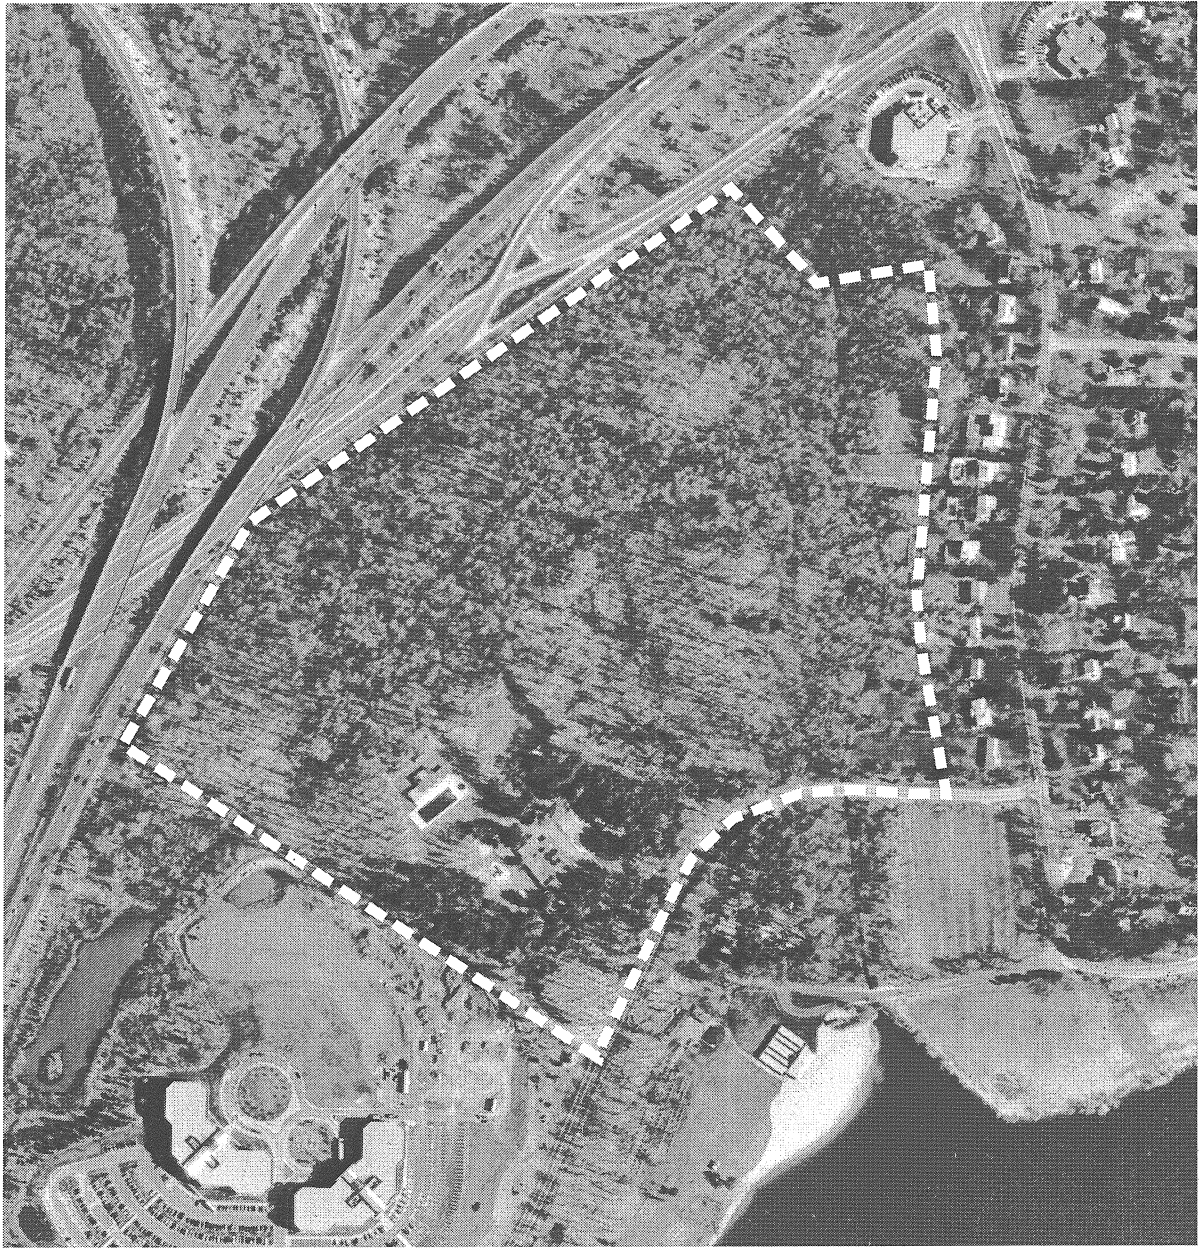
Figure 4.

Camp Courant, Farmington CT

The 36 acre parcel belonging to Camp Courant straddles a north-northeast valley drained by a permanent stream which flows into Batterson Pond (Figure 4).

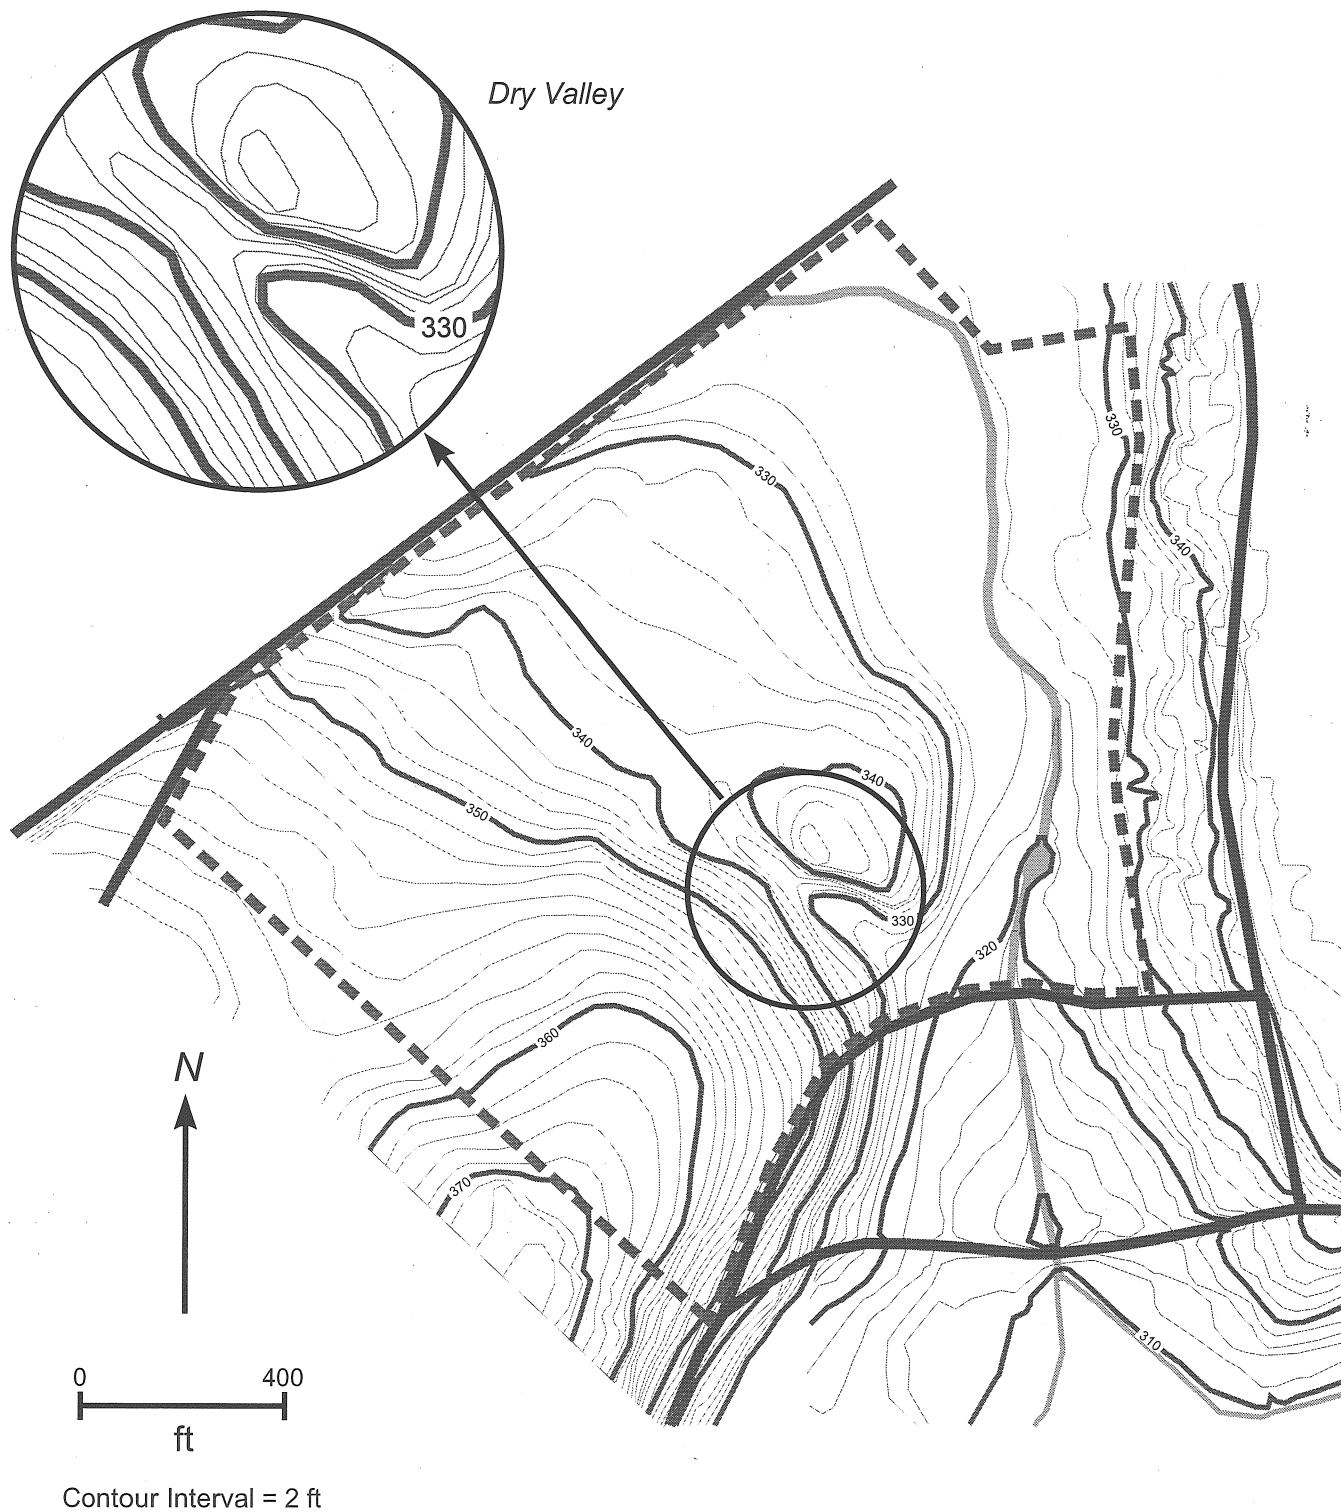
Figure 6.

Topography of Camp Courant showing detail of the 'Dry Valley'

Slopes are gentle most everywhere except along a steep sided northwest-southeast ravine just east of the main camp buildings. This "dry valley" is perhaps the most unique and interesting natural feature of the property.

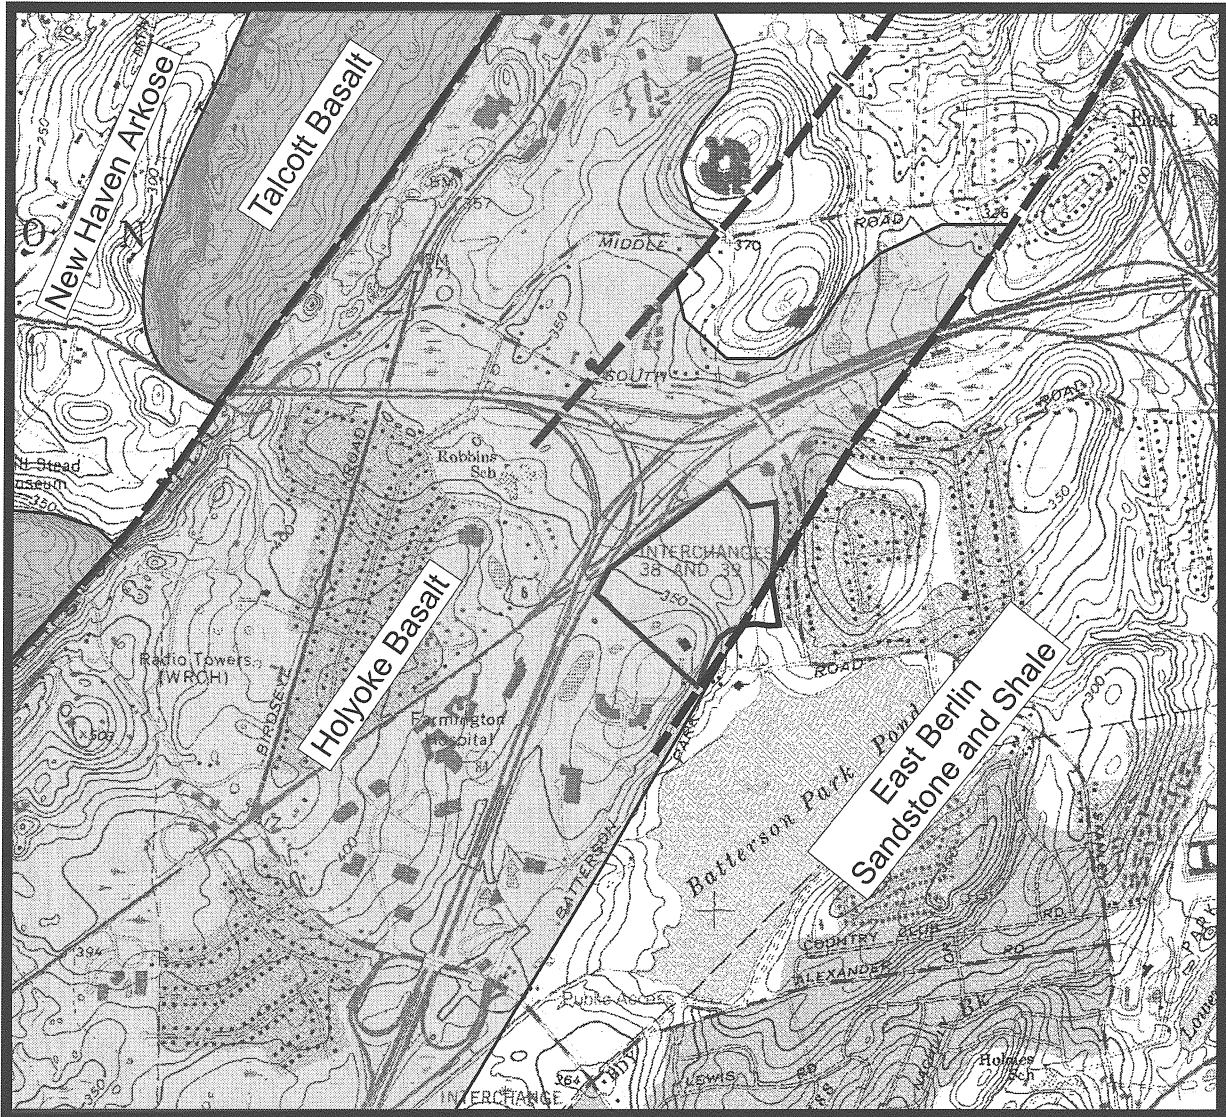
Figure 7.

Bedrock Geology in the Neighborhood of Camp Courant

Although not exposed anywhere on the property the bedrock beneath the till is either the Holyoke basalt lava flow or the red sandstones and shales belonging to the New Britain Formation. The upper contact of the Holyoke is inferred to pass along the southern boundary of the camp. (Figure 7) The bedrock is roughly 200 million years old and was deposited just as Pangea began to break up to form the Atlantic Ocean.

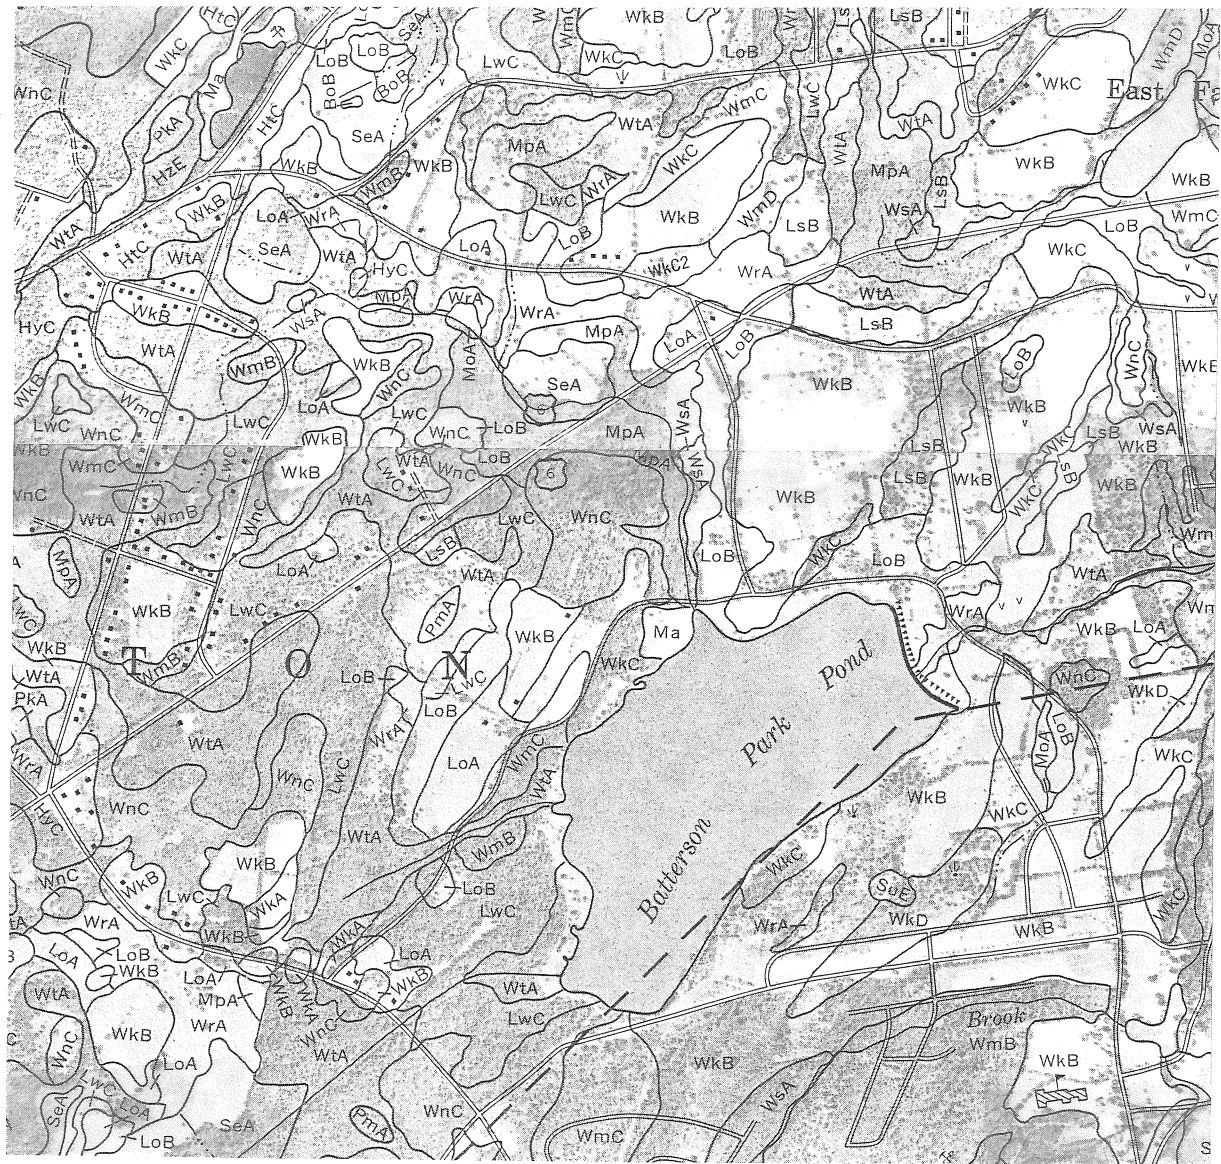
Figure 8.

Soils Map

Scale 1" = 1667'

The general mapping unit descriptions from the USDA Hartford County Soil Survey, 1962, shows that the site contains a range of well drained to poorly drained soils including; Ludlow, Watchaug, Menlo, Wethersfield and Wilbraham soil types. Reference the soil tables and descriptions for more information (see Appendix A). The soil survey information is intended for use as a general planning tool and its limited accuracy may have excluded wetland inclusions.

The wet soils appear to border the property on the east, north and west sides while the well drained soils are located in the center. Most soils on site tend to be well drained and well suited for recreation trails if properly installed and maintained. Some wet area crossings may be needed in the poorly drained soil types. Please keep in mind that wetlands are regulated and that local and state permits may be needed before work begins in or near wetlands. There are two areas along the trail that may contain vernal pools (please refer to Wetland Review and

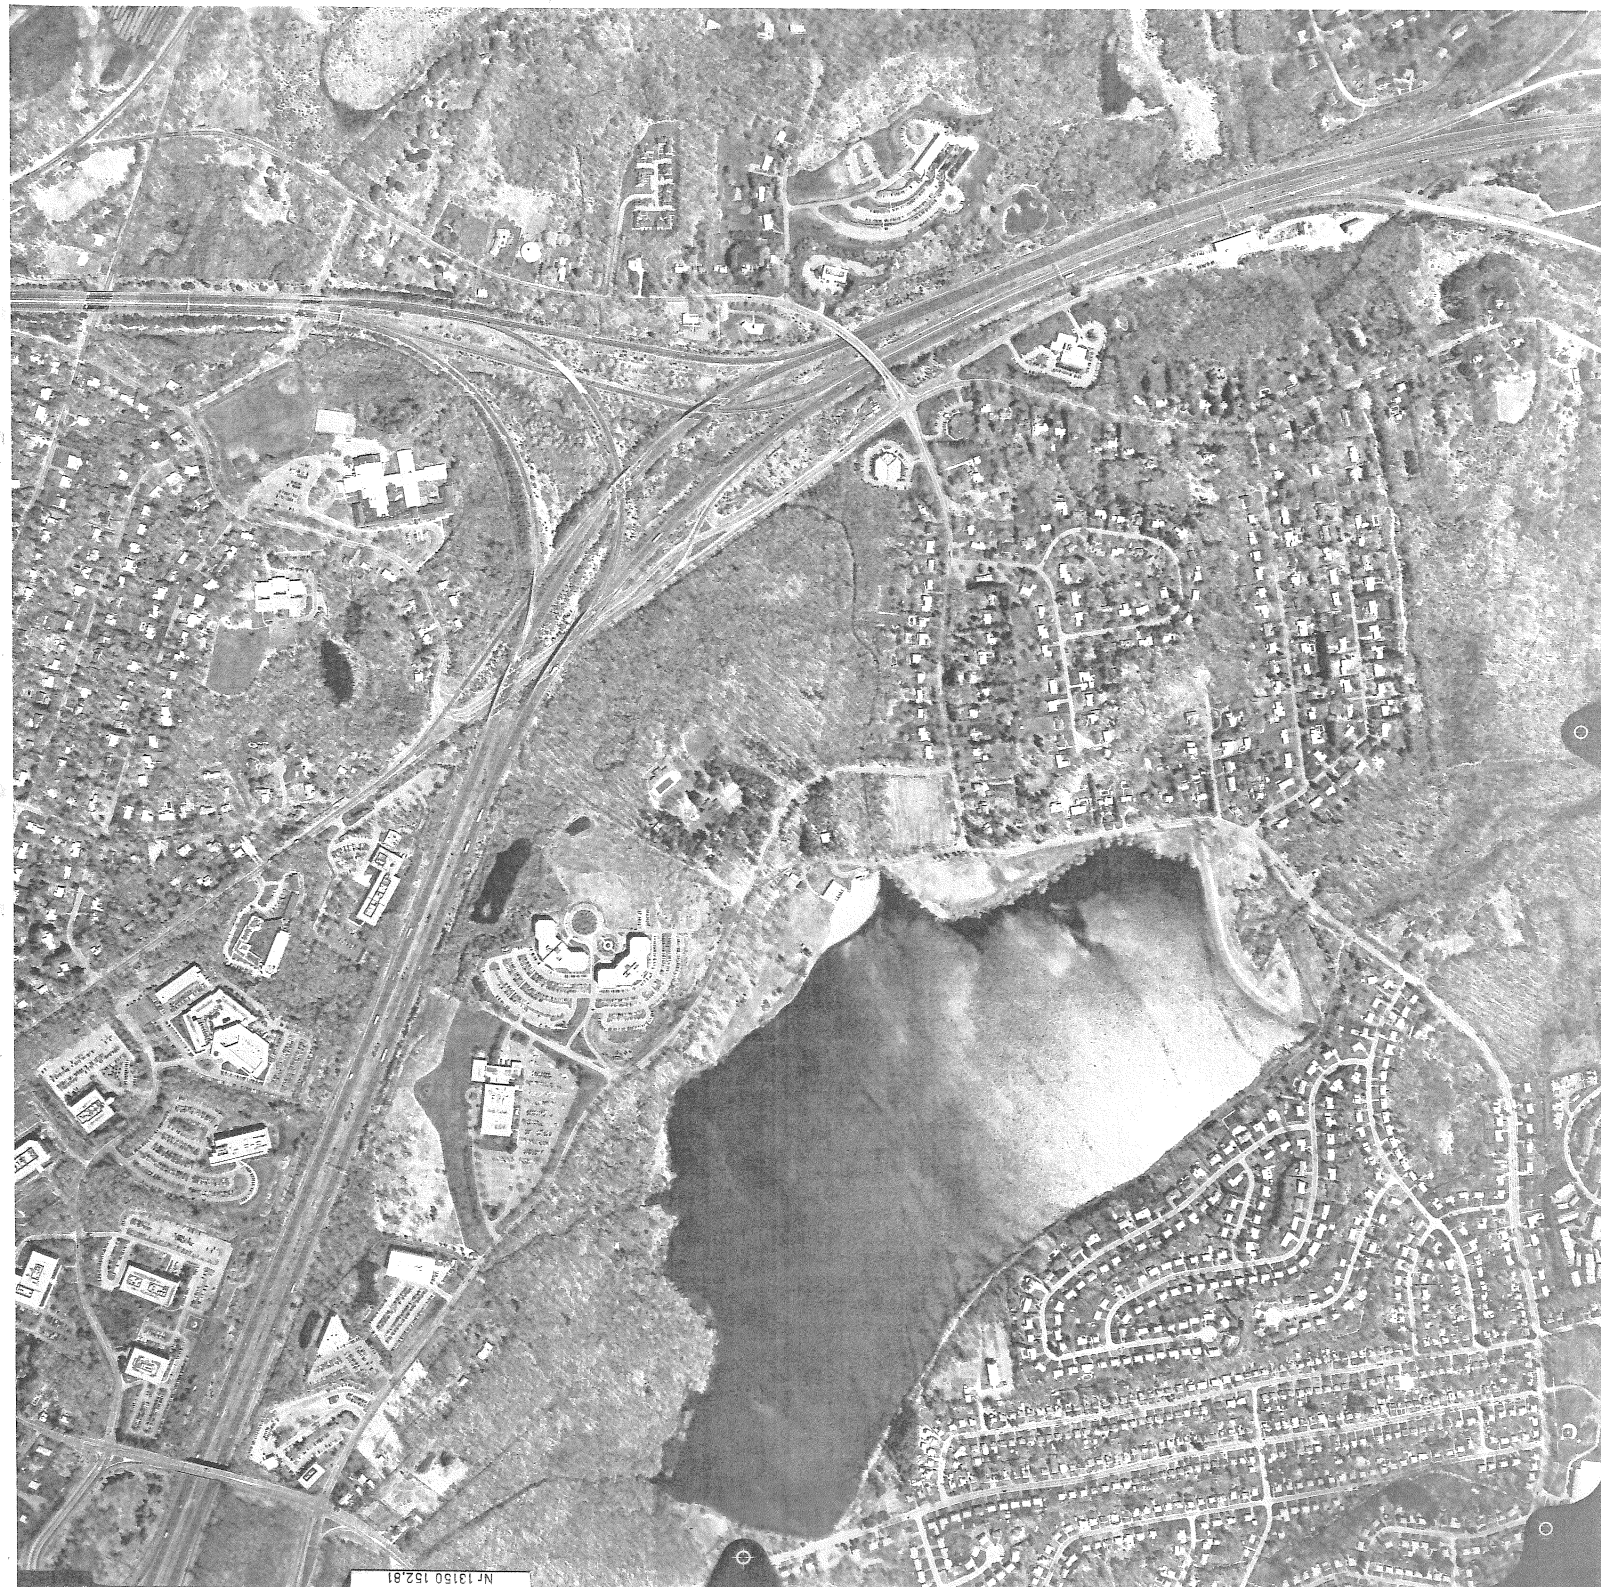
Figure 9.

Aerial Photo

Scale 1" = 1000'
