Tunxis Mead Park Expansion

Eastern Connecticut Environmental Review Team Report

Tunxis Mead Park Expansion Farmington, Connecticut

May 2000

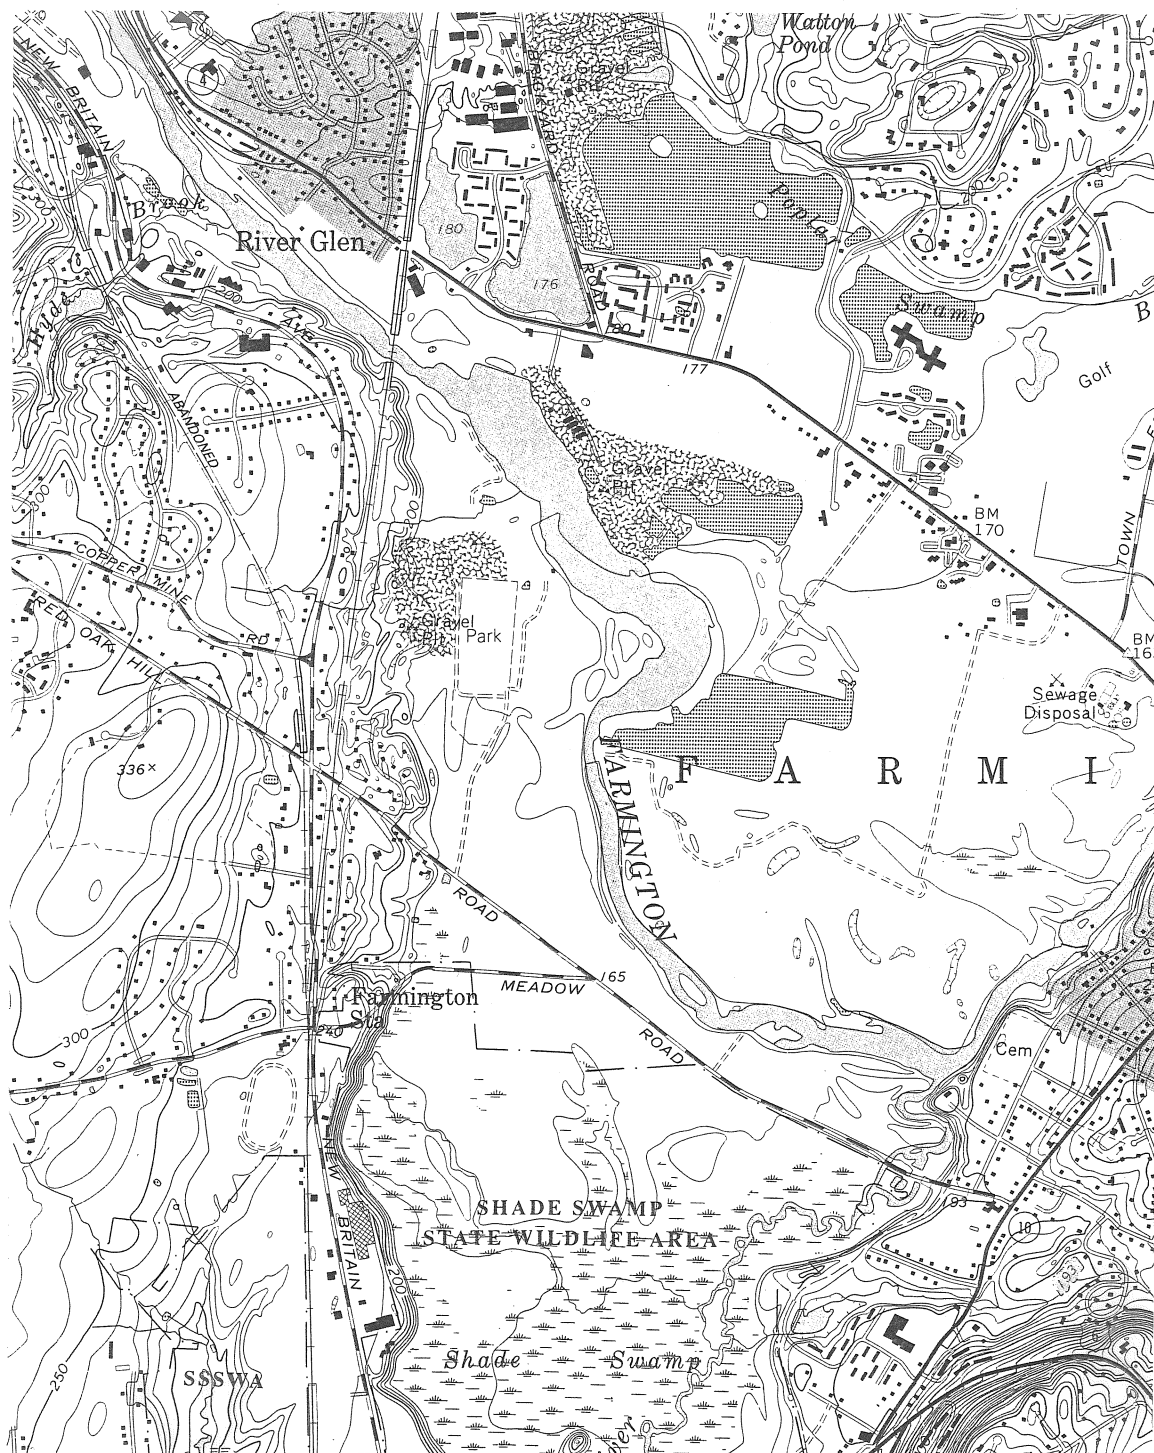
Figure 1.

Location and Topographic Map

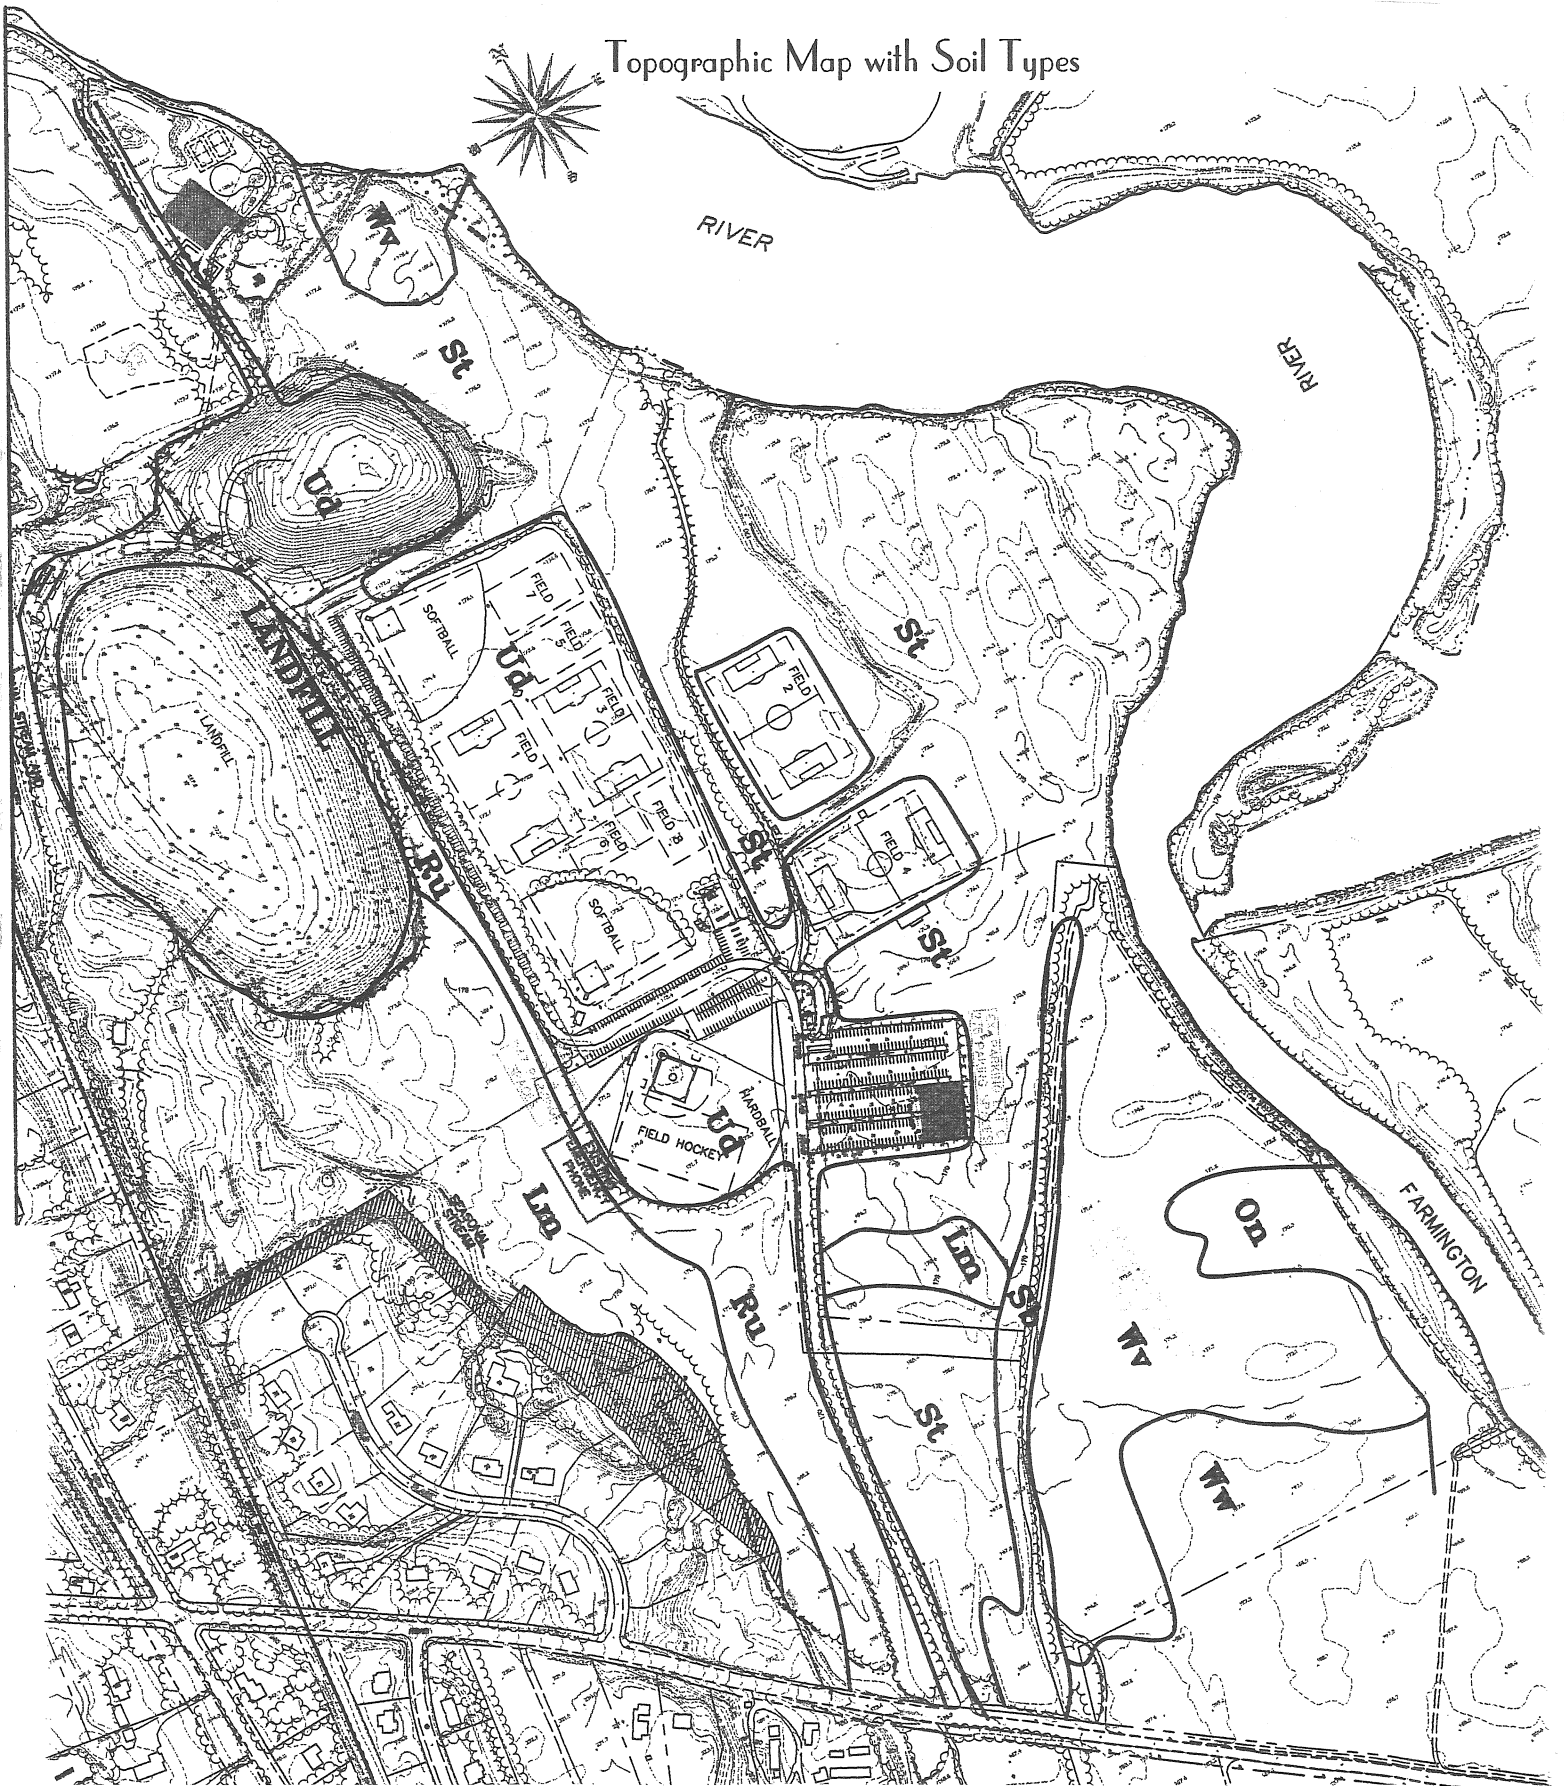
Figure 3.

Topographic Map with Soil Types

According to the USDA Soil Survey of Hartford County, 1962, most of the woodland contains Suncook loamy sand (StA), an excessively drained soil. The gravel pit area has been disturbed and now includes a pond and stockpiles of soil. A drainage swale diverts water away from the gravel pit area through the woodland and outlets into the pond. Other soils found in the parcel are Podunk sandy loam (PoA), Limerick silt loam (LmA), Ondawa sandy loam (OnA) Riverwash (Re), Rumney sandy loam (RuA), and Windsor loamy fine sand (WvA). Limerick and Podunk soils tend to experience frequent flooding with short durations in the winter and early spring. Rippowam soils tend to flood frequently with short durations from fall through spring and Suncook soils tend to flood frequently with brief durations in the spring time. Occum soils may flood occasionally and Windsor soils generally do not flood. See the soil tables and soil map for more details (Appendix A).

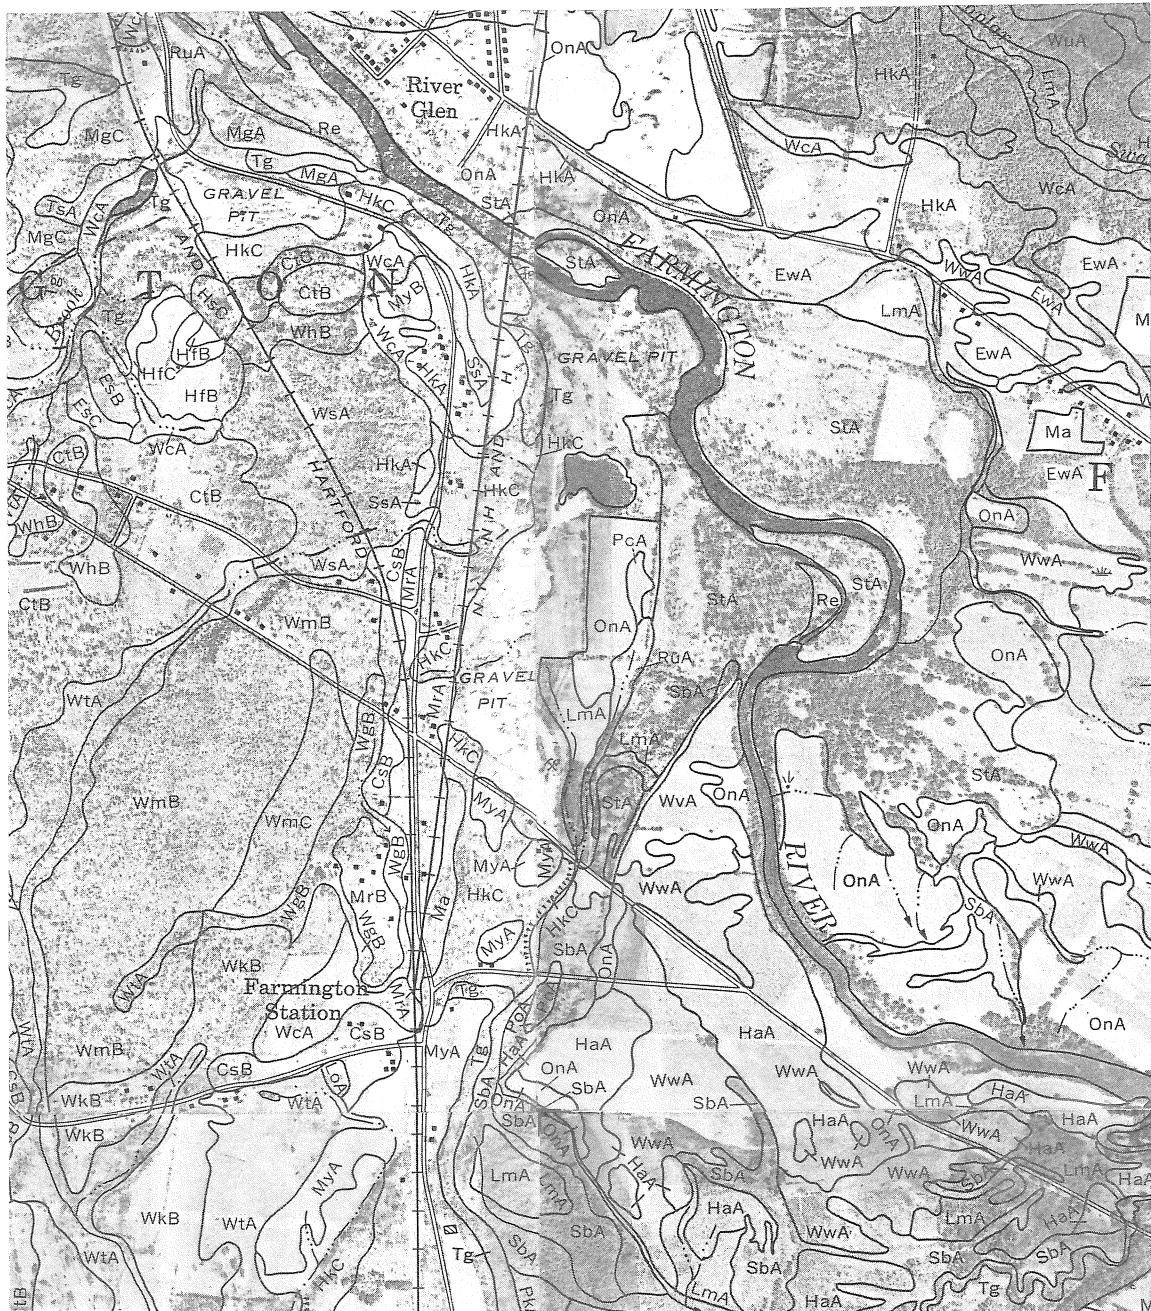
Figure 4.

Soils Map

Excessively well and well-drained alluvial soils make up a majority of the inland wetland soil map units of this study area (see soil map unit "St" on accompanying map). An area of poorly drained, alluvial soil (Ru, Lm) has been mapped to the west of the park access road.
