ENVIRONMENTAL REVIEW TEAM REPORT

SOUTHWESTERN CONNECTICUT GIRL SCOUT CAMPS

KING'S MARK
ENVIRONMENTAL REVIEW TEAM REPORT

MARCH 1982

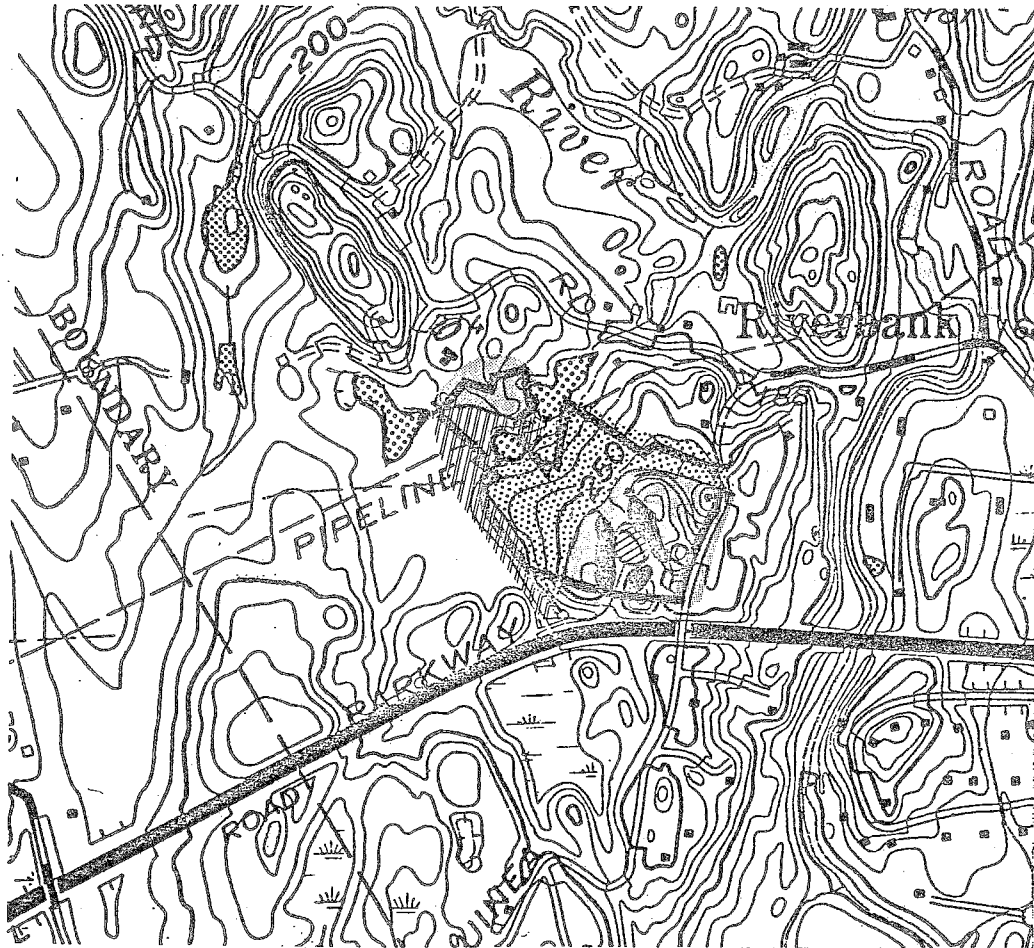
FIGURE 2.2
SURFICIAL GEOLOGY

Swamp and floodplain sediments. Sand, silt, and clay mixed with decayed organic materials.
