**YMCA  
LATHAM  
CENTER**

**Groton,  
Connecticut  
July 1990**

**Eastern  
Connecticut  
Environmental  
Review  
Team  
Report**

**YMCA LATHAM CENTER  
Groton, Connecticut**

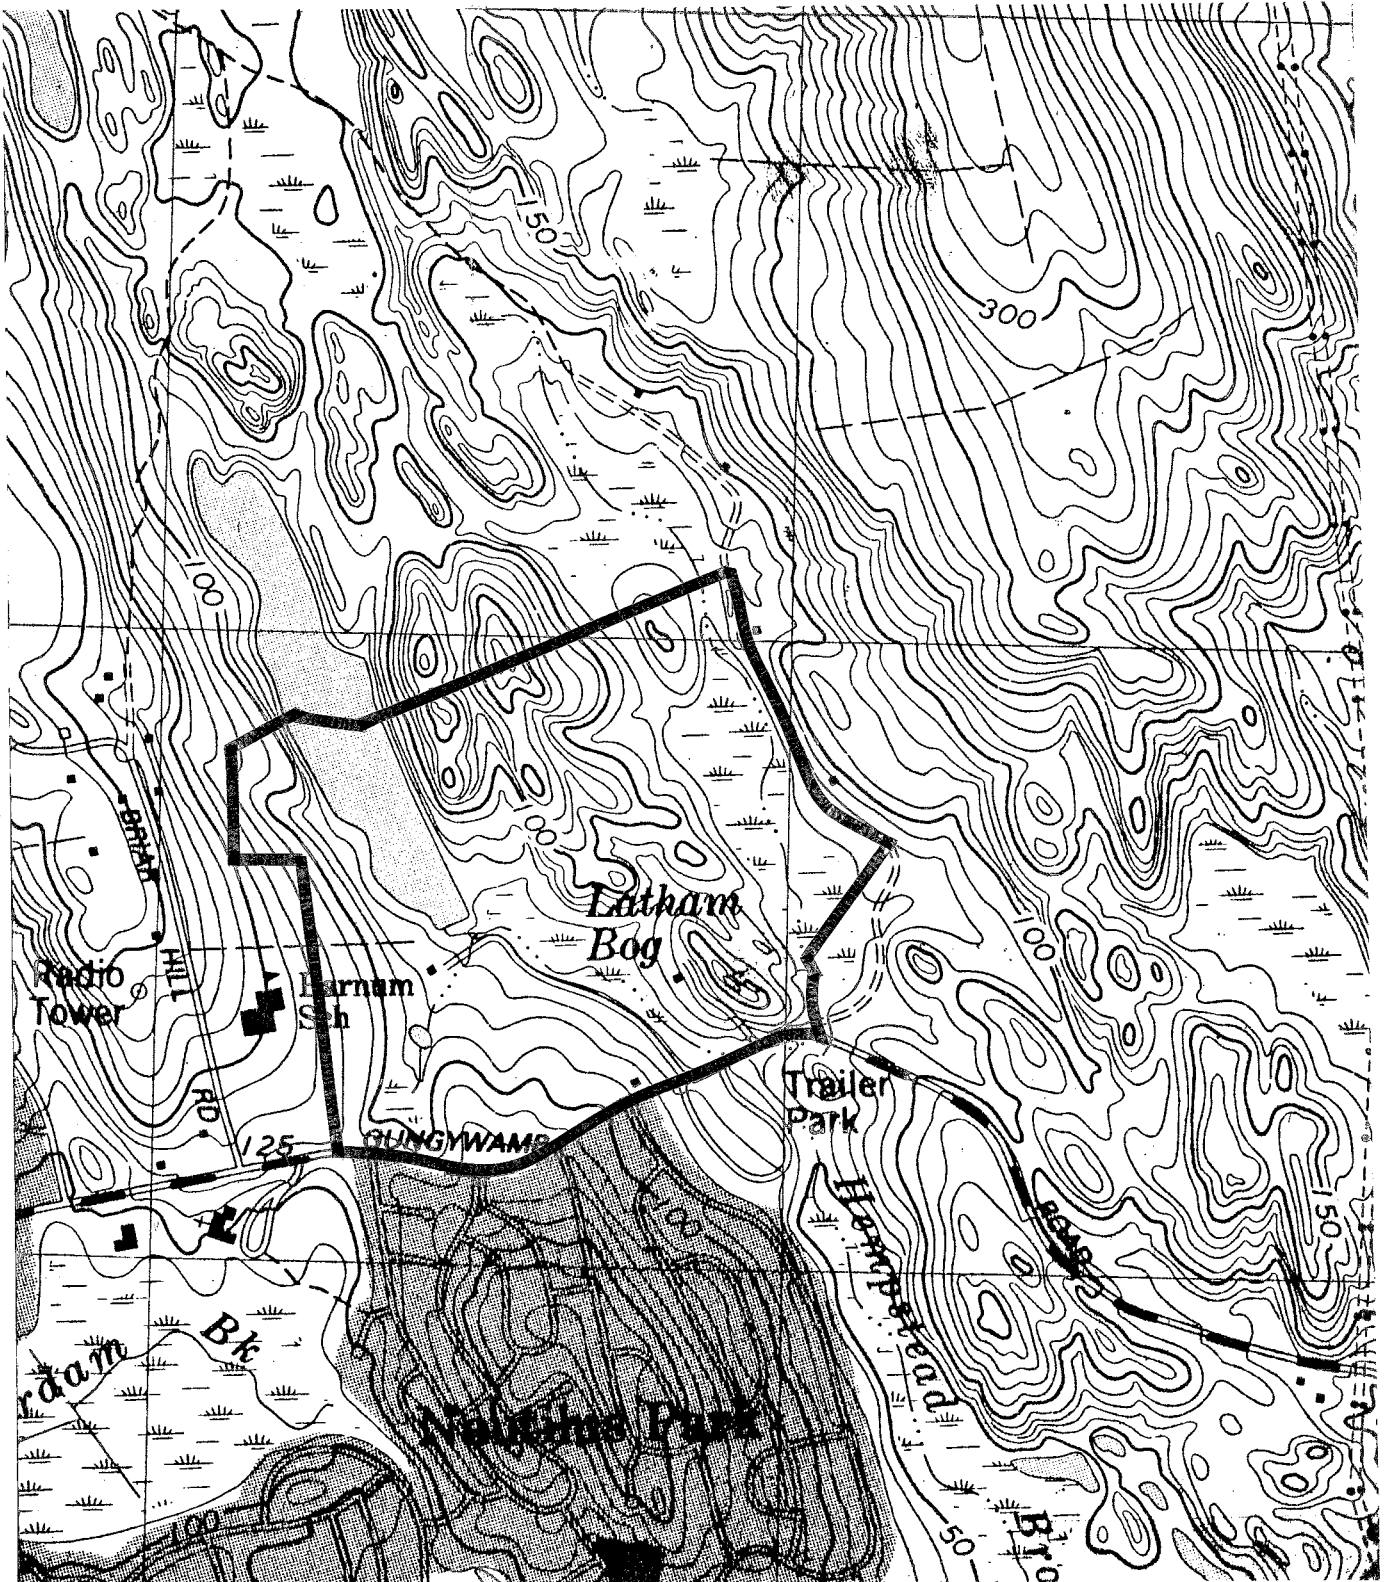
## TOPOGRAPHIC MAP

Approximate Site Boundary

The principal topographical features of the site are found in the low-lying parts of the site and include Latham Lake in the northeast corner, Latham Bog southeast of the Lake, and a  $\pm 22$  acre wetland in the eastern parts. The remainder of the site consists of bedrock controlled uplands that have slopes which range from gentle to very steep. Steepest slopes occur mainly in the northern parts east of Latham Lake. Bedrock is at or near ground surface in this area. Gentle slopes occur mainly west of the entrance road. The remainder of the site contains moderate slopes. Maximum and minimum elevations are about 170 feet above mean sea at the site's northern limits and 70 feet above mean sea level as represented by the surface of Latham Bog, respectively.

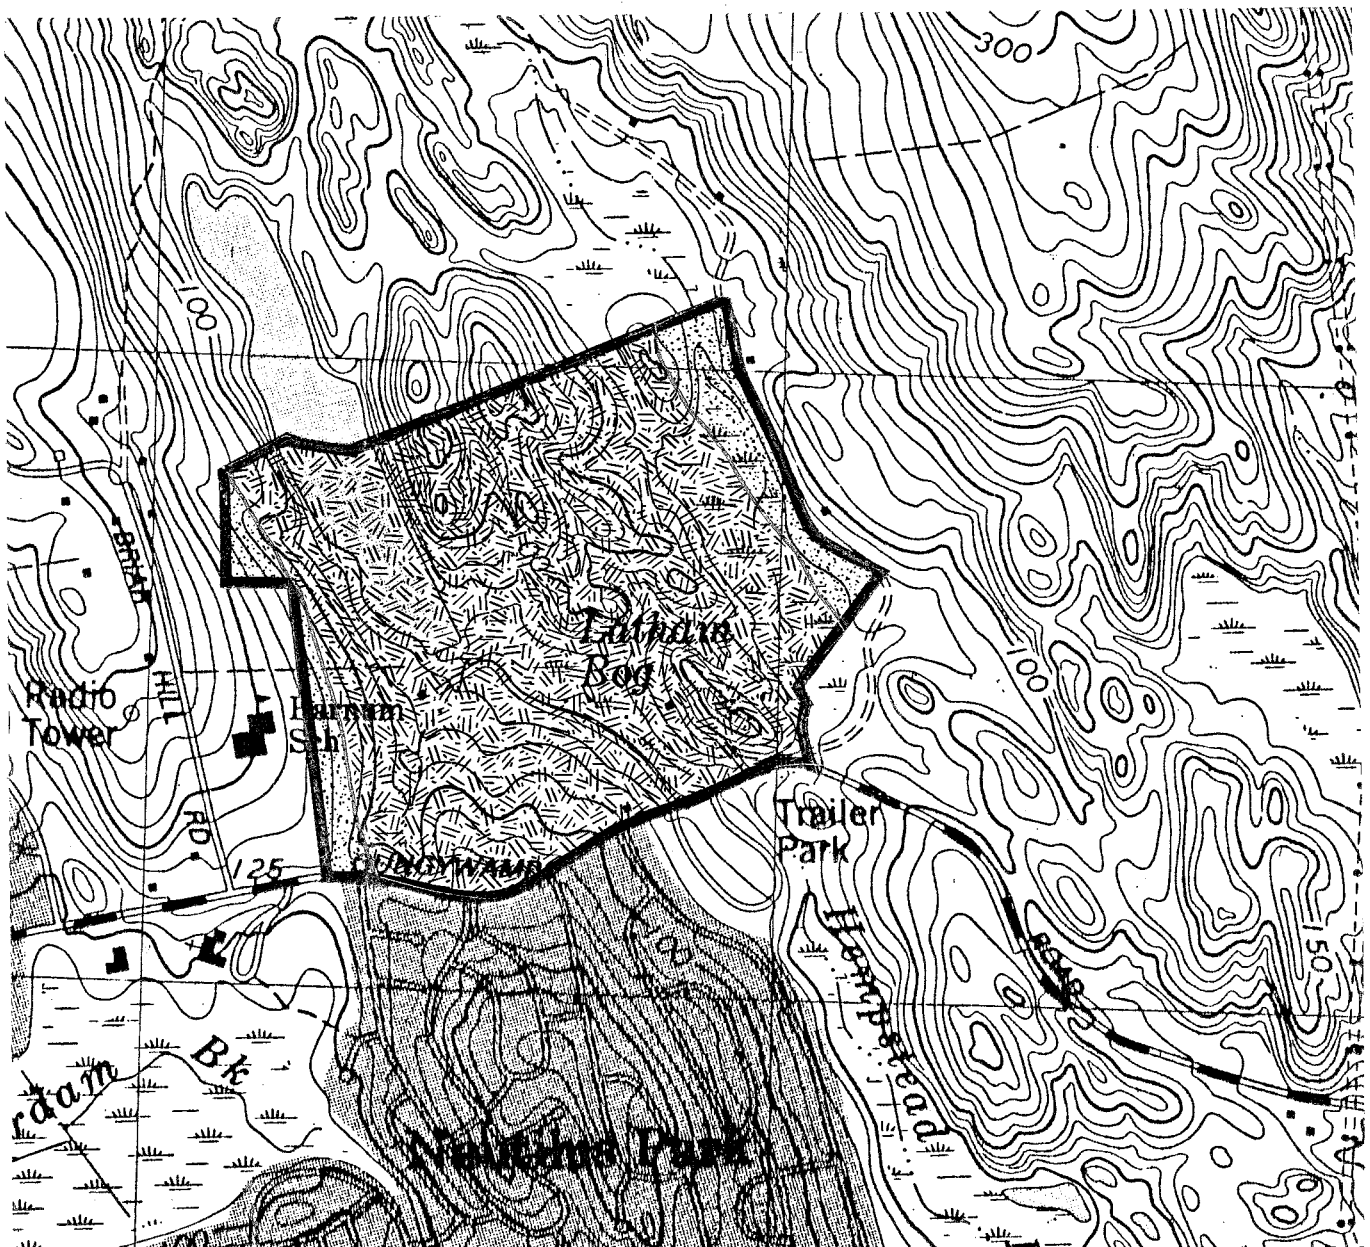
### **BEDROCK GEOLOGIC MAP**

Granitic Gneiss

Plainfield Formation

As mentioned earlier the site is controlled largely by the underlying bedrock. Bedrock is exposed mainly in interior and southern parts of the site. Goldsmith (GQ-576) identified two bedrock types on the site; a granite gneiss and Plainfield Formation. The principal rock type found on the site is a subunit of the Plainfield Formation. It occurs throughout the central parts and, in general, consists of interlayered thinly bedded quartzites, mica schists, and dark gray gneisses. At the site's eastern and western limits, the Plainfield Formation is in contact with granite gneiss. These rocks are described as orange-pink to light-gray medium grained gneissic biotite granite whose major minerals include quartz, microcline, oligoclase, biotite and iron oxides.
