**MARY HOOKER
ELEMENTARY SCHOOL
OUTDOOR CLASSROOM**

HARTFORD, CONNECTICUT

**EASTERN CONNECTICUT
ENVIRONMENTAL REVIEW TEAM
REPORT**

**Eastern Connecticut Resource Conservation and Development Area, Inc.
February 1996**

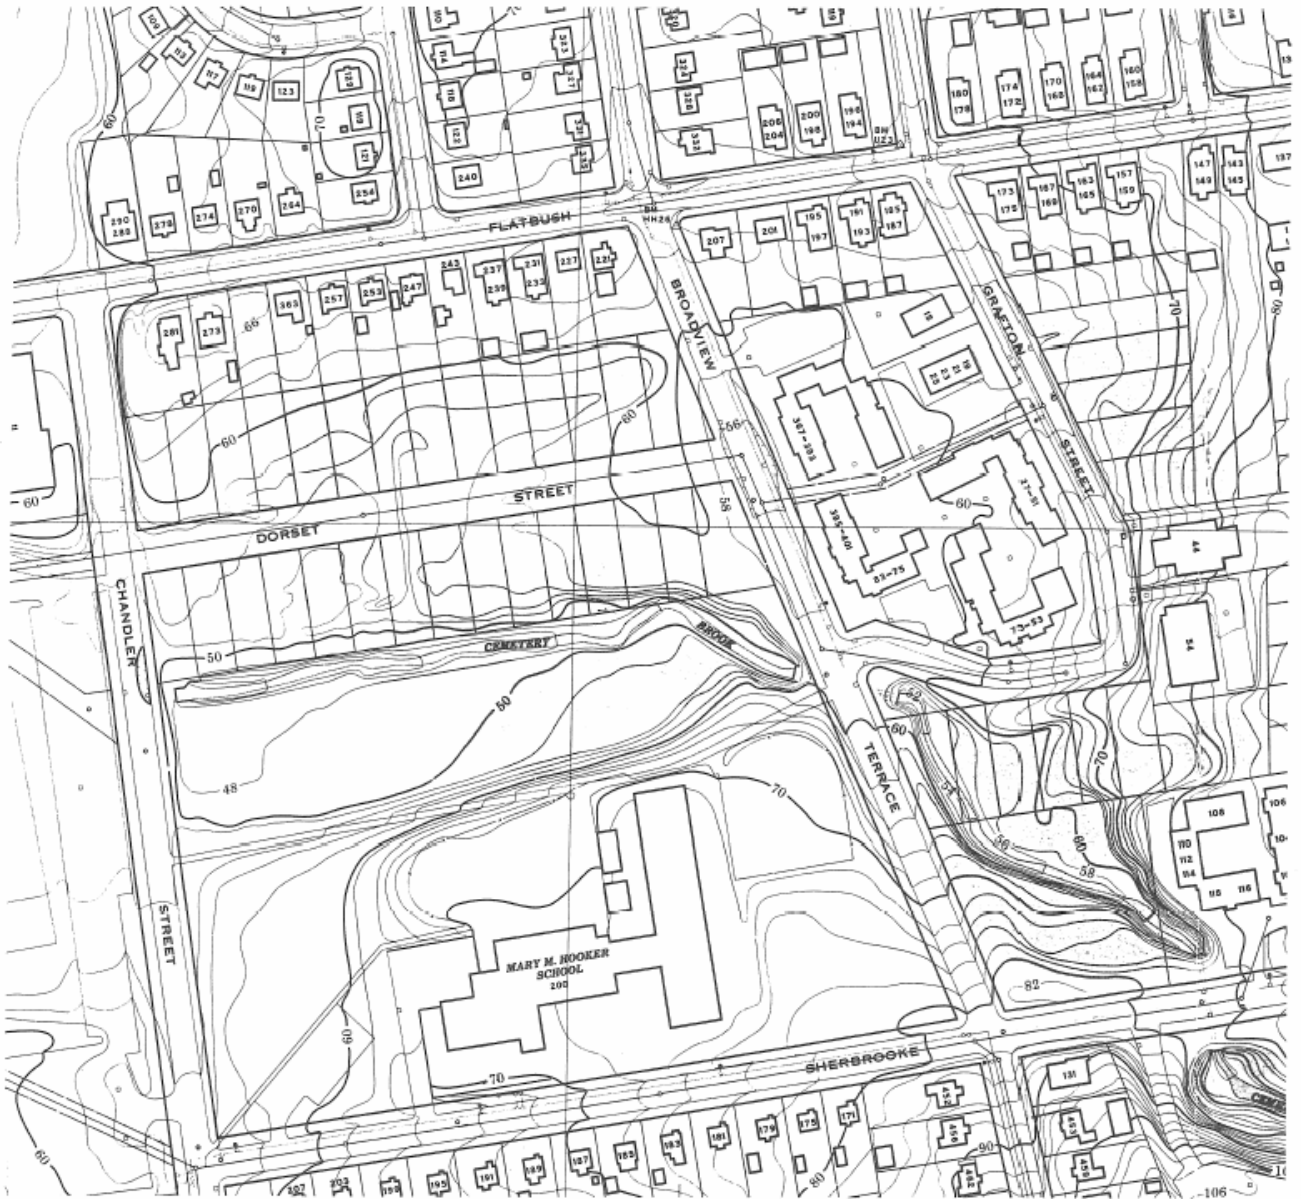
Figure 2

Site Map

Scale 1" = 200'

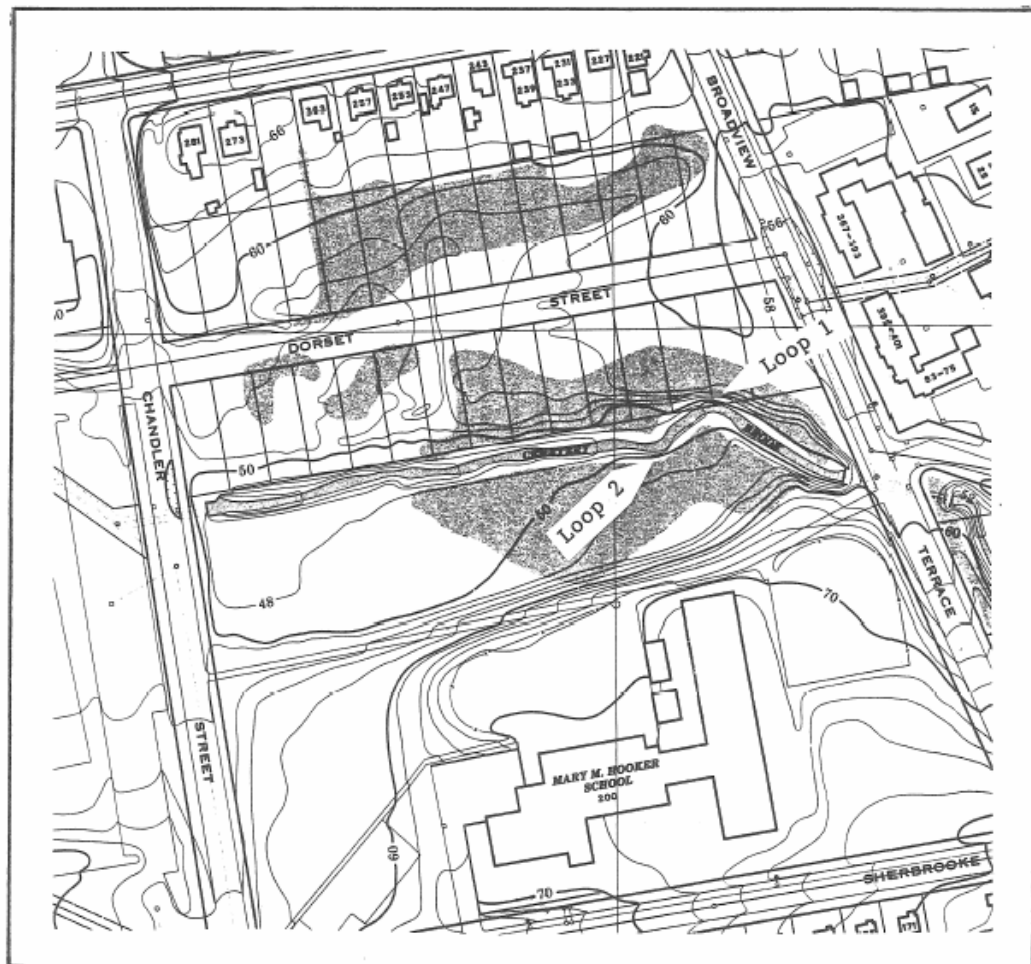
This behavior can be seen in Cemetery Brook. When cemetery Brook merges from the culvert under Broadview Terrace, it has been constricted and the water is flowing rapidly. After it has flowed a hundred feet or so, it must turn to the west, because its channel has been modified to flow along the backs of the building lots that were planned along Dorset Street. Where the brook must turn, a small set of meander loops is developing (see figure 6). Since the water is flowing rapidly, it will erode its stream banks more, and the curve where the stream must turn (Loop 1 in figure 6) will become more exaggerated. Downstream from the curve, another small meander (Loop 2) is developing, and will also become exaggerated with time. On-site, an overhanging tree with roots exposed at Loop 2 is a vivid demonstration of the erosion taking place. If nature is allowed to take its course, both of these loops will widen, and more loops will develop downstream, converting the man-made straight channel into a natural, meandering channel.

Since the outside of the meander loop is where the most erosion is taking place, that is often the best place to observe the geological materials the stream is flowing through. At Loop 1, three different layers of deposits can be observed. Starting from the top, these

were a 1-2 foot thick grayish black deposit, 1-2 foot thick brownish-red deposit, and a light gray clay deposit. The upper two deposits are bulldozed material from apparently two different bulldozing episodes. The fact that bulldozing has occurred is evident from the artificial nature of the stream channel mentioned above. The rocks in the bulldozed material are, for the most part, either traprock (grayish-black) or brownstone (reddish-brown). (The geologic term for traprock is *basalt*, and the geological term for brownstone is *arkose* or *arkosic sandstone*.) It pays to be cautious, however, because much of the rock-like material that has been bulldozed is manmade. Materials to watch out for include asphalt, concrete, and brick.

From MDC Map, scale 1 inch = 200 feet; contour interval is 2 feet.

It is possible to see sediments deposited on the inside of both meander loops, in the low energy environment. These deposits are low, about the same level as the water surface, and usually just look like mud. These sediments are being built up towards the center of the river as the river is eroding its channel outward, helping to exaggerate the meander shape.

The MDC map reproduced in Figure 6 shows a small depression on Chandler Street where the river enters the culvert to go under the street. This indicates that there may be erosion under the street by stream water that does not enter the culvert, but erodes around the outside of the culvert under the street when the water is high. Observation of the street revealed cracks in the same area, confirming this possibility.
