# **Camp Alice Merritt Land Use Study**

**August 1993**

## **King's Mark Environmental Review Team Report**

Environmental Review Team Report

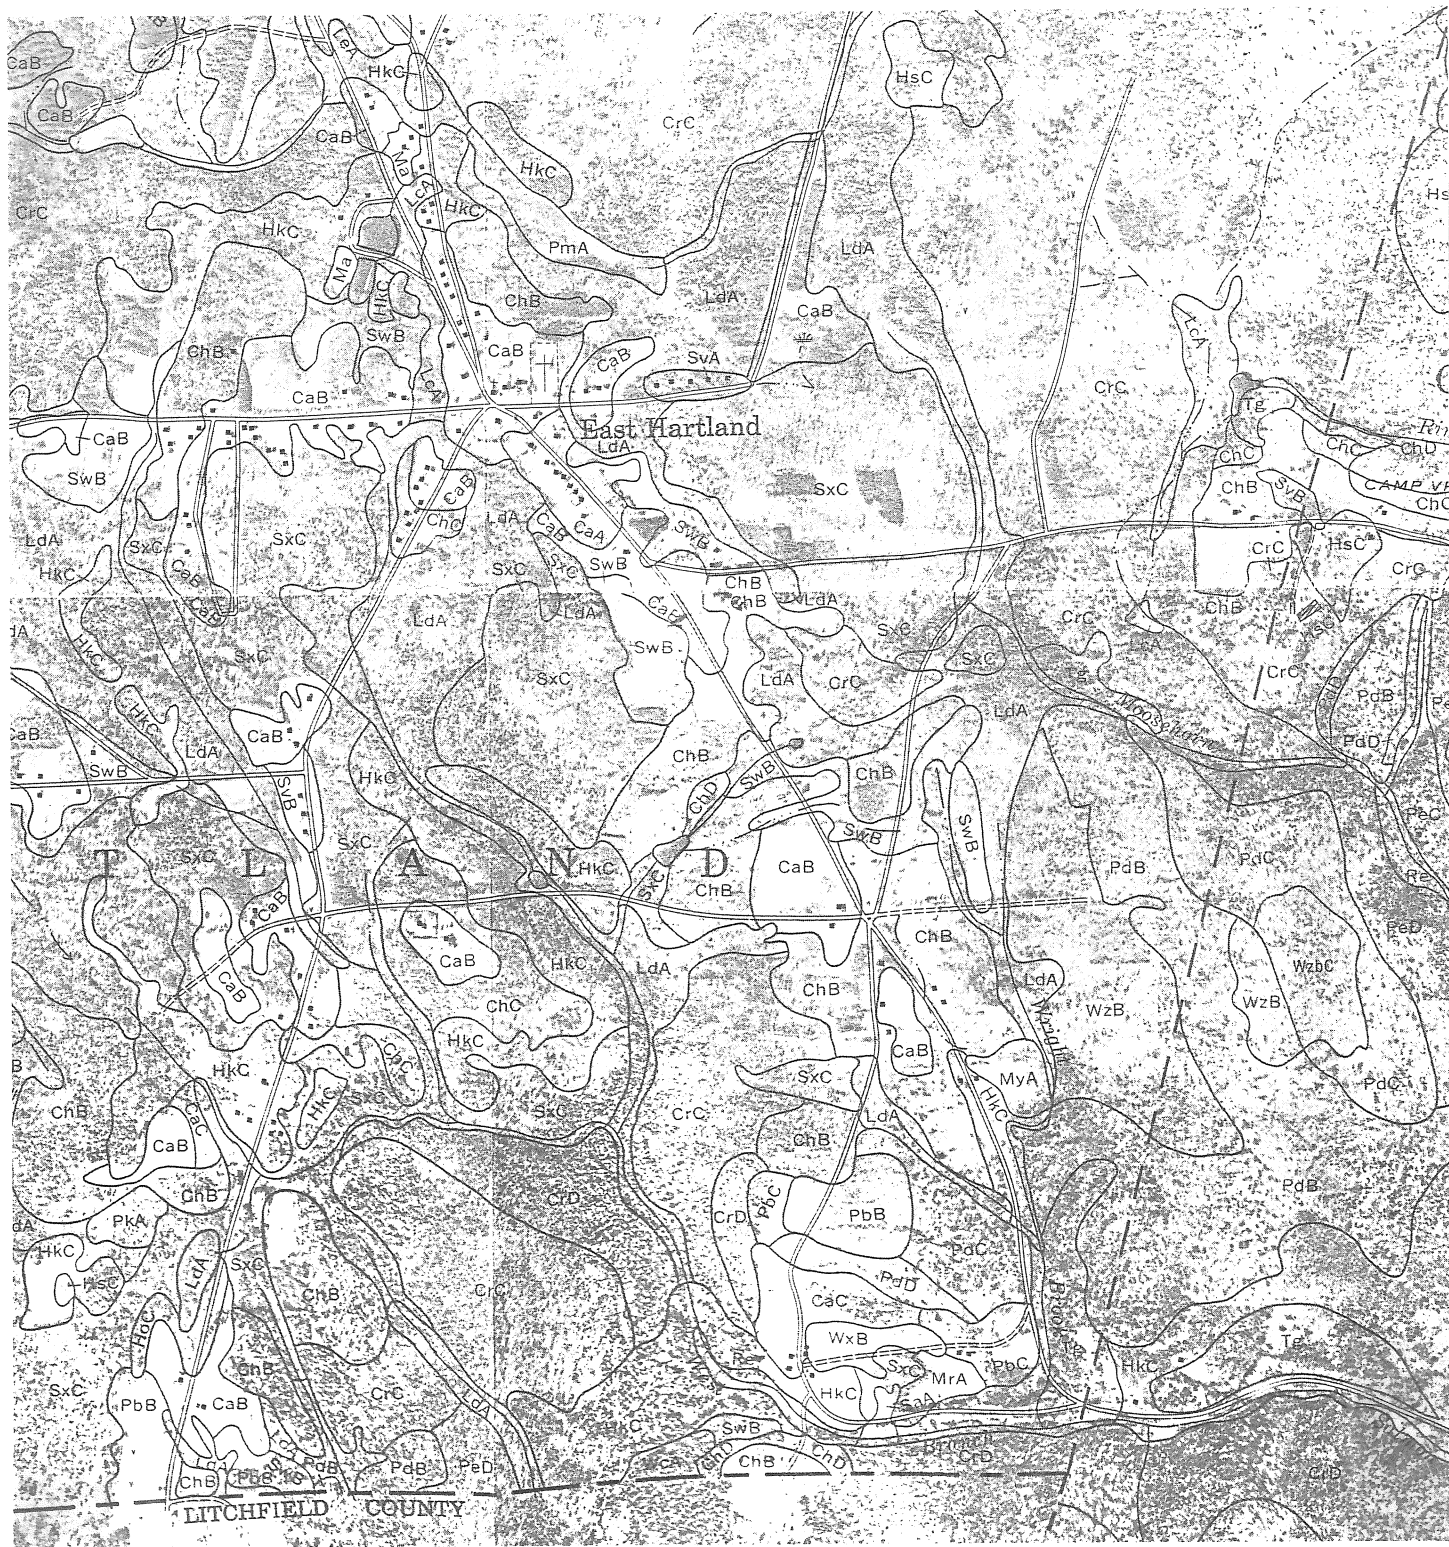
# SOILS MAP

According to the Soil Survey of Hartford County, Connecticut, there are 6 soil units mapped on this 47.89 acre parcel. These soils are outlined on **Table 1**. **Table 2** shows the soil map unit name, acreage of each soil on the property and the percent of area that each soil occupies on the site.

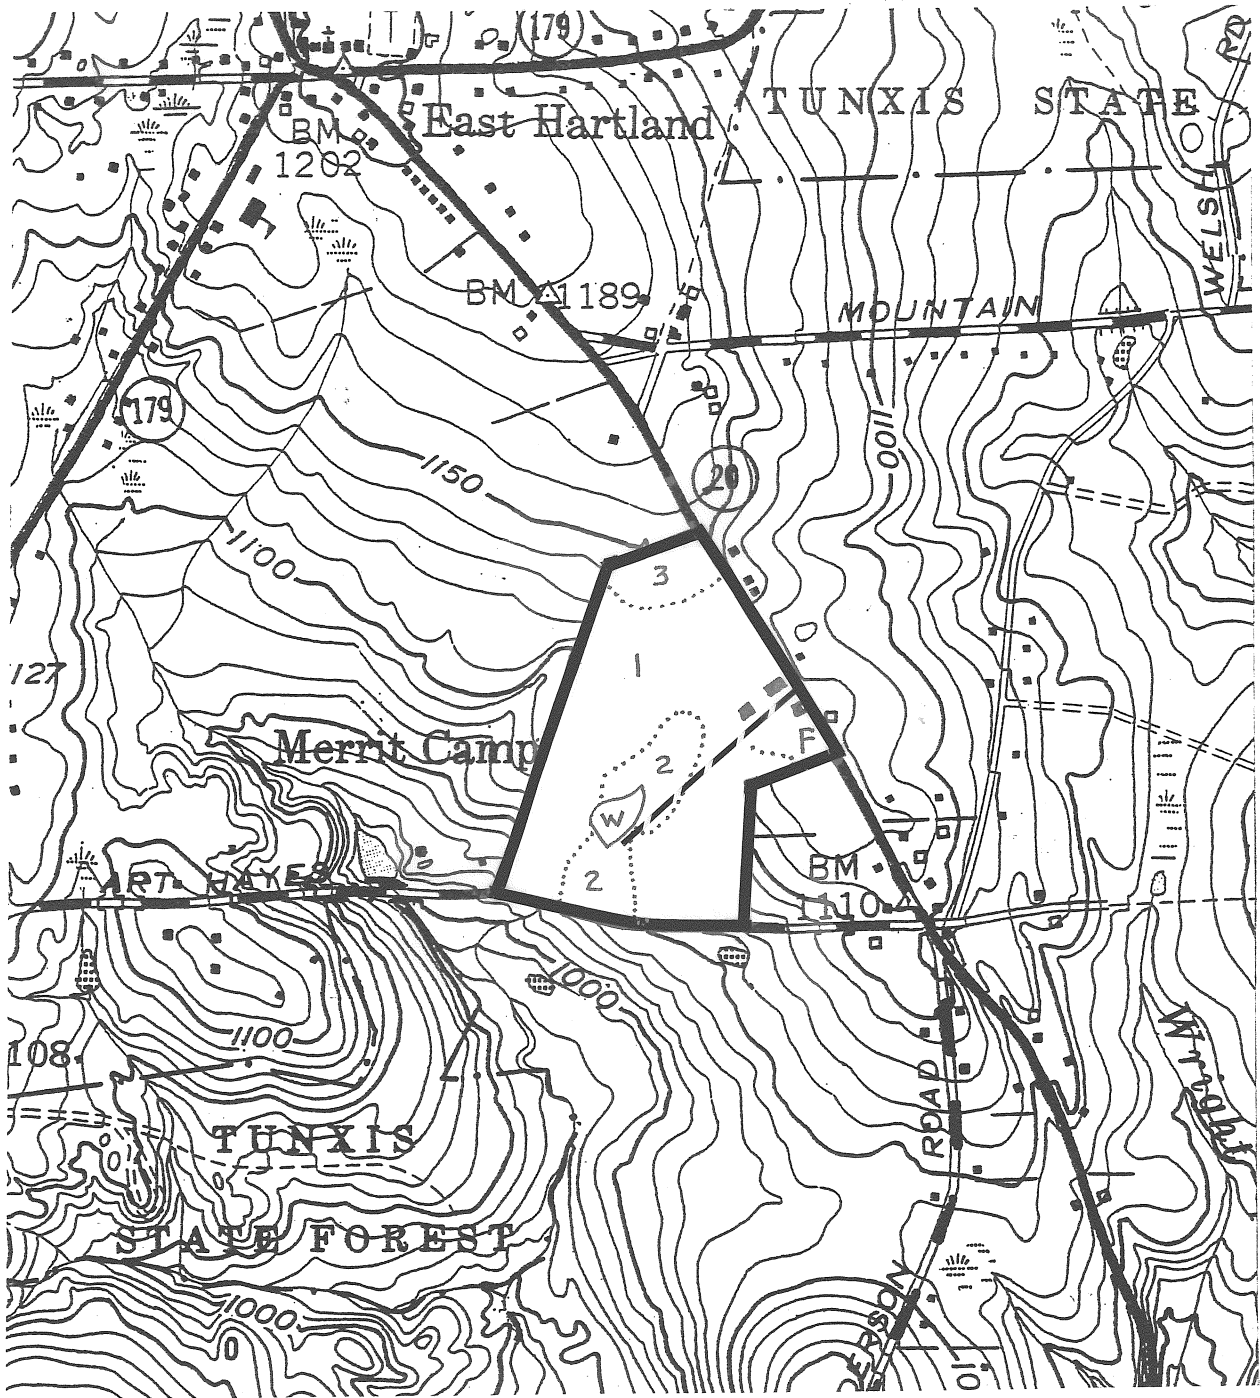
- Approximate Site Boundary
- 1** - Mixed Hardwoods
- 2** - Mixed Softwoods
- 3** - Old Field
- F** - Open Field
- W** - Water
- - -** Access Road
- ■** Structures

The following is a broad breakdown of the vegetation cover types found on the property. The types are directly influenced by either soil conditions, historical use, past management, or a combination of these factors. Soil types often dictates the moisture availability which can limit or restrict certain vegetation's growth. Historical use and the past management of the land also influences the occurrence of the types of vegetation present.
