# VENUTI PROPERTY KILLINGWORTH, CONNECTICUT

## Environmental Review Team Report

Prepared by the  
Eastern Connecticut Environmental Review Team  
of the Eastern Connecticut  
Resource Conservation and Development Area, Inc.

December 1997

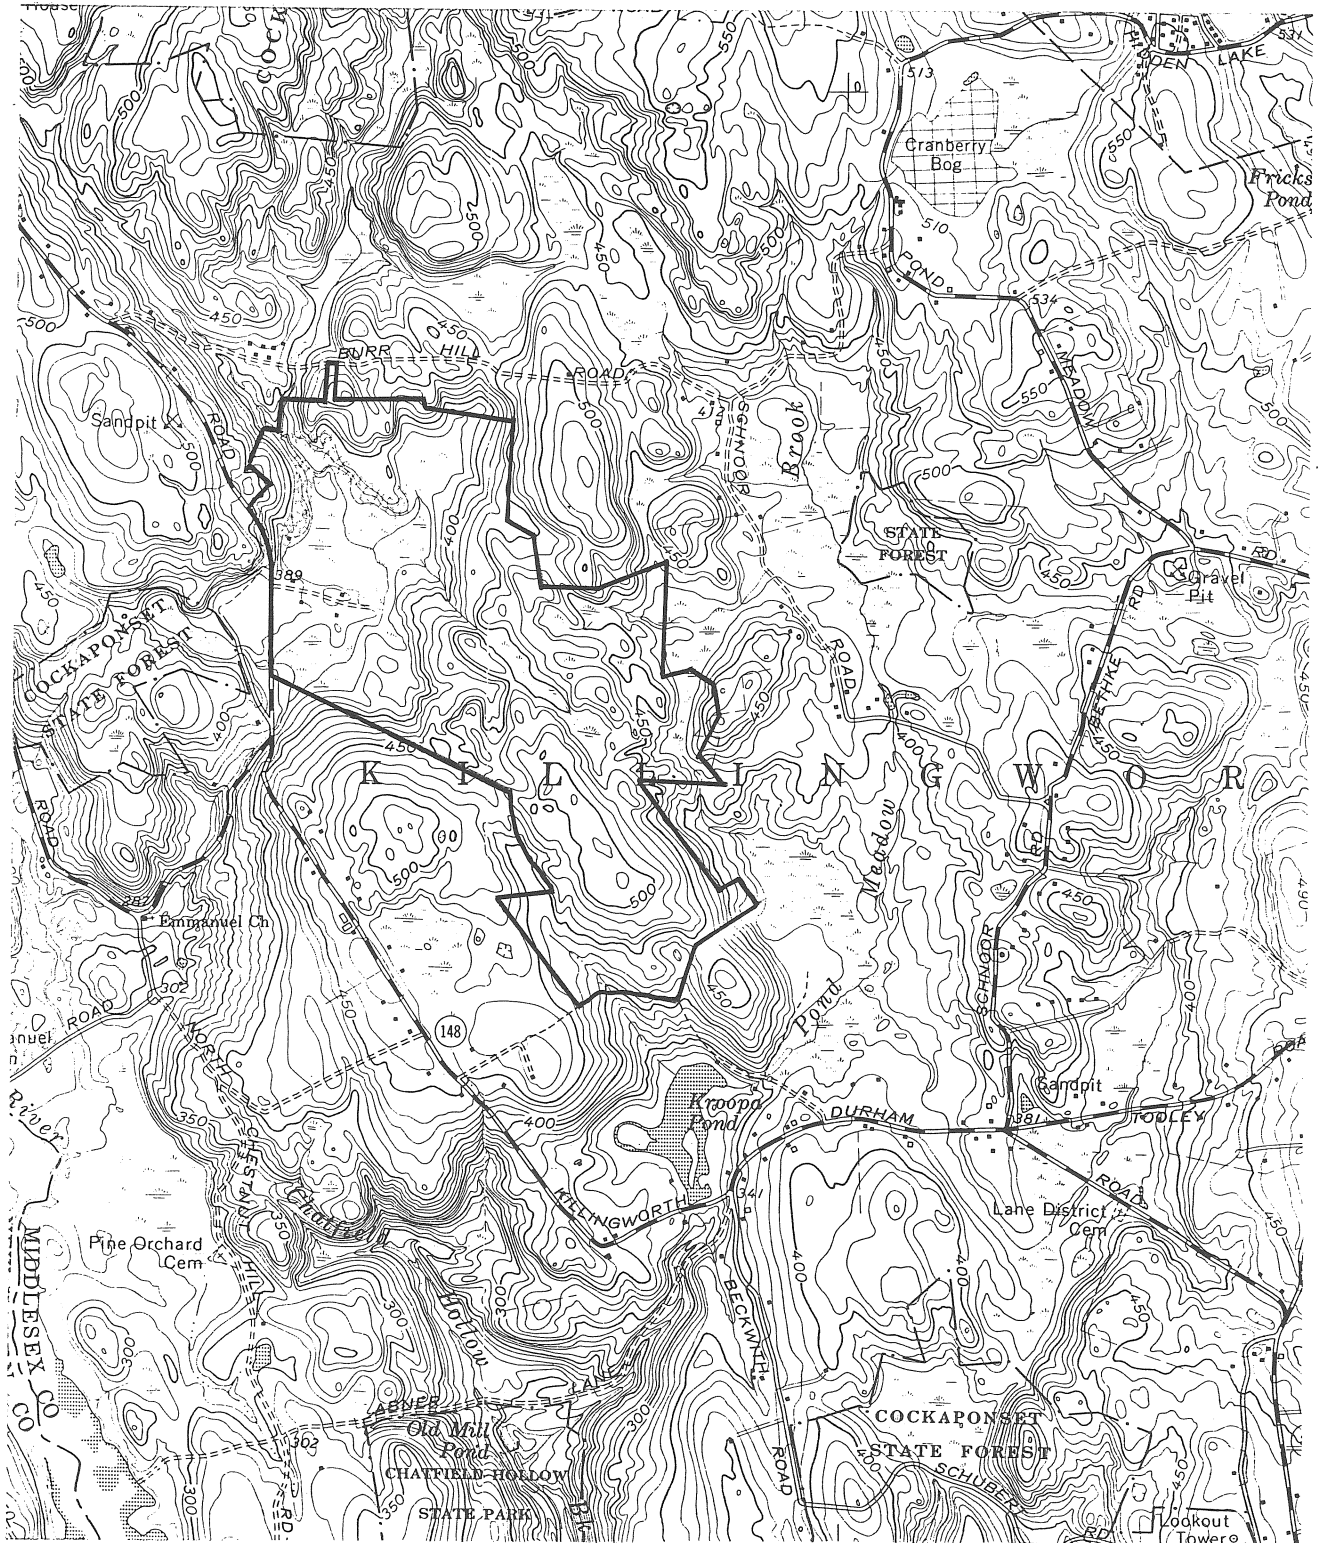
Figure 1

Topographic and Location Map

Scale 1" = 2000'

— Approximate Site

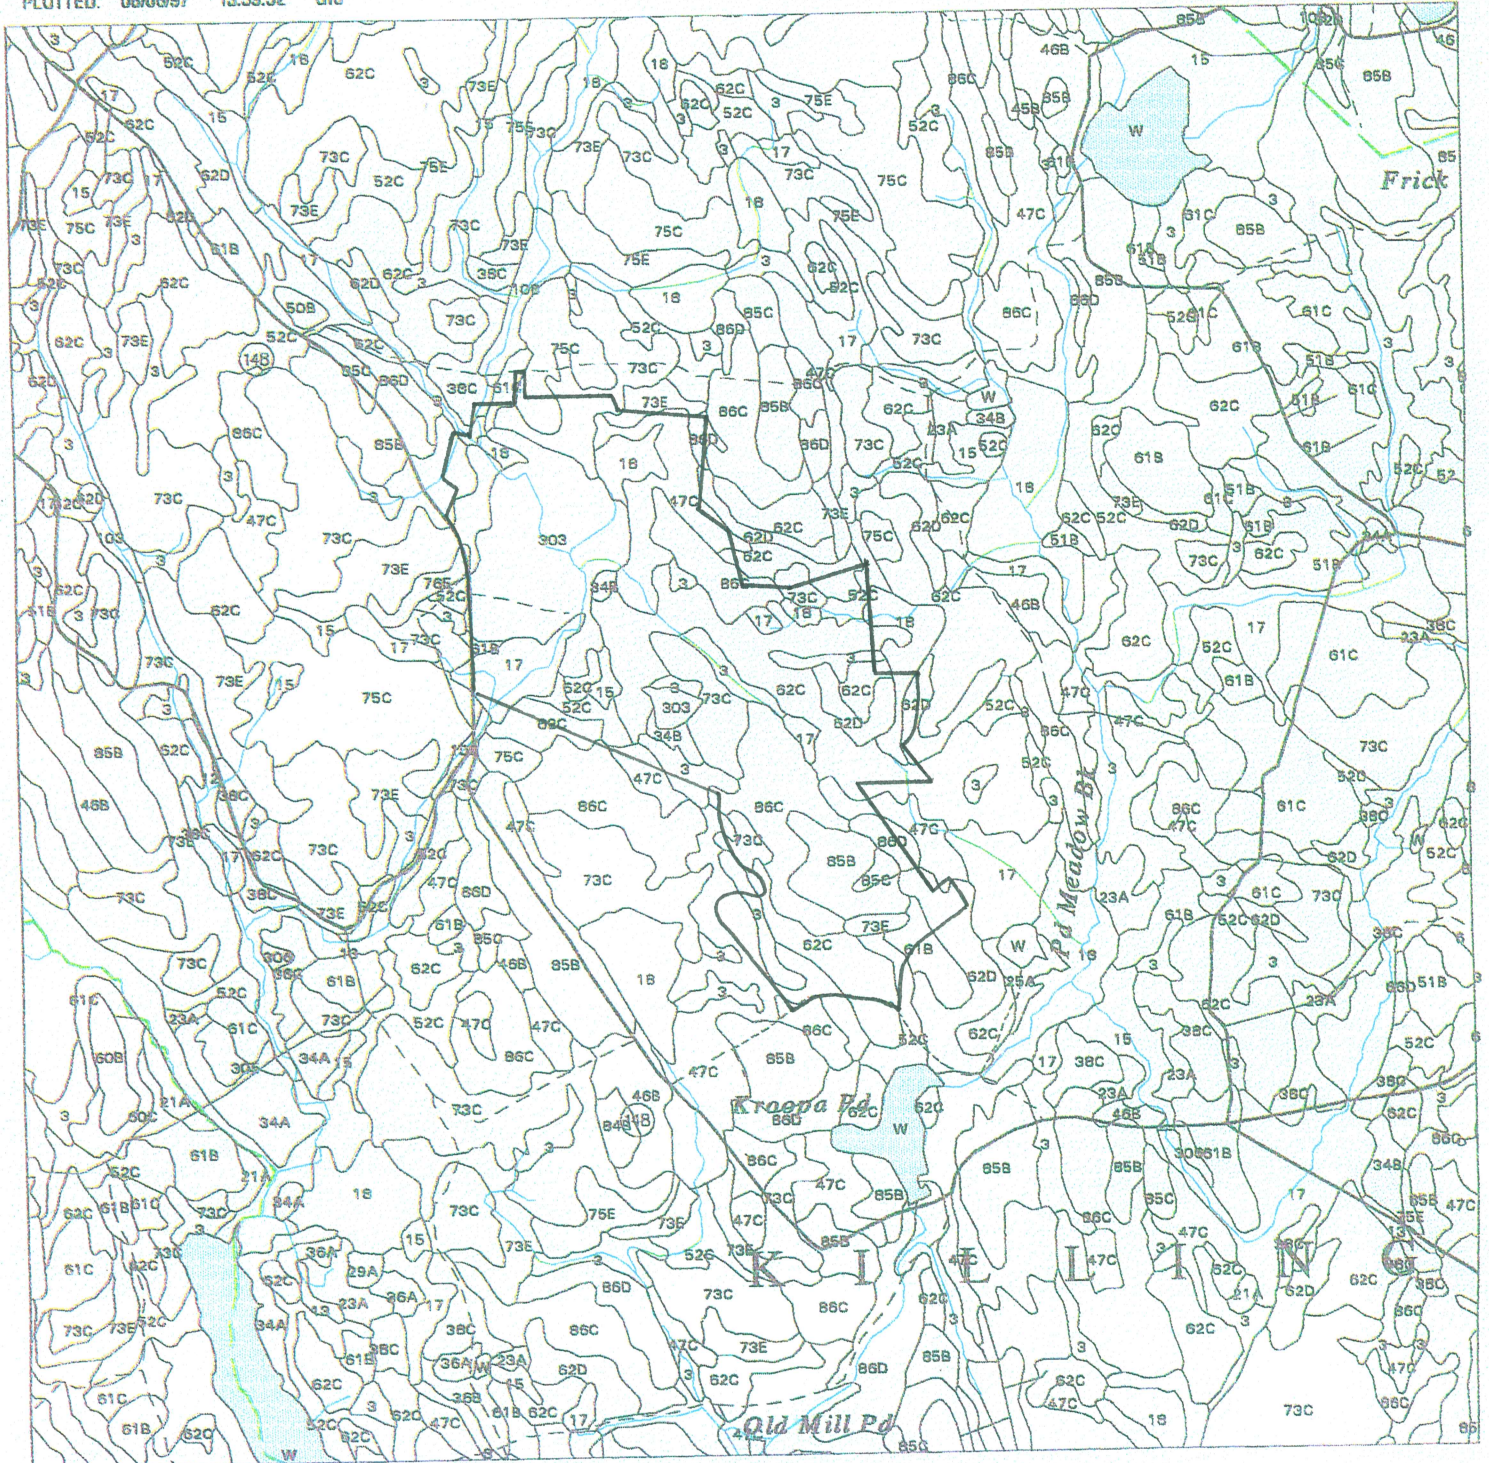
**Figure 3**  
**Soils Map**

SOILS, SOIL SPECIAL FEATURES - Soil map units and soil special features from the Advance Connecticut Soil Survey Database, 1:12000 scale data. Soils mapping and digital data was produced under the Connecticut Department of Environmental Protection / Natural Resources Conservation Service soils cooperative. This information is being provided as "ADVANCE INFORMATION SUBJECT TO CHANGE". This data has NOT been certified by Natural Resources Conservation Service as meeting all SSURGO (State Geographic Soil Survey Database) standards.

\*Please see the following soil map (Figure 3) and key for the digitized soil survey information provided by the Connecticut Department of Environmental Protection's Natural Resources Center GIS system. (Please note: this data has not been certified by Natural Resources Conservation Service as meeting all State Geographic Soil Survey Database standards.)
