HAMMONASSET SCHOOL PROPERTY

MADISON,
CONNECTICUT

Environmental Review Team Report

NOVEMBER 1991

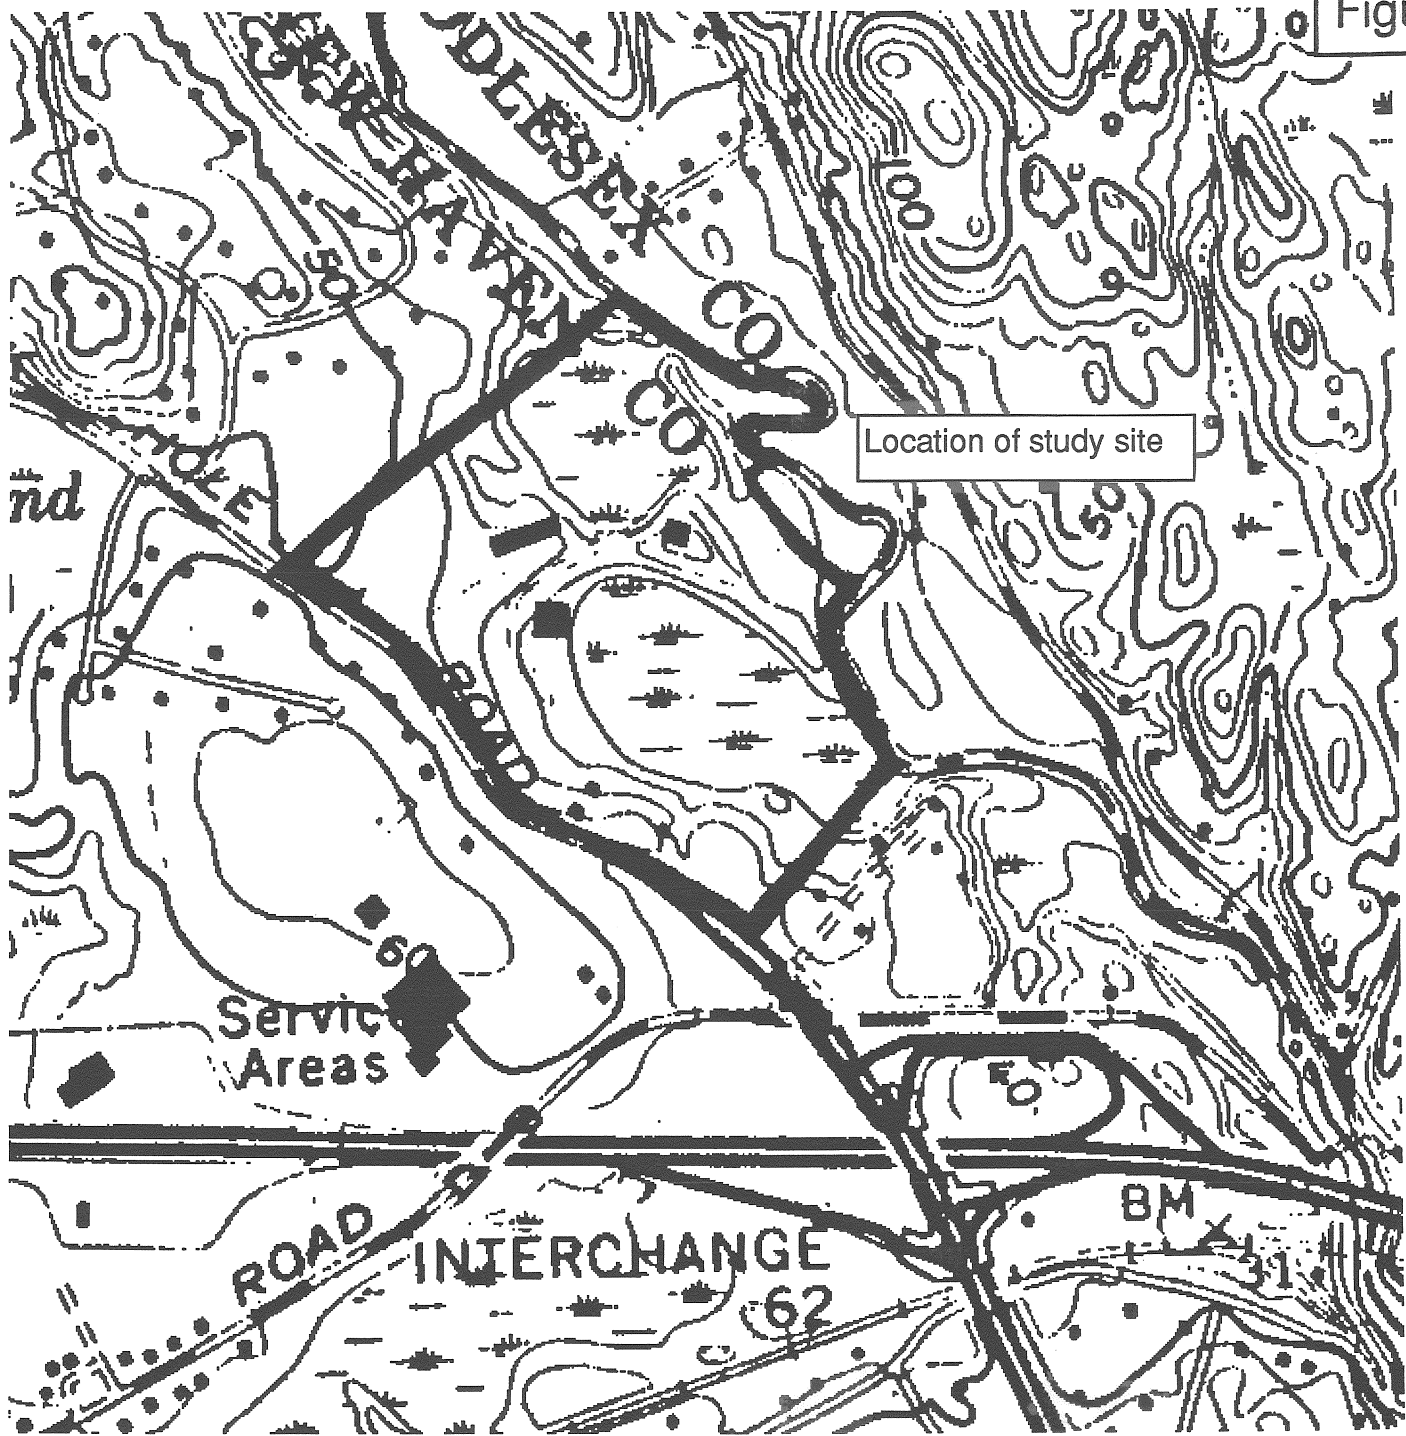
Figure 3

The Hammonasset School Property is located in the southern drainage basin of the Hammonasset River. The topography is characterized by gently rolling hills, most of which have a thin venier or glacial till (see Figure 3). Few steep slopes exposing bedrock exist. The valley floor contains stratified sand and gravel deposits that may be as much as 50 to 100 feet in thickness. Topography of the sand and gravel train is hummocky with numerous kettles. The sand and gravel was deposited by glacial melt-water streams on a broad braided flood-plain on top of, against and surrounding blocks of melting ice left over at the end of the last ice-age. The melting ice caused the irregular topography.

Topography

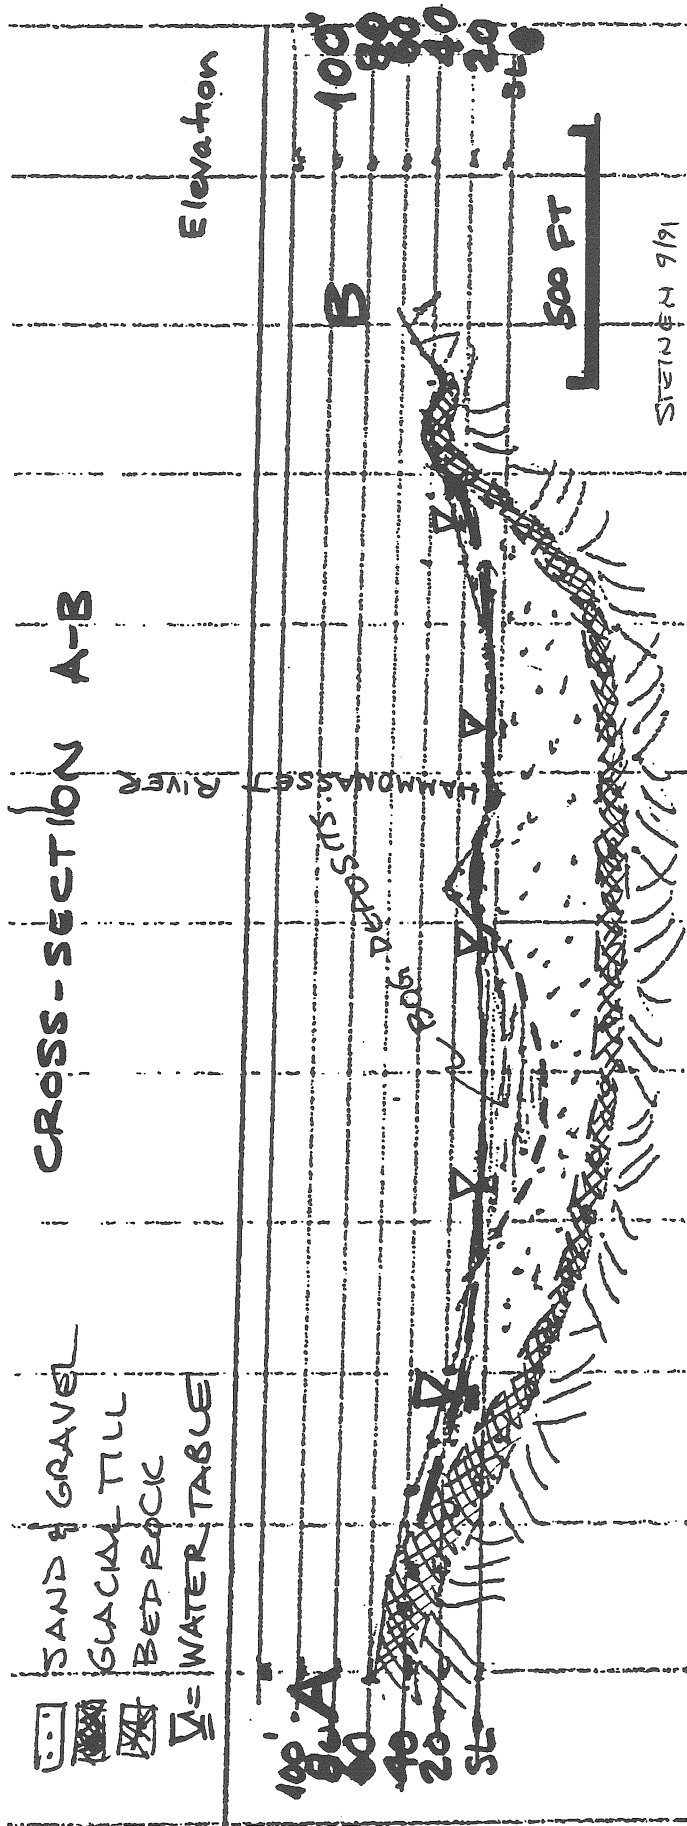
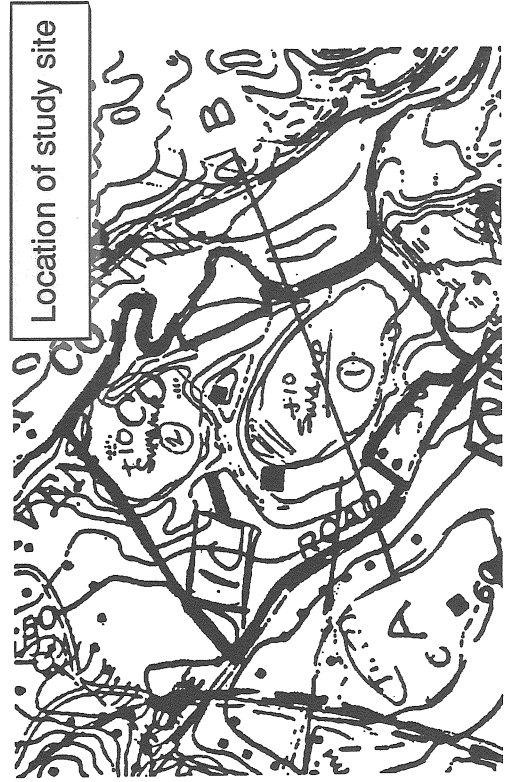
Figure 4

Bedrock does not crop out on the property. According to Lundgren and Thurrell (1973), bedrock below the sand and gravel deposit should be part of the Monson Gneiss, a hornblend-plagioclase-quartz gneiss (see Figure 4).

<p>Geology</p>
--	--	-----------------------

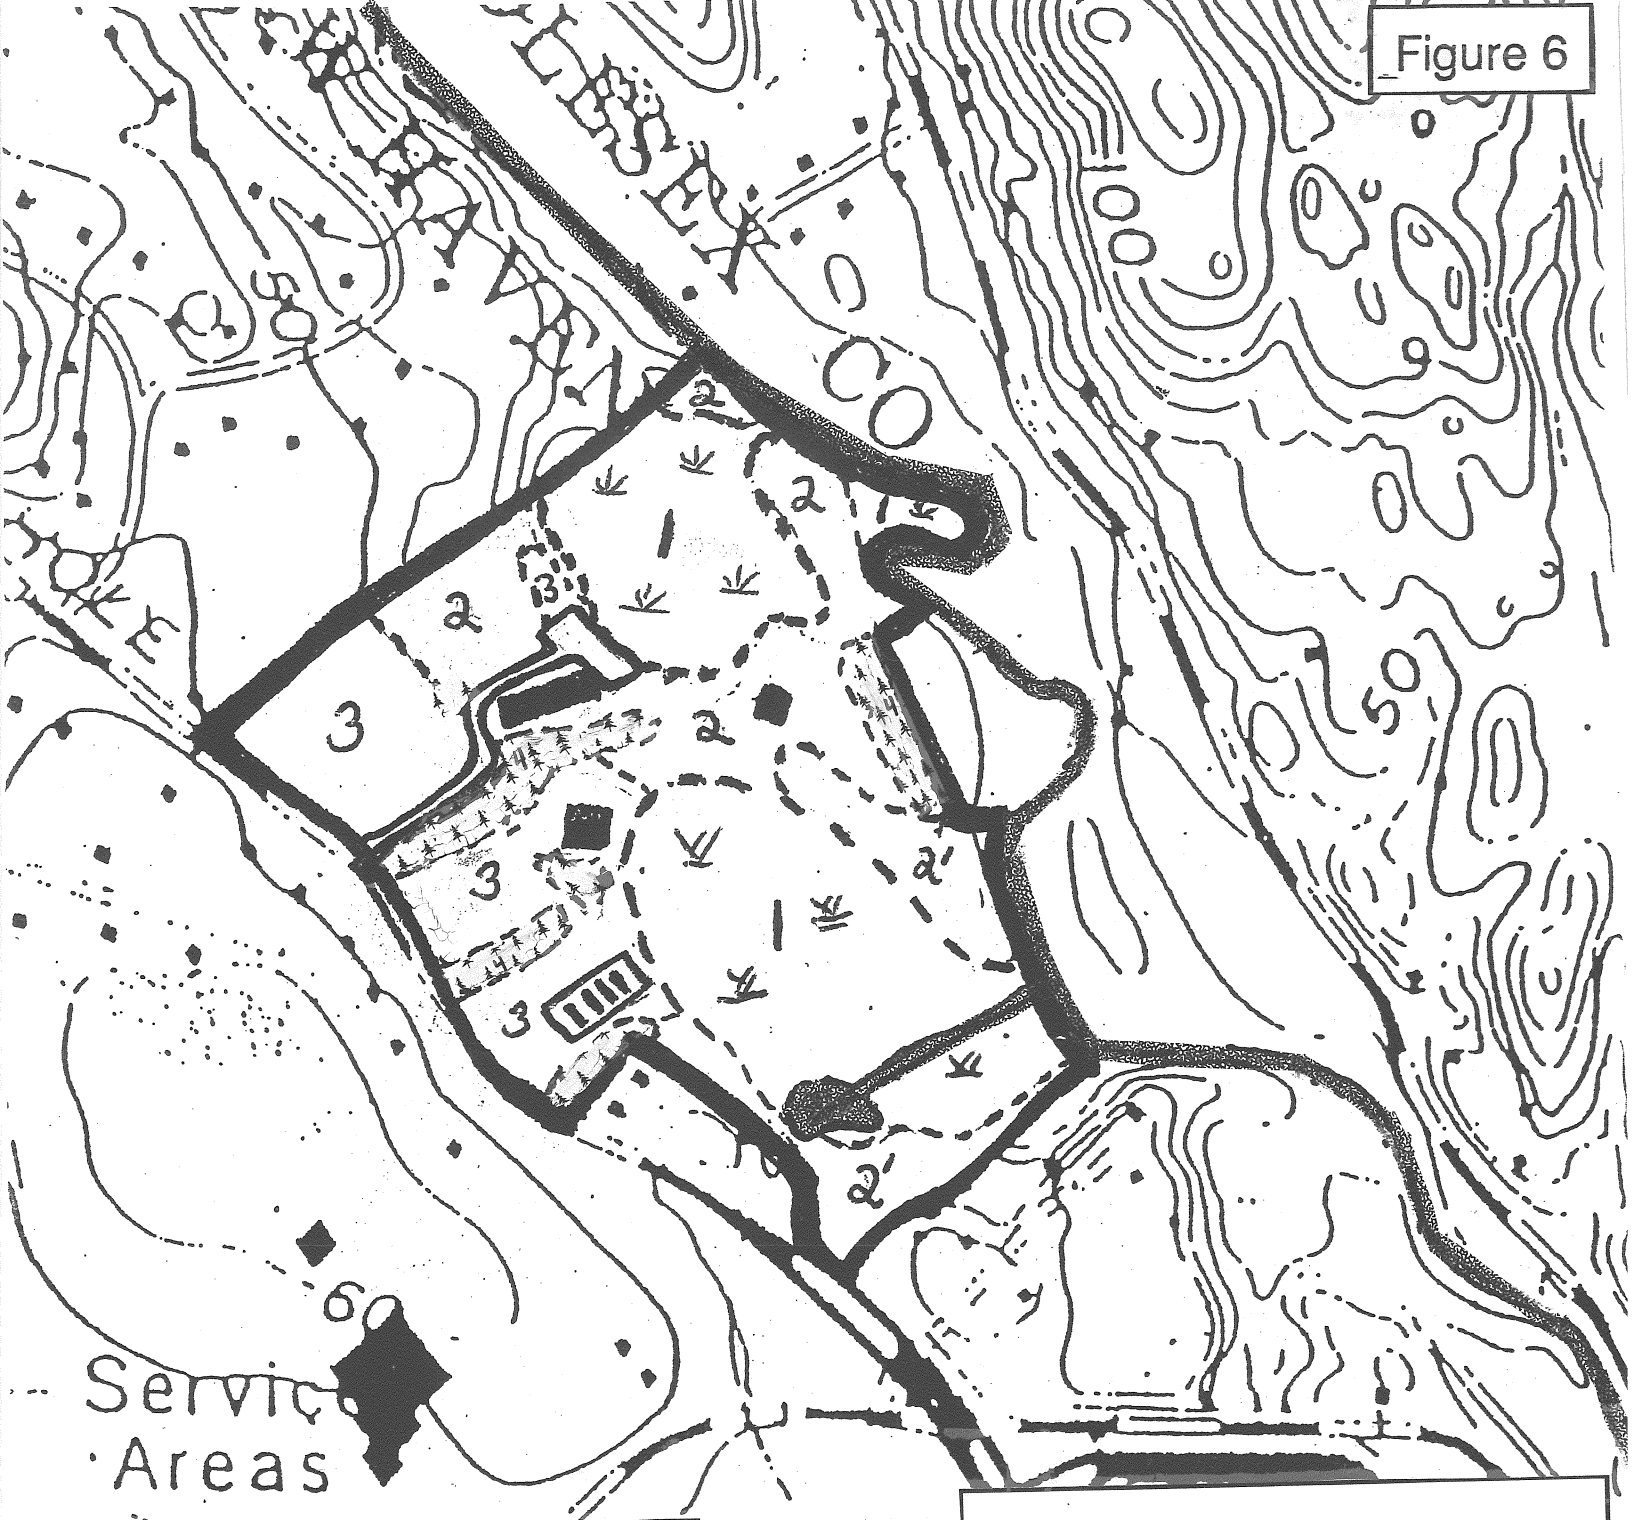
Figure 6

Type 4 - conifers
