Eisenhower Park Revitalization

Milford, Connecticut

Environmental Review Team Report

Report #350

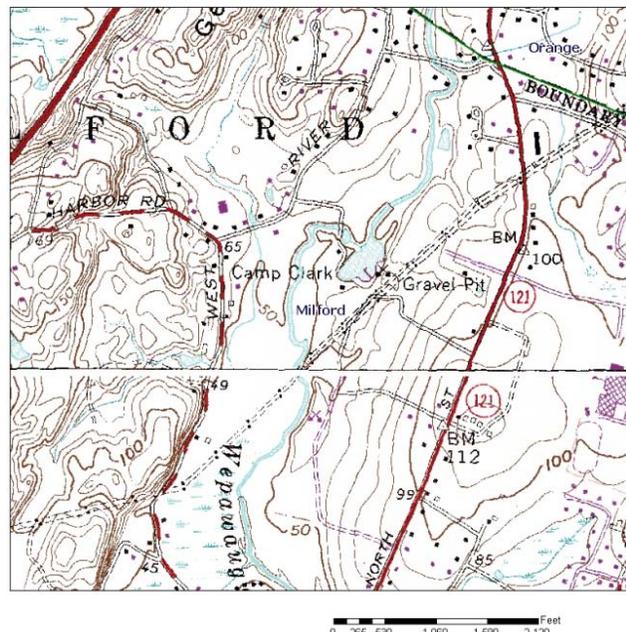
Figure 1. Topographic map: contour interval = 10'

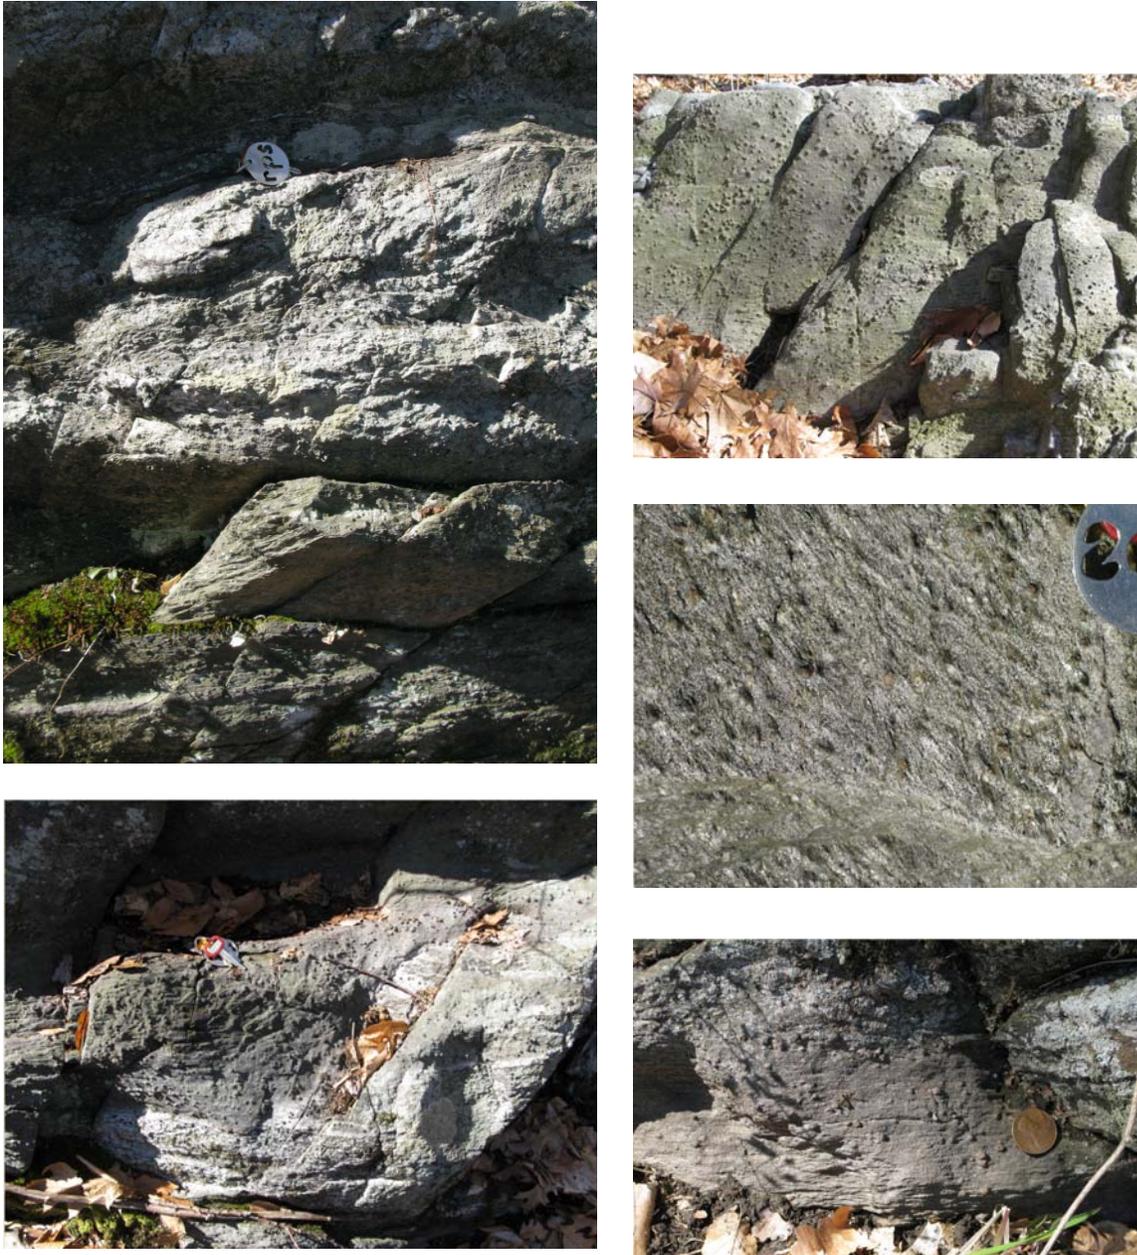
Figure 2. Wepawaug Schist. Upper left shows general concordance of bedding and schistosity seen at most (but not all) exposures (key chain in upper center is 2" in diameter). Lighter layers contain more quartz and feldspar and less muscovite mica. Lower left shows similar stratigraphy. Here garnets are a significant part of the mineral composition. Length of keys just to left and a little above center are 2.5". Right top shows garnetiferous schist. Garnets up to one-half inch in diameter (scale inadvertently omitted: maple leaves are about 4" in diameter). Center right picture shows detail of schistosity (upper left to lower right), garnets and bedding (along bottom of picture) that is cut by schistosity. Letter on key chain disk is about 3/4". Lower right shows bedding (manifest by garnet abundance) and schistosity (penny for scale).

It is gray, dark gray and silvery gray. It consists of muscovite-garnet schist and contains muscovite and garnet with lesser amounts of quartz and feldspar. Some layers contain small amounts of staurolite. Some places graphite is reported, but none was observed during the field

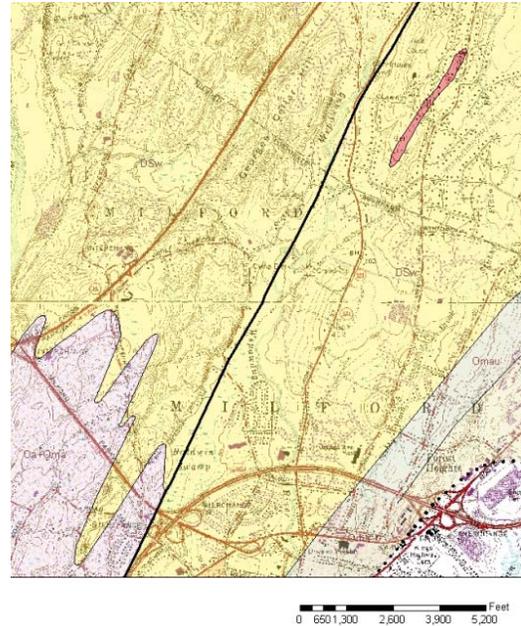
Figure 3. Bedrock geological map (after Rodgers, 1985). Yellow area is underlain by Wepawaug Schist (Siluro-Devonian in age). Pale purple area is underlain by Ordovician-aged metamorphosed volcanic rocks and the light blue and green areas are underlain by additional metavolcanic rocks. Red area is younger intrusion of diabase of Jurassic age. This diabase is a feeder dike for the youngest lava flow in the Hartford Basin to the east. Diagonal black line is trace of fault that uplifted the west side relative to the east side.

Regional mapping (Rodgers, 1985) has revealed a major fault that bisects the park. Neither the fault itself, nor fractures parallel to the fault were recognized during the field visit, but is shown on a bedrock geologic map (Figure 3).

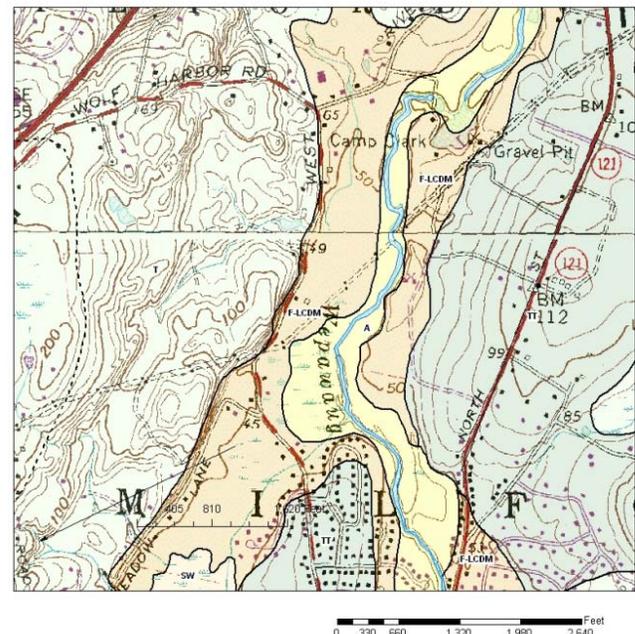
Figure 4. Quaternary (surficial) geologic map of the area in and around Eisenhower Park (after Stone and others, 2005). Grayish green area on west is area of thick till, Pale green area on west is thin till. Pale orange area is underlain by gravel terrace-deposits and yellow area is underlain by modern alluvium and is part of the modern flood-plain. Note the scale is different than in Figure 3.

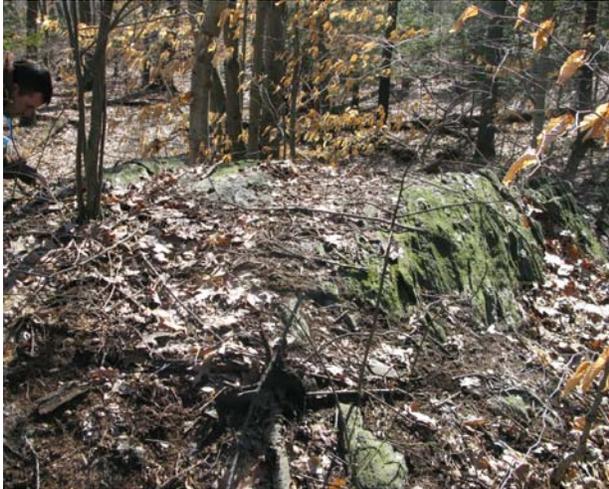
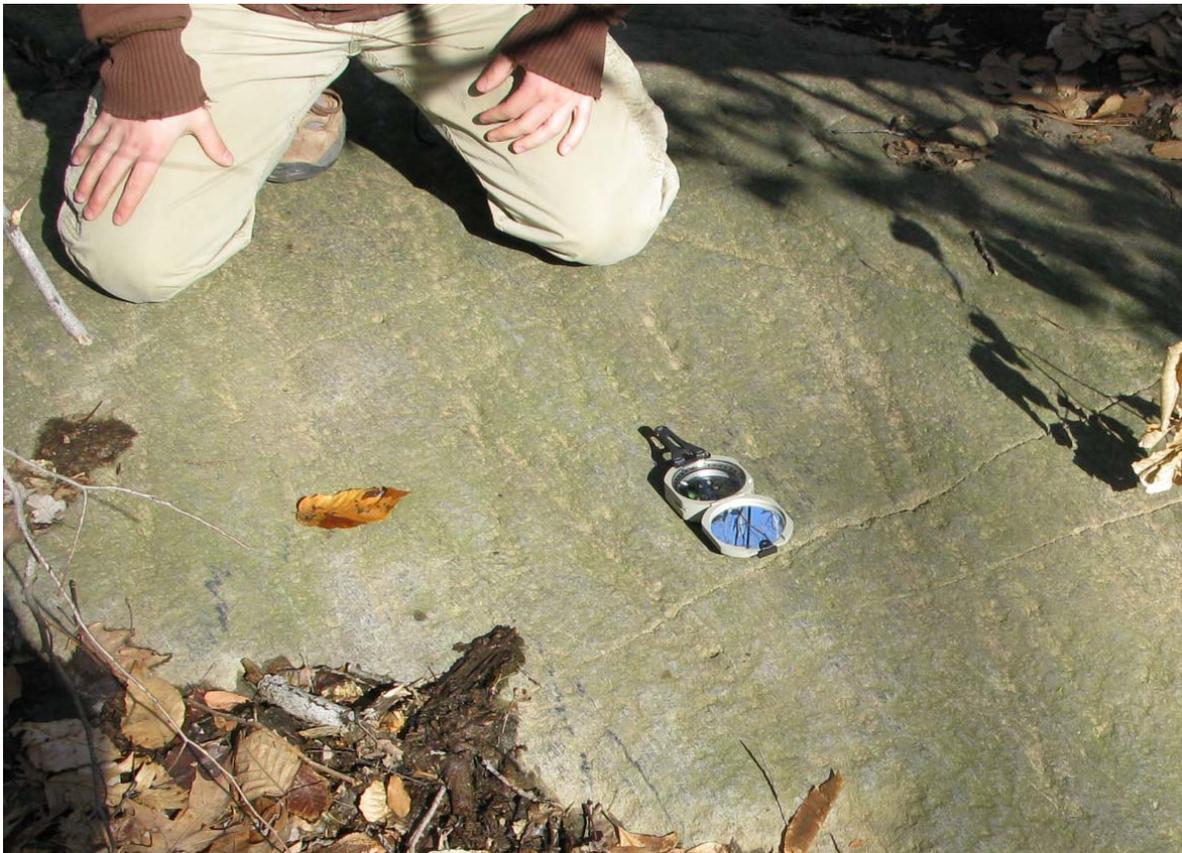
Figure 5. Image at left shows typical bedrock surface that has weathered since deglaciation. The surface although somewhat smooth is rough in detail and no surface marks caused by passage of the glacier remain. Image below shows ledge recently uncovered by construction of a road. The surface is very smooth and has glacial striations that cut diagonally across the outcrop. Notice the line of garnets (foliation of rock) parallel to the side of the compass and at an angle to the striations. Notice also that striations are not parallel to the roadway and hence were not made by bulldozers. Striations indicate ice movement toward the southwest, parallel to the elongation of the drumlin on the other side of the river.

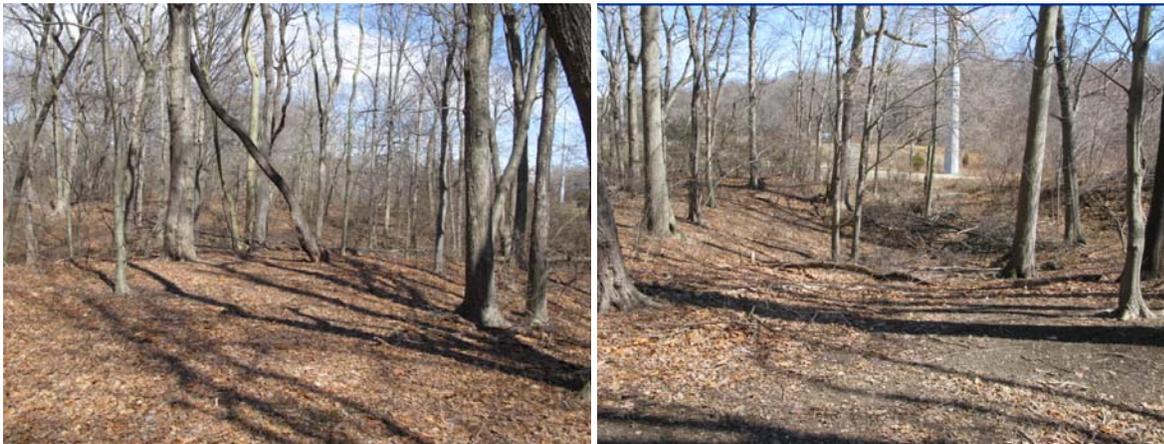
Figure 6. Terrace topography, where undisturbed, is generally hummocky and uneven. Terraces are underlain by sand and gravel that most likely is stratified. The depression on left side of left image is possibly a shallow kettle.

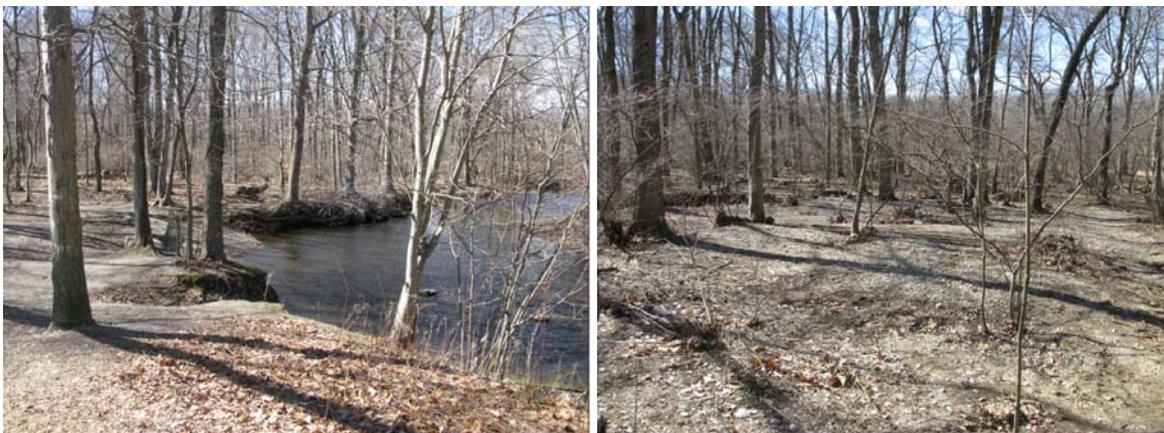
Figure 7. Wepawaug River and its flood plain just downstream from the pond in Eisenhower Park. Images were taken during March, 2009. Moderate to heavy rainfall during December caused minor flooding the extent of which can be recognized in the images by noticing here the past autumn's leaf-fall has been washed away by the high water. Image on left shows bend in the river with typical eroding cutbank on the outer part of the bend and the depositional point-bar on the inner part of the bend (partially obscured by trees on the right).

The modern flood-plain is covered with a veneer of modern alluvium that likely buries older terrace gravel. Minor flooding occurs regularly (Figure 7).

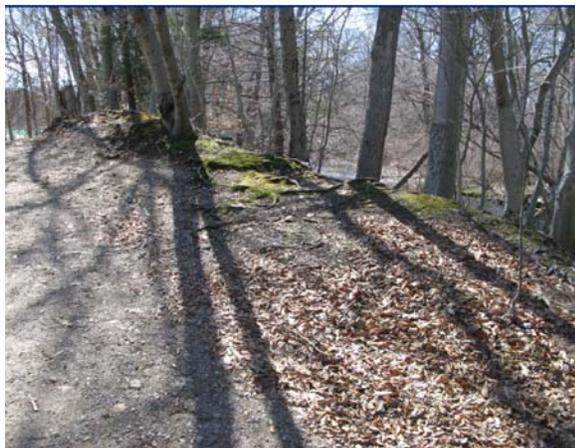
Figure 8. Artificial levee built to a height of 10± feet above flood stage. View taken near south central part of park near a wetland restoration area. Levee continues for about 1000 feet and ends abruptly in a swamp.

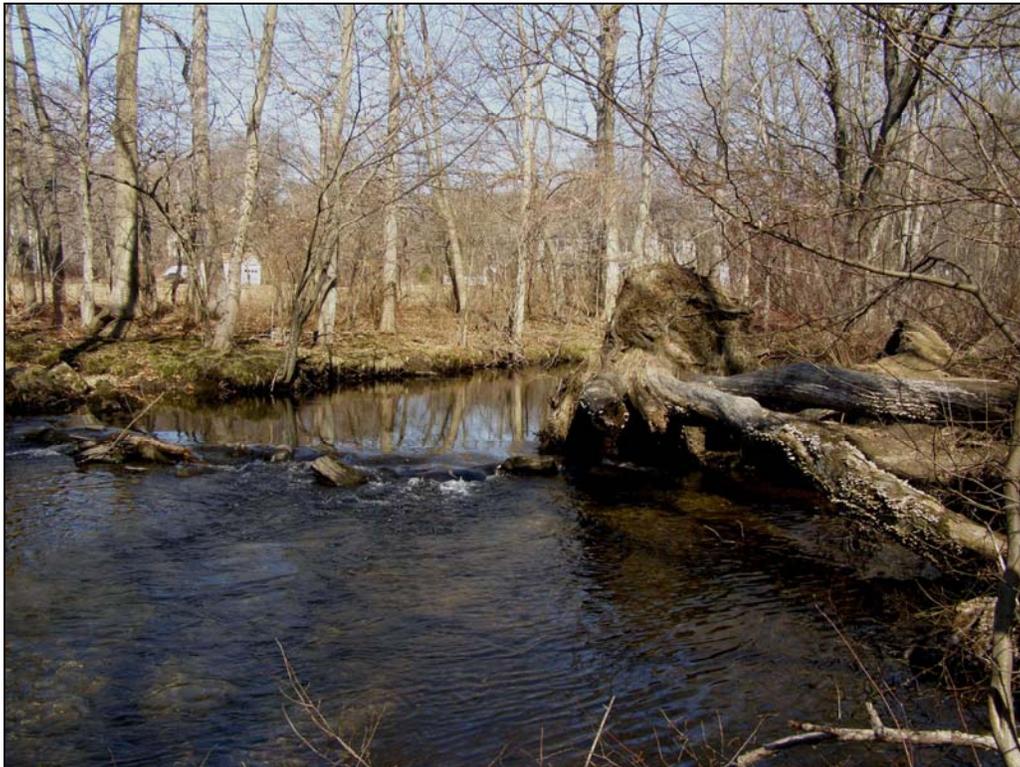
The Wepawaug River originates in Woodbridge as the outfall from a group of small ponds. The 5,000[±] foot reach of river within Eisenhower Park is contained in a channel that is roughly 30 feet in top of bank width and is low to moderate in grade. Surface flow of the river is predominated by pool and run interspersed by shallow riffle. The normal flow depth in the riffles is approximately 1 foot with greater depths (2-3 feet) found in pools and runs. The riverbed is composed of small boulder, cobble, gravel, coarse sand, and sand. Instream habitat is provided by the water depth in pools and runs, boulders, undercut banks, and fallen or overhanging vegetation.

The Wepawaug River within Eisenhower Park.

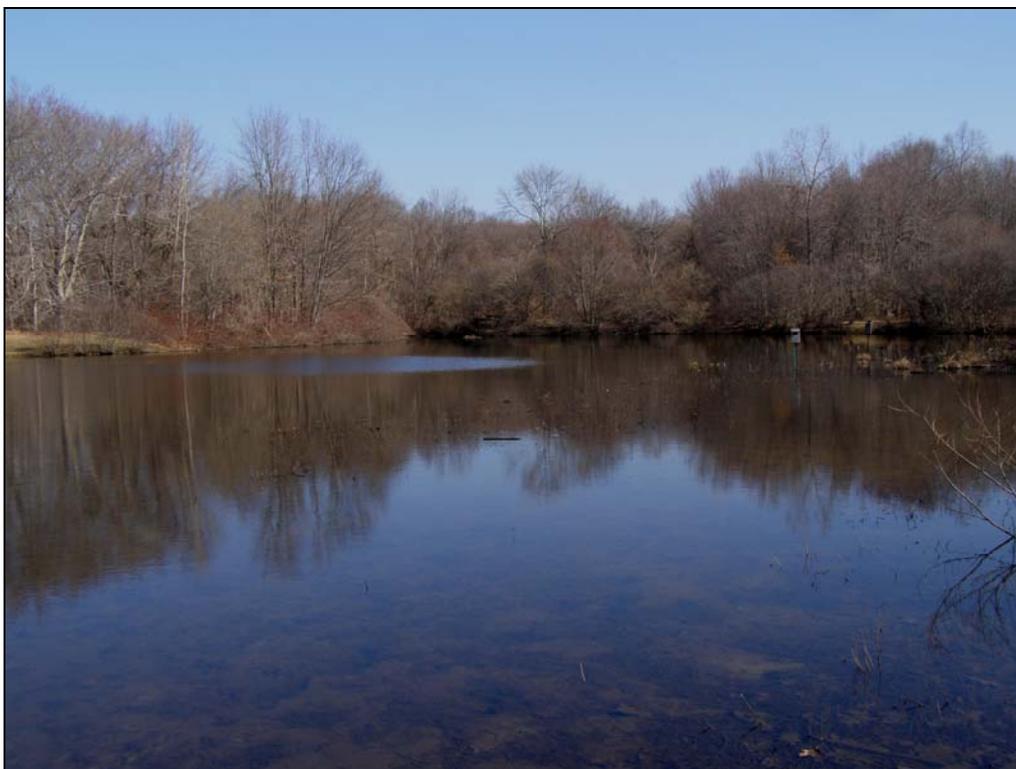
The unnamed pond within Eisenhower Park is an artificial waterbody that was created by excavation in the riparian area adjacent to the Wepawaug River. The 2.5[±] acre pond receives most of its water supply from the bypass of flow from the Wepawaug River. Land-Tech Consultants, Inc. of Southbury conducted an evaluation of the unnamed pond and presented their findings in a report entitled *Natural Resources Inventory Eisenhower Park* (the Land-Tech Report) that was dated December 2005. The evaluation, completed during the summer and early fall of 2005, indicated that the pond had a maximum water depth of 5 feet and an average water depth (readings from 11 sampling points) of slightly more than 3 feet. A significant deposit of sediments in the pond was noted; the depth of accumulated sediment varied throughout the pond and ranged from 0.5 to 2 feet in the northern to middle sections of the pond and up to 6 feet in the southern portion of the pond near the outlet. The accumulation of flow-transported sediments into lakes or ponds constructed as either impoundments on rivers or as flow bypass waterbodies is commonplace.

The unnamed pond within Eisenhower Park.

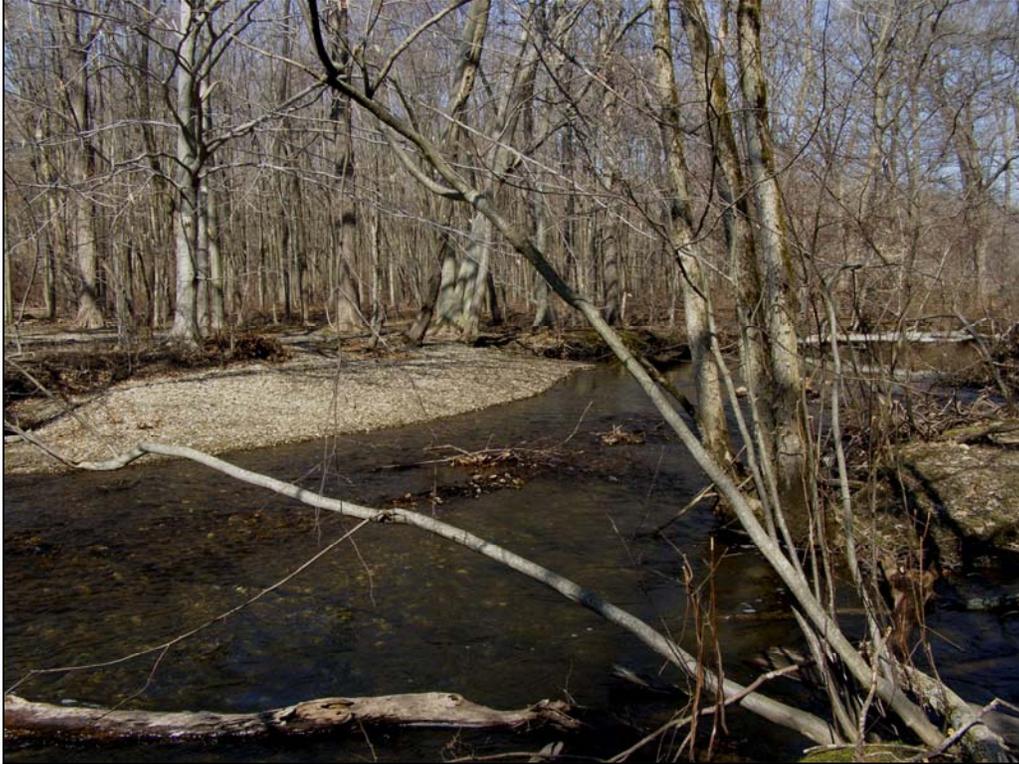
Riparian vegetation along the Wepawaug River within Eisenhower Park.

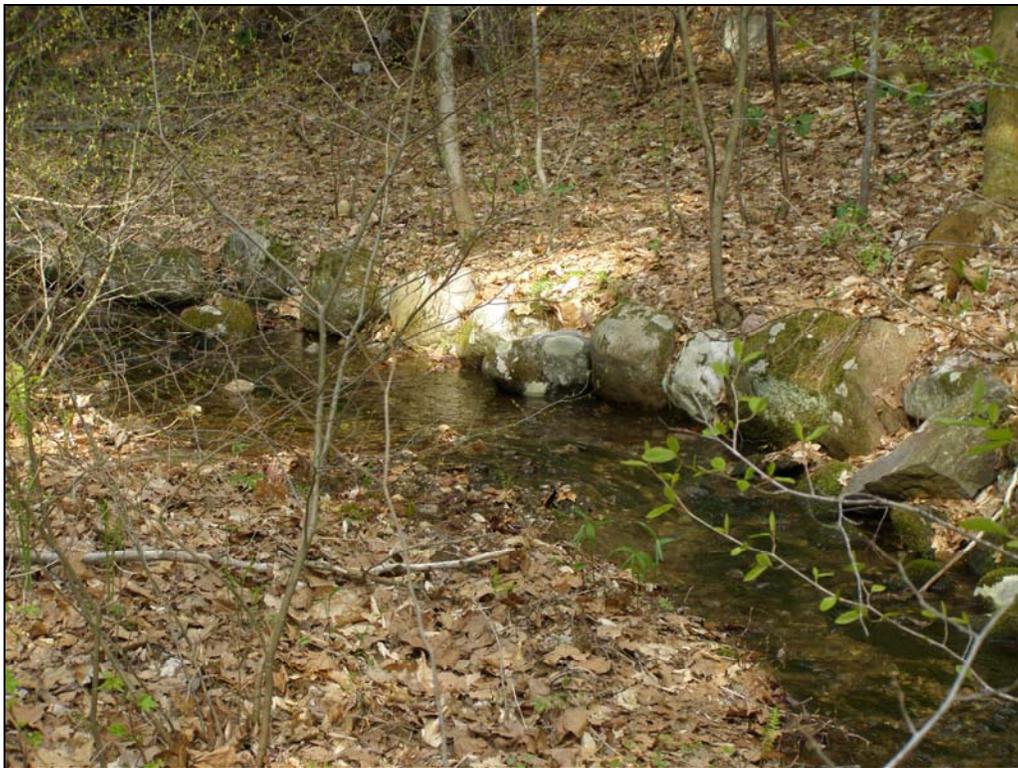
An example of bank placed boulders with reestablished vegetation.

The need for installing measures to abate riverbank erosion was noted in an April 18, 2007 report entitled *Master Plan for Eisenhower Park City of Milford, CT* prepared for the Eisenhower Park Study Committee by Stantec Consulting Services, Inc (the Stantec Report). The Stantec Report rightly endorses the use of bioengineering techniques and boulder vanes to stabilize the river banks. A bioengineered technique consists of both a structural or mechanical element (e.g. hard armoring such as bank placed boulders) and vegetative elements working together to stabilize a site-specific condition. The structural components are employed to allow the establishment of vegetative elements while at the same time providing a level of protection for stability.

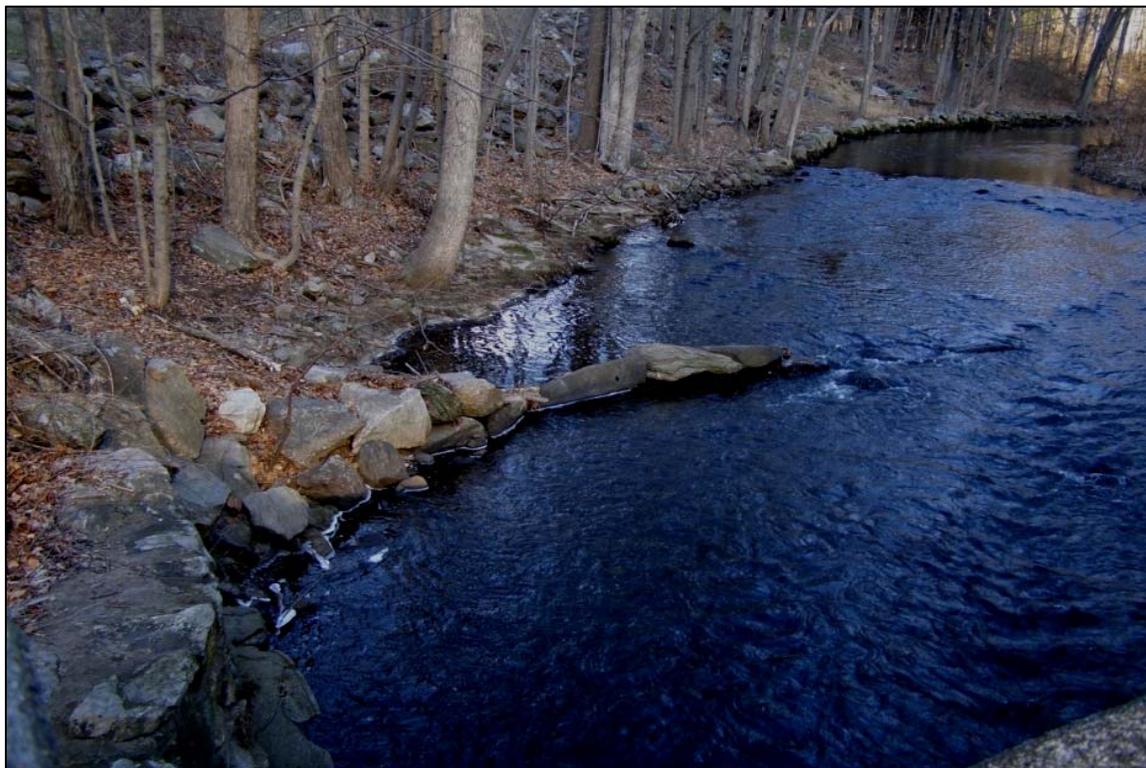
An example of a rock vane.

secondary circulation of flow thereby promoting the development of scour pools. Scour pools are critical for fish survival either during low flow periods of the summer months or during the winter when ice may encapsulate shallow water. Rock vanes can also be paired and positioned in a river reach to initiate meander development.

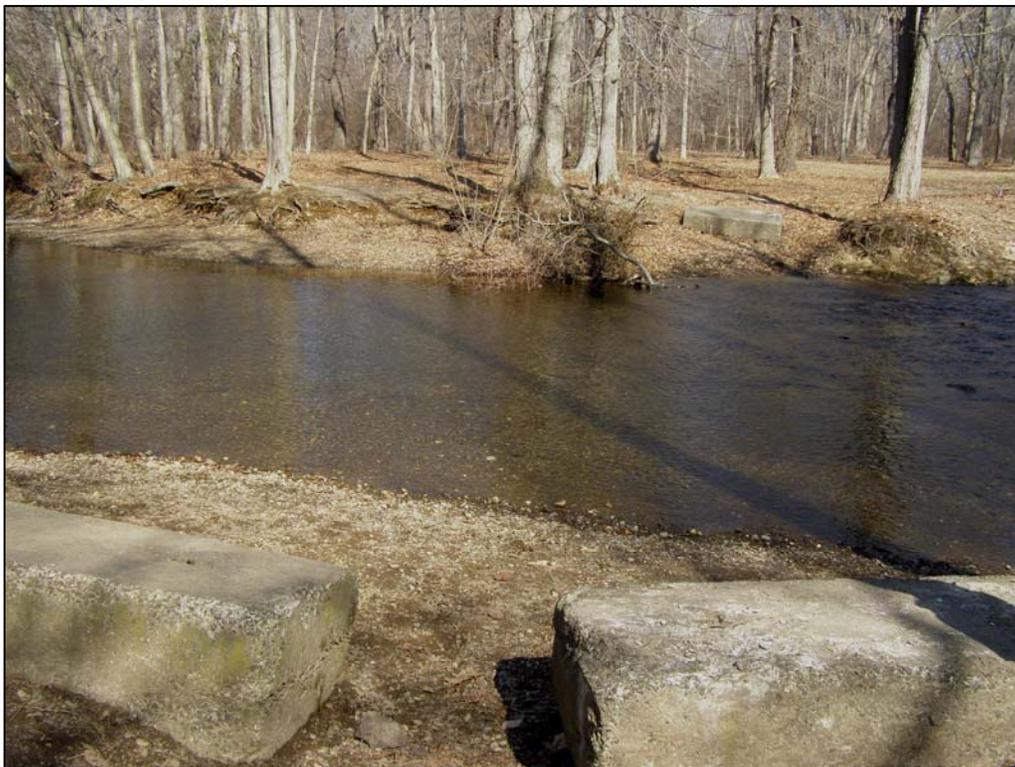
Unauthorized crossing of the Wepawaug River.

The installation of bioengineered bank stabilization and rock vanes require the use of machinery. There is limited access for machinery along most of the Wepawaug River within Eisenhower Park. However, there is one readily accessible area that is in dire need of bank restoration and instream habitat enhancement. The location is immediately downstream of the unnamed pond outlet where horseback riders reportedly cross the river. Apparently unauthorized (as evident by the City of Milford's installation of large concrete block as a barricade) there is evidence of continual crossing. The banks are completely worn, there is a minimal growth of riparian vegetation, and the instream habitat lacks diversity. The site is ideally suited for rebuilding the banks with boulders, organic soil and vegetation along with a series of rock vanes to enhance instream habitat and create a meandering flow pattern

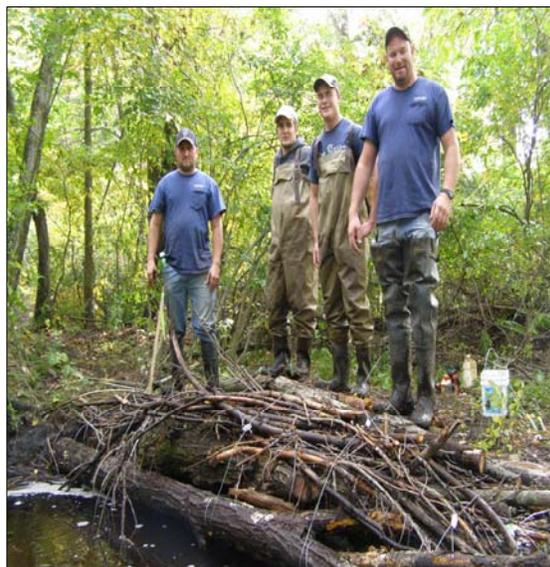
The photograph at the right shows an engineered log jam constructed solely by a four-man work crew.

The Stantec Report recommends stabilizing the banks along the Wepawaug River and enhancing riverine habitat in Phase I of a three phase plan for park improvements. Staff of the Inland Fisheries Division can provided the City of Milford with further guidance relative to site selection for the aforementioned stabilization and enhancement structures and/or oversight during the structure installation.

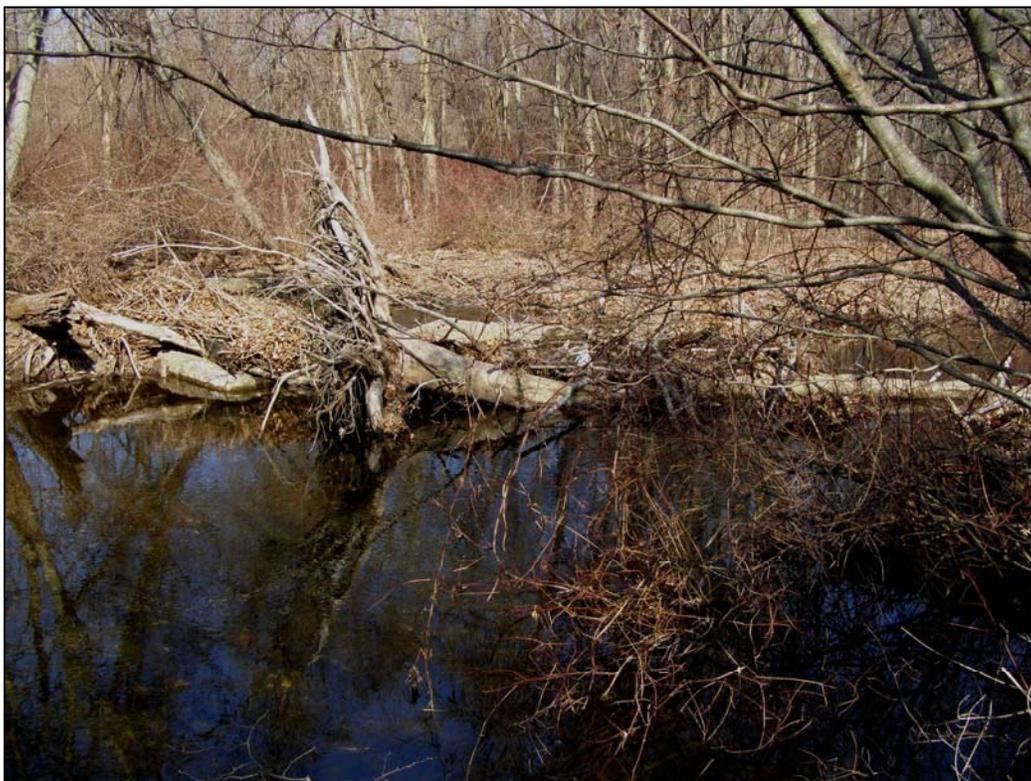
The unnamed pond in Eisenhower Park had been created by excavation with its water supply provided primarily by the diversion of flow from the Wepawaug River. The diversion structure consists of large concrete blocks placed across the river channel that shunt a portion of the flow into the northern end of the pond. A dam is located at the pond's southern end. The dam consists of staked concrete block with a central spillway that is 44 feet in length and approximately 9 feet in width. A low level outlet discharges flow to a channel that ultimately rejoins the Wepawaug River.

**The diversion structure in the Wepawaug River.
View of the structure is partially obstructed by fallen trees.**

2. The crest of the diversion structure should be set at an elevation that allows for the discharge of flows up to the 1.5 to the 2-year storm frequency downstream in the Wepawaug River.

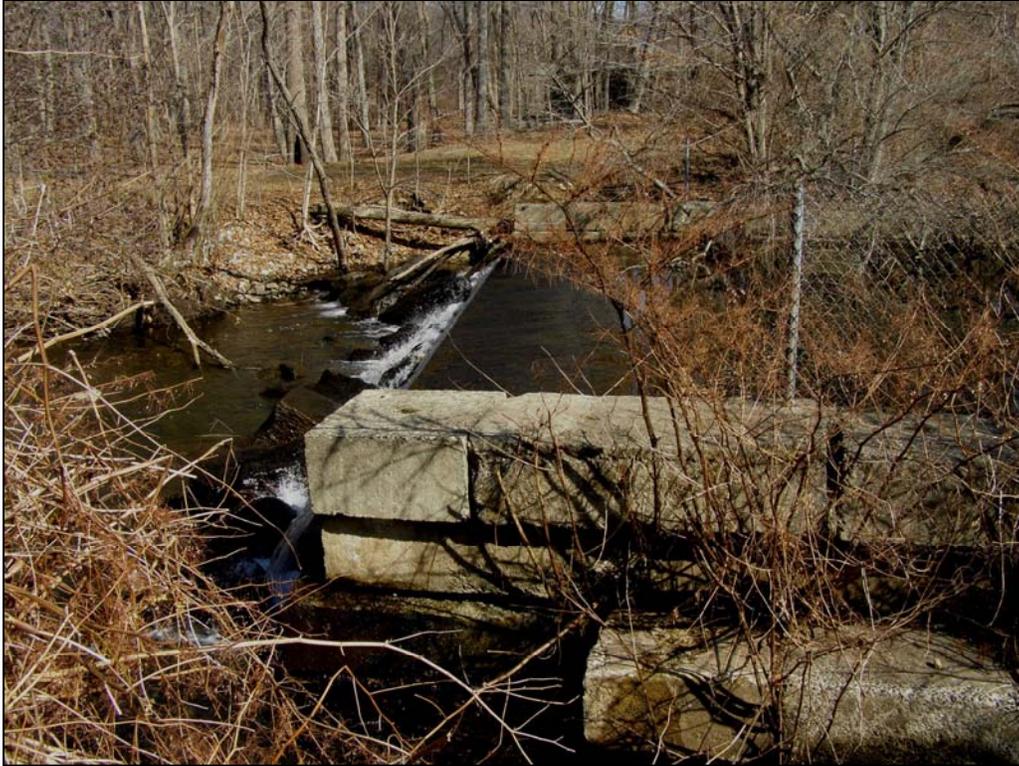
Dam at the outlet of the unnamed pond.

- **Outlet Structure** - The dam spillway and sidewalls are in need of repair and upgrade as an outlet control structure. Once corrected, the dam control device will allow for greater water level control, which would facilitate draw downs to manage aquatic weeds, future dredging operations and access to all structures within the ponds confines.
- **River Inlet** – Periodically isolating flows from the river to the pond for maintenance and flood control would be beneficial to the pond. The control and diversion of in-flow from the river will allow for facility repairs, removal of sediments and restoration of storage capacity.

1. A water control structure should be incorporated into the dam so that the water surface elevation in the pond can be actively controlled. The invert of the water control structure should

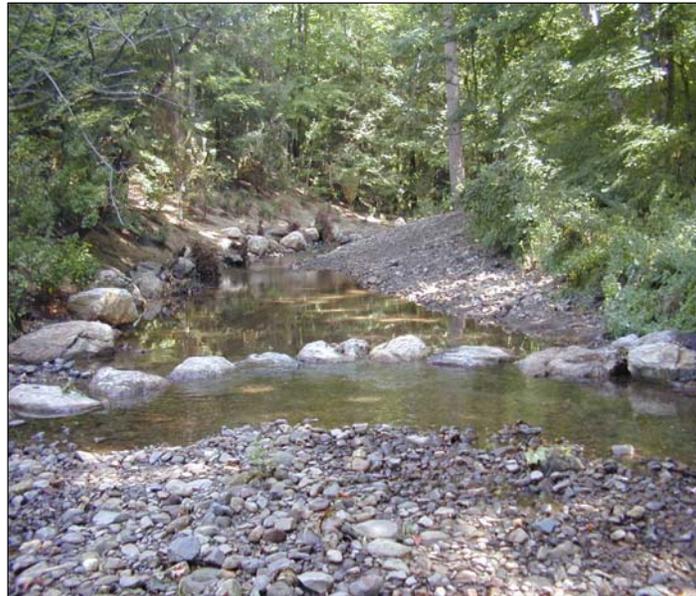
An example of a vortex rock weir.

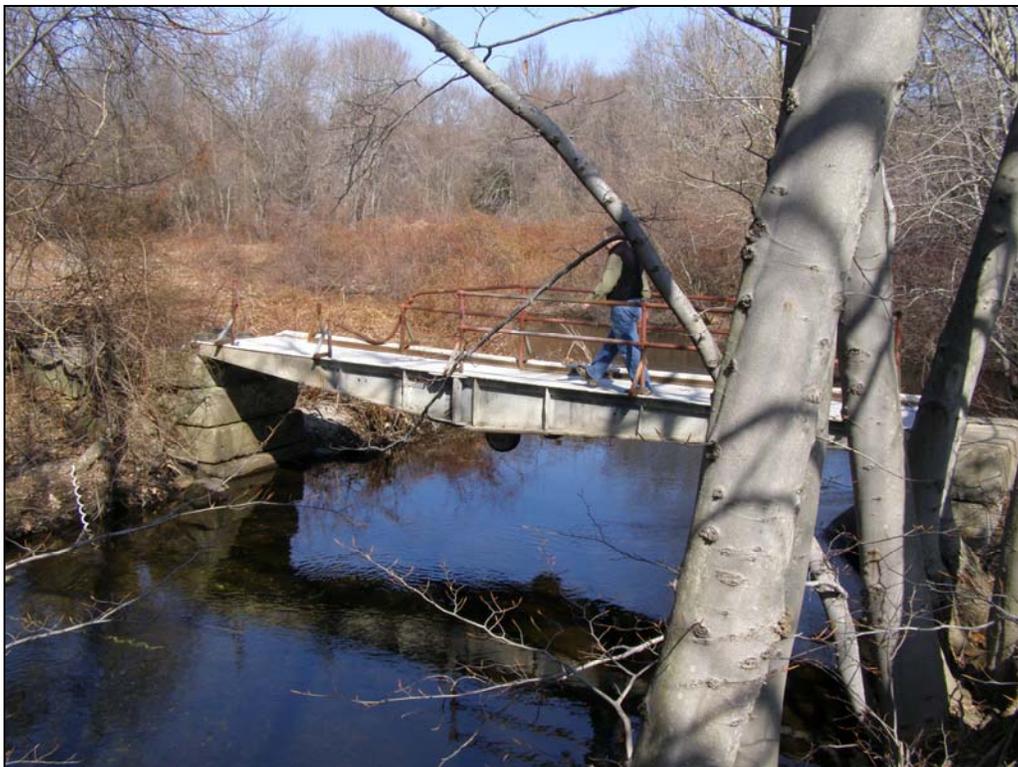
“South bridge” over the Wepawaug River within Eisenhower Park.

The Stantec Report indicates that the “north bridge” is in generally fair condition however, repairs are necessary. Short term recommendations are the replacement of the existing railing while long term recommendations are for a complete replacement. The “south bridge” is in poor condition; it has been recommended that the bridge either be replaced or removed entirely depending on the intended need for the crossing. The Stantec Report had recommended the bridges be rehabilitated and/or replaced in Phase I of a three phase plan for park improvements.

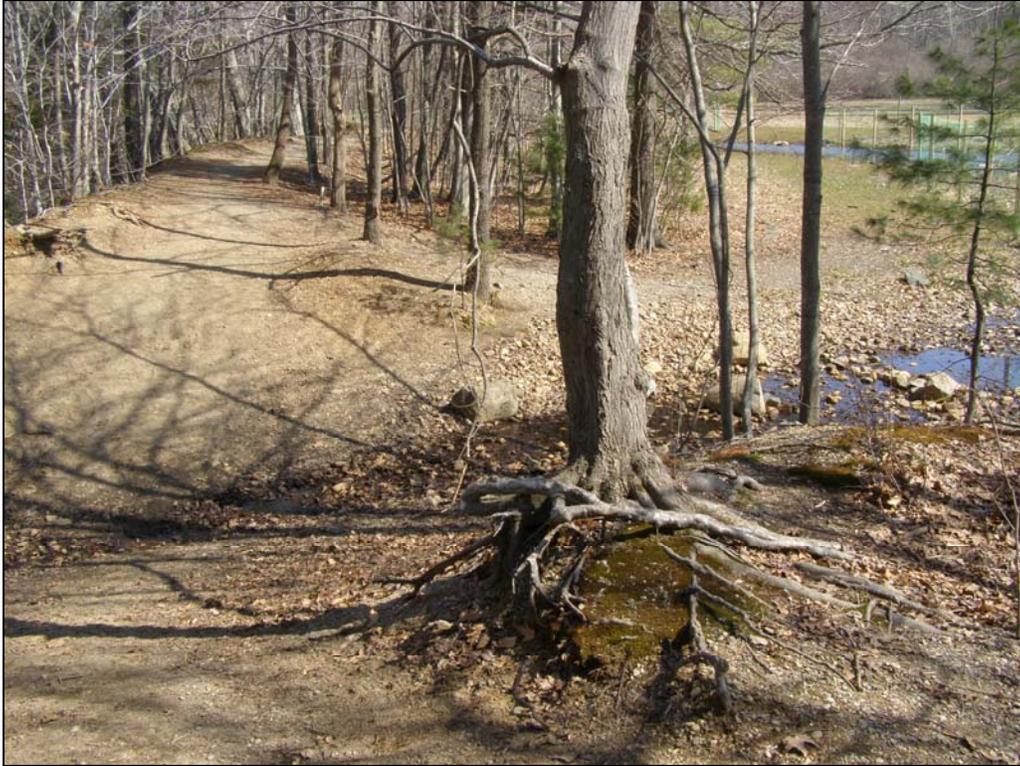
Trail crossing of the outlet of a drainage to the Wepawaug River within Eisenhower Park.

The Stantec Report had recommended trail improvements, particularly in the former Solomon and Alter properties, in Phase I of a three phase plan for park improvements.

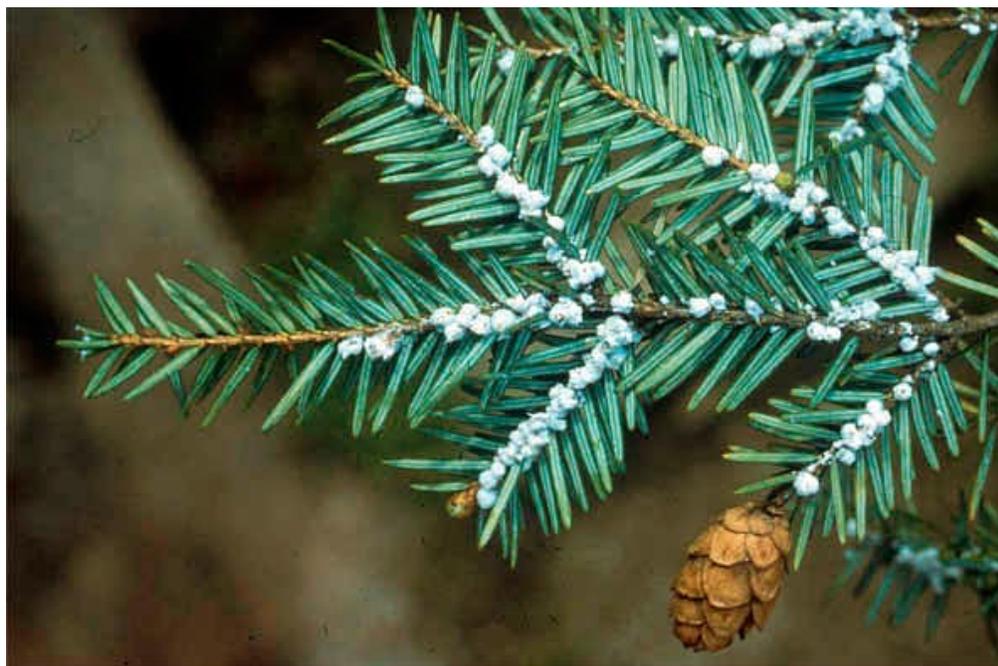
Hemlock Woolly Adelgid infested branch. http://na.fs.fed.us/fhp/hwa/gallery/photo_gallery.shtm

On the ERT walk downstream of the pond, this reviewer observed a small hemlock tree that had hemlock woolly adelgids on the underside of its foliage. Hemlock woolly adelgids are tiny insects that encase themselves in what looks like a speck of cotton fluff. An infestation can kill hemlock trees. In a garden landscape situation, people set up spraying programs to control adelgids. This is not practical in the wild. Consideration should be given to learning to recognize hemlock woolly adelgids and keeping an eye on the hemlocks in the mature deciduous forest on the west side of West River Street. If those hemlocks are killed, then invasive plants may become a problem in sunny openings.
