KING'S MARK ENVIRONMENTAL REVIEW TEAM REPORT

A.W. Stanley Park
New Britain, Connecticut

Prepared For
The New Britain Parks and Recreation Department
and the Friends of Stanley Park

August 1995

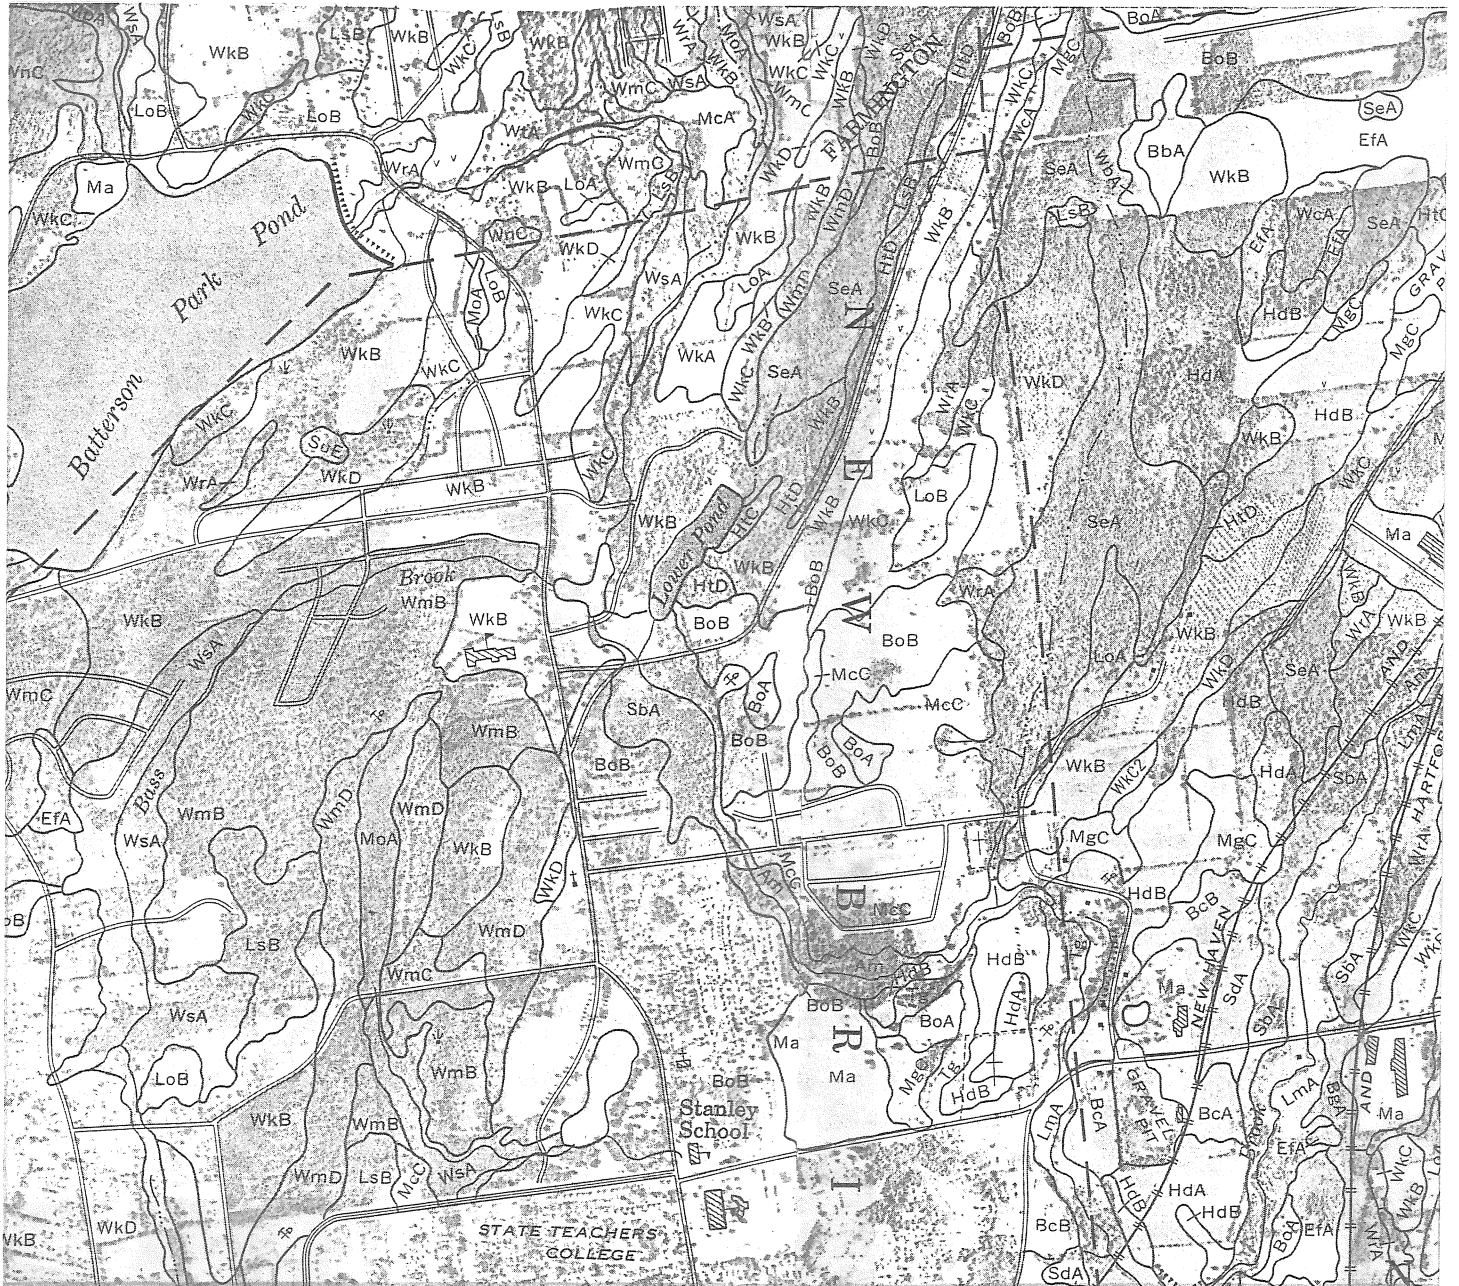
Figure 7

Soils Map
Scale 1" = 1667'

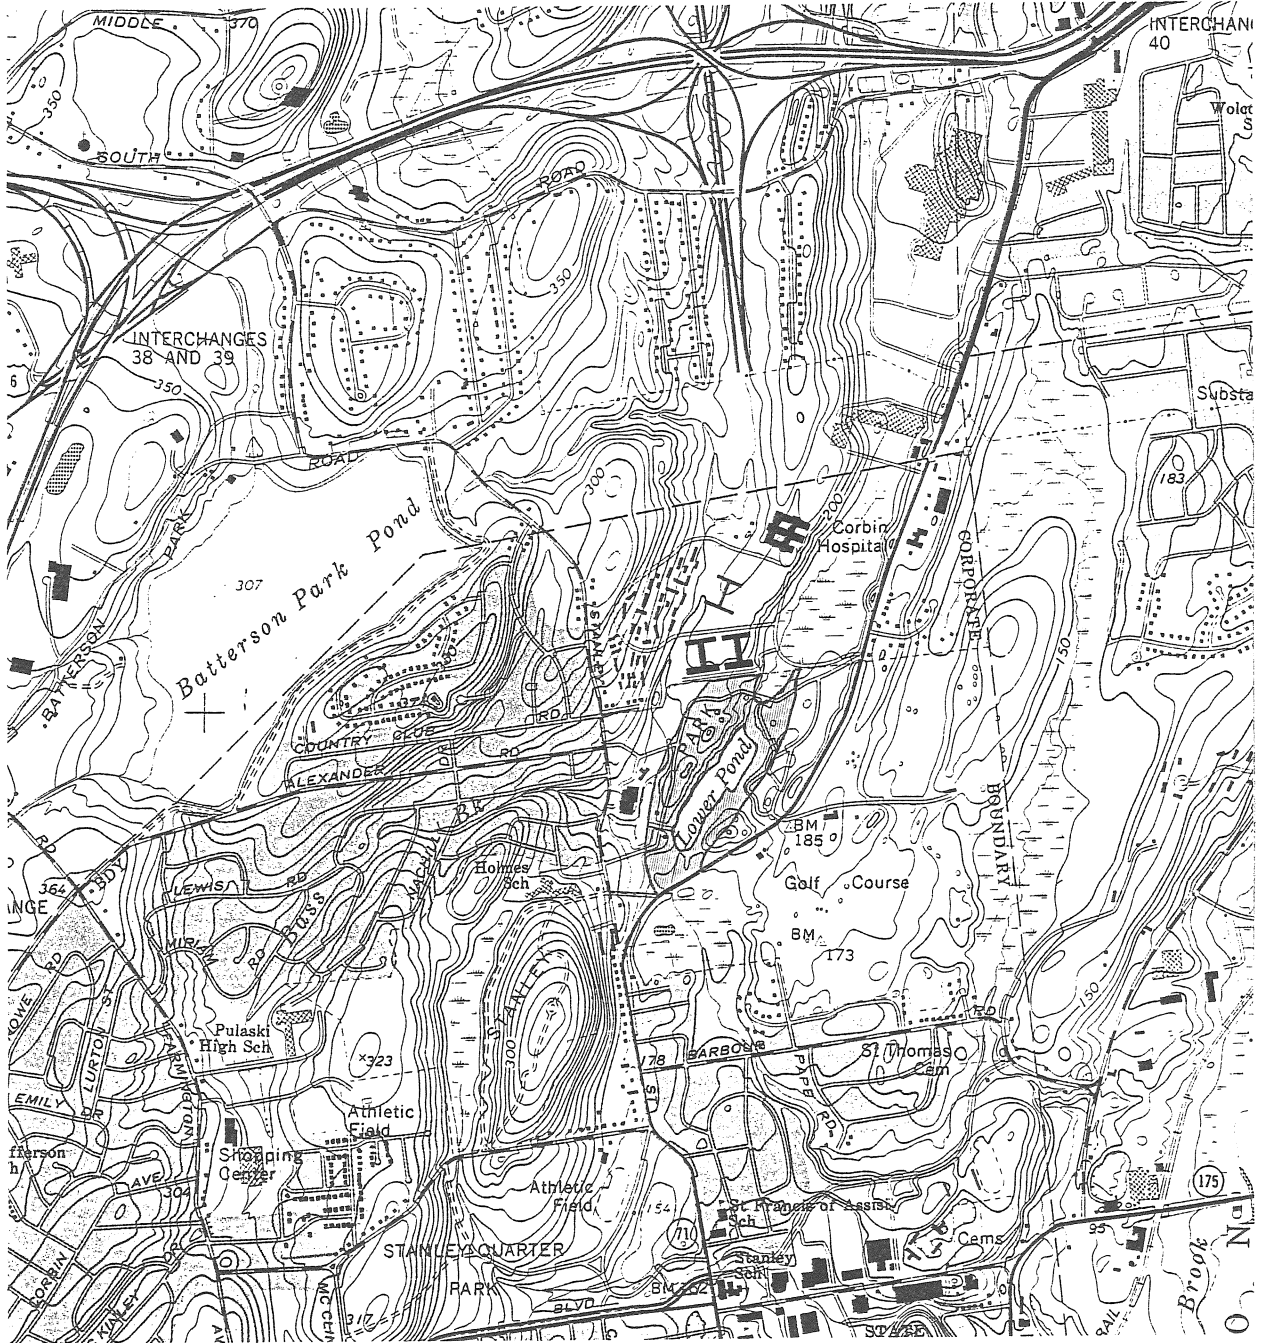
Potential Archaeologically Sensitive Area

Scale 1" = 2000'

The Office of State Archaeology recommends an archaeological survey of portions of the park that represent previously undisturbed land that have some proximity to wetland features. This survey would locate any below-ground archaeological resource and should be conducted prior to any landscaping or construction activities. Our office is prepared to offer the City of New Britain any technical assistance in completing the survey. It is further recommended that the city consult with Dr. Kenneth Feder, Anthropology Department, Central CT State University, for data on local Indian sites from his office. In addition, local Indian artifact collectors should be interviewed for information on reported Native American artifacts found at the park. Likewise, the New Britain Historical Society may have sources helpful to this inventory of cultural resources.
