ENVIRONMENTAL REVIEW TEAM REPORT

NEW CANAAN LAND TRUST PROPERTIES NEW CANAAN, CONNECTICUT

KING'S MARK
ENVIRONMENTAL REVIEW TEAM REPORT

NOVEMBER, 1982

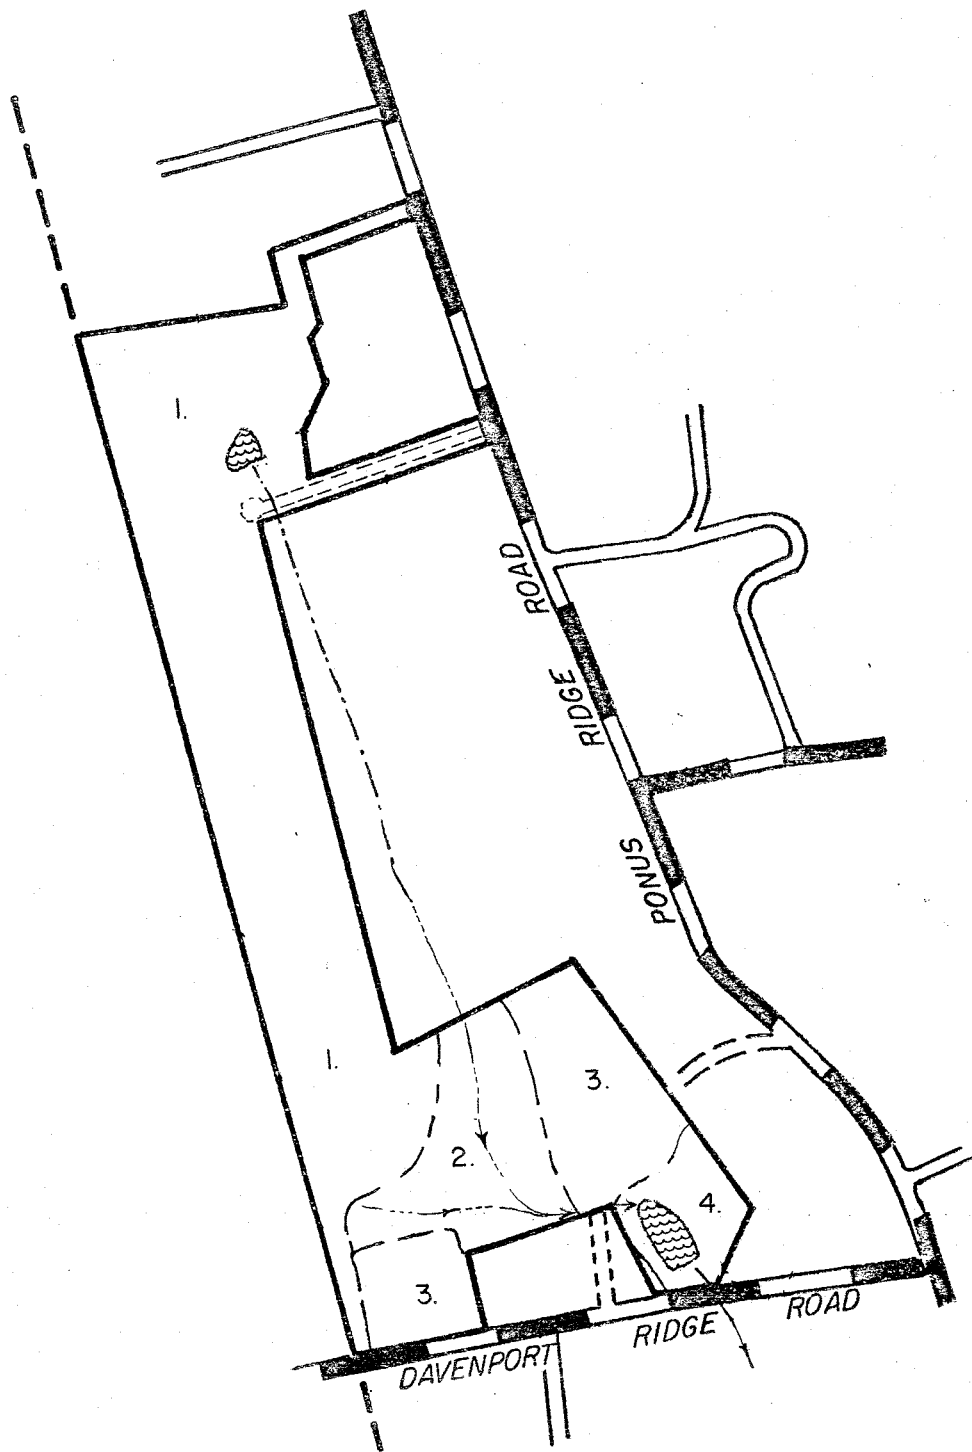
FIGURE III b.
VEGETATION TYPE MAP

VEGETATION TYPES

- STAND 1. Mixed Hardwood, 15.3 acres
- STAND 2. Hardwood Swamp, 3.1 acres
- STAND 3. Open Field, 4 acres
- STAND 4. Pond and Vicinity, 1.6 acres

STAND 1. MIXED HARDWOOD. This 15.3 acre stand occupies the northern two-thirds of the property. The overstory is composed of good quality, pole size (5-11 inches in diameter) red oak, yellow poplar, yellow birch, black birch, and scattered shagbark hickory. White oak and American beech are found on the driest areas. Stocking levels are relatively constant throughout, with the area being fully stocked. The understory, somewhat dense in the wetter areas, is composed of spicebush, highbush blueberry, maple leaved viburnum, and an area of scattered hemlock saplings which have been introduced. Sweet pepperbush can be found in wet pockets along the eastern boundary. Ground cover here consists of wild lily of the valley, princess pine, poison ivy, Christmas fern, and limited hardwood reproduction of the same species as are in the overstory. Of note in this stand is the incidence of damage to black birch from nectria canker, and the presence of American chestnut saplings, which are root suckers from now defunct parents.

STAND 3. OPEN FIELD. Four acres of this property are in open field and are not stocked with forest species. The fields are covered with grasses, common cinquefoil, and patches of goldenrod. Although retention of these fields is desirable from a wildlife standpoint, it would be feasible to establish a

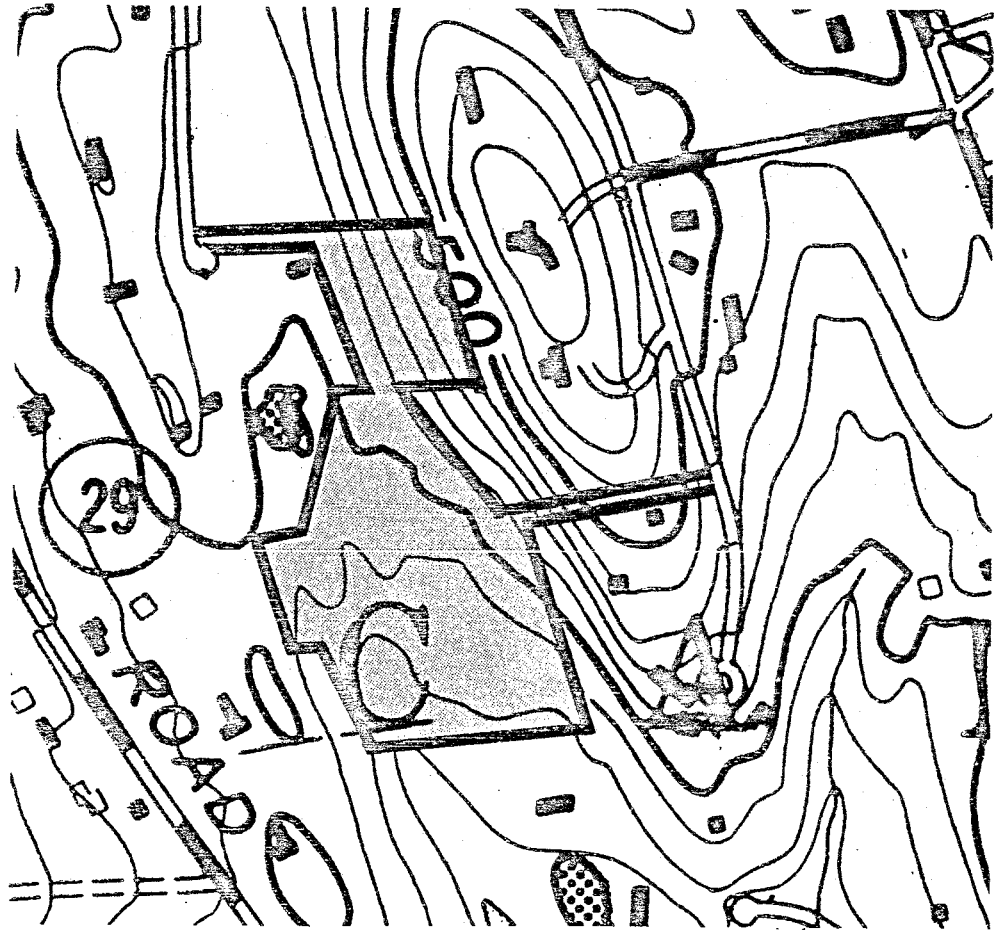
FIGURE IV a.

TOPOGRAPHIC MAP

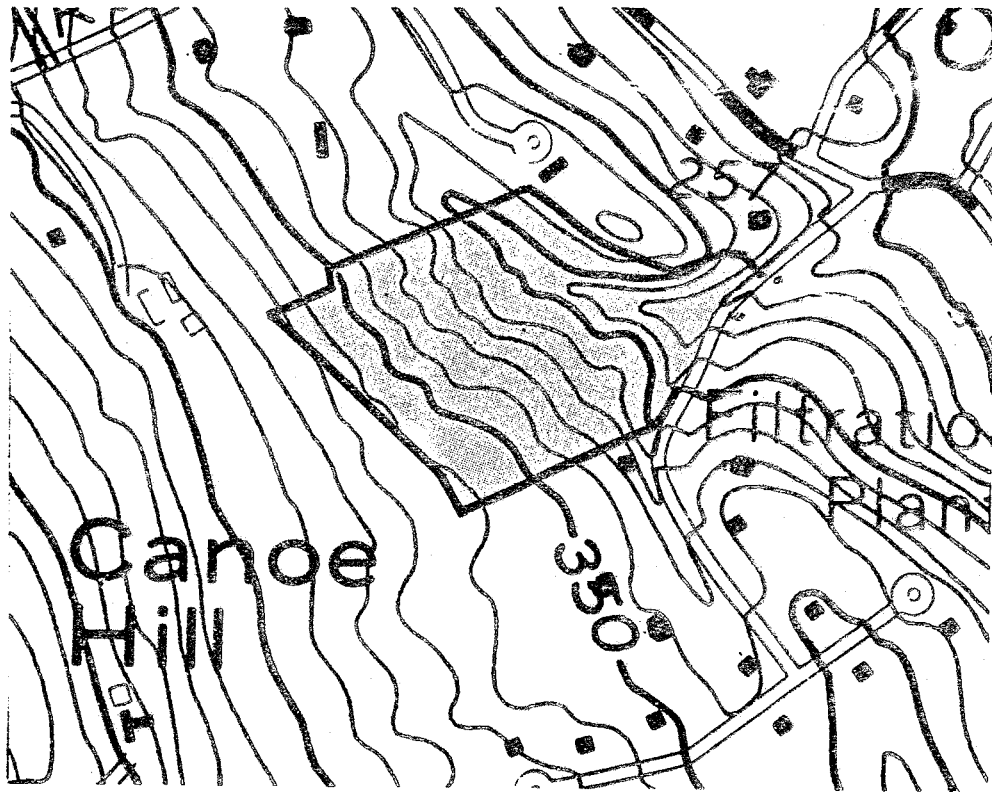
FIGURE V a.

TOPOGRAPHIC MAP

The Noble Sanctuary is located on the eastern flank of Canoe Hill. The site slopes moderately (about 12 percent) northeastward to a watercourse which flows along or just inside of the northeastern boundary of the site (see Figure Va). The slope is fairly smooth, broken only by the several intermittent streamcourses on the parcel.

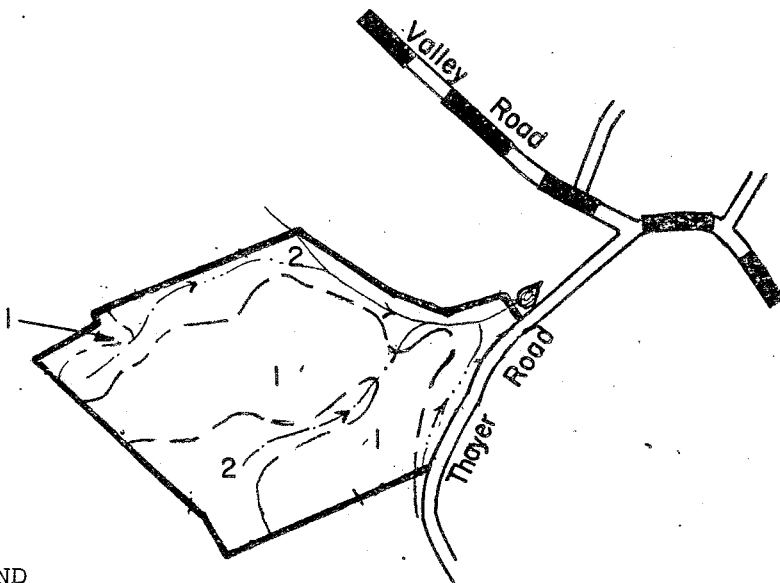
FIGURE V b.

VEGETATION TYPE MAP

As shown in Figure Vb, the Noble Property contains two basic vegetation types: mixed hardwood forest and hardwood swamp. These vegetation types correspond to the wildlife habitat types found at the site.

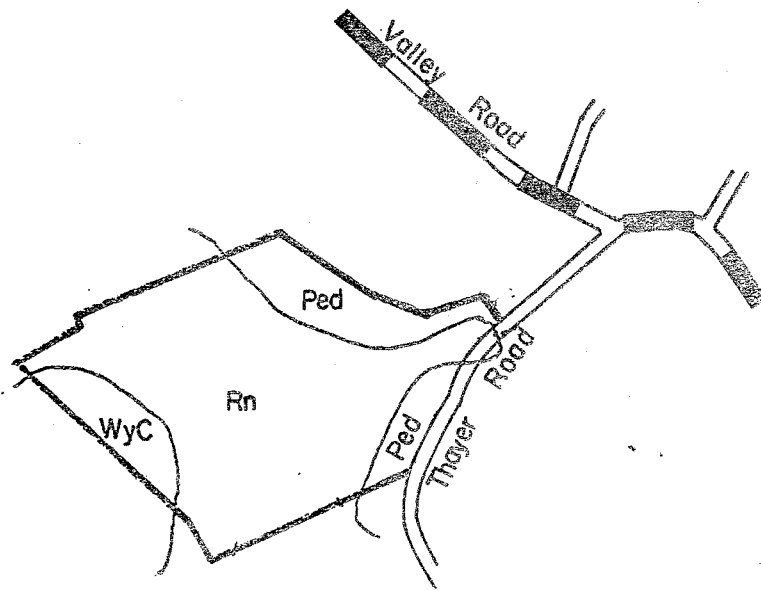
FIGURE Vc. SOILS MAP

Soil boundary lines derived from smaller scale map (1"=1320') and should not be viewed as precise boundaries but rather as a guide to the distribution of soils on the property.

Adopted from Fairfield County Soil Survey, USDA-SCS

PeD - Paxton extremely stony fine sandy loam, 15 to 35 percent slopes. This moderately steep to steep, well drained soil is found along the eastern edge of the property. Stones and boulders cover 5 to 35 percent of the surface.

WyC - Woodbridge very stony fine sandy loam, 8 to 15 percent slopes. This sloping, moderately well drained soil is found along the western border of the property. Stones and boulders cover 1 to 5 percent of the surface.

This Woodbridge soil has a seasonal high water table at a depth of about 20 inches from fall until late spring. The permeability of the soil is moderate or moderately rapid in the surface layer and subsoil and slow or very slow in the substratum. Runoff is rapid, and available water capacity is moderate. The soil is very strongly acid to medium acid in the surface layer and subsoil and very strongly acid to slightly acid in the substratum. The hazard of erosion is severe.

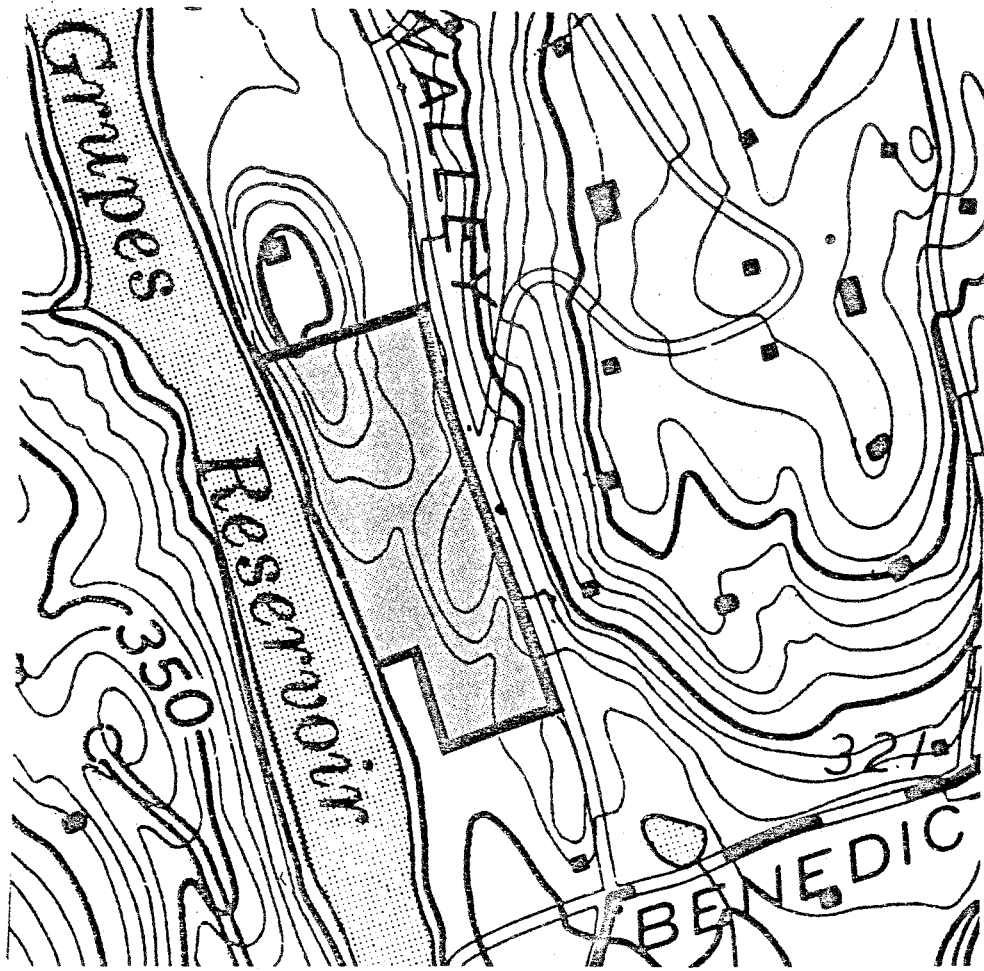
FIGURE VI a.

TOPOGRAPHIC MAP
