# ENVIRONMENTAL REVIEW TEAM REPORT

## SQUANTZ POND

NEW FAIRFIELD and SHERMAN, CONNECTICUT

JUNE, 1983

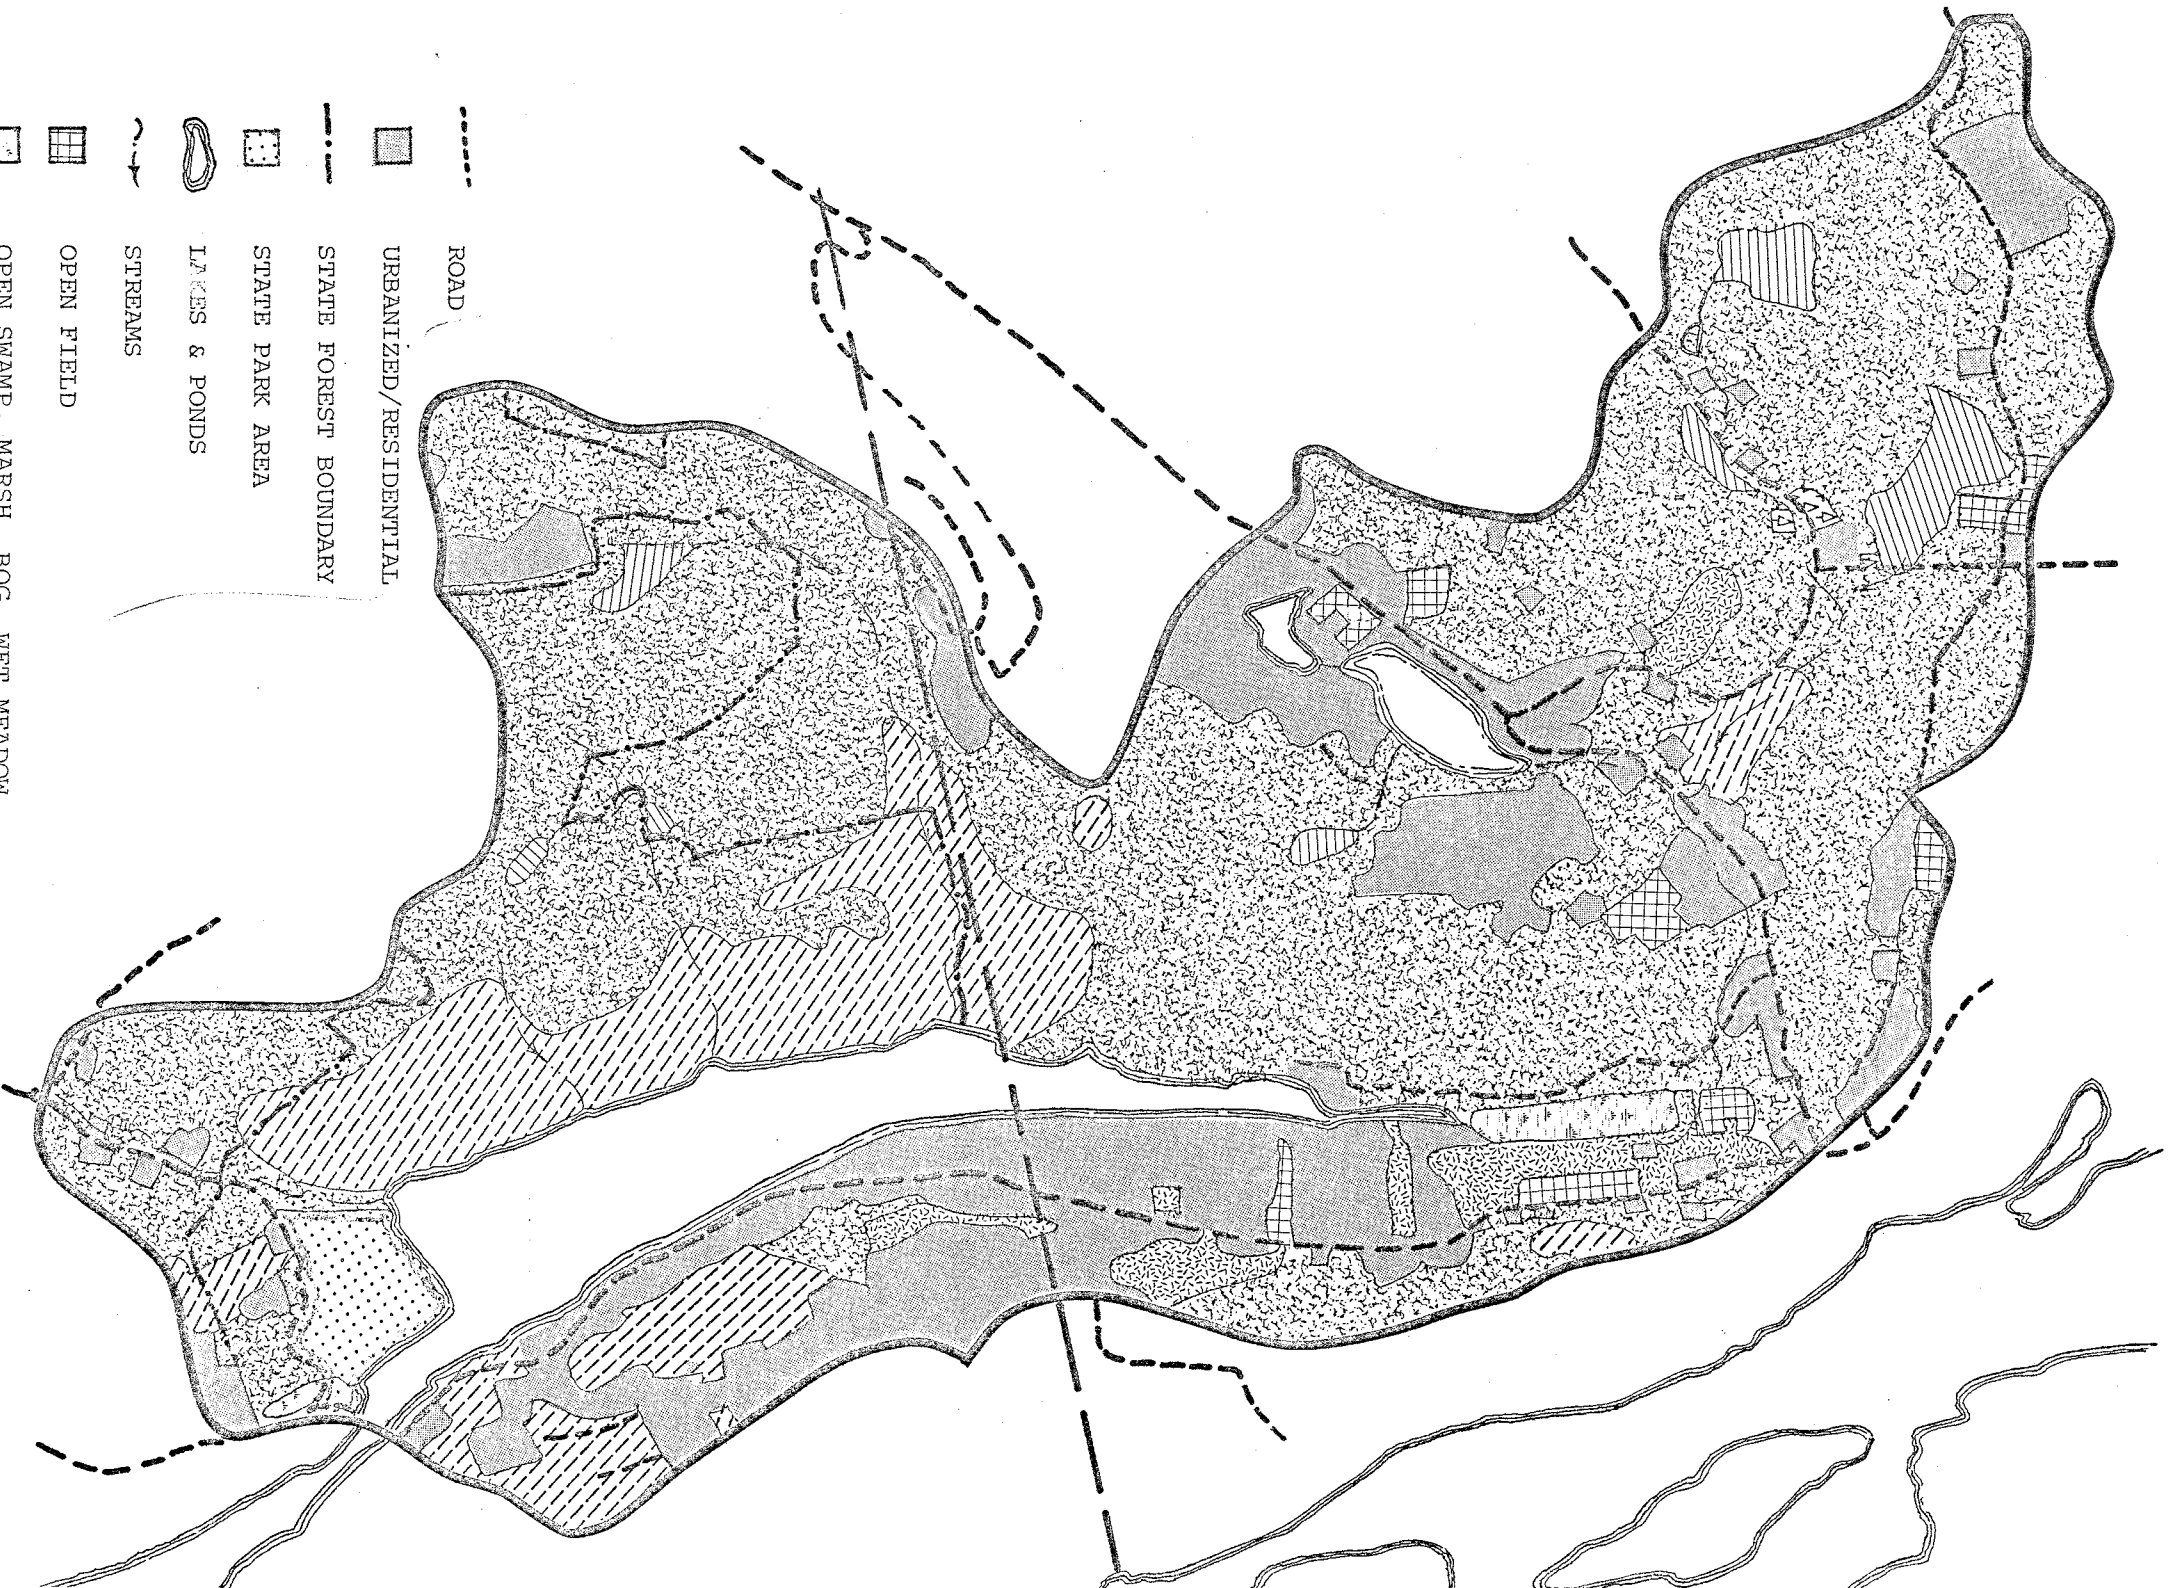
Figure 4  
**VEGETATION TYPE MAP**

- ROAD
- URBANIZED/RESIDENTIAL
- STATE FOREST BOUNDARY
- STATE PARK AREA
- LAKES & PONDS
- STREAMS
- OPEN FIELD
- OPEN SWAMP, MARSH, BOG, WET MEADOW
- HARDWOOD SWAMP
- OLD FIELD
- SOFTWOOD
- SOFTWOOD/HARDWOOD
- MIXED HARDWOODS AND NORTHERN HARDWOODS

For the purposes of this report, the Squantz Pond watershed may be divided into seven vegetation types. For the most part the boundaries of these vegetation types gradually grade into one another, causing wide transition zones where tree species dominant in one type are present in another. These conditions cause difficulty in mapping. In other areas, transition zones are almost non-existent and mapping is greatly simplified. The composition and potential for management of the seven major vegetation types is discussed below.
