RUDE ROAD - PRESTON

Resource Inventory and Analysis

Environmental Review Assessment

Report #1004 - January 12, 2017

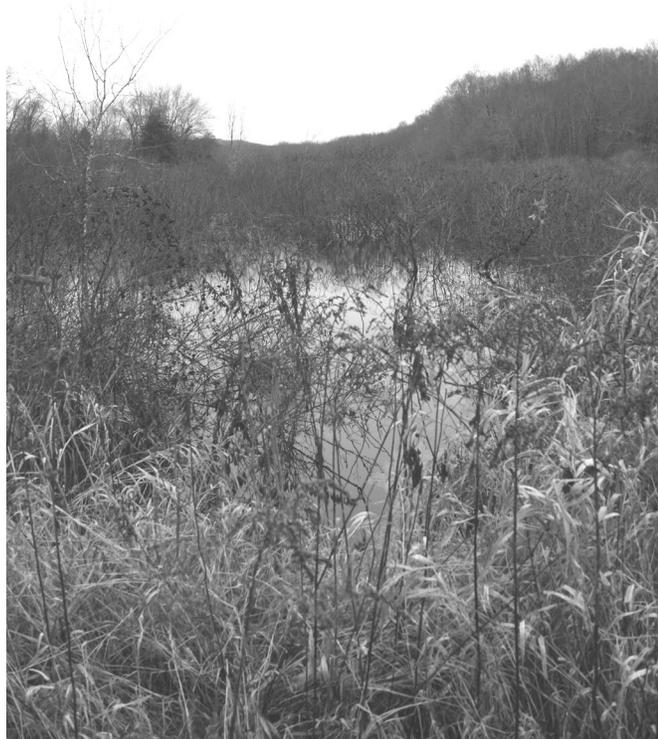
Figure A-6—Broadbrook flowing through property at Rude Road - Photo: J Davies—CTRC&D 2016

Area #5: Broad Brook is a perennial watercourse that flows across the subject property. Its watershed extends far off-site to the southeast, to near Route 165. It receives inflows from Folly Works Brook from the south, and from Rattlesnake Brook from the north. Broad Brook is classified as a Class A watercourse by the Connecticut Environmental Conditions Online website. The watercourse was viewed upstream of the bridge at Parks Road (Photo 9). In this general area the wooded channel banks are stable, and the channel is shaded by riparian trees. Instream habitat consists of shallow riffles and runs. Boulders and fallen logs in the channel provide cover and velocity shelters for fin-fish.

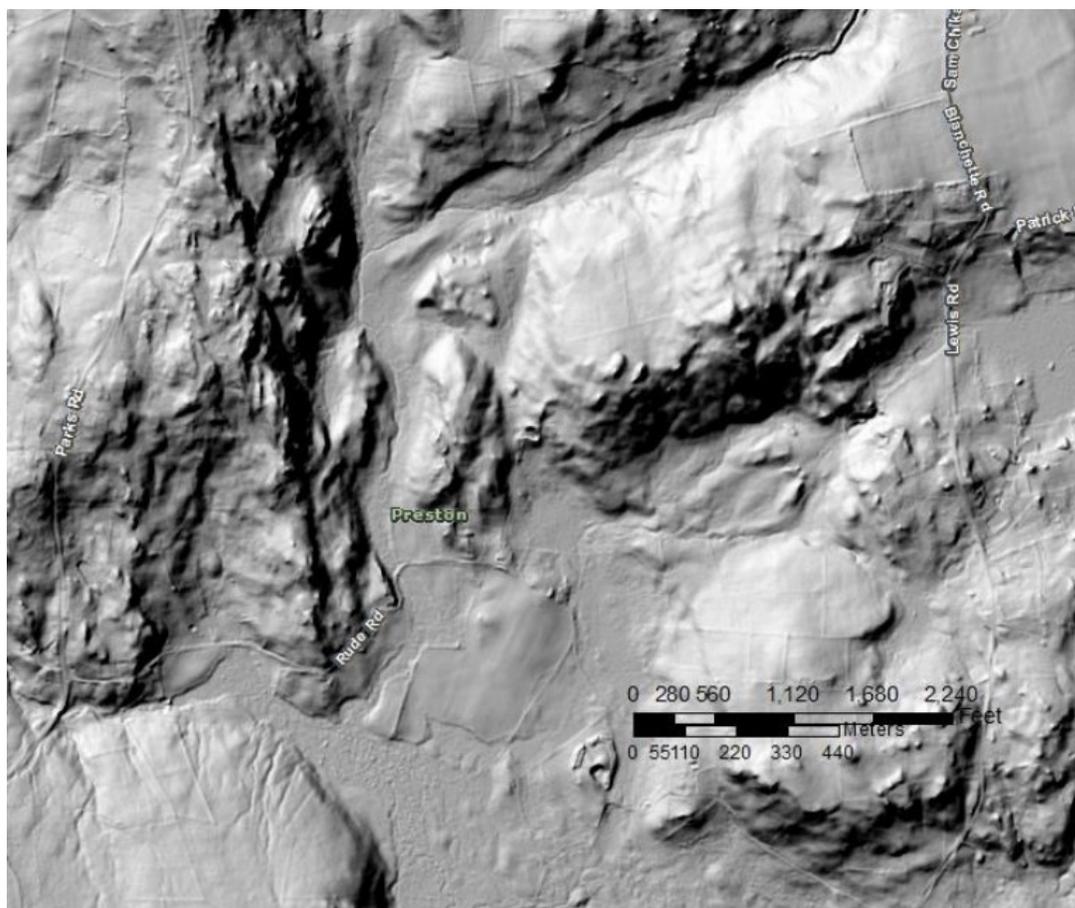
Figure A-13 (From R Steinen report)
Hillshade-Lidar digital elevation model illustrating the topography (relief) of the area around the Kendall and Thoma properties

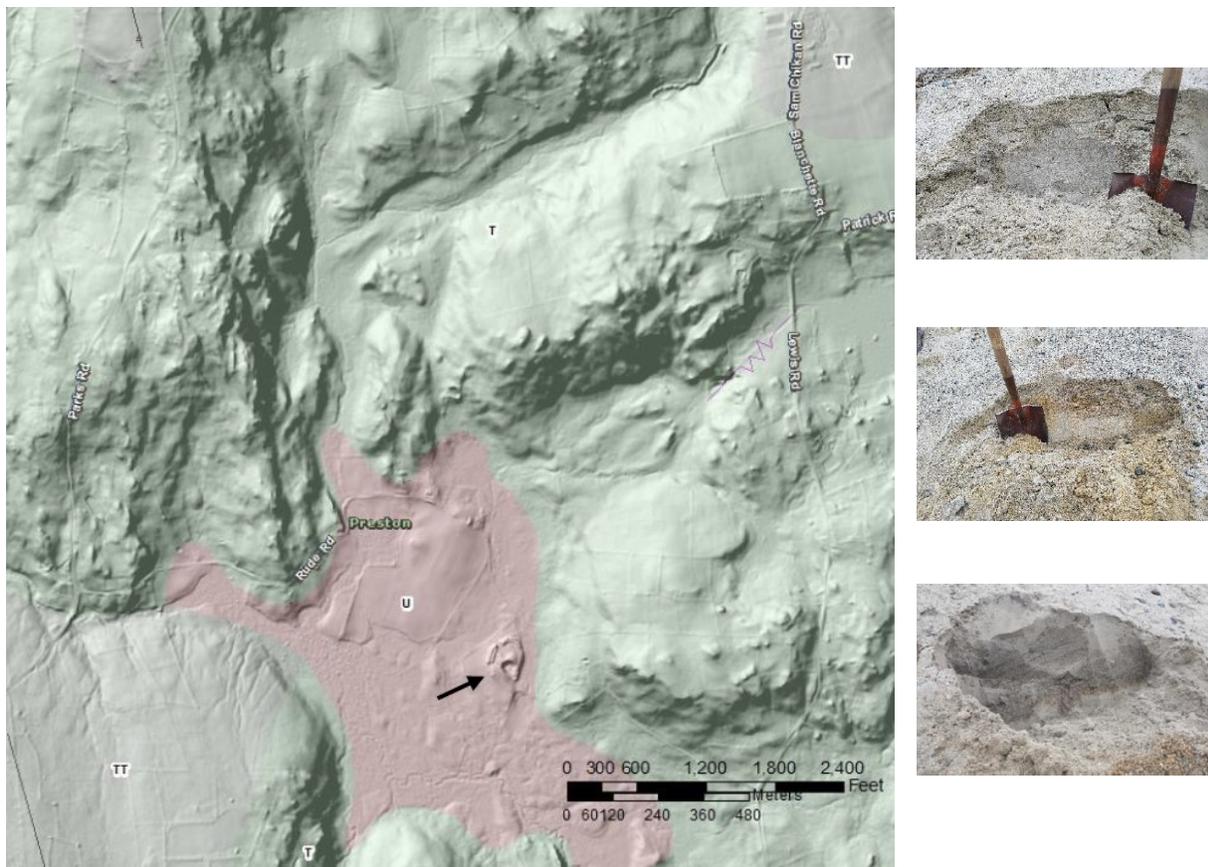
Figure A-14 (From R Steinen report) - Ice age deposits in area around Kendall Thoma properties. Areas colored green (labeled T) are covered by thin glacial soils (till); gray areas (labelled TT) are covered by thick glacial soil; area shaded cream color (label U) is sand and gravel deposit. Black arrows point to areas mined for sand and gravel at some time in the past. (Geology from Stone and others, 2005) Photos to the right illustrate sand layers at increasing depth in the deposit. Left image shows pit was dug near the top of the deposit; center slightly lower stratigraphically and right about 5-6' below the top. Note decreasing grain-size with increasing depth below the top of the deposit. Internal stratification shows cross-beds and climbing ripples, suggestive of rapid subaqueous deposition. These data are consistent with deposition on a delta rather than deposition as wind-blown sand.

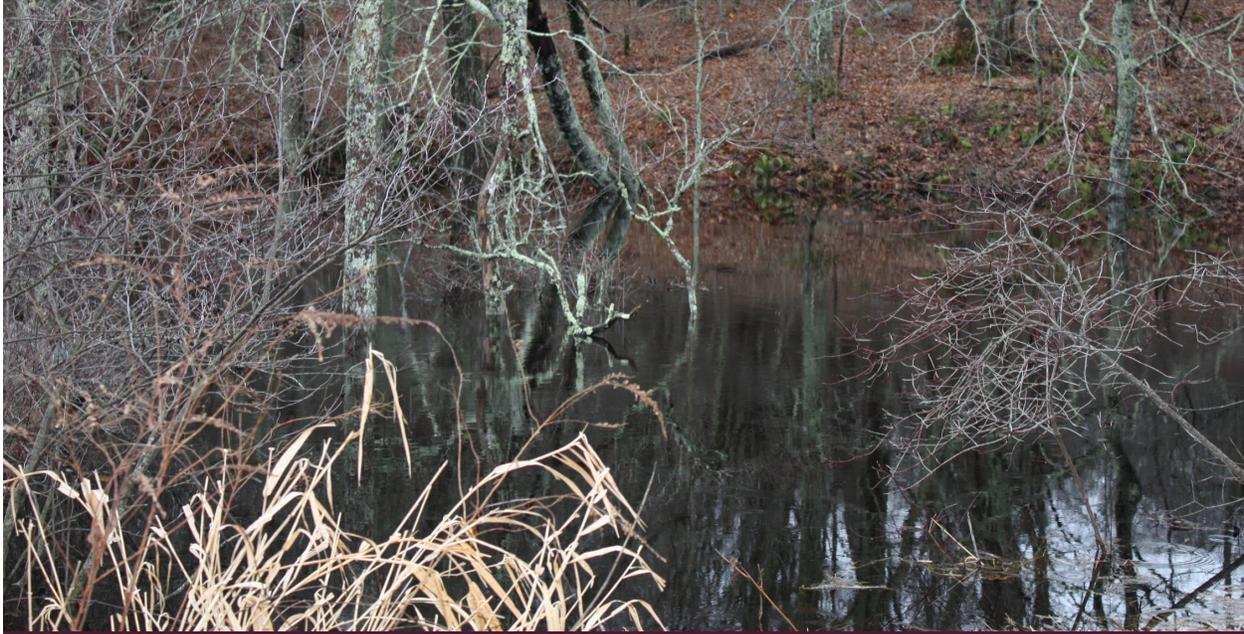
Figure A-15—Photo of Broadbrook—area behind small dam on stream—Source: J. Davies, CTCR&D

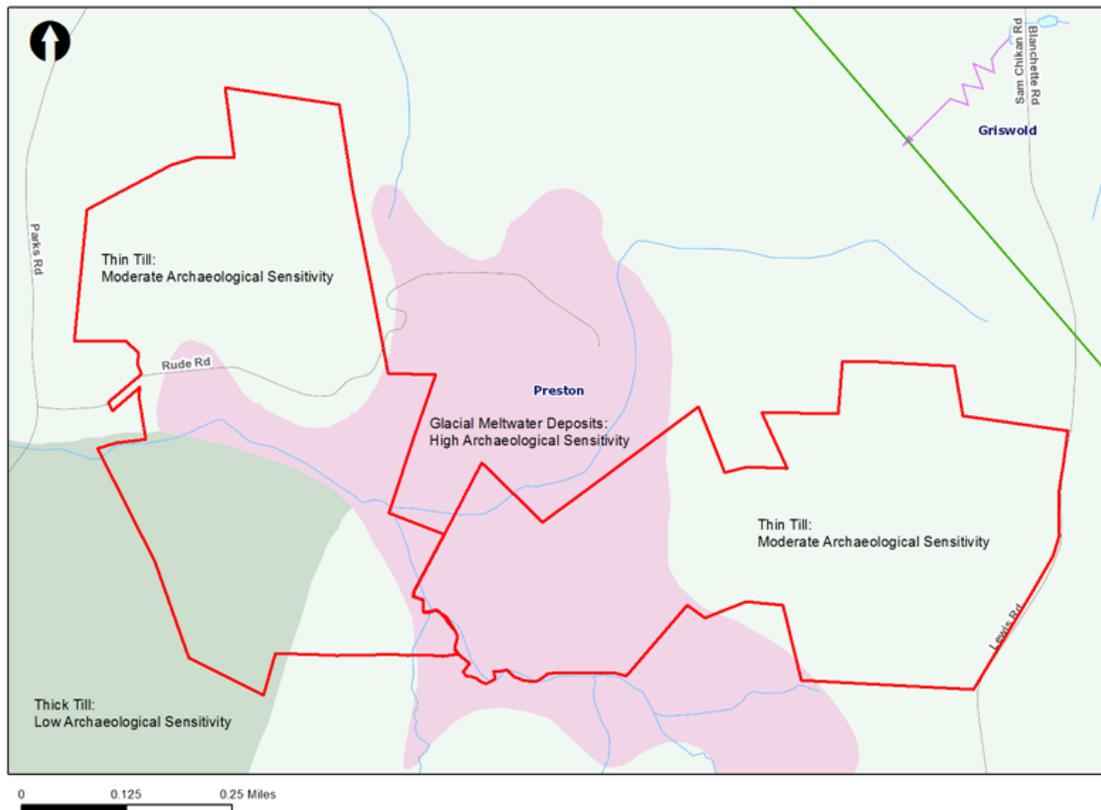
Figure A-18 Quaternary sediments and modeled archaeological sensitivity.

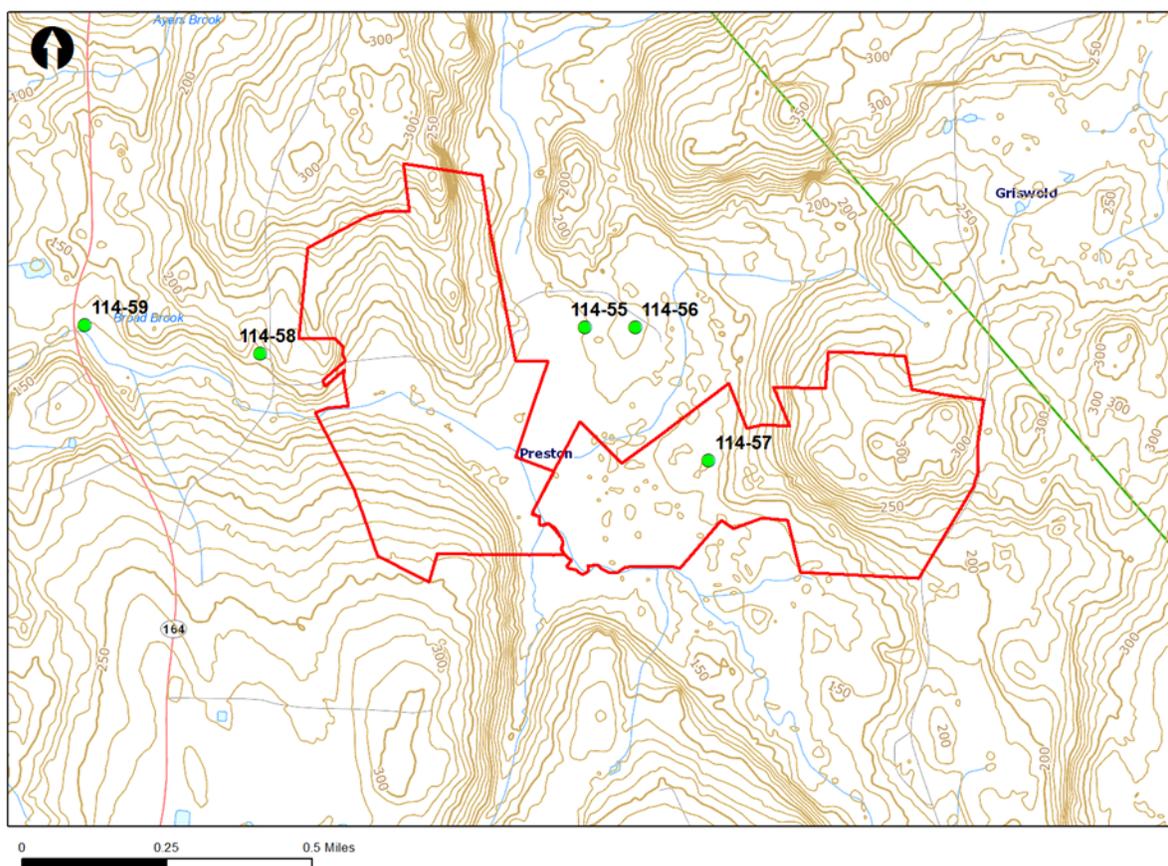
Figure A-19: Archaeological sites on file with the Office of State Archaeology in the vicinity of the Kendall/Toma properties.

Sites 114-155 and 114-156 lie in the large farmed field just north of the Kendall/Toma properties. This area of Sudbury sandy loam and Windsor loamy sand was used as a corn field when the artifacts were found on the surface. Site 114-55 is said to have contained at least 100 artifacts, including stone axes and celts. These had been in the collection of Bill Cray but are believed to have been sold and their whereabouts remain unknown. Bayer collected his own artifacts at nearby site 114-156. Photographs of some of the artifacts from this collection suggest site use during the Early Woodland period (2500 – 2000 years ago), and perhaps the Late Archaic (5000 – 4000 years ago). Sites 114-58 and 114-59 reflect locations where Bayer found artifacts in other nearby cornfields just west of the Kendall/Toma properties, but unfortunately no specific information is known about them.

Figure A-19 shows known archaeological sites in the vicinity of the Kendall/Toma properties. These sites were all documented by Louis Bayer, a former DEP game warden who walked and inspected much of southeastern Connecticut during his long career in the mid-20th century. Site 114-57 lies within the proposed conservancy area. The site is mapped in the vicinity of a recent sand pit, and may have actually been located within that area of disturbance from the mining of Windsor fine loamy sand in this area. Documentation indicates a site area of ca. 5 acres, suggesting that artifacts were collected from a broad area within this area of former corn fields. Unfortunately, no specific details exist about the type or age of the artifacts collected here.

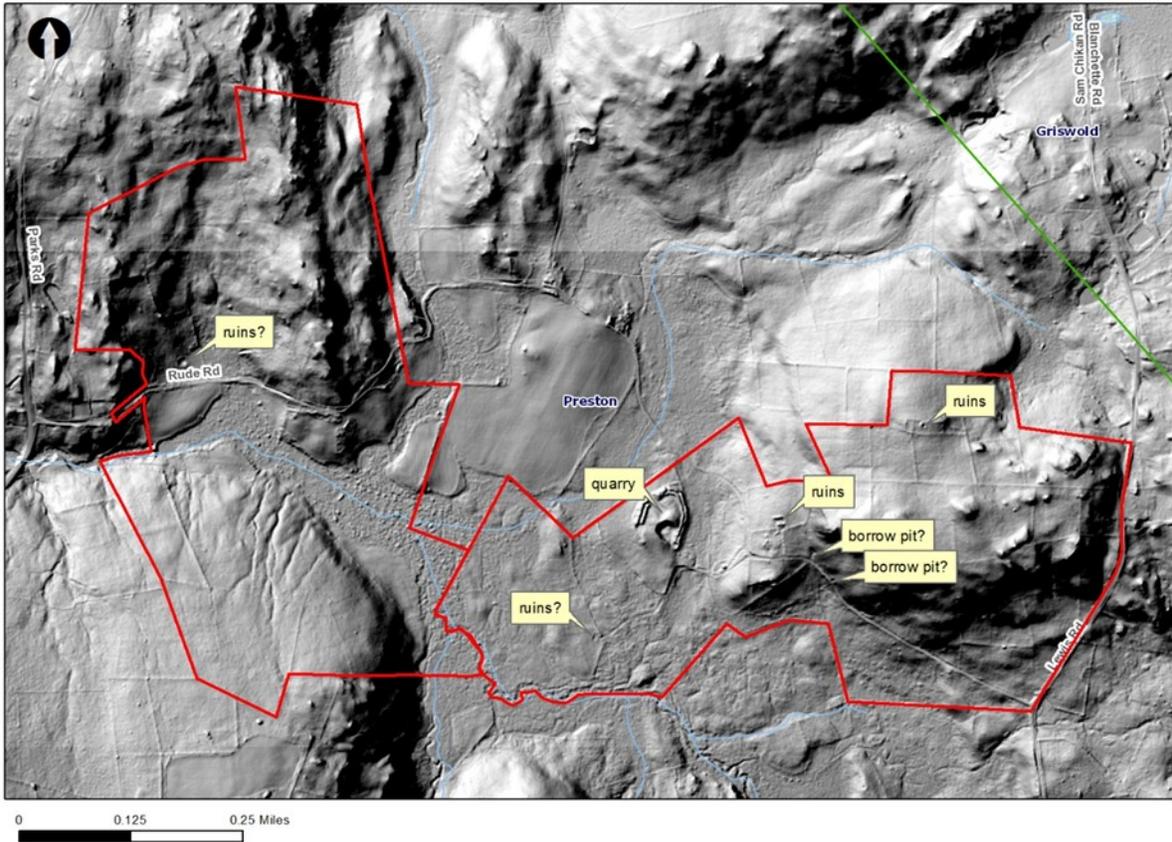
Figure A-20: Possible historic period features visible in Lidar imagery.

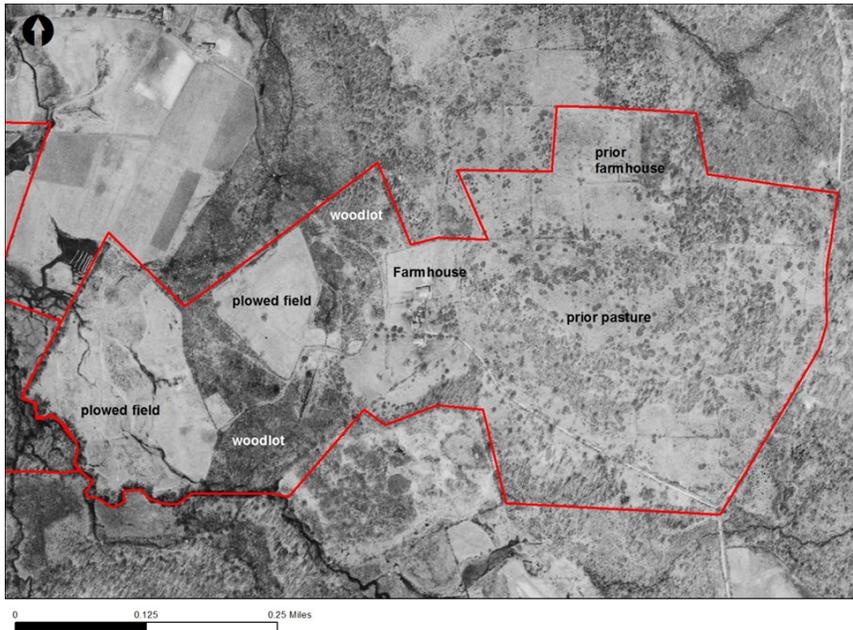
Figure A-21: 1934 Fairchild aerial map of the eastern property showing active farmhouse and associated fields and areas of prior pasture in an early successional state.

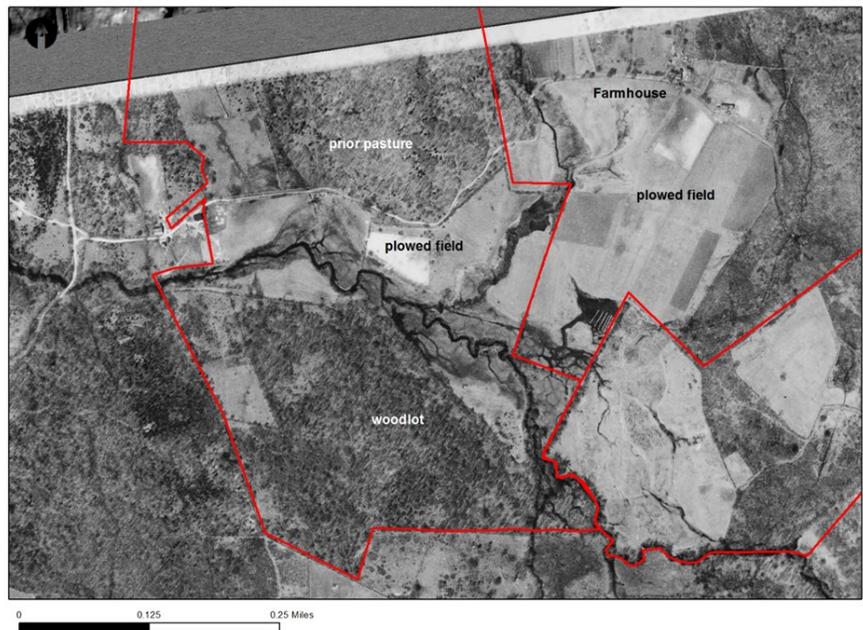
Figure A-22- 1934 Fairchild aerial map of the western property showing active farmhouses to the north and west. Associated plowed fields, woodlot and areas of prior pasture are also evident.

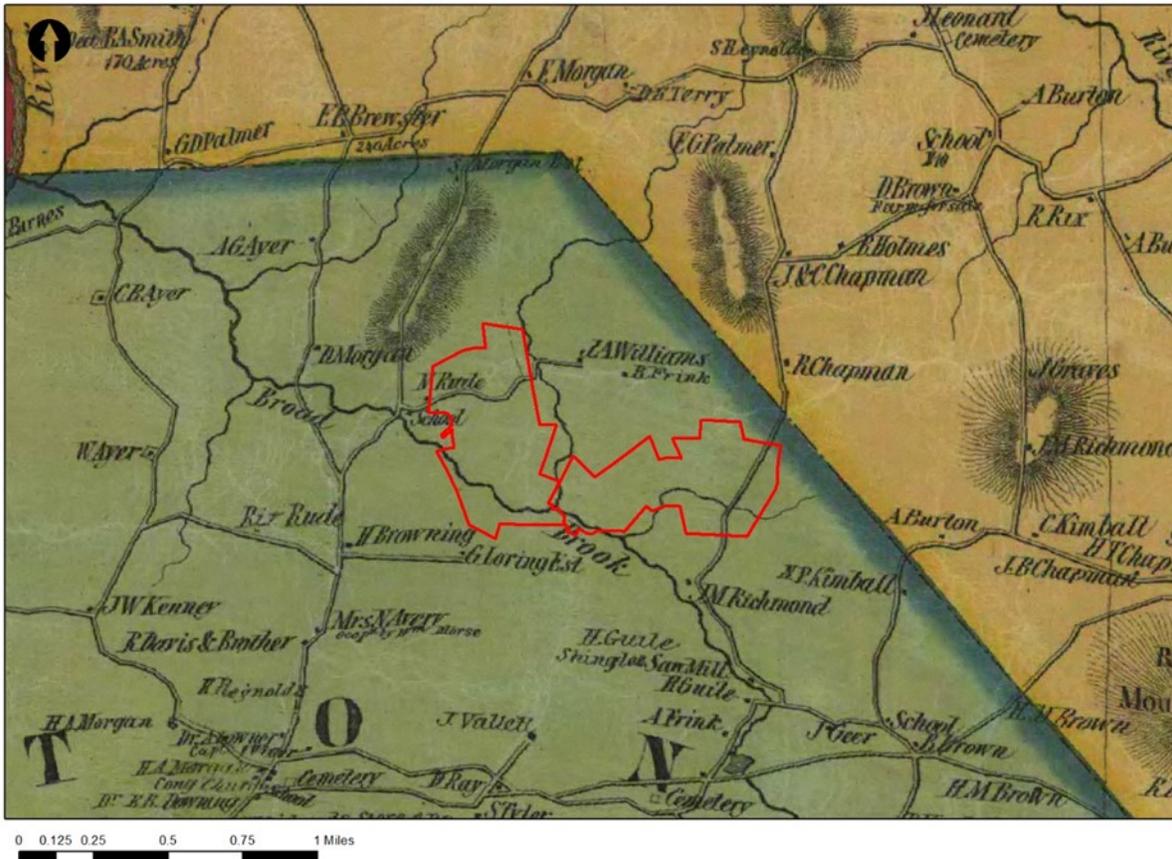
Figure A-23 Portion of the 1854 Baker Map of New London County, showing the nearby residences of Z.A. Williams, N. Rude, and a schoolhouse. Project overlay is approximate.

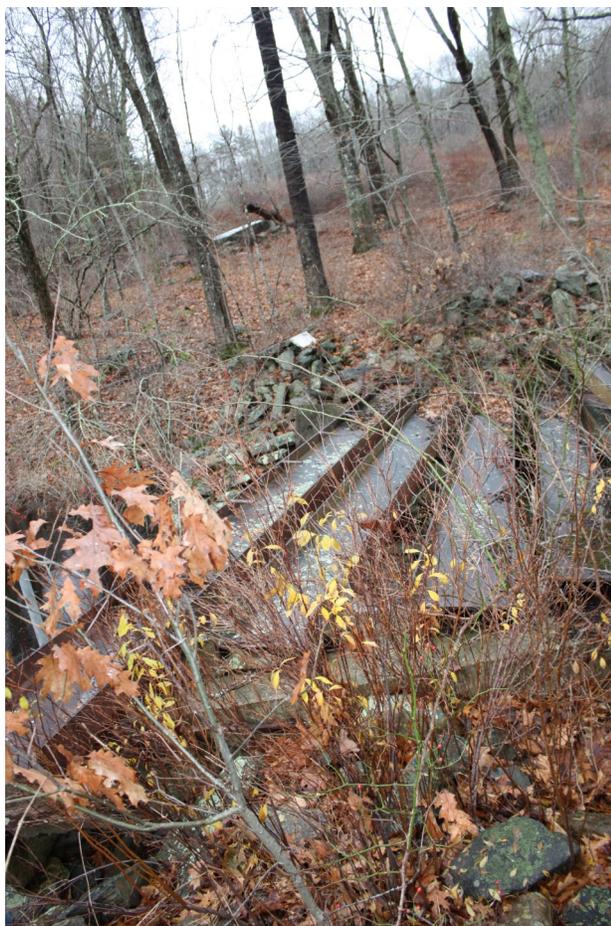
A bridge previously was utilized to access farmland to the south of Broad Brook on the Kendall property appears to have been impacted by flooding, rendering it non-functional for access and traffic. While bridge stringers remain, both deck and foundation damage making the crossing unsafe. Repair or removal should be considered for safety consideration. Conservation access for the public for recreational use would not necessarily require a replacement bridge of the same specifications, however a desire to continue farming fields south of the brook, yielding a partnership between Avalonia and farmer may necessitate more enhanced improvements to the bridge.

Figure A– 25– Photo of damaged Broadbrook crossing on south end near small dam. Source: J.Davies, CTC&D 2016

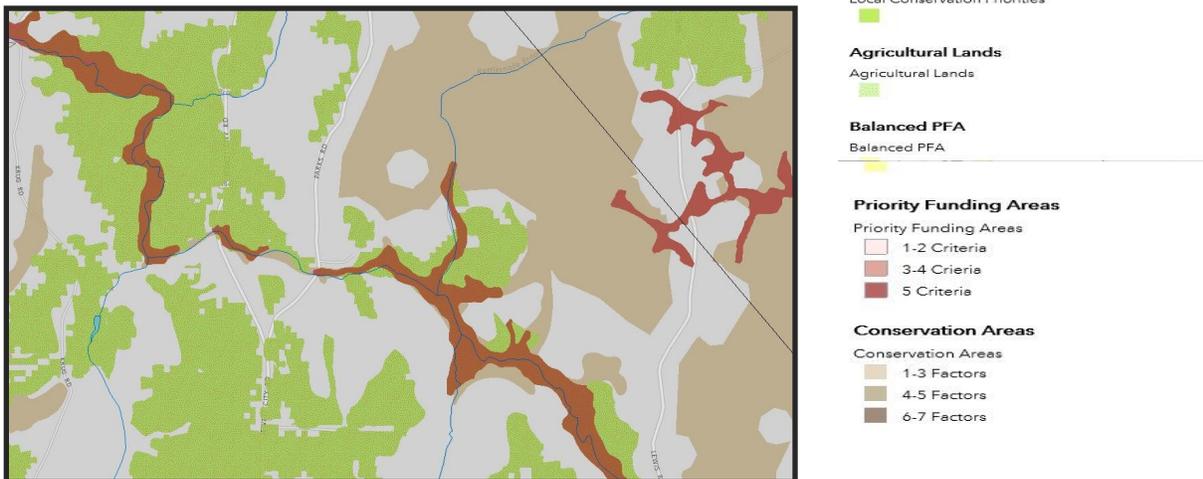
Figure A-28—CT POCD Interactive Map—Focus Area— Rude Road—Preston, CT

The area of Rude Road and Broad brook is listed as a local priority conservation area and is also adjacent to a level 1-3 factor state priority conservation area. This may be due to a several factors including potential forest and habitat continuity with Pachaug State Forest nearby.

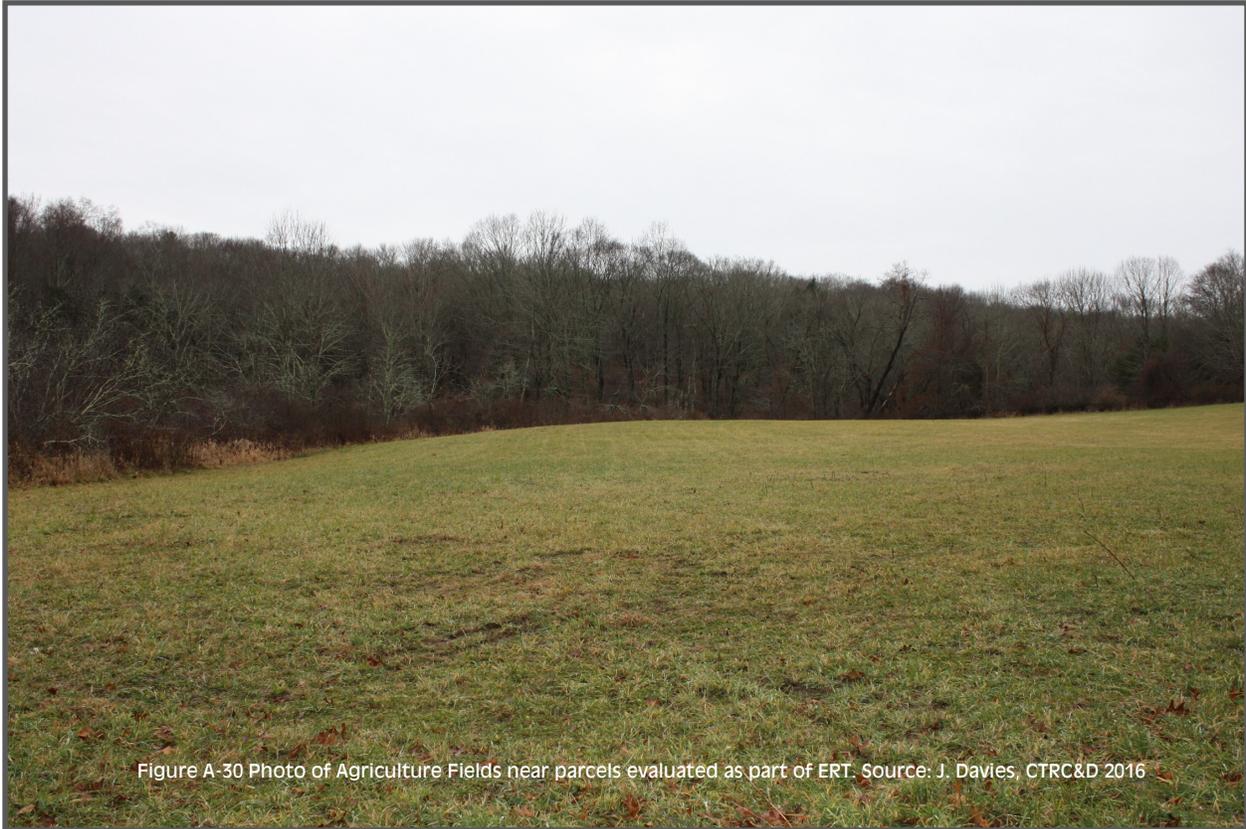
Figure A-30 Photo of Agriculture Fields near parcels evaluated as part of ERT. Source: J. Davies, CTC&D 2016

Most of these soils are actively farmed and in either hay or corn production. They are highly productive agricultural soils suited to a wide variety of crops. Areas of 8-15% slopes are best suited to hay, pasture, or fruit/tree crops. There are a number of farms in close proximity to these parcels. It is recommended the fields continue to be available for agriculture, with management under a conservation plan.

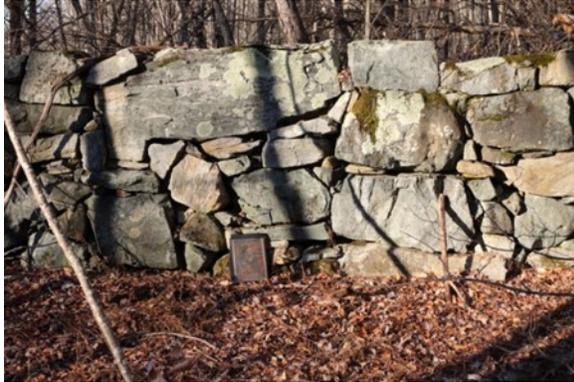
the door yard and a barn foundation behind. (I will refer to this site as the house/barn foundations.) The rockwork in the sunken barn foundation is interesting; it includes large worked rocks and what appear to be Inca-like steps in one wall (Photos 1 and 2). (An archaeologist's opinion might yield light on the "steps".)

notebook at base of barn foundation is 13" tall

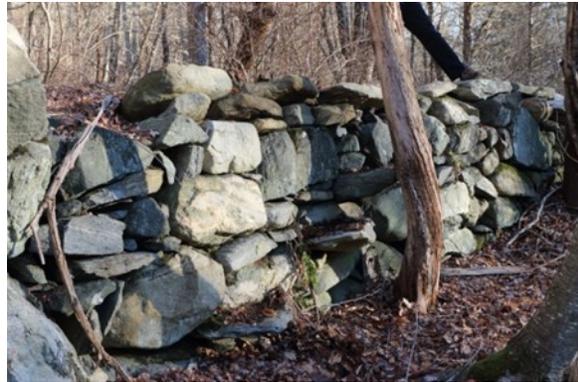
foundation wall with 3 flat, extruded steps" (3rd step touches tree trunk)

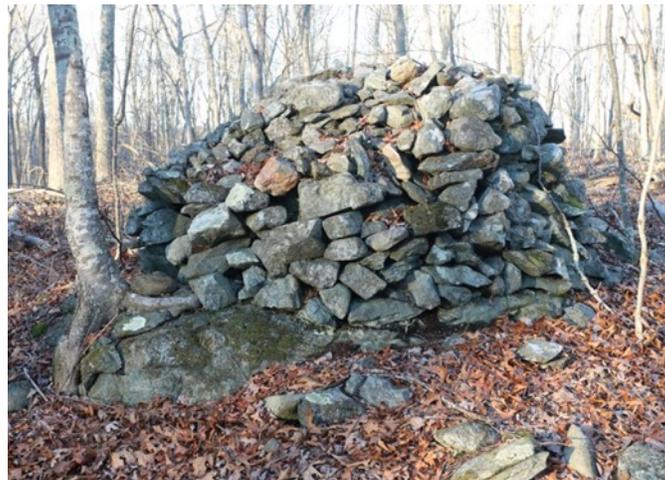
Within the flattish area are two piles of carefully stacked rocks. Further investigation by an expert as to whether or not they are of Native American origin is recommended.

Rock pile in elevated flat north of Rude Rd on Thomas East parcel

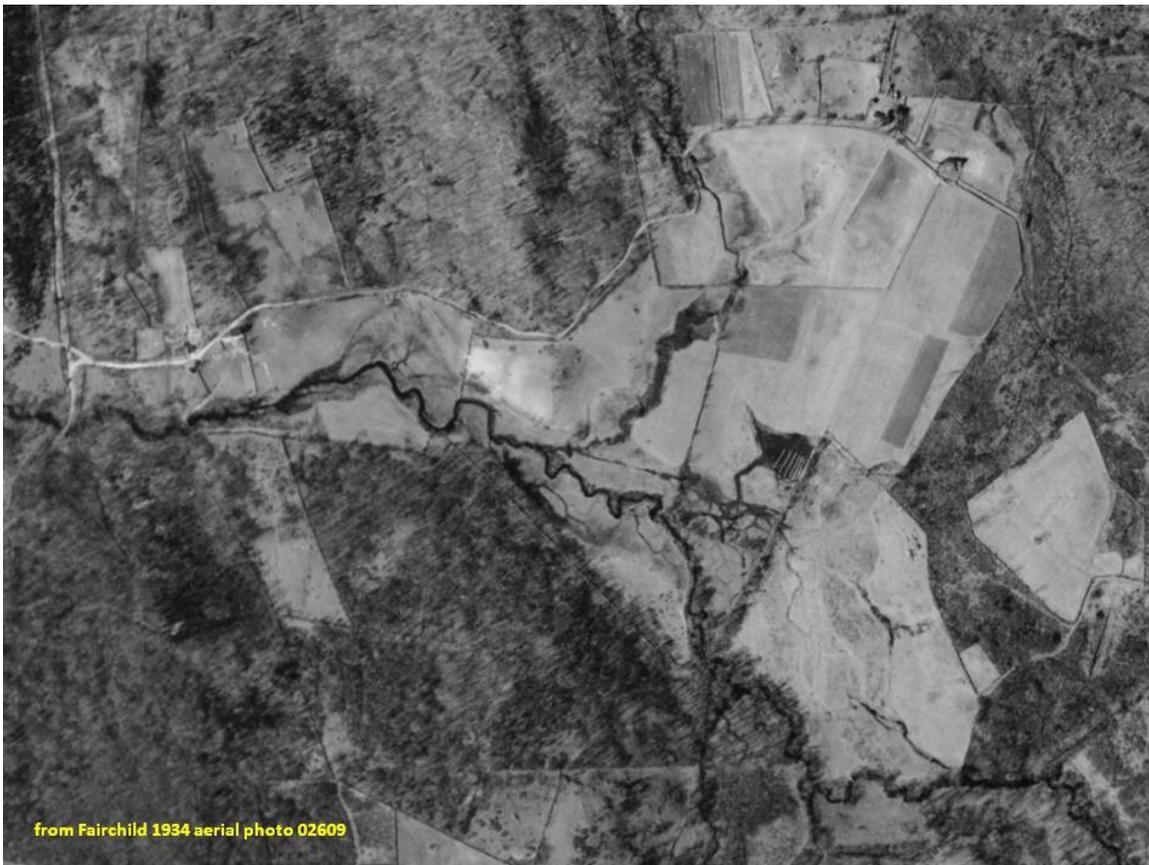
from Fairchild 1934 aerial photo 02609

Open areas of Broad Brook in 1934
Kendalls, middle parcel, and Thoma East parcels

East of the house/barn foundations and north of Rude Road, steep slopes and some ledge lead to a high flattish area with multiple rock walls. This area had scattered trees in 1934 (as seen on Fairchild aerial photo 02609). More recently there has been logging. Despite being quite obstructed by trees, the winter view from the south edge of the upland (above the ledge) offers a pleasing sense of being at an elevated overlook.
