Mukluk Preserve Property Sprague, Connecticut

Eastern Connecticut Environmental Review Team Report

Environmental Review Team Report

Report # 615

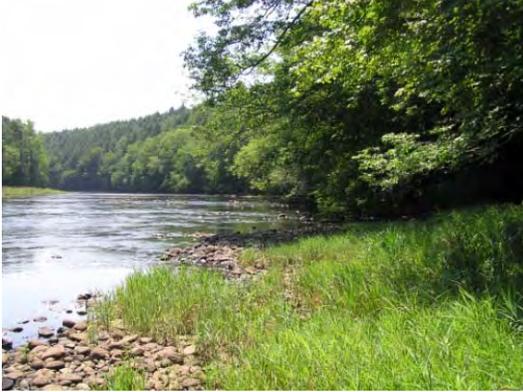
Figure 3. Shetucket River, looking downstream. Steep forested bluffs seen on the riverside downstream are underlain by sand and gravel. The bluff top elevation is about 80 feet above the river. The Shetucket River does not have a well developed flood plain at this location. Modern floodplain elevation may be seen in the small tributaries that empty into the Shetucket (see Fig.8).

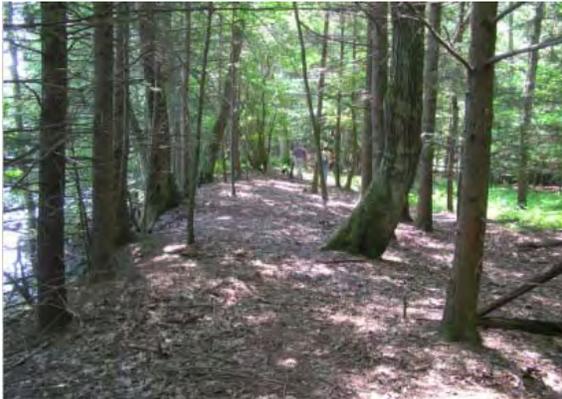
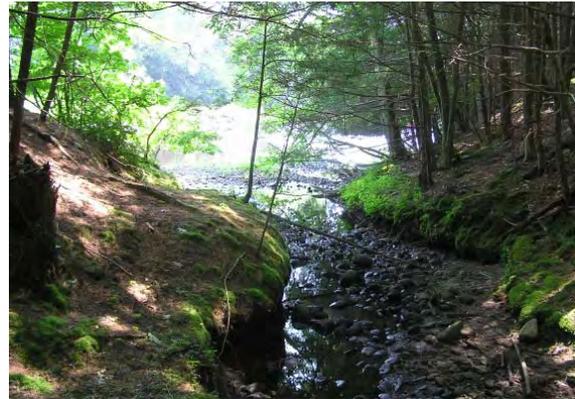
Figure 4. A. Terrace along the Shetucket River (on right side of image) and natural levee associated with the terrace rather than with the modern river floodplain. Terrace stands 8-10 feet above the river level and the natural levee top stands 10-15 feet above the modern river elevation. The river may be seen on left side of image. This was mapped as modern alluvium (and therefore a modern levee) by Shaw (Dixon and Shaw, 1965). B. Breach in terrace and levee by modern stream.

The Shetucket River forms the northern boundary of the Preserve and the lowest elevation in the Preserve (just lower than 90 feet above sea level) is along the river's downstream banks. It flows southeasterly at a gradient of about 10 feet/mile. It passes through a shallow bedrock-gorge (about 300 feet deep) along the northwestern part of the parcel. Thereafter the river flows beside forested sand and gravel banks that form riverside bluffs, up to 90 feet high, near the eastern part of the preserve (Fig. 3). The river frontage in the central part of the Preserve is an older river terrace that stands about 10 feet above modern river elevation. The older terrace has a natural levee (Fig. 4A) that has been breached by local modern streams (Fig.4B).

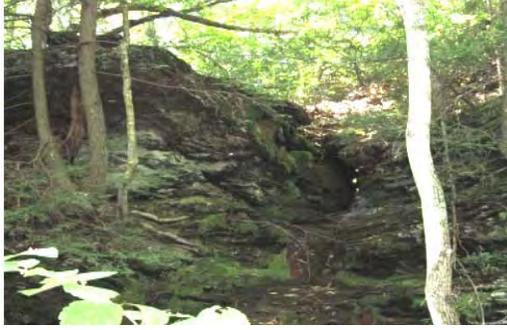
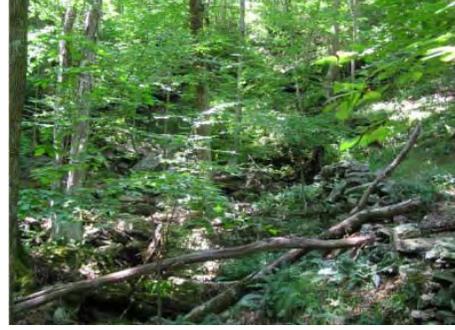
Figure 5. A. Lower waterfall (dry in August, 2007) cascades over an outcrop of Hebron Gneiss. Image by A. Johnson. B. Stepped cliff over which water cascades when intermittent stream is flowing. This is the upper falls; it is greatly concealed by leaves during the spring and summer. The cascade falls over Scotland Schist.

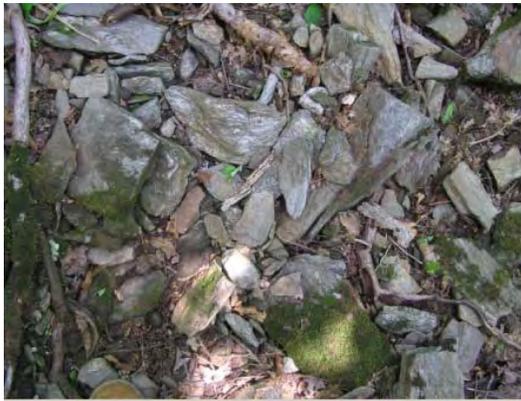
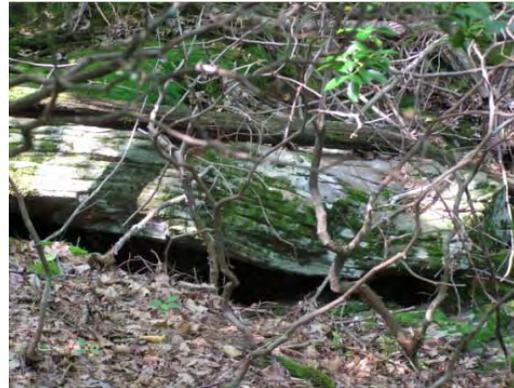
Figure 6. A. Fragments of Scotland Schist. B. Outcrop of Hebron Gneiss. This is a calc-silicate gneiss. The major foliation and bedding coincide. Beds are several centimeters thick (1-2 inches) and are defined by thin micaceous seams (recessive weathering).

The Mukluk Preserve is underlain by two geologic formations: the Scotland Schist and the Hebron Gneiss (Figure 6A and 6B). The Hebron Gneiss is poorly exposed; most of the bedrock outcrops on the Preserve consist of the Scotland Schist. The foliation strikes northeast-southwest and dips (is tilted) toward the southwest.

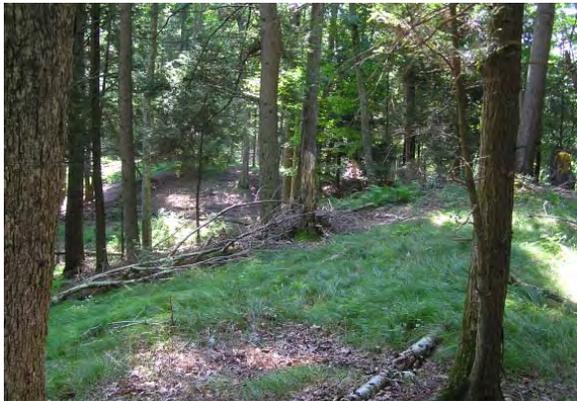
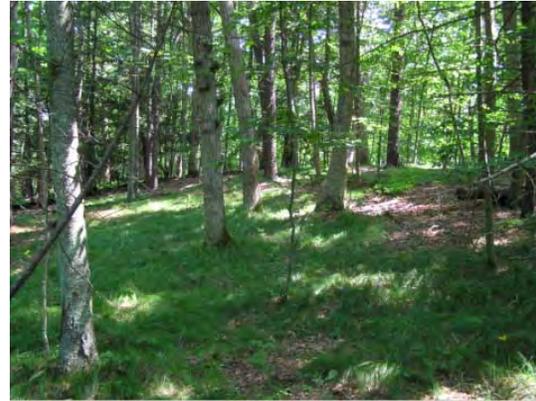
Figure 7. A. Hummock topography is characteristic of sand and gravel deposited against and upon left over glacial ice. When the left over ice melts the sand surface subsides into the space formerly occupied by the ice. This results in the uneven topography. The low area on the left of the image is where the left over ice was thicker. B. Ridge of sand and gravel must have been formed where ice was thin, possibly in a crack or channel. Space for thicker sand to accumulate

A deposit of sand and gravel covers the eastern two-thirds of the Preserve. It may be as much as 100 feet or more in thickness. Glacial melt-water streams at the end of the last Ice Age deposited the sand and gravel. Small amounts of left over glacial ice remained in the valley and the melt-water streams flowed over and around the ice. Sand and gravel were deposited against and upon the left over ice. The streams likely formed a fairly broad alluvial plain over the ice. When the leftover ice melted, the surface of the sand and gravel alluvial plain deposit settled or collapsed into the space the ice occupied before melting. This process created the hummocky topography (Figure 7A).

Thicker deposits of sand formed in the hollows or thin areas of the left over ice and today, with the ice gone, they form the high areas of the deposit. For instance, sand deposited in a crack or crevasse in the ice would appear as a ridge today (Figure 7B). Sand deposited around a large chunk of left over ice would today appear as a low spot, referred to as a kettle.

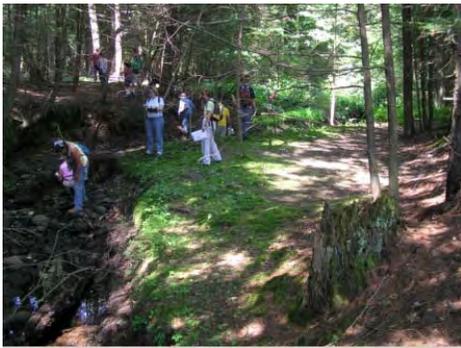
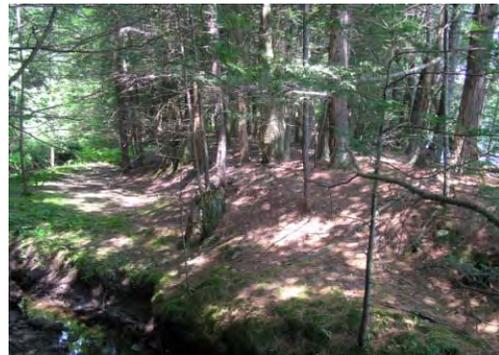
A.

Figure 8. Modern flood elevation indicated by flood plain on tributary stream just inboard from its confluence with the Shetucket River, which can just barely be seen on the right side of Figure 8B. Note terrace levee on the right of both images. An erosional scarp made by tributary stream can be seen in levee.

A floodplain and modern alluvium can be found on the opposite side of the Shetucket River abutting the Preserve and in local areas where tributary streams breach the terrace levee (Figure 8A and B). The modern flood plain lies 4-7 feet lower than the terrace levee and 2-4 feet lower than the terrace elevation. It lies approximately at the flood elevation (see FEMA Flood Maps). The flood plain is only identifiable on the parcel at the confluence of two tributary streams with the Shetucket.

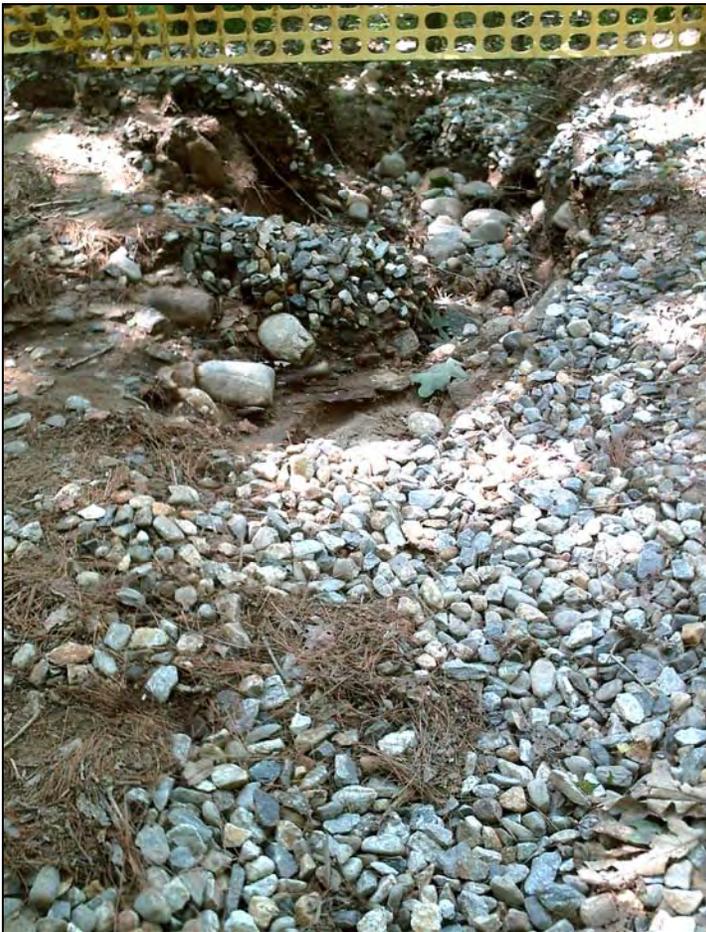
Secondly, and far more simply, the open water in the wetland has much fine-particle sediment in suspension. The walk the Team took brought us along the road immediately to the east of the wetland pond. The gravel road is the apparent source of sedimentation and erosion problems.

In this photograph, the gravel road immediately to the east of the to-be-mitigated wetland runs parallel with the orange fence. This washout is perpendicular to the fence and thus is headed directly downhill into the pond. It brings with it substantial sediments. This location is underlain by sand and gravel so that any surface disturbance will easily transform into sediment laden runoff, the results of which were readily apparent in the pond.

- 3.) Repair erosion on the main woods road in both locations. It is clear that the washout on the road abutting the pond, and where the road crosses the intermittent stream are causing and/or will continue to cause on site sedimentation problems until the concerns are corrected.

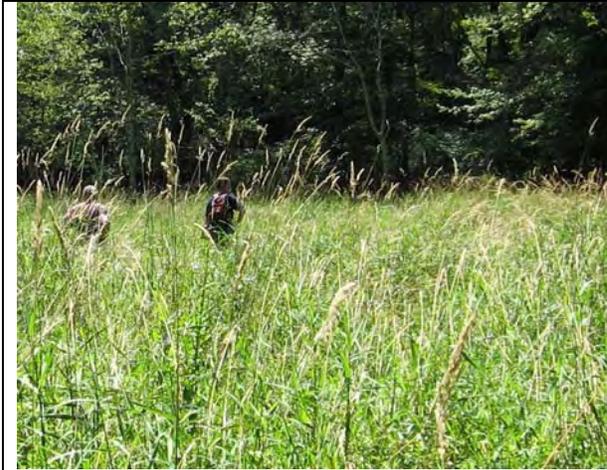
Team members passed through the wetland north of the remediation site. In the absence of trees and shrubs the herb layer dominates with a thick, healthy organic cover.

The lowest point of this wetland was toward the center, it being wet underfoot until that point. Though indiscernible in the photo to the right, a small streamlet was actively flowing at the base of these thick grasses.

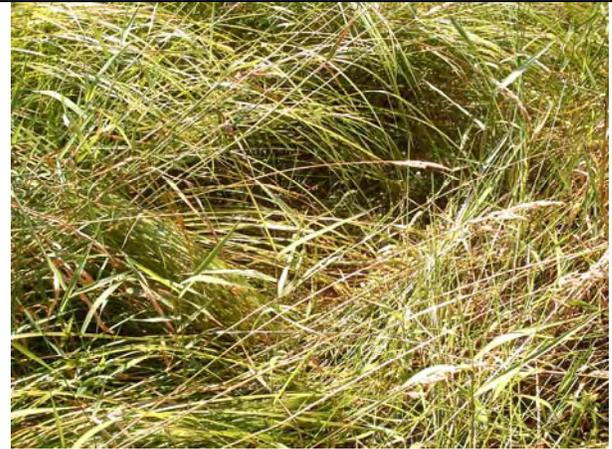
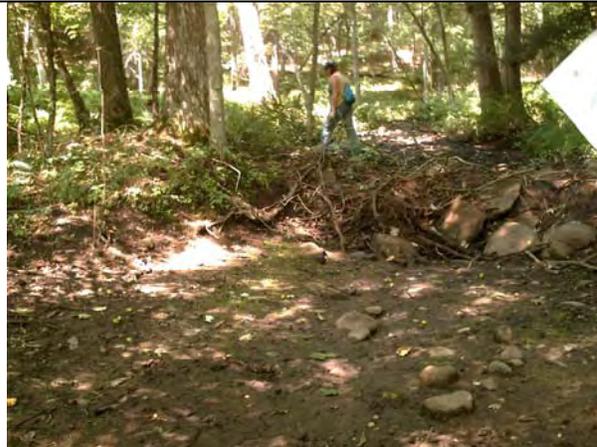
The team found no outlet at the time of the visit. However, the area that appears to be the main outflow, geographically to the northwest of the wetland, has been barricaded or dammed with small boulders, dirt and vegetative debris. No one was clear about the origin or use of this ‘construction.’

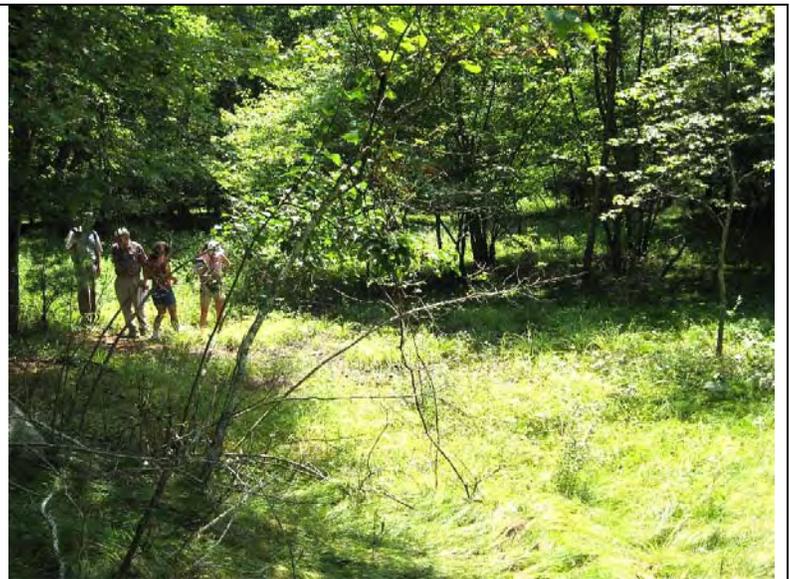
The third wetland (below) visited was small, elongate, and quite close to the Shetucket River. It is depicted by two wetland symbols on the Boundaries, LLC map of May, 2006.

There was some conjecture that this wetland was at one time a cranberry bog. However, soil sampling into the bottom of this open area revealed an organic layer of about 5-6 inches overlying mineral soils.

Its overall position on the landscape, being in so flat an area, did not lend itself to being capable of impounding standing water, but rather just a low point or drainage on the landscape where moisture is carried in the wettest times of the year. At the time of the visit the area was dry and dominated by the herb layer with a complete absence of the shrub and tree layer, except at subtle elevation changes.

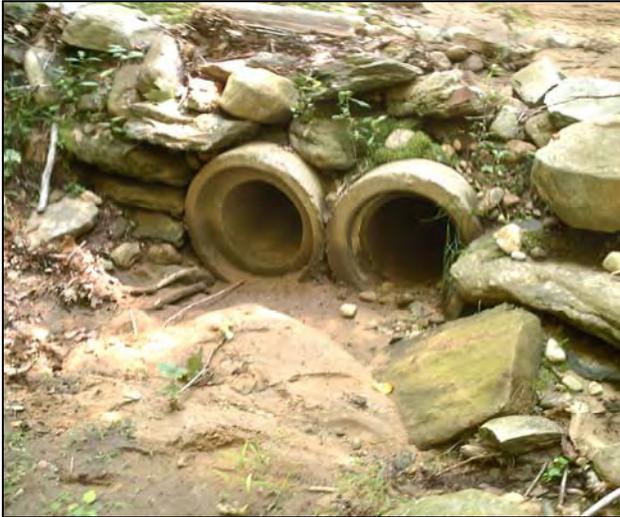
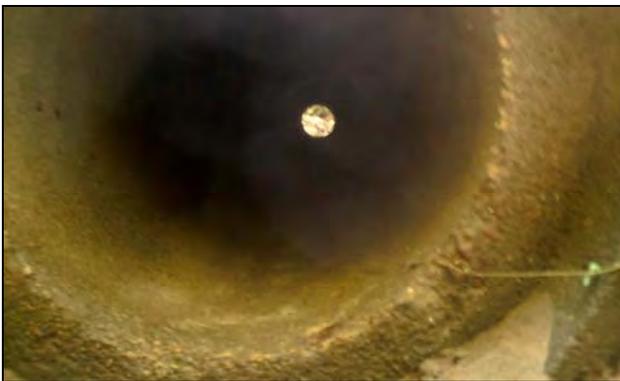
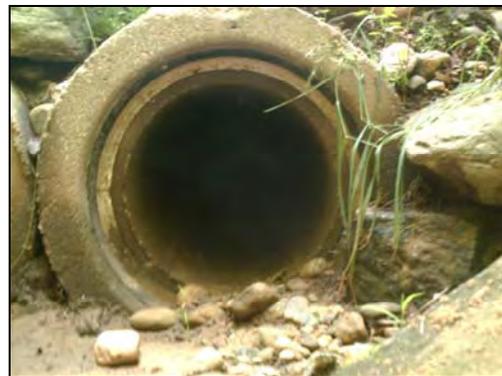
In this series of photos the west-to-east, well defined, intermittent stream course passes under the old road via twin concrete pipe culverts. Actually, the pipe on the left (north) is clear for passing water but the pipe on the right (as seen below) is clogged. This clog forces all the flow to the pipe on the left and most likely passes it with increased velocity. That could have downstream impacts of sediment in the watercourses.
