Environmental Review Team Report

# Pawcatuck River

Stonington, Connecticut

June 1983

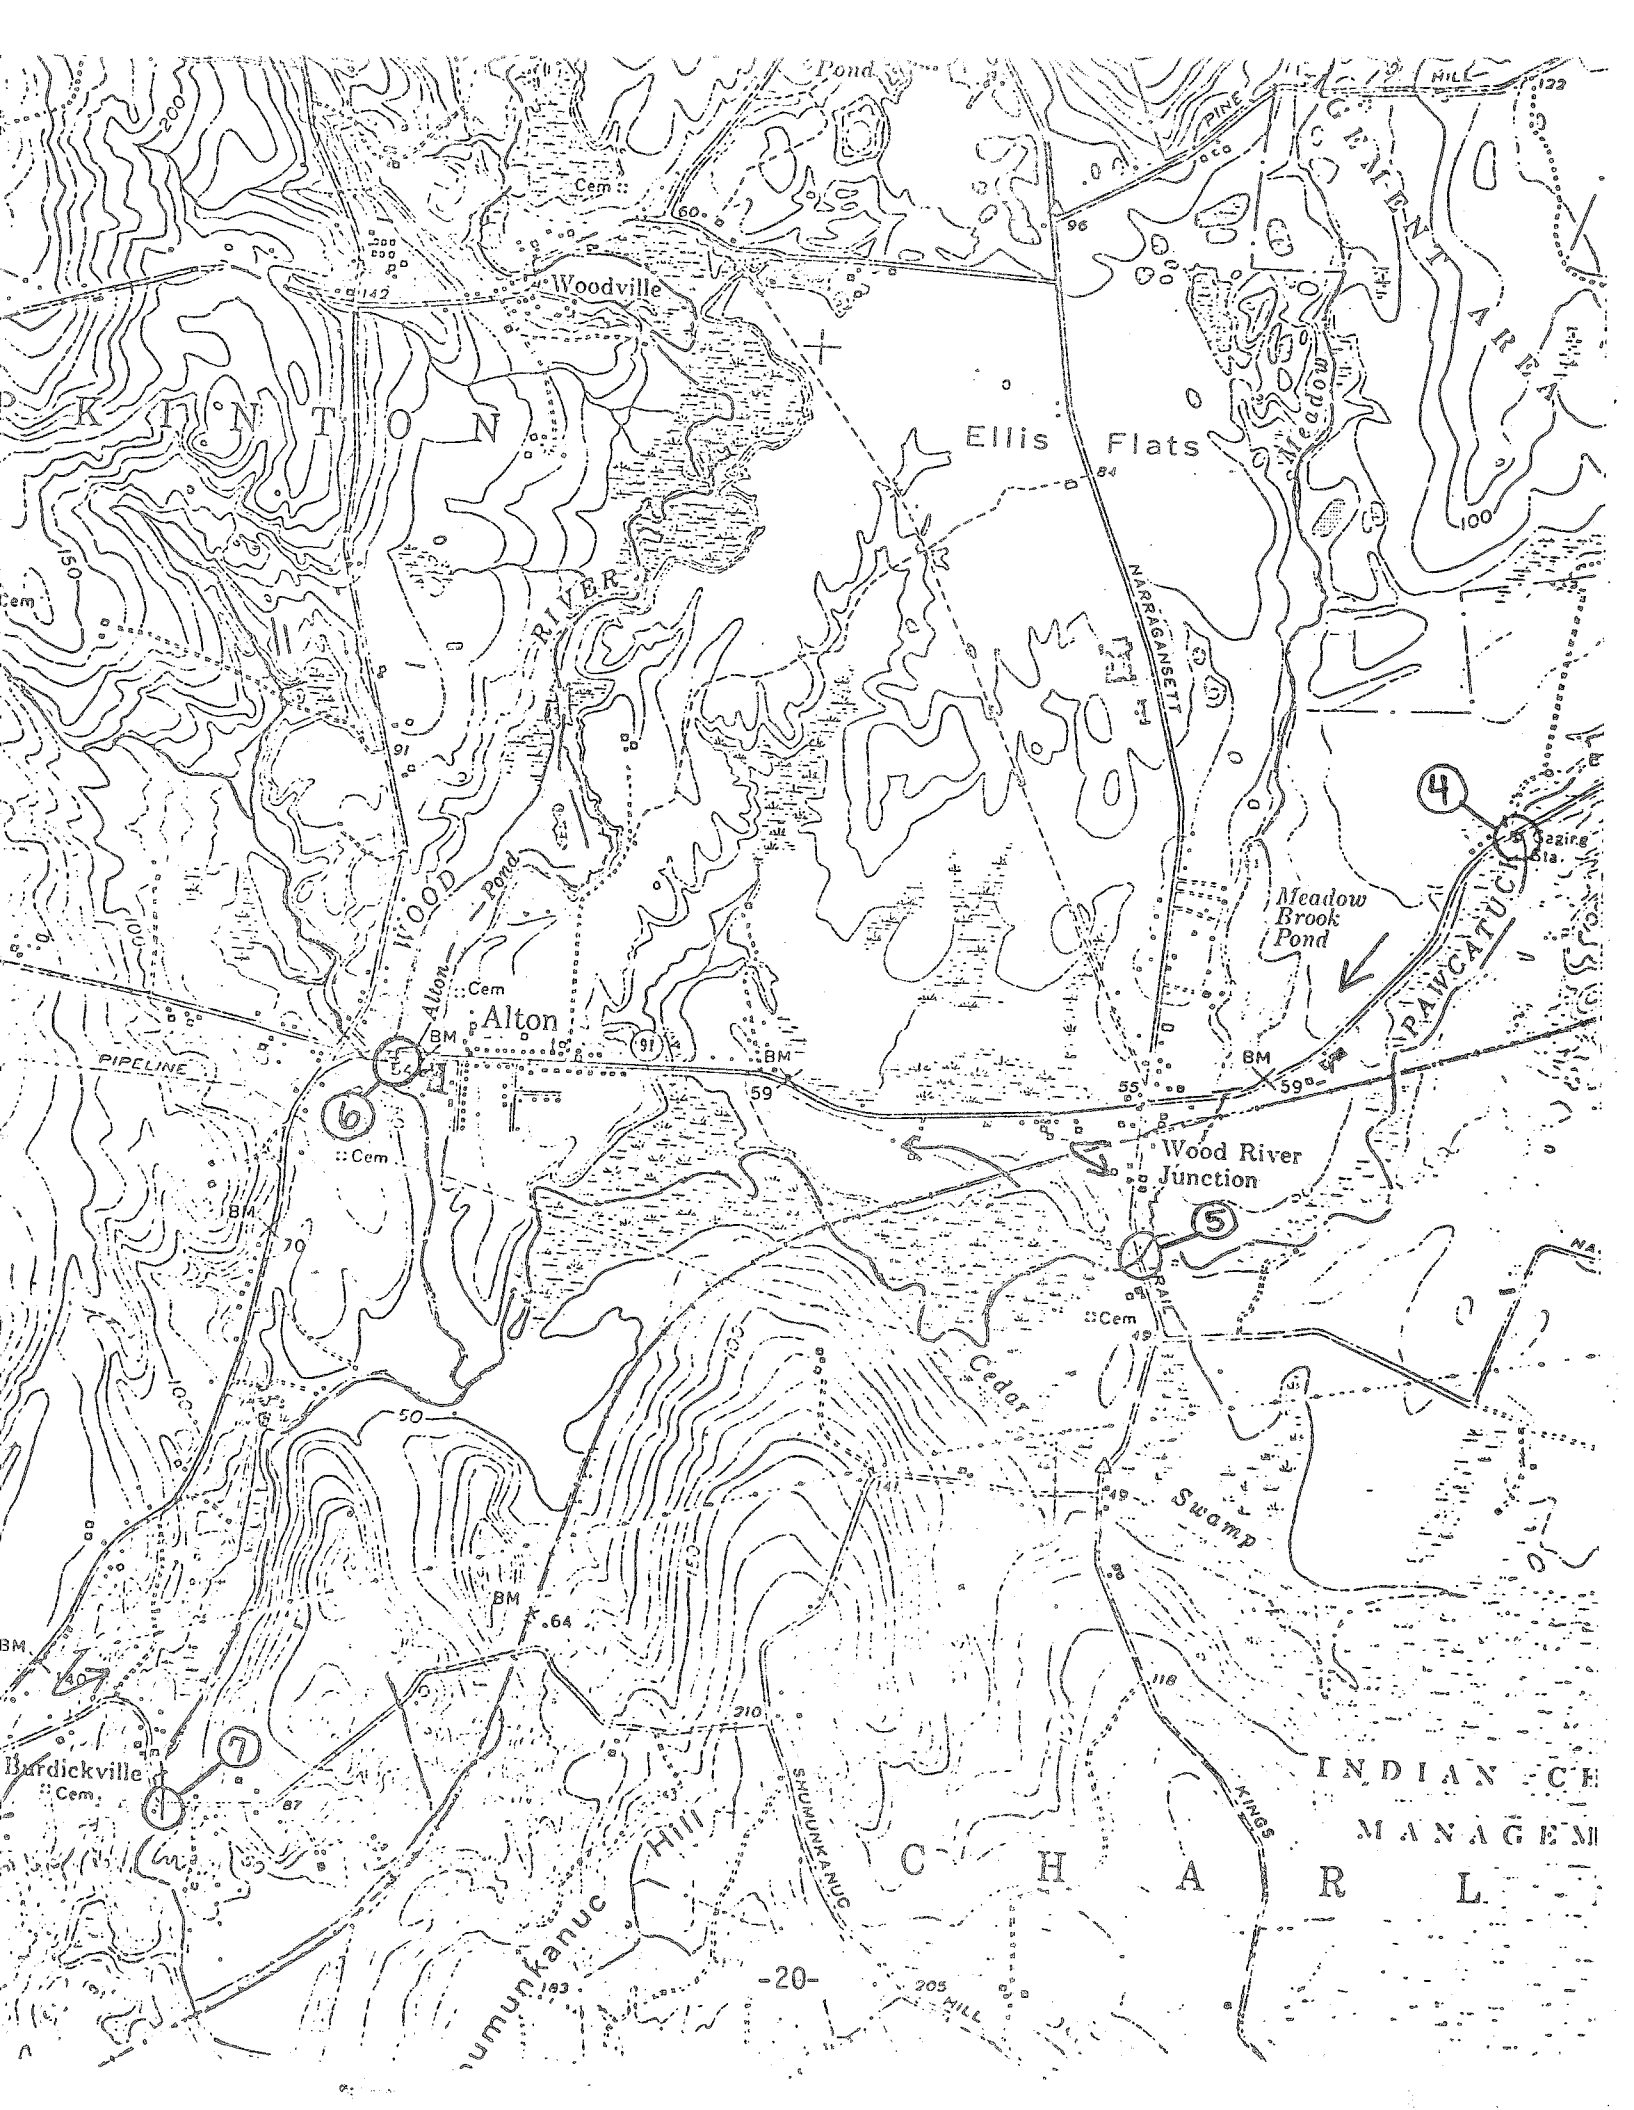
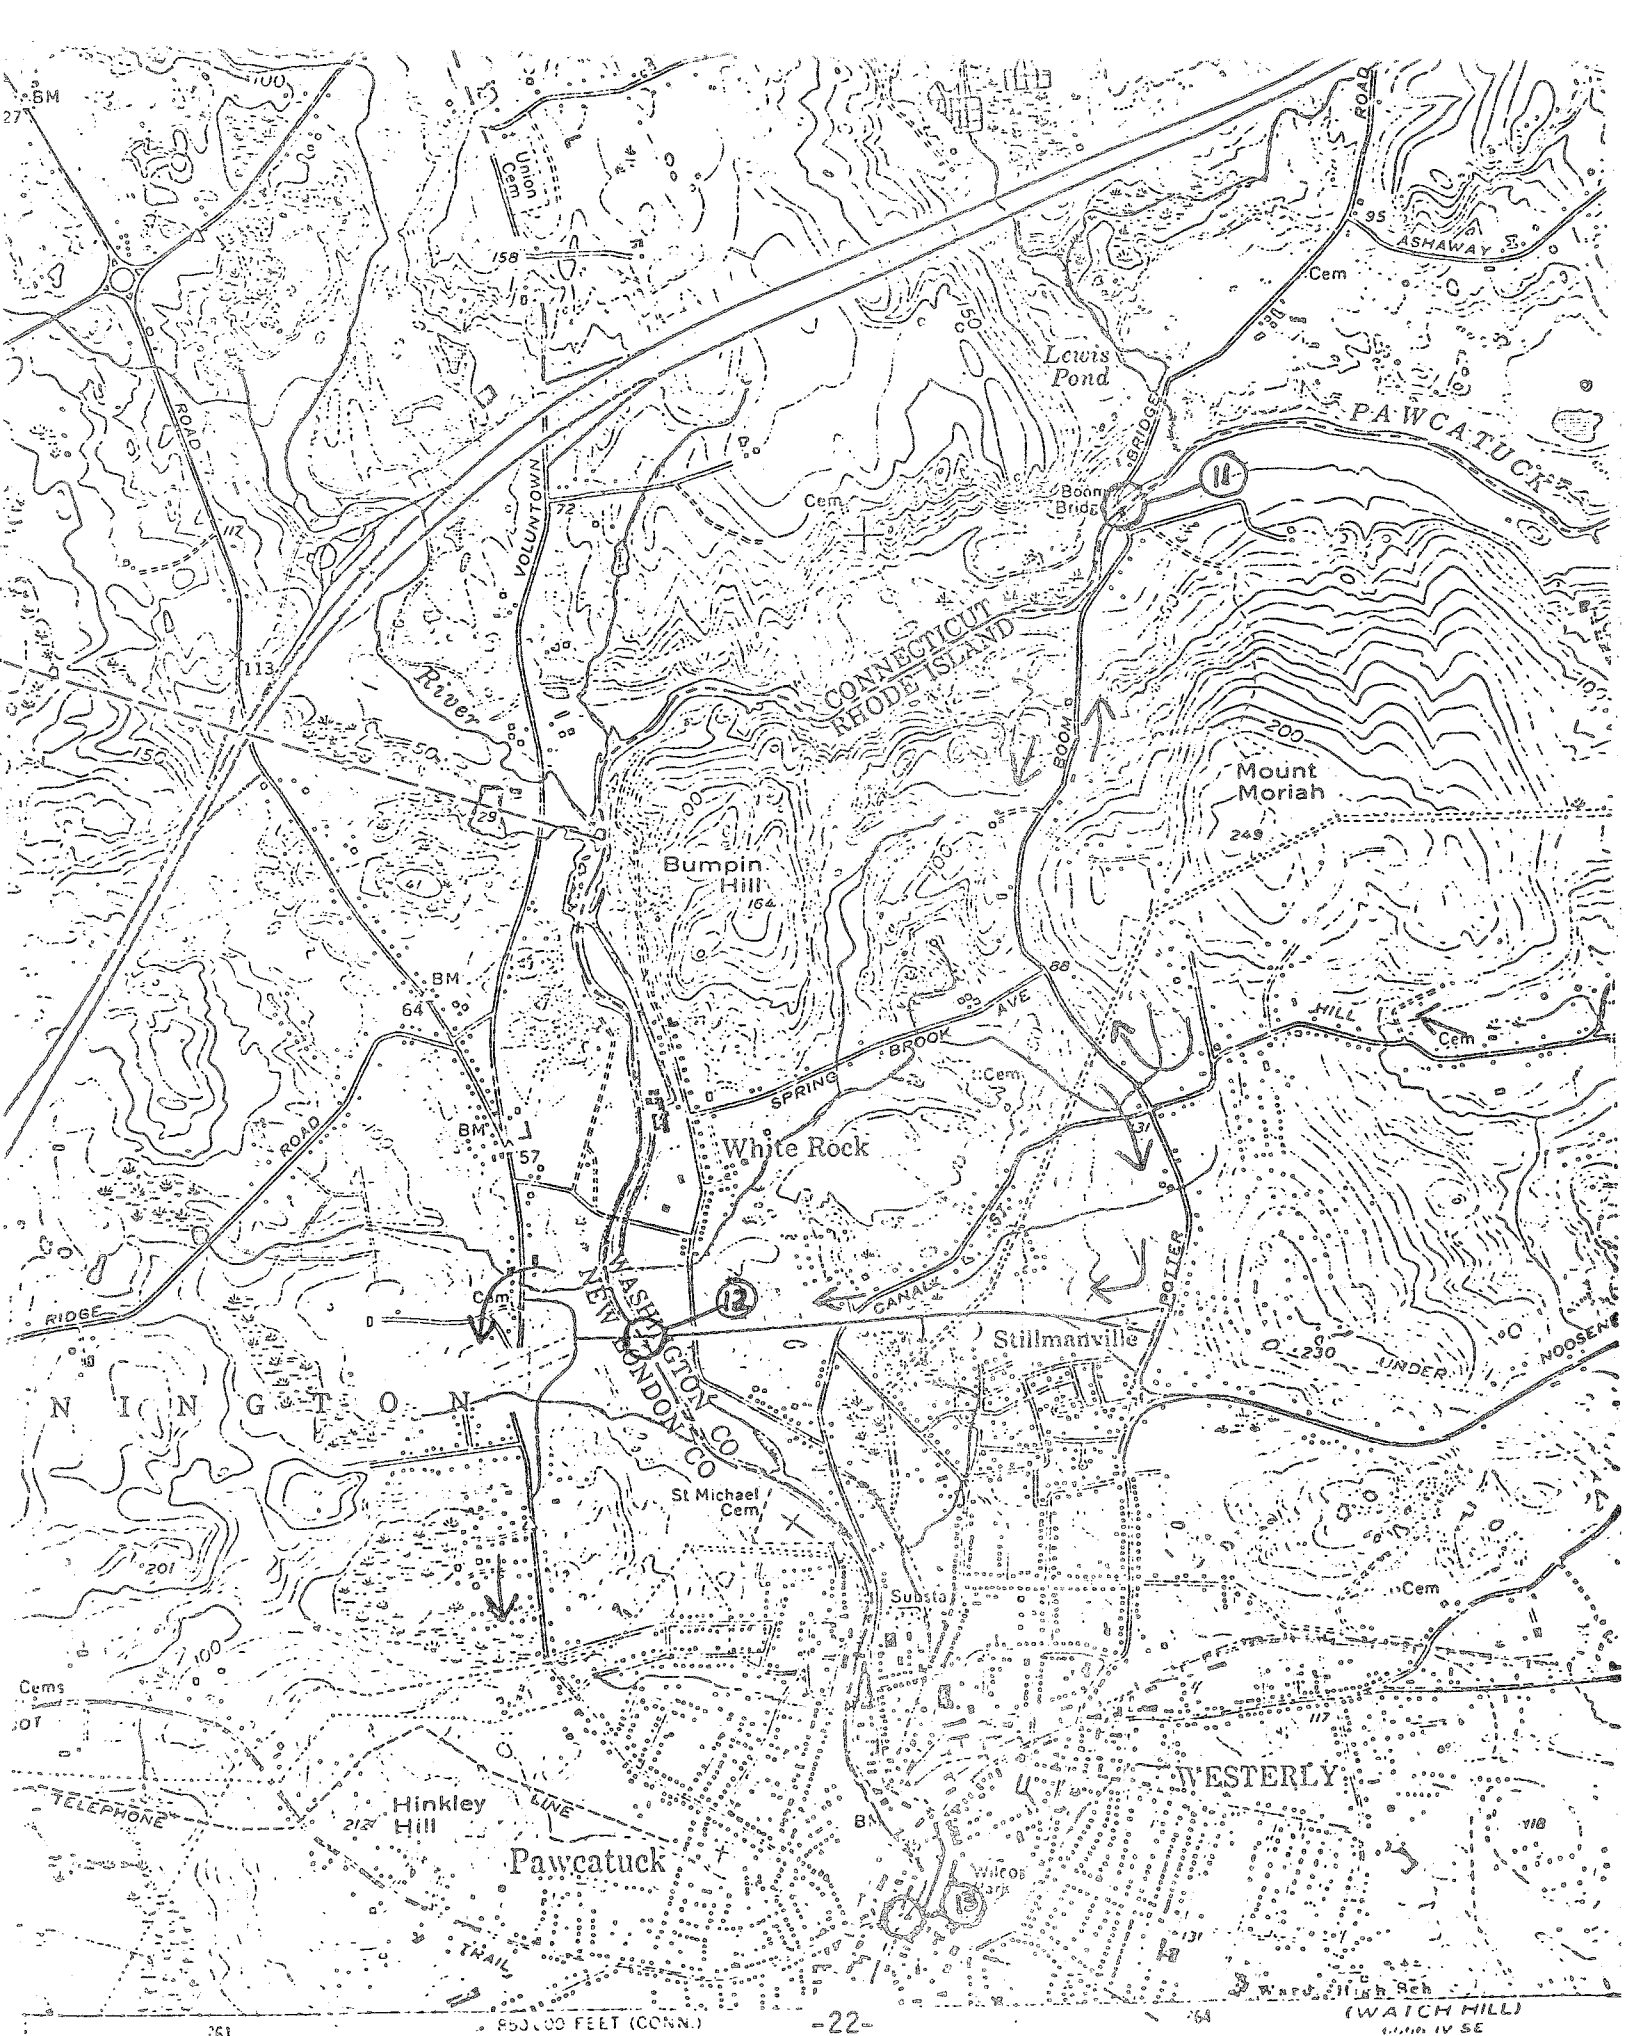
# Appendix

STATION #	LOCATION
1	Pawcatuck River at Route 2 Bridge
2	Pawcatuck River at Shannock Dam
3	Pawcatuck River at Carolina Dam
4	Pawcatuck River at Alton-Carolina Road (Rte. 91)
5	Pawcatuck River at Kings Factory Road
6	Wood River at Alton-Carolina Road (Rte. 91)
7	Pawcatuck River at Burdickville Road Bridge
8	Pawcatuck River at Bradford Road Bridge
9	Pawcatuck River at Narragansett Electric Co. Substation
10	Pawcatuck River at Meeting House Bridge (Chase Hill Road)
11	Pawcatuck River at Boom Bridge
12	Pawcatuck River at Route 78 (Westerly Bypass) Bridge
13	Pawcatuck River at Main Street Bridge

The survey consisted of thirteen river sampling stations and three industrial waste effluent samples. A map showing these locations as well as tables showing sampling results are included in the Appendix to this report. The first river station was at the Route 2 Bridge at Kenyon (River Mile 31.1) and the last was at the Main Street Bridge in Westerly (River Mile 5.0). The river flow at the Westerly gage (River Mile 5.5) was 144 CFS (cubic feet per second). The three industries sampled were the Kenyon Piece Dye Works, Bradford Dyeing Association and the Imperial Wallpaper Company. There are no municipal sewage discharges to the portion of the Pawcatuck River that was surveyed, although raw sanitary discharges still exist in some of the former mill villages.
