Naugatuck River Greenway Project

**Torrington, Harwinton and Litchfield
Connecticut**

**King's Mark
Environmental Review Team
Report**

May 2003

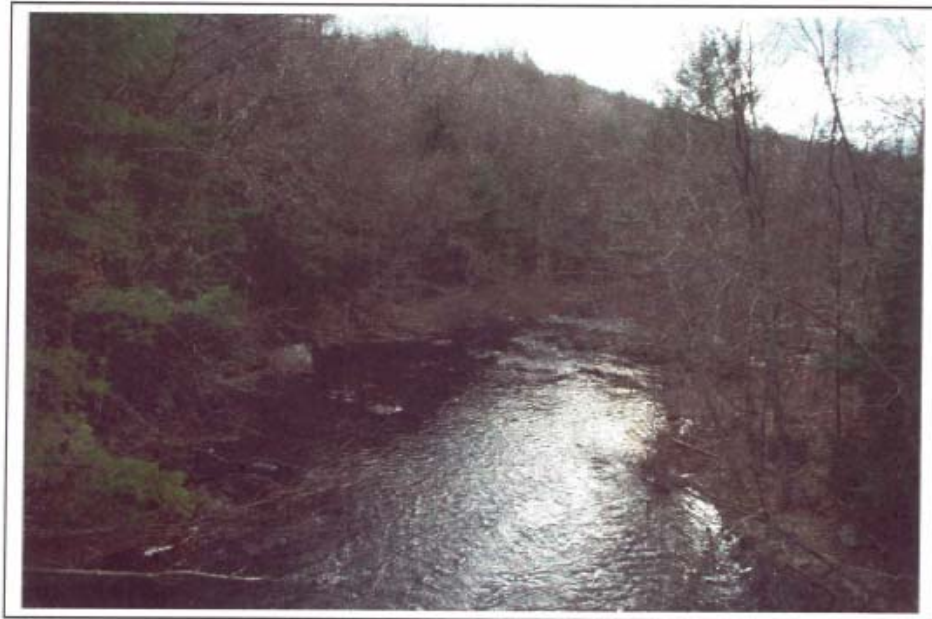
West Branch Naugatuck River downstream of Stillwater Pond Road.

This section includes the West Branch Naugatuck River from Stillwater Pond downstream to Wolcott Avenue. The river reach from Stillwater Pond to the Brunswick Dam impoundment is in a natural condition with light to moderate development within the riparian corridor. The following habitat enhancement measures are recommended for Section One:

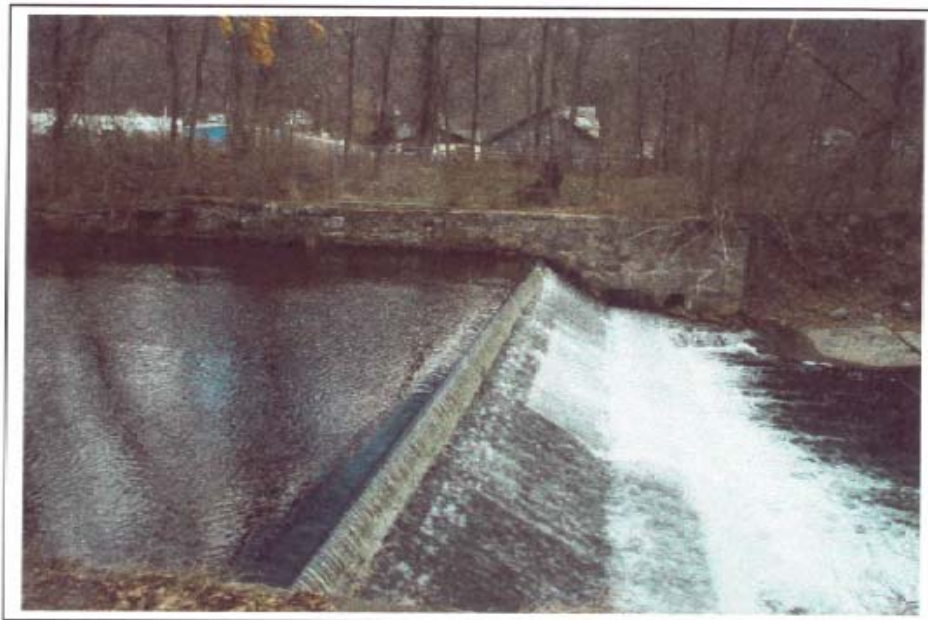
Brunswick Dam across West Branch Naugatuck River.

- A low head dam spans the West Branch Naugatuck River approximately 750 downstream of the Route 4 crossing. The dam, which I refer to as the Brunswick Dam, was installed to provide water power to an industrial complex (once housing the Brunswick Corporation) located off Migeon Avenue. The intake to a canal from the impoundment has been sealed and therefore the dam itself is no longer serving the function as it was once intended. Complete removal or breaching of the dam is recommended. This will allow for fish passage and the restoration of riverine habitat within the "footprint" of the impoundment.

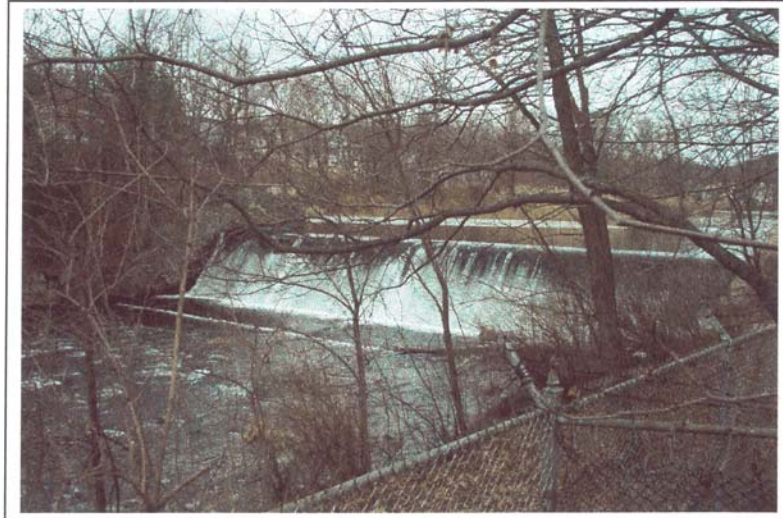
Brass Mill Dam across West Branch Naugatuck River.

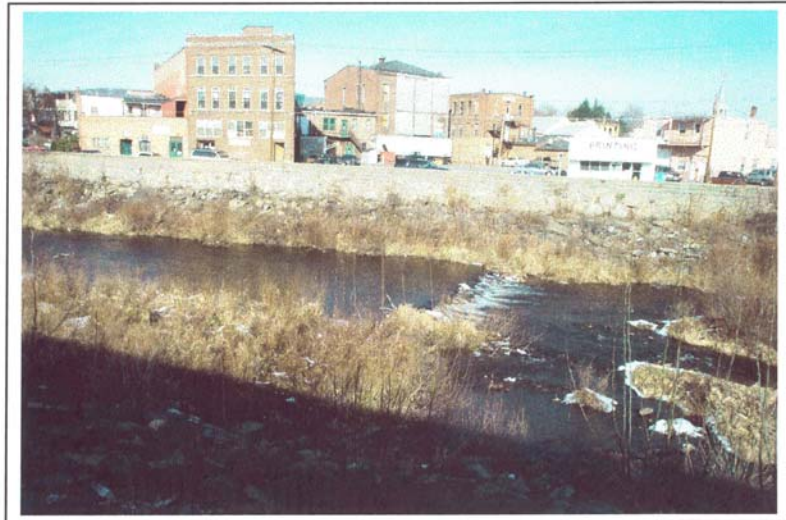
Conduit crossing of the West Branch Naugatuck River downstream of Route 202, Torrington

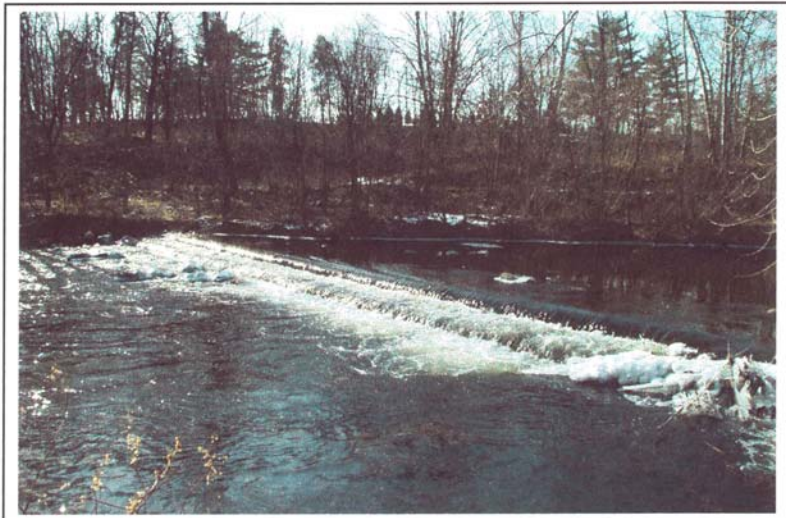
Conduit crossing of the Naugatuck River at the John Toro Sports Complex, Torrington.

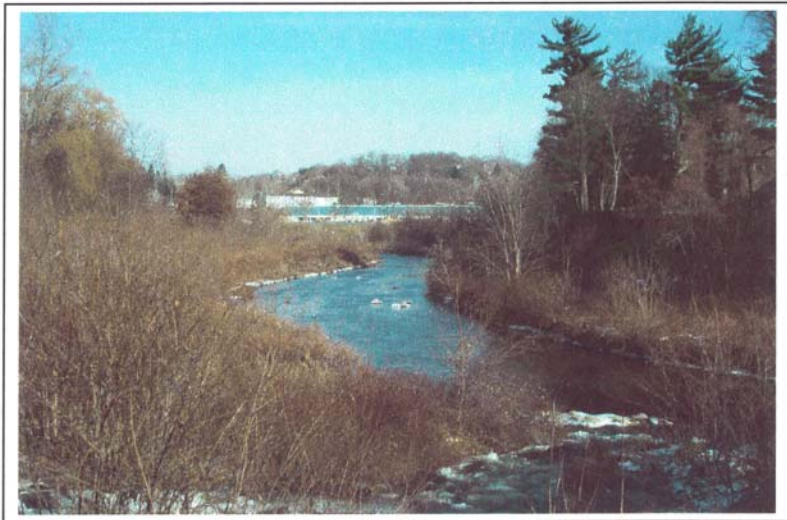
Boulders placed in the Naugatuck River within the US Army Corps of Engineers flood control channel Torrington as a fish habitat enhancement project. Project. completed September 2002.
