SPRUCE GLEN AND ORCHARD GLEN

WALLINGFORD,
CONNECTICUT

Environmental Review Team Report

AUGUST 1991

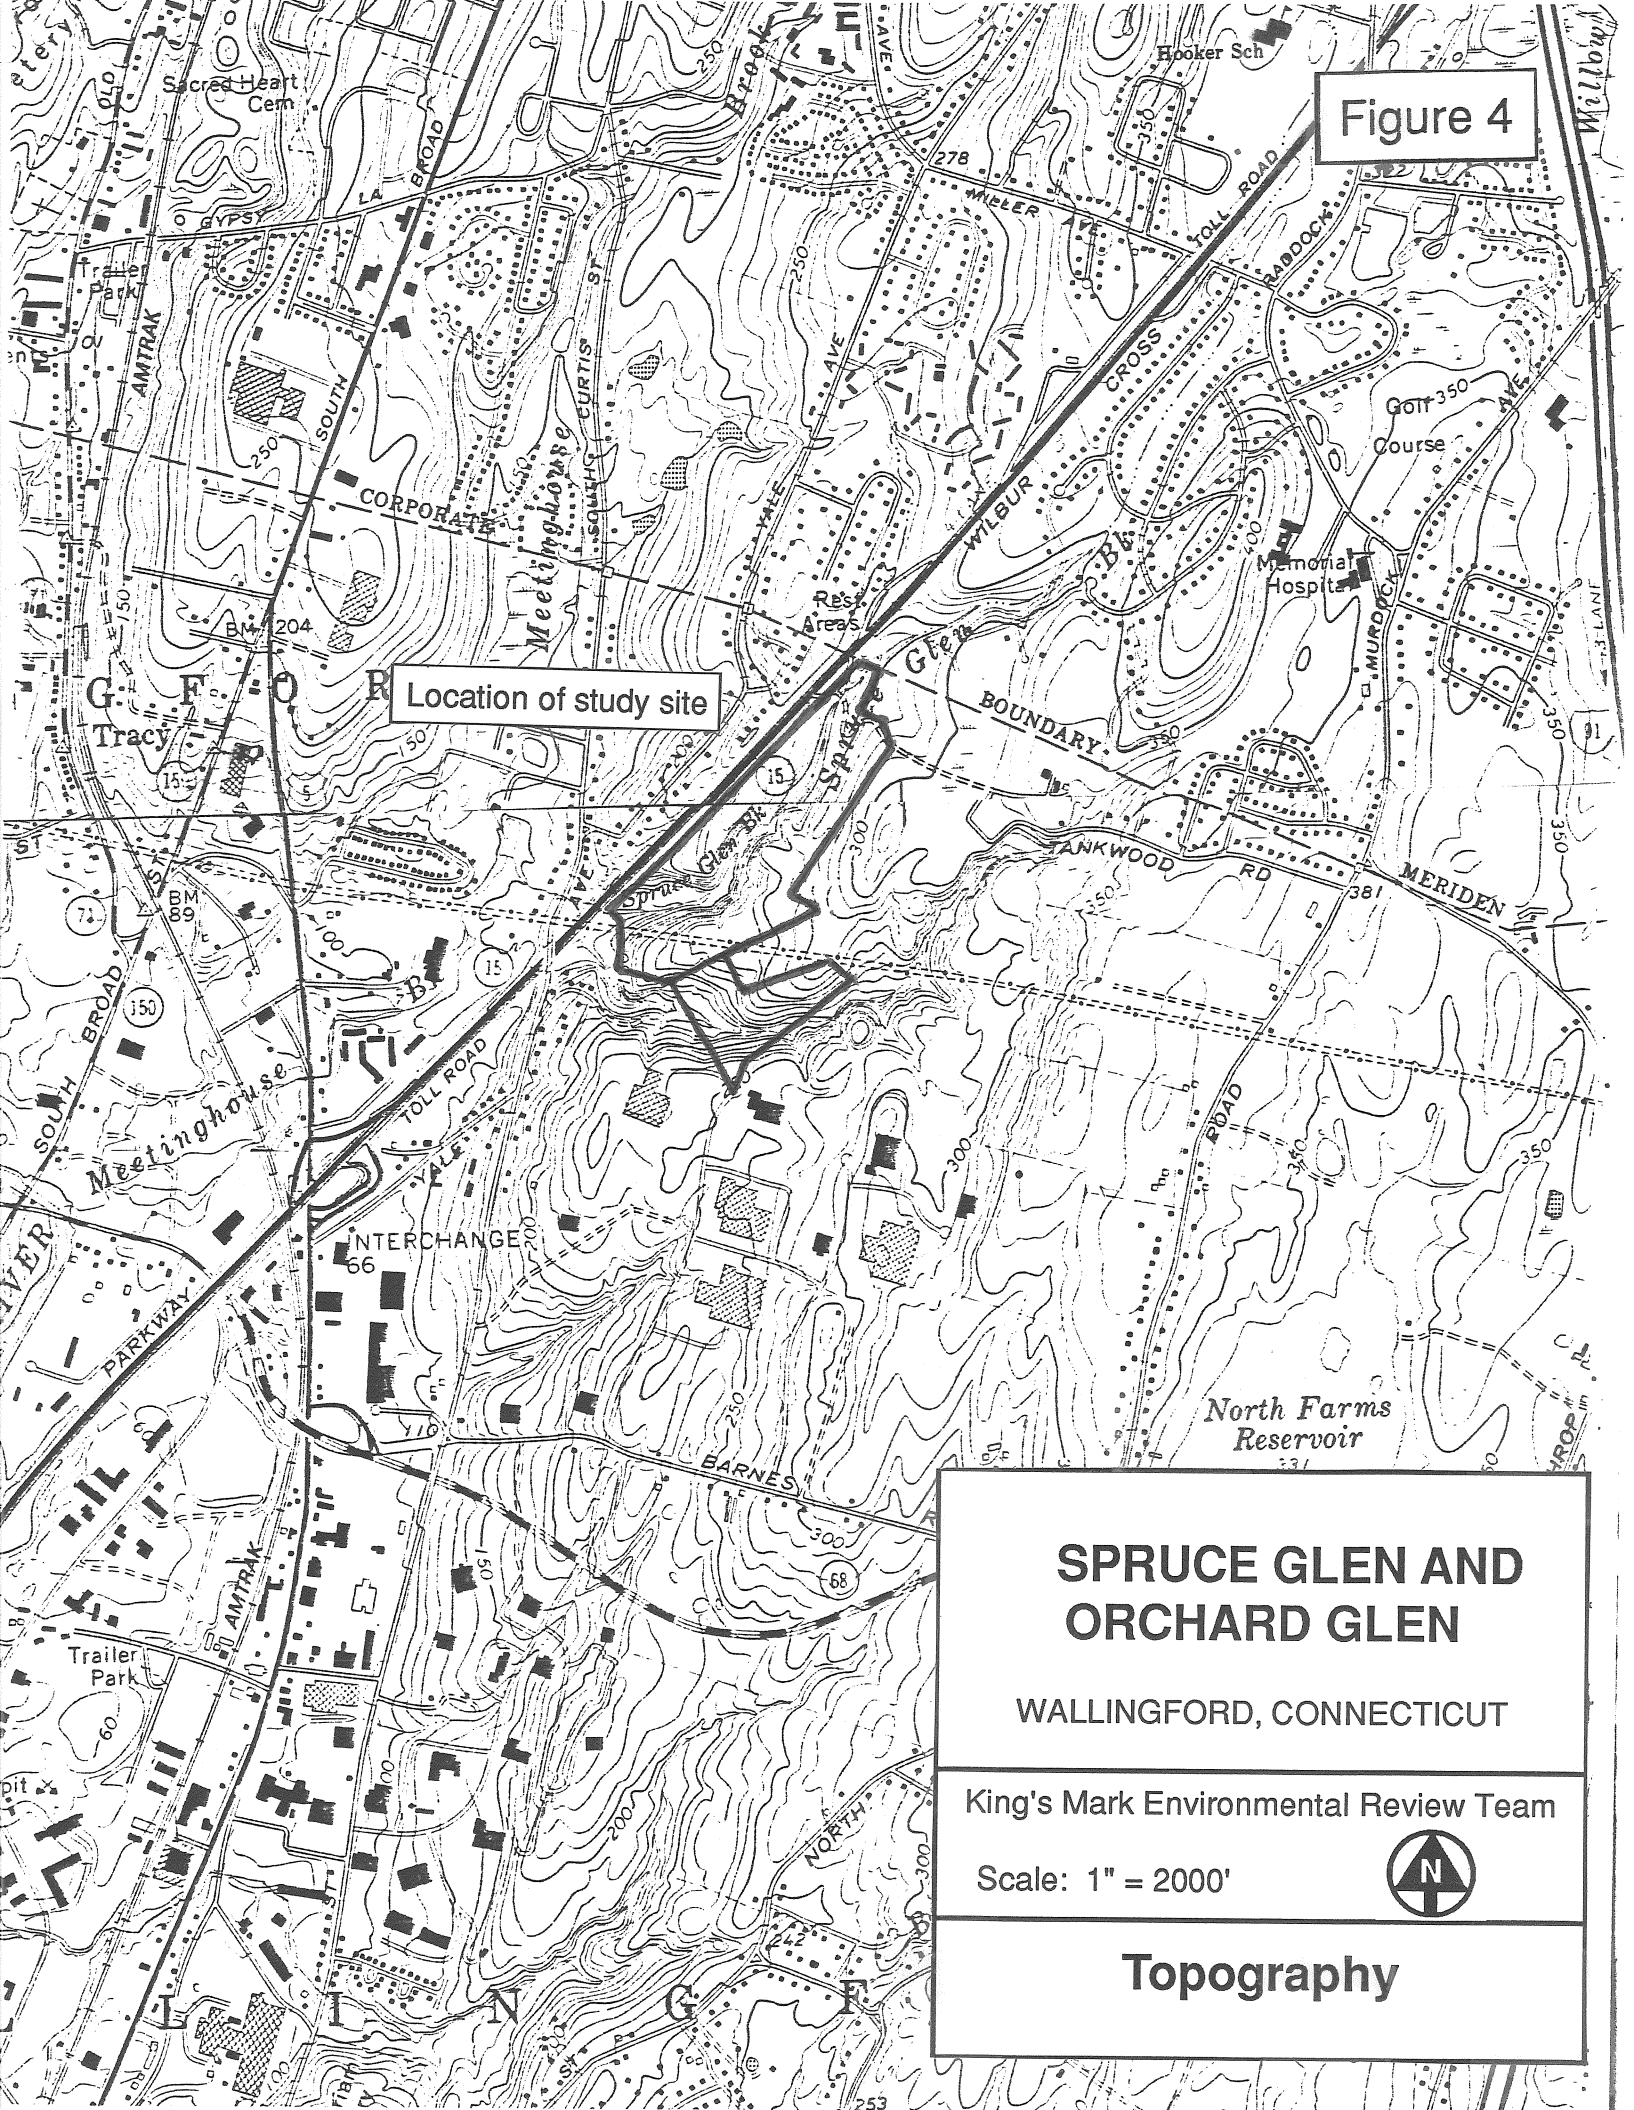
Figure 4 Topography

The principal topographic features of the parcels are the valleys of Spruce Glen Brook and of an unnamed brook on the Orchard Glen parcel and the intervening ridge (see Figure 4). The flow of Spruce Glen Brook has formed a spectacular gorge in bedrock from just below the old mill site at the northerly border of the parcel to just above its confluence with the unnamed brook on the Orchard Glen parcel. The gorge widens just below a waterfall 8 to 10 feet high, located approximately 600 feet downstream from the footbridge at the old mill site. Slabby rock at the top of the fall overhangs the pool below, posing a danger to hikers.
