*Manatuck Hill  
Subdivision  
Waterford, Connecticut*

*EASTERN CONNECTICUT  
ENVIRONMENTAL  
REVIEW TEAM  
REPORT*

*Review Date: April 24, 1990*

*Report Date: July 1990*

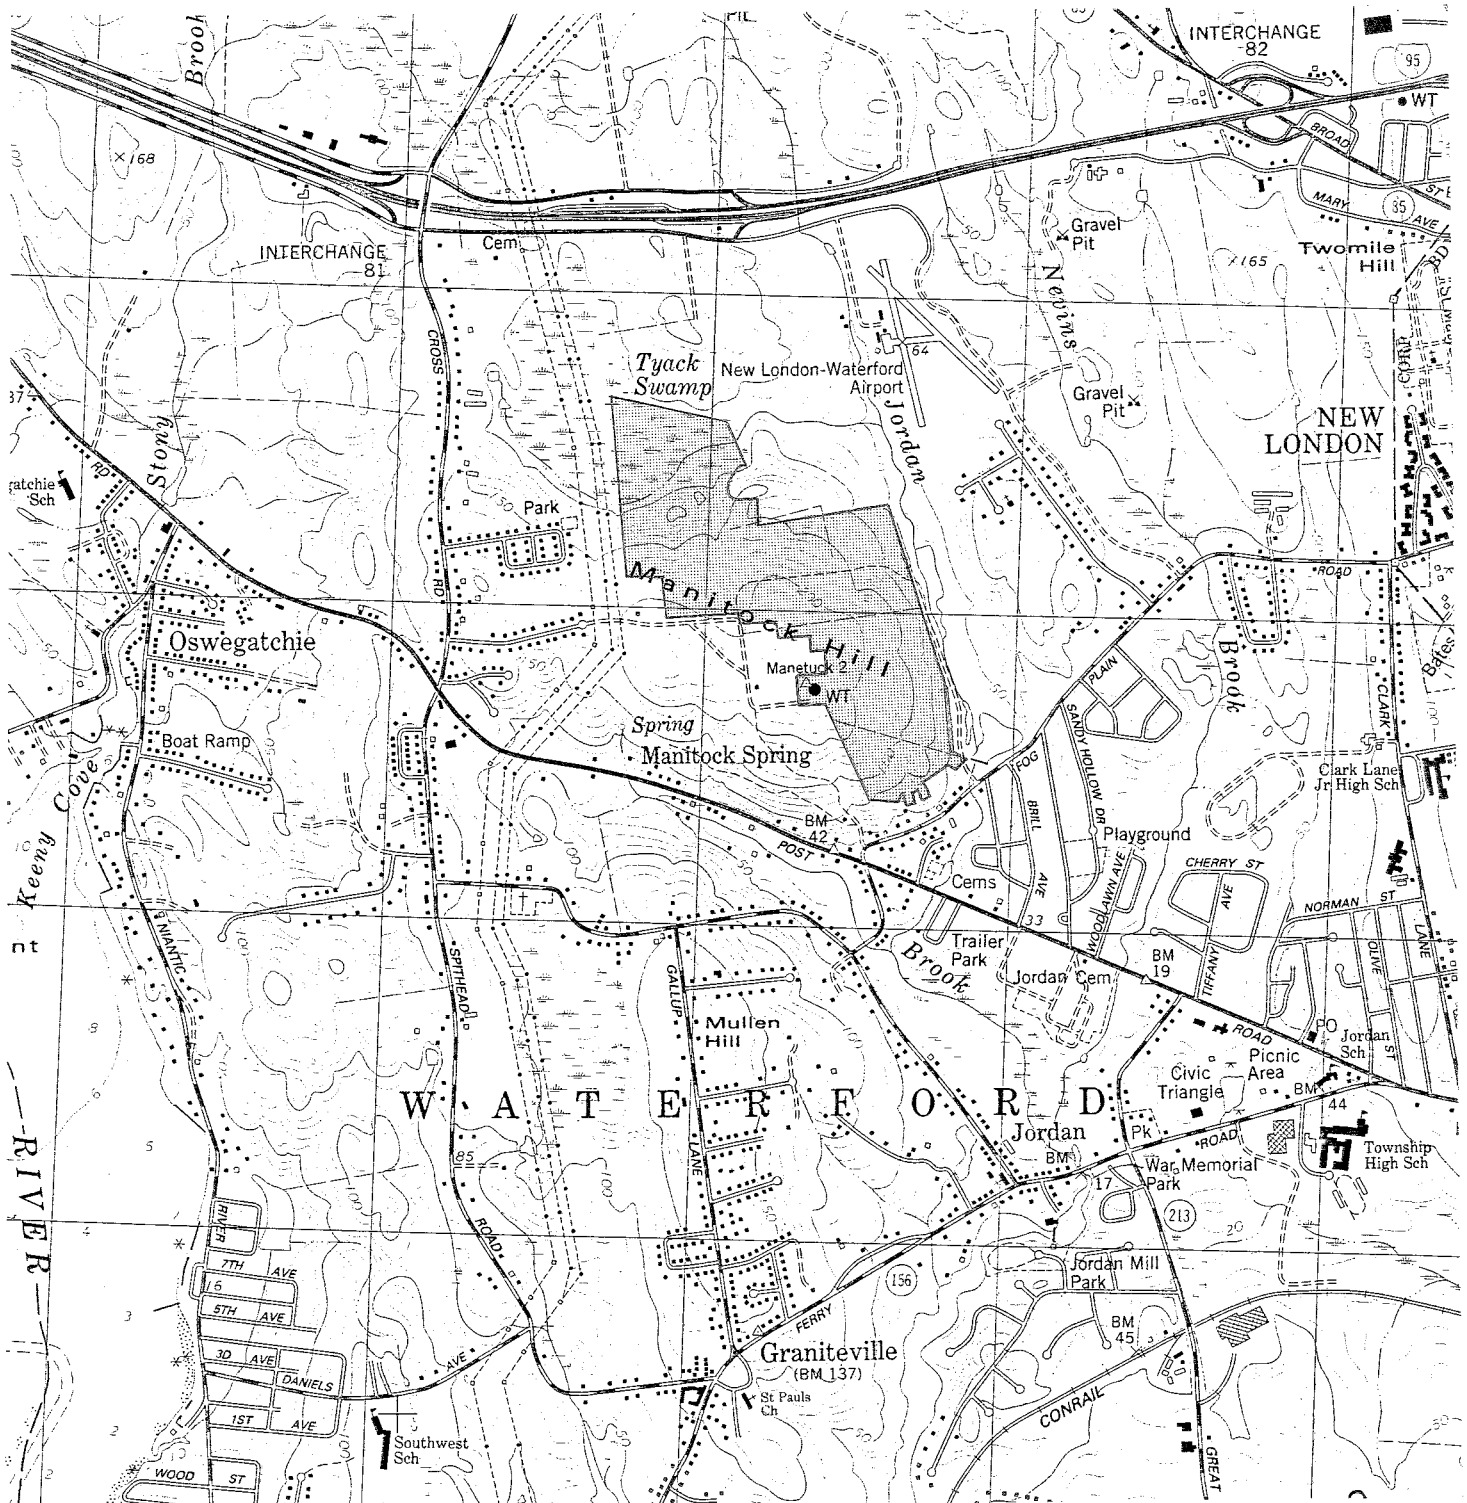
### LOCATION MAP

Approximate Site Location

The approximately 130 acre site is located in southcentral Waterford. It is bounded on the east by Jordan Brook and its accompanying floodplains, Fog Plain Road and residential properties on the south, wooded, undeveloped land and a Connecticut Light and Power Company high tension wire right-of-way on the west and wooded, undeveloped land on the north. A private driveway that serves a few homes and that extends from Rockridge Road on the west abuts an interior part of the site. Also a segment of Tyke Lane, a cul-de-sac off Parkway South, abuts a northern section of the site.

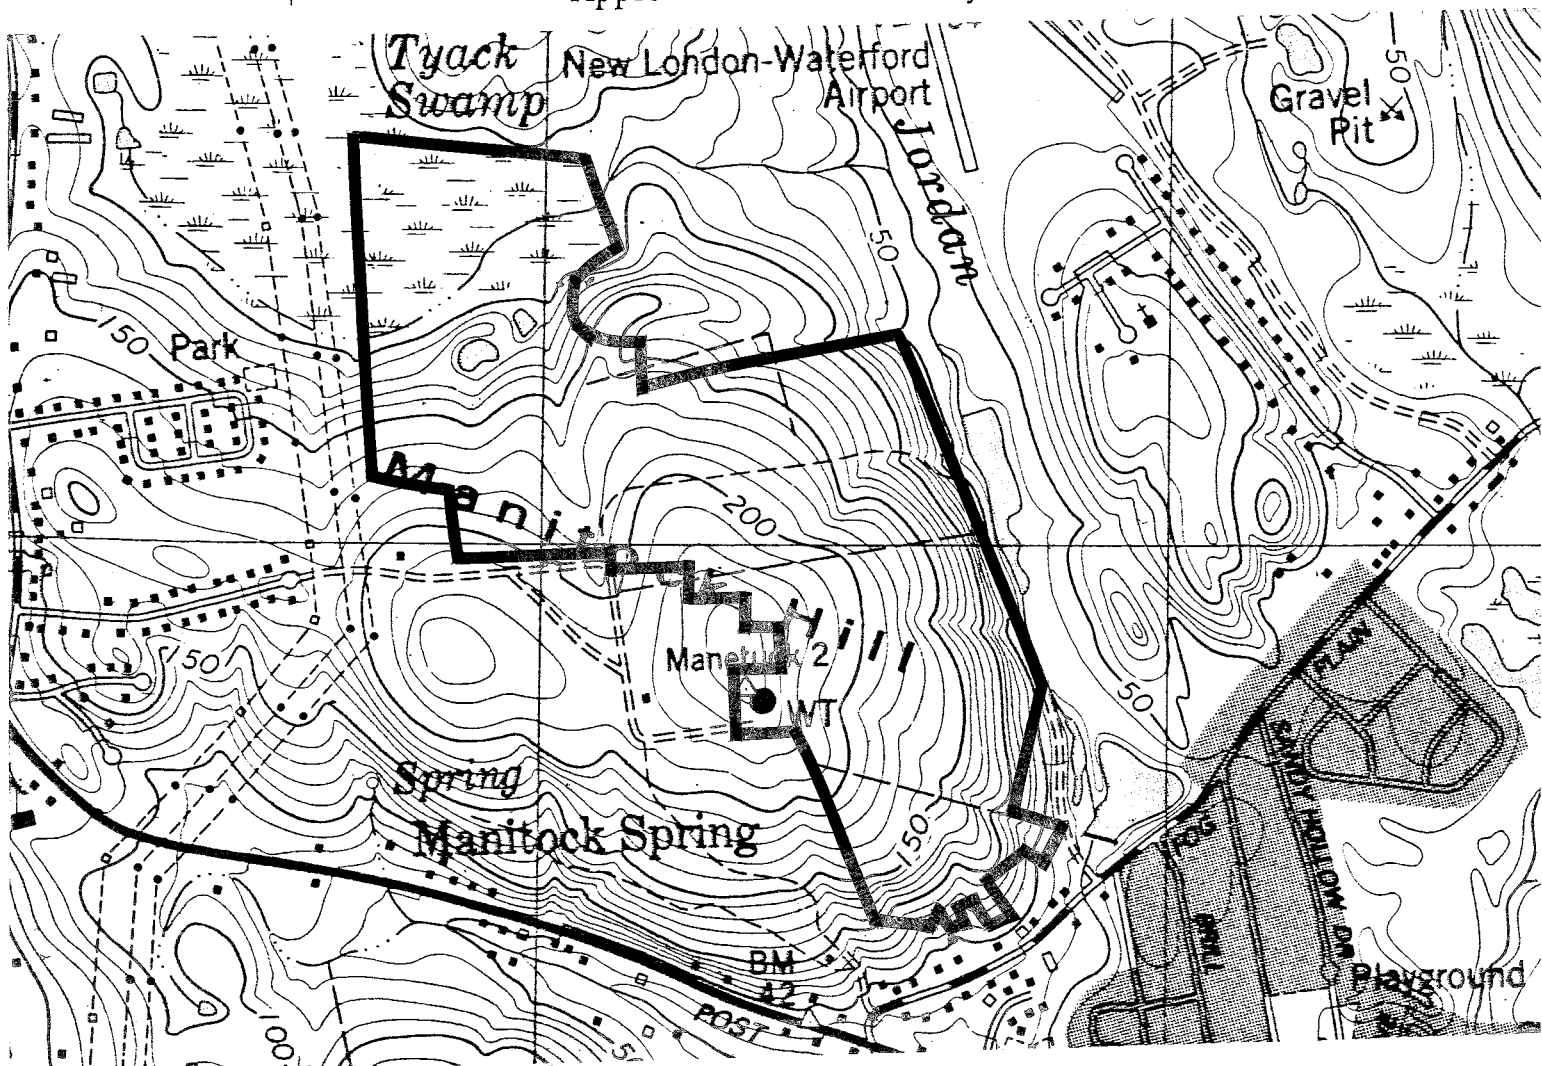
### TOPOGRAPHIC MAP

— Approximate Site Boundary

The site encompasses the north and east side of Manatuck Hill, a rock cored hill which is one of the highest peaks in southern Waterford. Approximately 20 acres of Tyack Swamp, which drains to Jordan Brook encompasses the northern limits of the property.

Site topography ranges from flat to very steep. The steepest slopes, which are controlled by the underlying bedrock, occur on the east flank and southern parts of Manatuck Hill. A small area of moderately steep slopes also occurs in the northcentral parts near Tyack Swamp. Flat slopes occur throughout Tyack Swamp and on the crest of Manatuck Hill. The remainder of the site contains slopes that range from gentle to moderate.

Maximum and minimum elevations on the site are  $\pm 240$  feet above mean sea level (crest of Manatuck Hill) and 50 feet above mean sea level (along the Jordan Brook floodplain in the eastern limits), respectively.

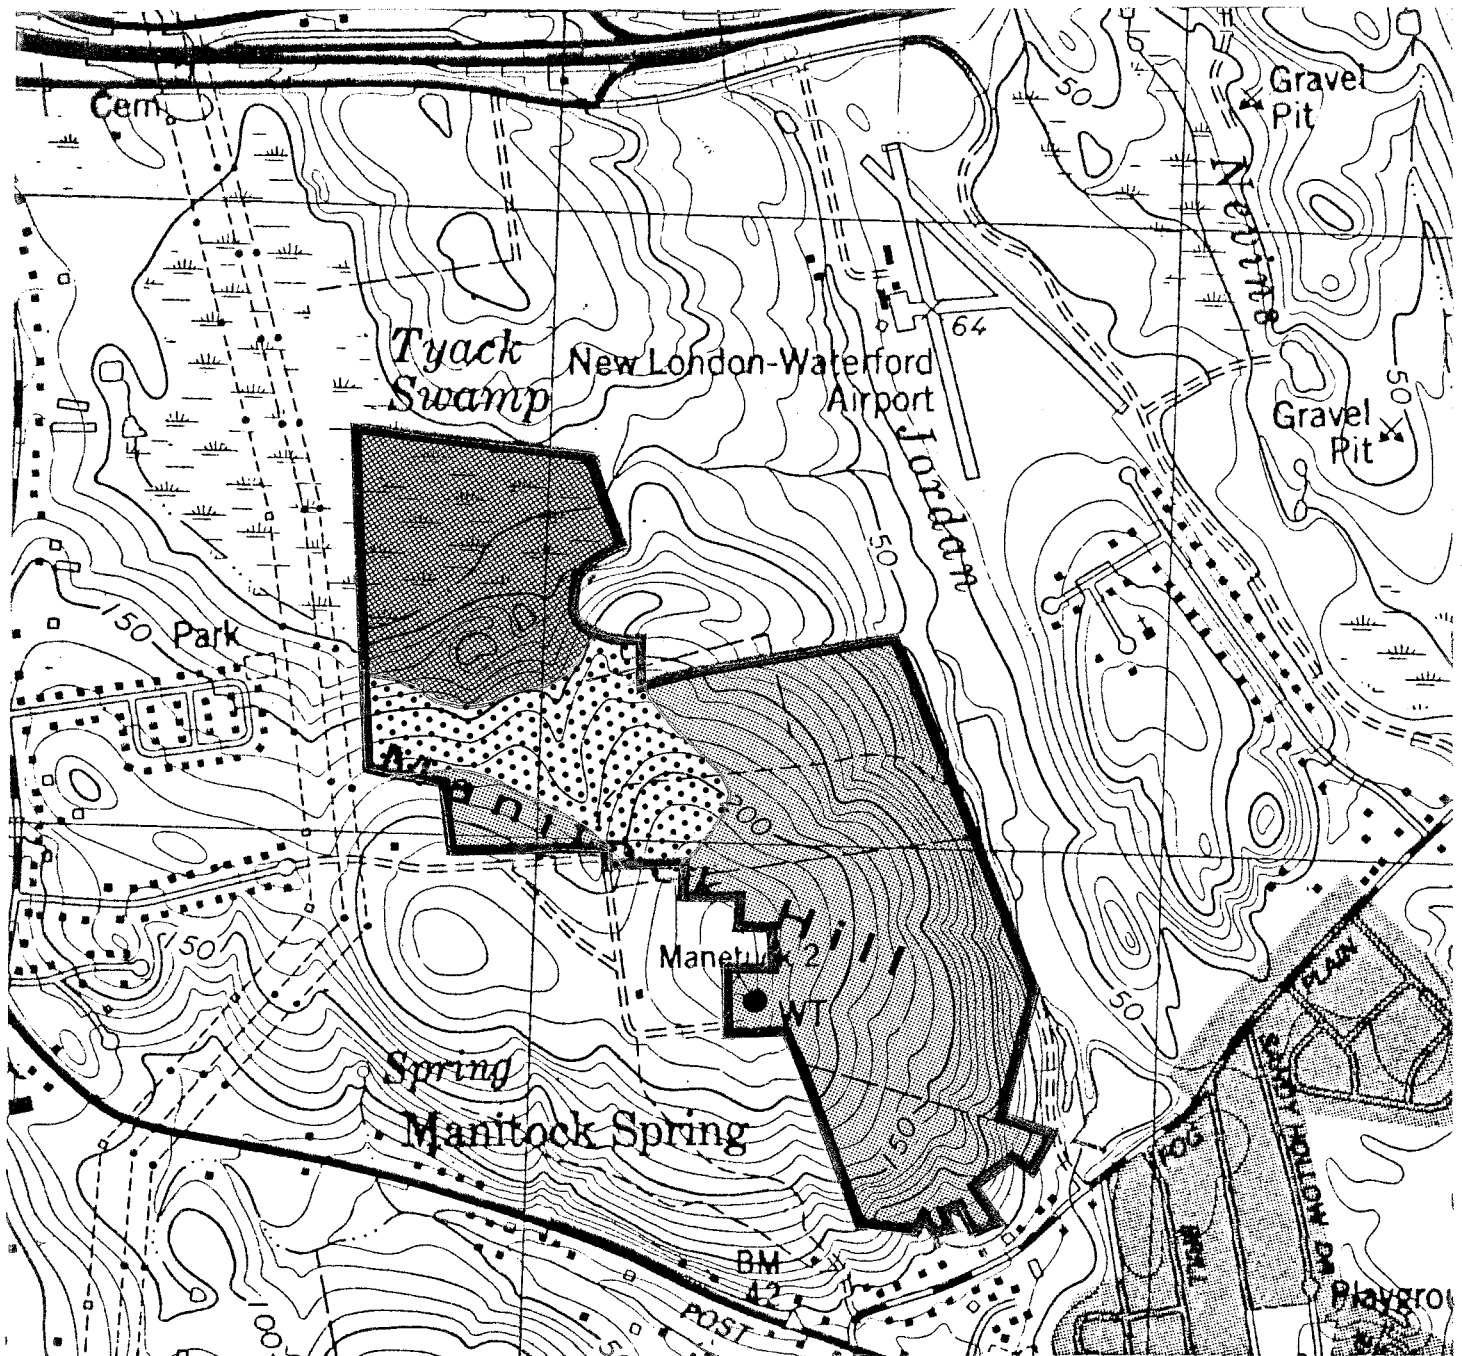
# BEDROCK GEOLOGIC MAP

New London Gneiss (Joshua Rock Gneiss Member)
-

New London Gneiss Subunit
-

Mamacoke Formation Subunit

Goldsmith (map GQ-575) indicates that the rock core of the site is comprised of three rock types; two subunits of New London Gneiss and a Mamacoke Formation subunit.

As can be seen by the accompanying bedrock geologic map, the majority of the site (southeast parts) is underlain by a New London Gneiss subunit known as the Joshua Rock Gneiss Member. It is described as a medium gray, medium grained equigranular (the mineral in the rock are similar in size) granitic gneiss which weathers with small cherry red-spots. Sparse outcrops of the rock unit occur on the east flank of Manatuck Hill. The central portion of the site is underlain by a New London Gneiss subunit described as massive, gray granitic gneiss which is peppered with brilliant black biotite and scattered prominent magnetite. Major minerals include quartz and oligoclase. The final rock type, found in the northern parts of the site is a Mamacoke Formation subunit. In general, it consists of interlayered light to dark gray, medium grained gneiss.

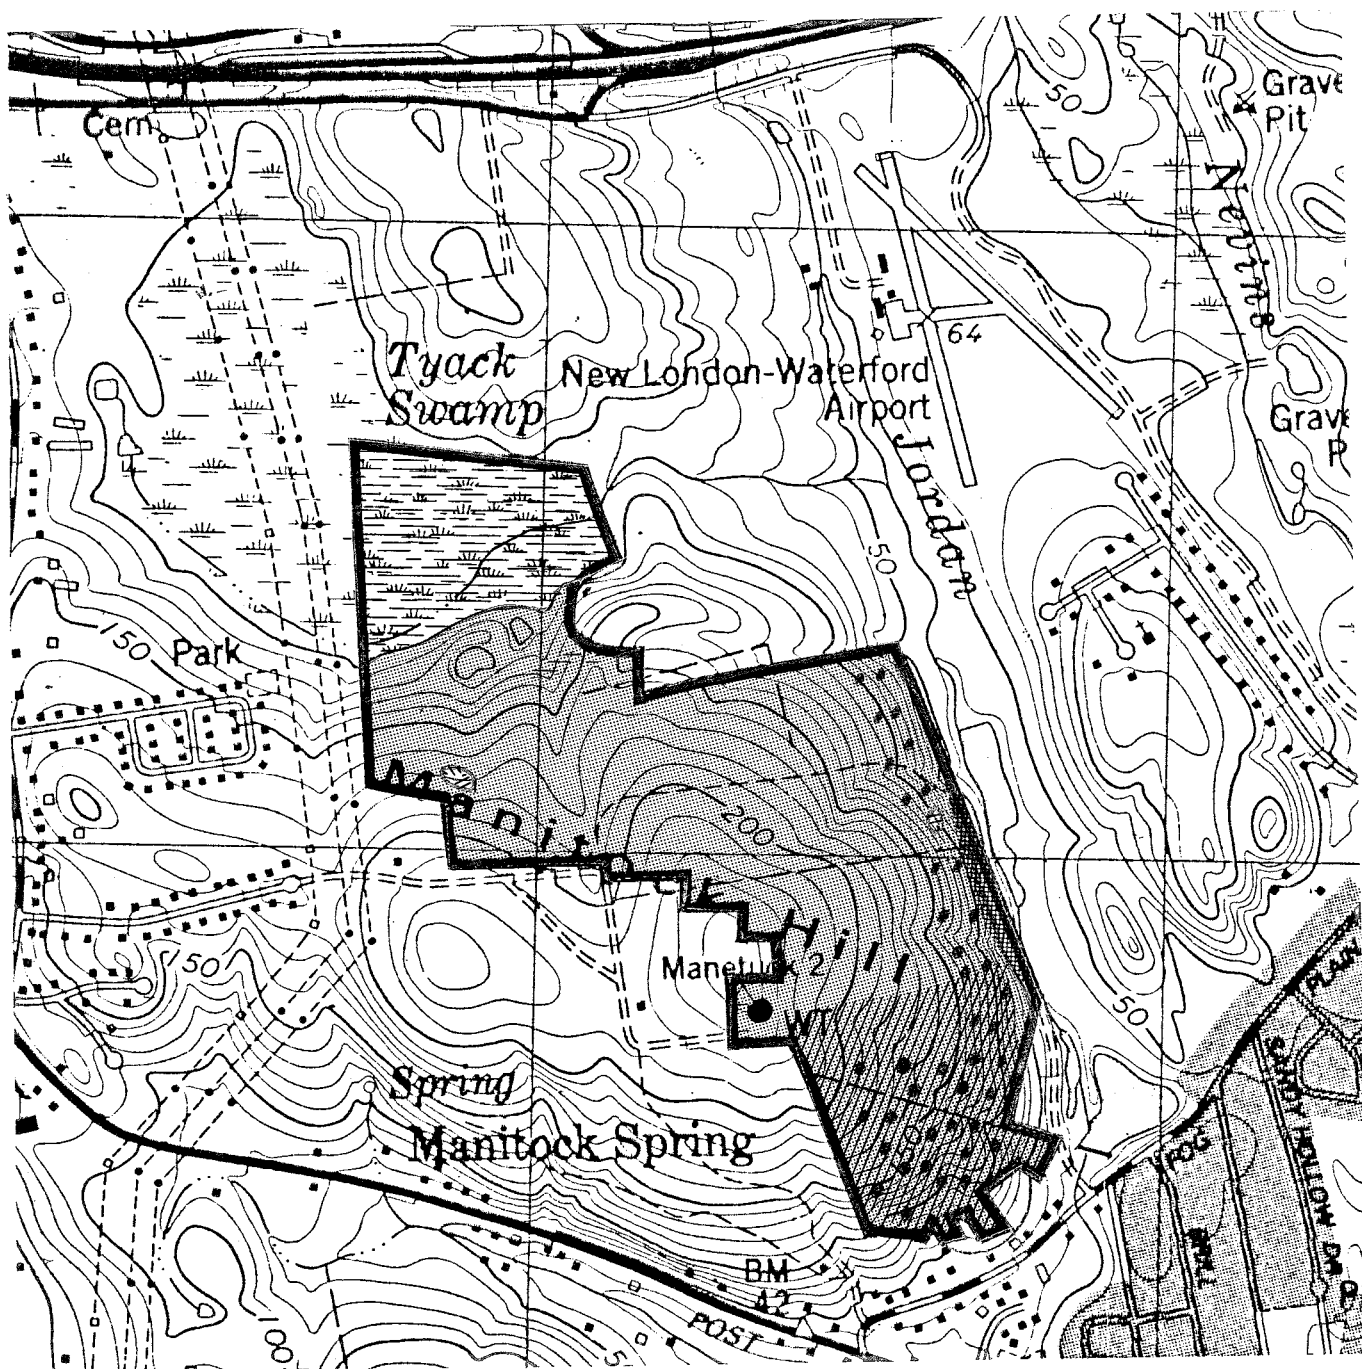
# **SURFICIAL GEOLOGY MAP**

Till
-

End Moraine Deposits
-

Swamp Deposits
-

Stratified Drift (sand/gravel)
-

Outcrops (approximate)
-

Surface Boulders

Overlying bedrock across the site is a relatively thin blanket (generally 10 feet or less) of unconsolidated sediments of glacial origin called till. Till consists of sediments that range in size from clay to large boulders, but is predominantly sand, silt and gravel. Based on soil mapping data, the texture of most till on the site is sandy and loose. The till sediments were deposited by glacial ice as it moved across the bedrock surface from north to south/southeast.

The composition of the till in the southern parts of the site is slightly different than the till on the remainder of the site. It is characterized by the presence of many large subrounded boulders that are concentrated at the surface. Additionally, poorly to well sorted stratified sand and gravels are found in the deposit. Map GQ-329 identified these sediments as end moraine deposits. They formed at the front margin of a glacier. The material in the end moraine is deposited by dumping of rock debris from the ice margin. Along the eastern property line, glacial stream deposits consisting of interbedded pebble gravel, sand, with minor layers of cobble gravel were deposited by streams flowing from wasting masses of glacier ice in the Jordan Brook Valley. These deposits, in places along the eastern property boundary, have been mined, probably for construction material.

Tyack Swamp, in the northern parts consists of post-glacial sediments called swamp deposits. These deposits consist of partly decomposed organic material mixed or interbedded with silt and sand.

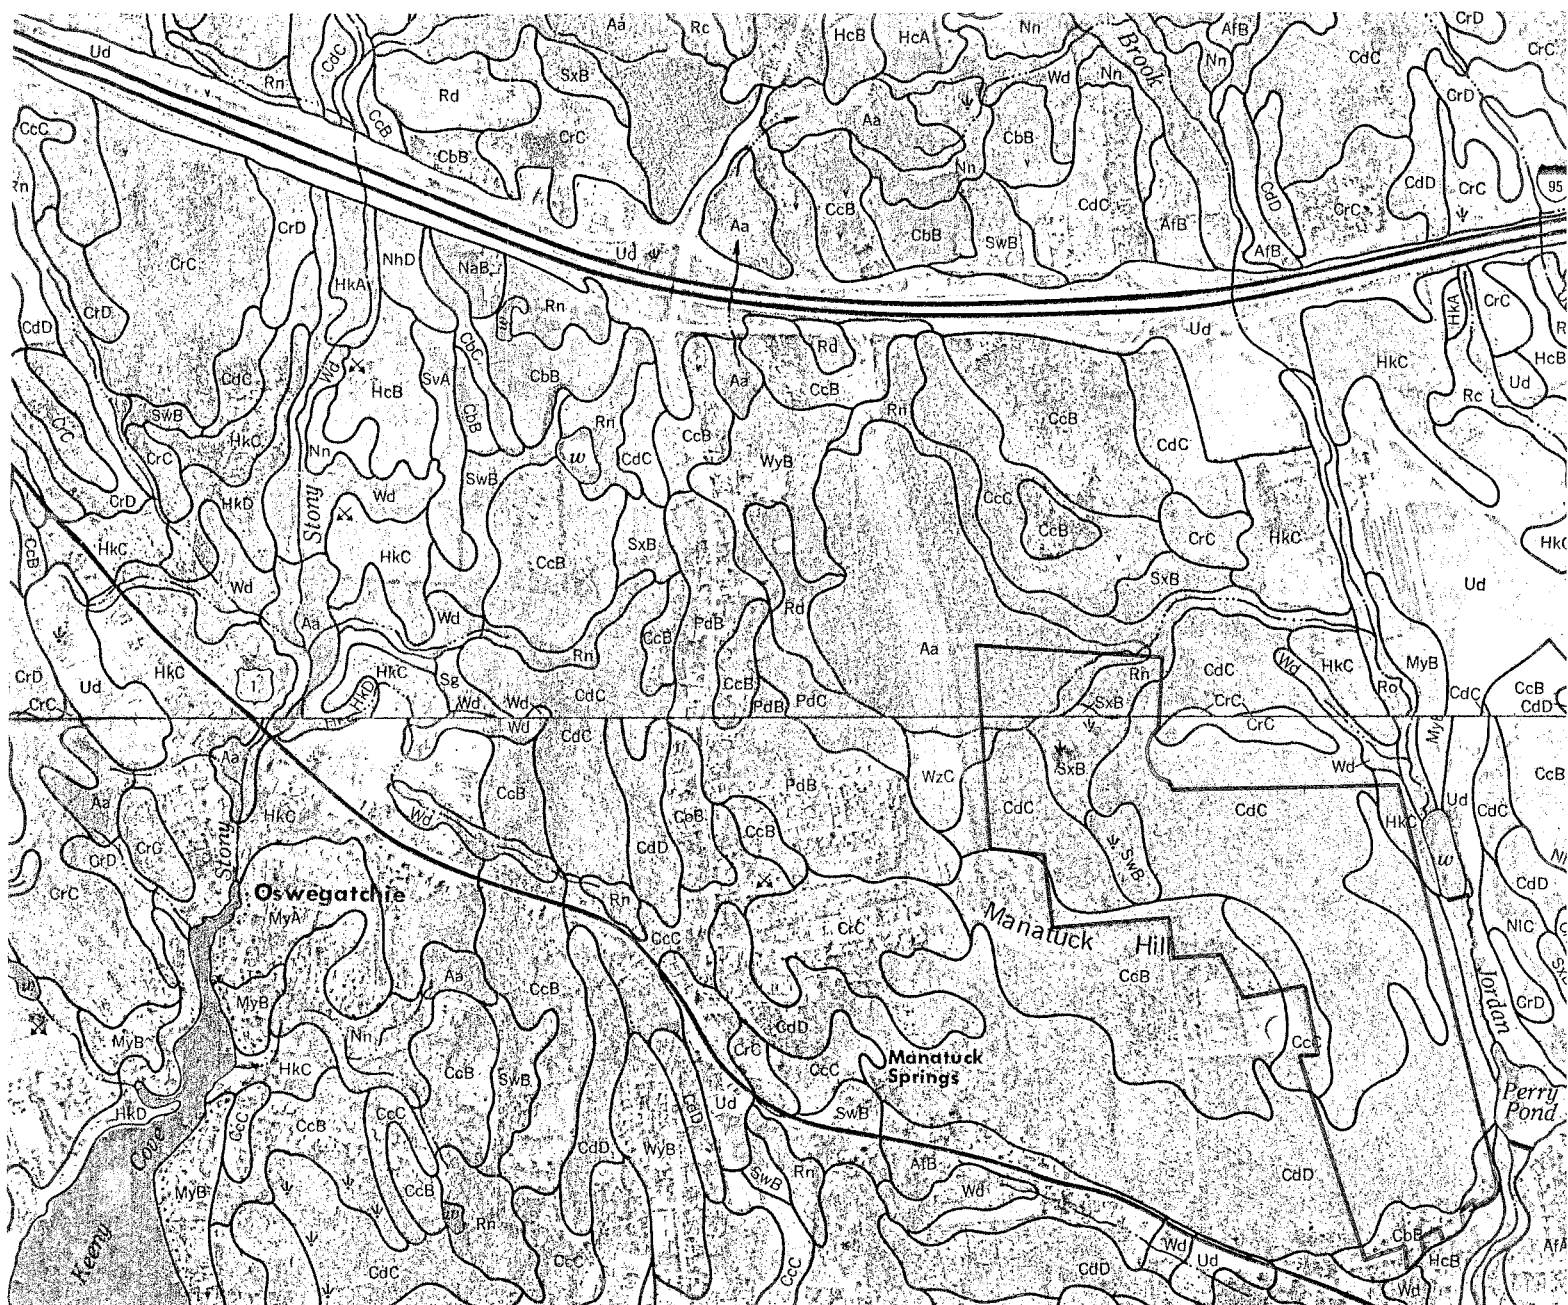
Scale 1" = 1320'

- \* - Prime Agricultural Farmland**
- \*\* - Farmland of Statewide Importance**
- \*\*\* - Wetlands**

• Approximate Site Boundary

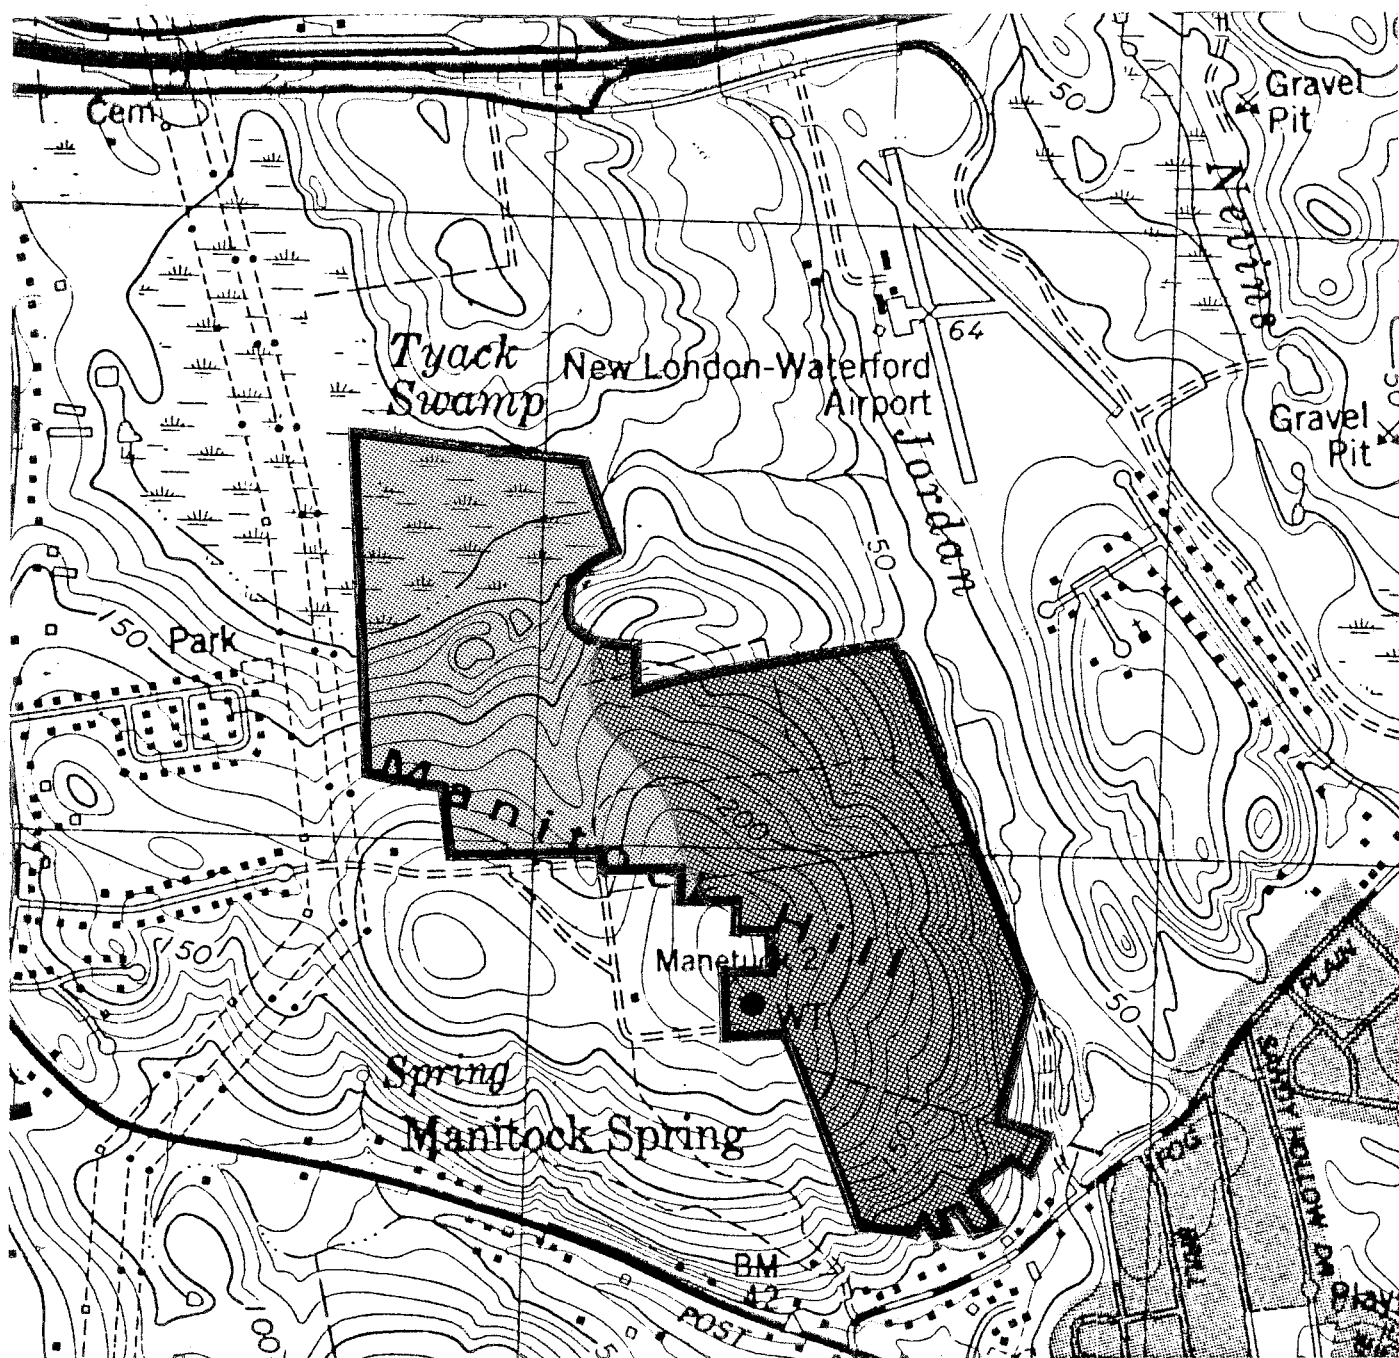
**WATERSHED BOUNDARY MAP**

Portion of the site that drains to Jordan Brook

The entire site is located within the Jordan Brook watershed area. A segment of Jordan Brook parallels the site's eastern property line. At its point of outflow to Jordan Cove, Jordan Brook drains an area of 10 square miles or 6,400 acres. The site therefore represents 2.5 % of its watershed area. On the site, surface drainage can be subdivided into two areas: surface runoff arising in the northwest corner of the site generally flows northward via topographic swales to Tyack Swamp. The outlet for Tyack Swamp discharges to Jordan Brook northeast of the site. Approximately 34 homes are located in this subdrainage area. The remainder of the site drains directly to Jordan Brook via topographic swales.
