**EASTERN CONNECTICUT
ENVIRONMENTAL REVIEW TEAM
REPORT**

CHAPMAN MILL POND OPEN SPACE WESTBROOK, CONNECTICUT

APRIL 2004

REPORT NO. 582

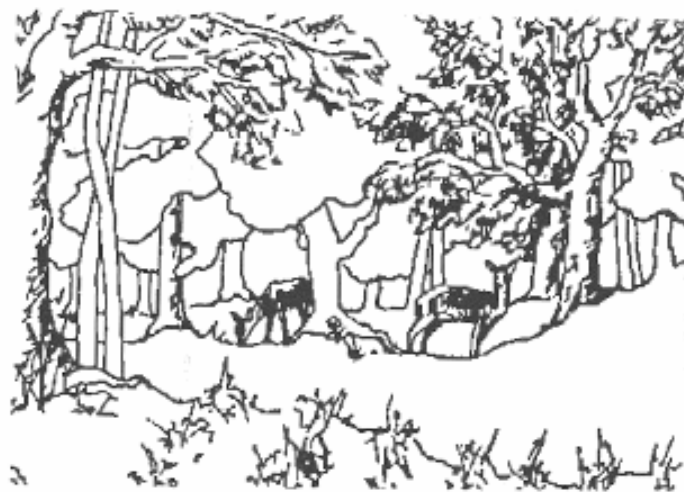
The CTDEP supports and recommends the use of buffers to protect wetlands and watercourses from environmental impacts. Leaving a vegetated strip around surface water resources, including wetlands helps protect surface and groundwater quality, and fish and wildlife habitats from nonpoint source pollution. Buffers trap road sands, contaminants and other pollutants contained in stormwater runoff generated from roadways, parking lots, roof tops, and other impervious surfaces, as well as eroded sediments occurring from natural scour or land moving activities such as site development and other soil disturbances, including farming activities. A 50 foot vegetated buffer is typical, but widths can vary depending on such factors as topography, the erosivity of the soil, and the

value or sensitivity of the water resource. The CTDEP Fisheries Division⁵ recommends a 100-foot buffer along perennial streams and a 50-foot buffer along intermittent streams; measured from the upland boundary of the regulated area, including any riparian wetlands. CTDEP Fisheries further recommends that the buffer remain in a naturally vegetated and undisturbed condition.

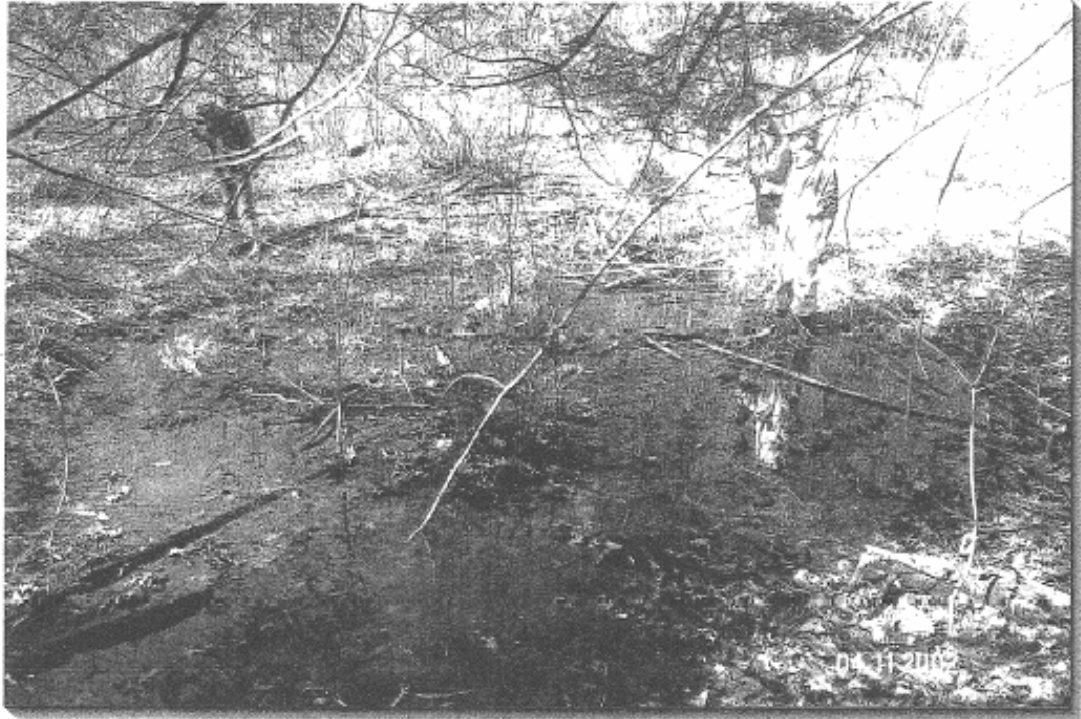
Photo 1. First vernal pool on Lake Laconia property.

Vernal pool habitats have been documented in three of the on site wetlands (Connecticut Ecosystems LLC report dated 4/22/02). A relatively small vernal pools was observed adjacent to an abandoned logging road, while two other were located in seasonally flooded wooded swamps. These latter two pools contained extensive shallow water and were noted to have particularly high amphibian productivity. The extent of seasonally ponded water, therefore the size and hydroperiod of the pools, can vary year-to-year and may continue beyond the surveyed wetland boundaries. Management or site improvement activities occurring near the vernal pool should be carefully evaluated with regard to protection and preservation of the pool's physical structure, water quality, and adjacent upland habitat (e.g., shading, moisture, amount of leaf litter and coarse woody debris).

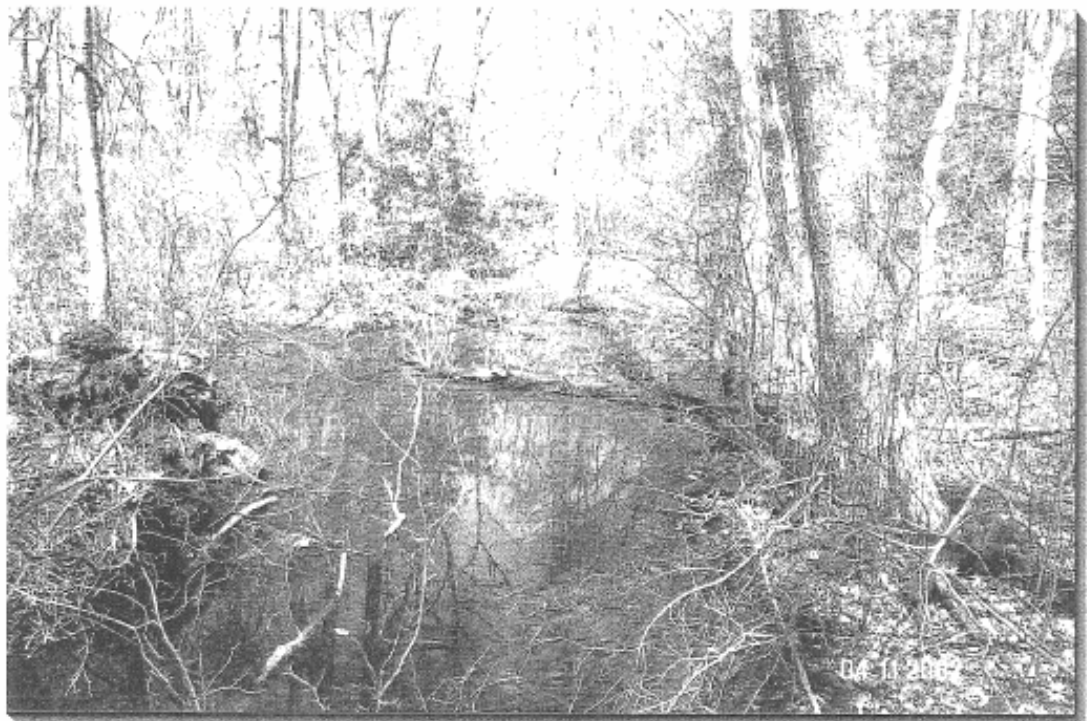
Photo 2. Second vernal pool on Lake Laconia property.

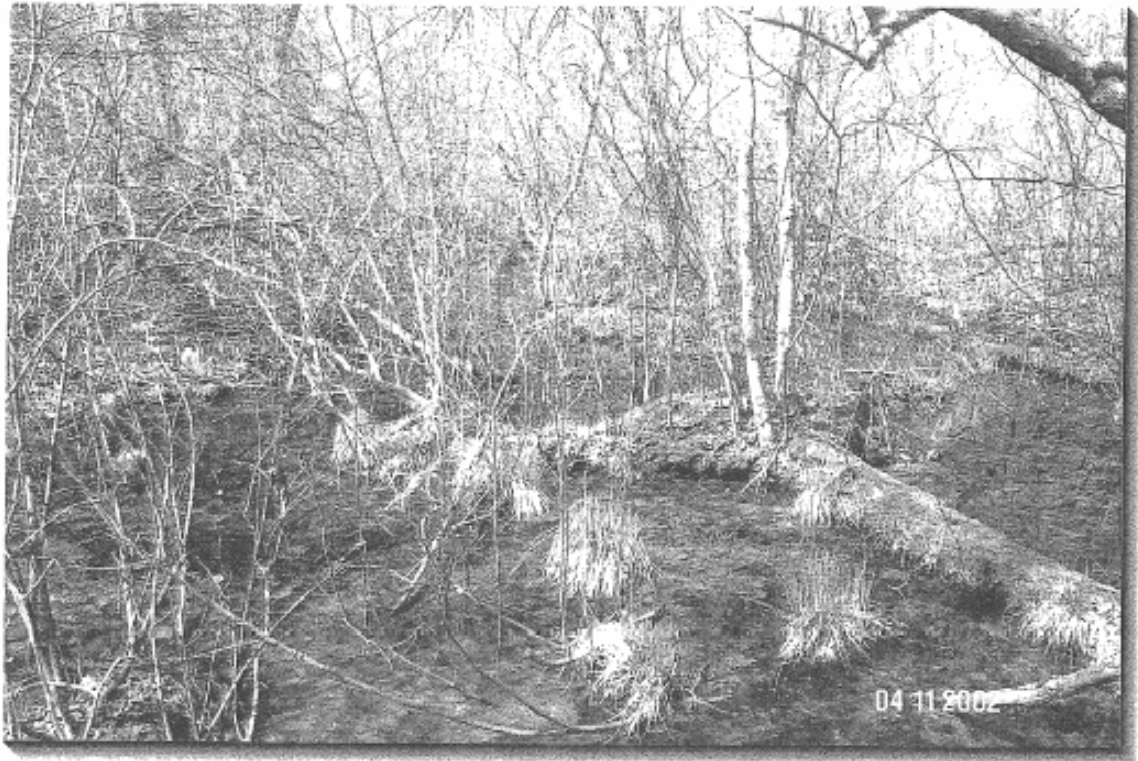
Photo 3. Third vernal pool on Lake Laconia property.

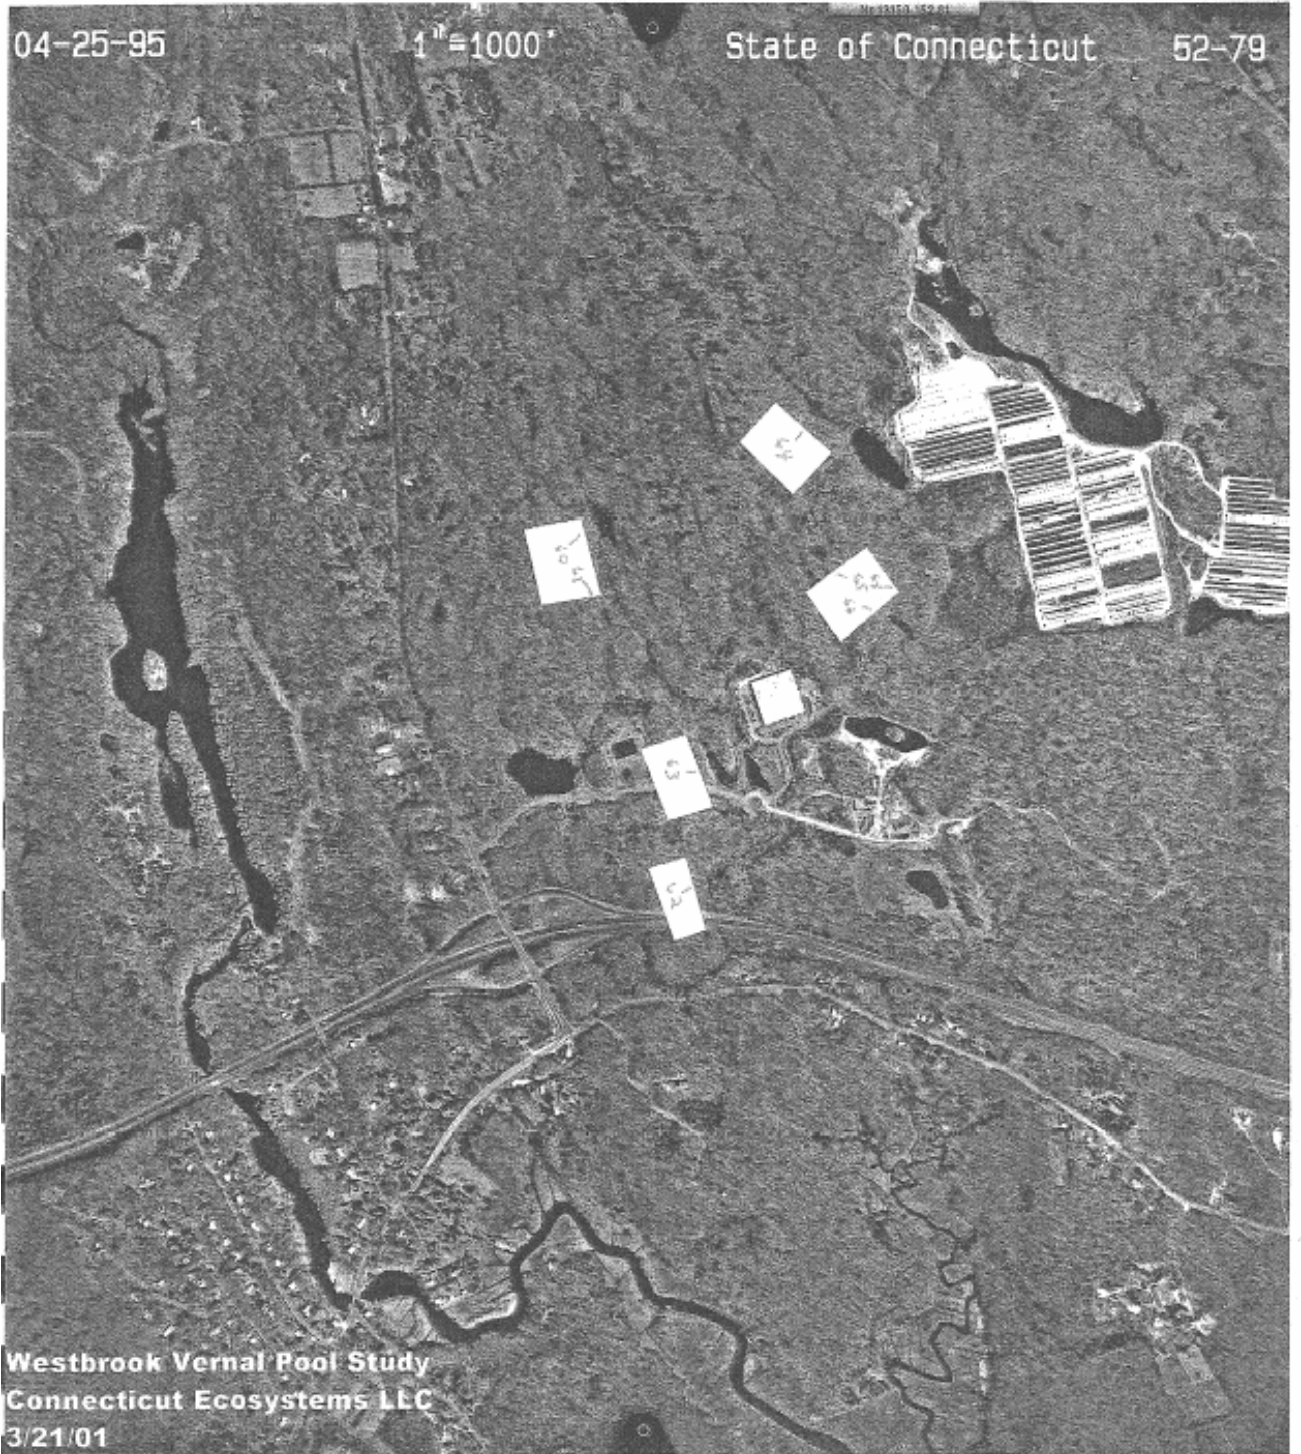
Westbrook Vernal Pool Study
Connecticut Ecosystems LLC
3/21/01
