**EASTERN CONNECTICUT
ENVIRONMENTAL
REVIEW TEAM
REPORT**

October 1994

Environmental Review Team Report on

**Westbrook Town Forest
Westbrook, Connecticut**

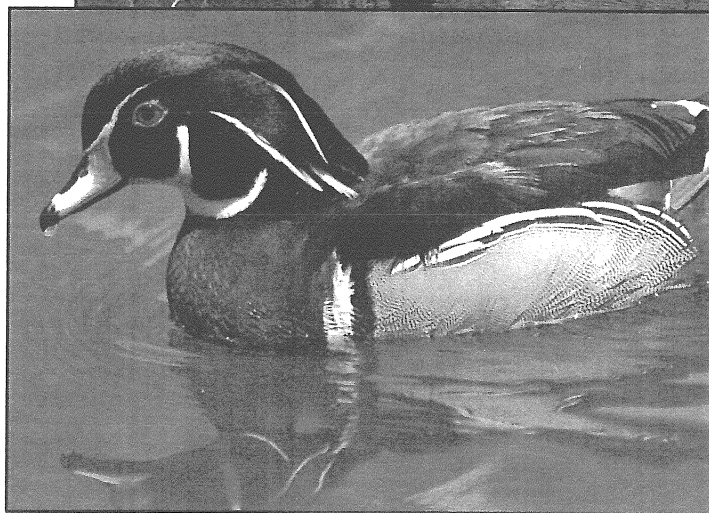
The use of wood duck nest boxes, as well as other wildlife management techniques, can be seen at CEDARS.

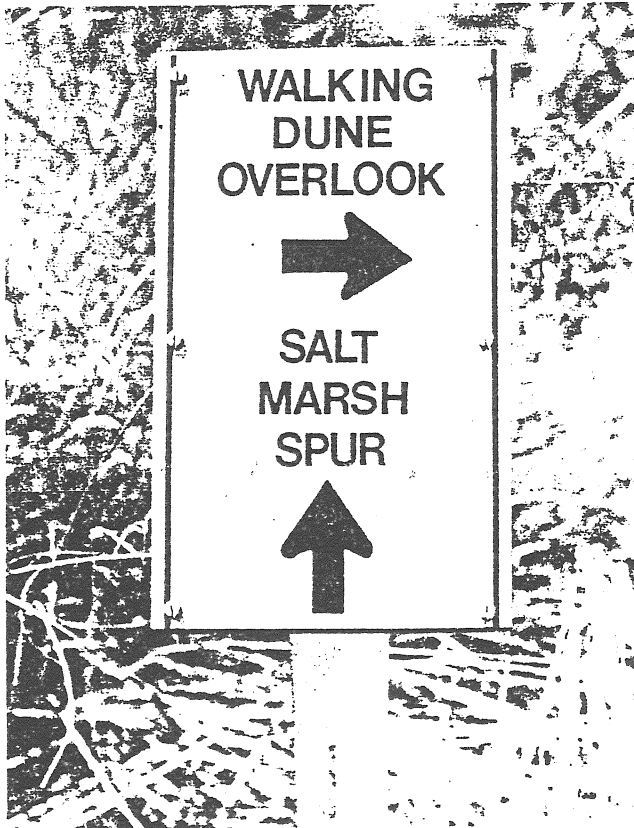
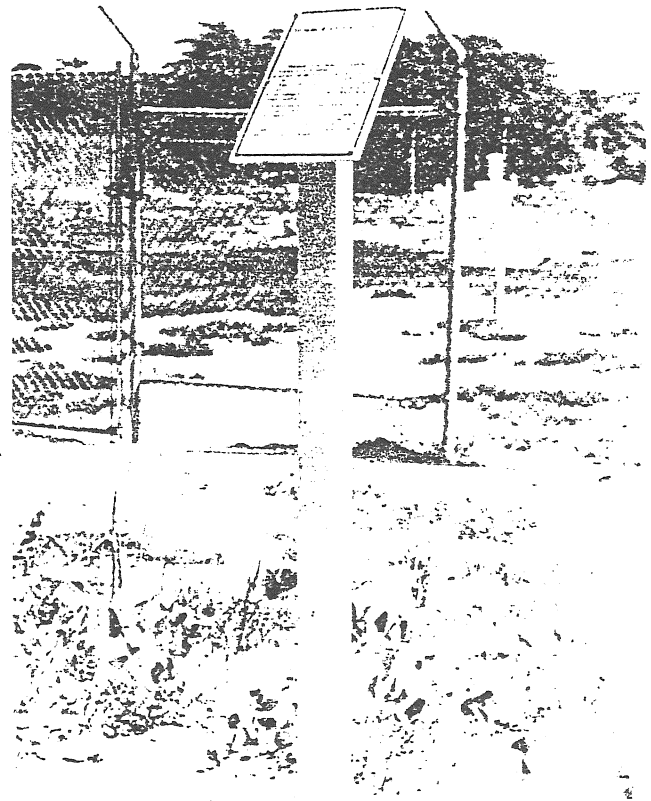
were addressed for the proposed trail signs. Due to the corrosive beach atmosphere in the park, the type and quality of material were major factors. Budget constraints and vandal-resistant materials were also assessed. Through the collective efforts of the Delaware Division of Parks and Recreation, an all-aluminum sign was selected.

ufacturer with the graphics, artwork and text. The metal photos are mounted by using an exterior strip adhesive and aluminum rivets. The adhesive acts as a barrier between the metal photo and aluminum plate to prevent oxidation. This entire unit is mounted to an aluminum plate which is welded to the top of the post at a 45° angle. Cost per sign is under \$80.00 which includes all materials, artwork, printing and installation.

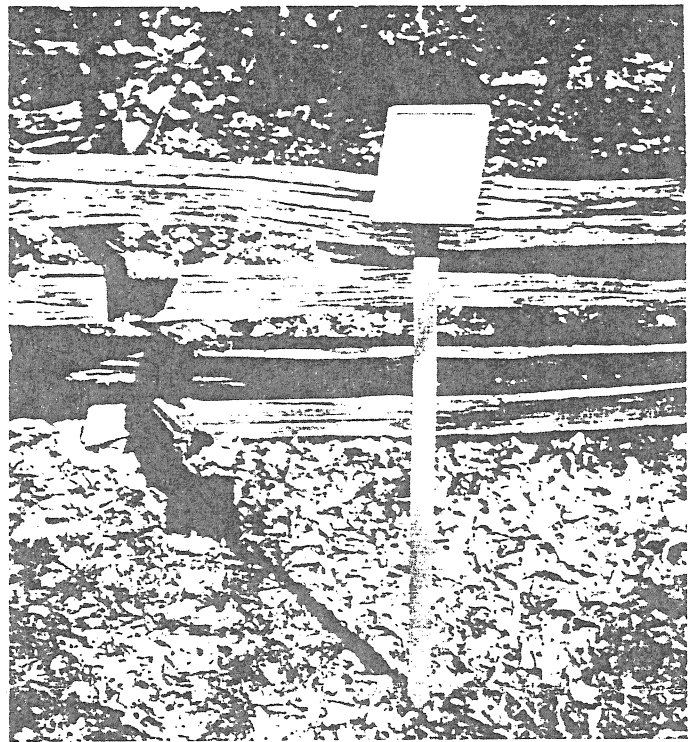
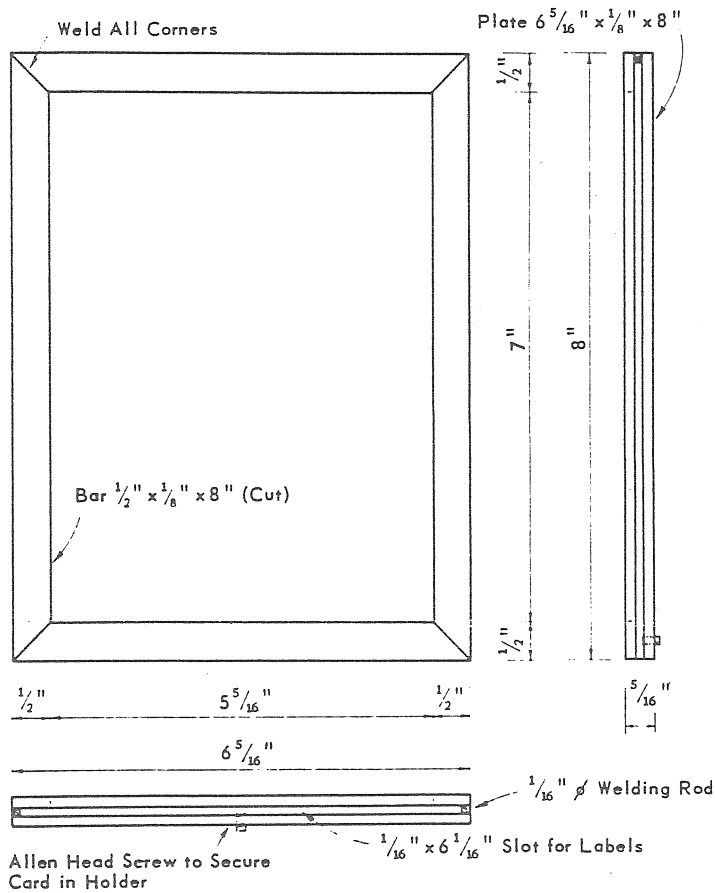
A simple, easily placed trailside marker which could be fabricated in most park shops.

Note anchor bar near the foot of the upright, placed to discourage unauthorized removal. Labels used in this holder are printed on cards and then laminated in plastic. All metal parts of this marker should be treated with rust preventive.

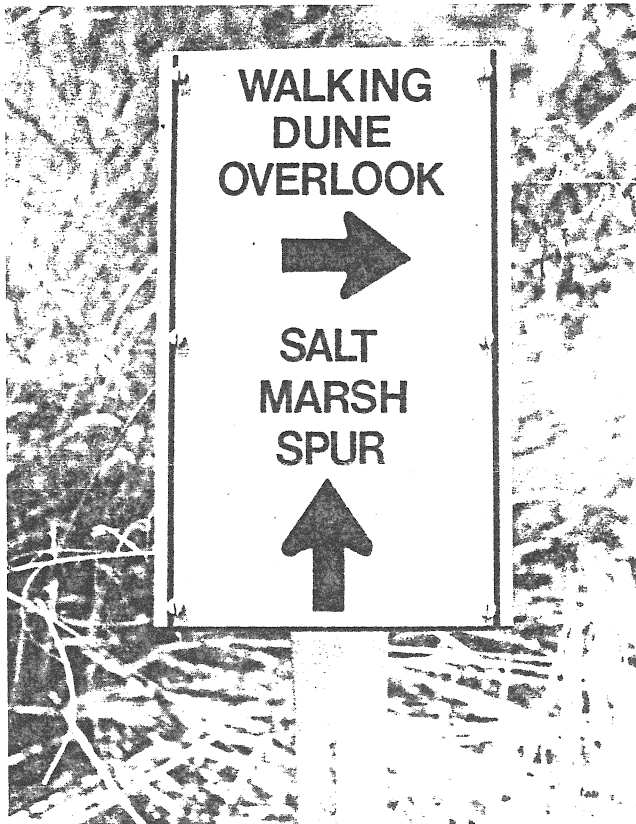
Interpretive Nature Trail Signs		Contributed by
Index I-6945	Winter 1986	C.L. Gaines
	Control N-1690-1	Delaware Parks/Rec

ufacturer with the graphics, artwork and text. The metal photos are mounted by using an exterior strip adhesive and aluminum rivets. The adhesive acts as a barrier between the metal photo and aluminum plate to prevent oxidation. This entire unit is mounted to an aluminum plate which is welded to the top of the post at a 45° angle. Cost per sign is under \$80.00 which includes all materials, artwork, printing and installation.

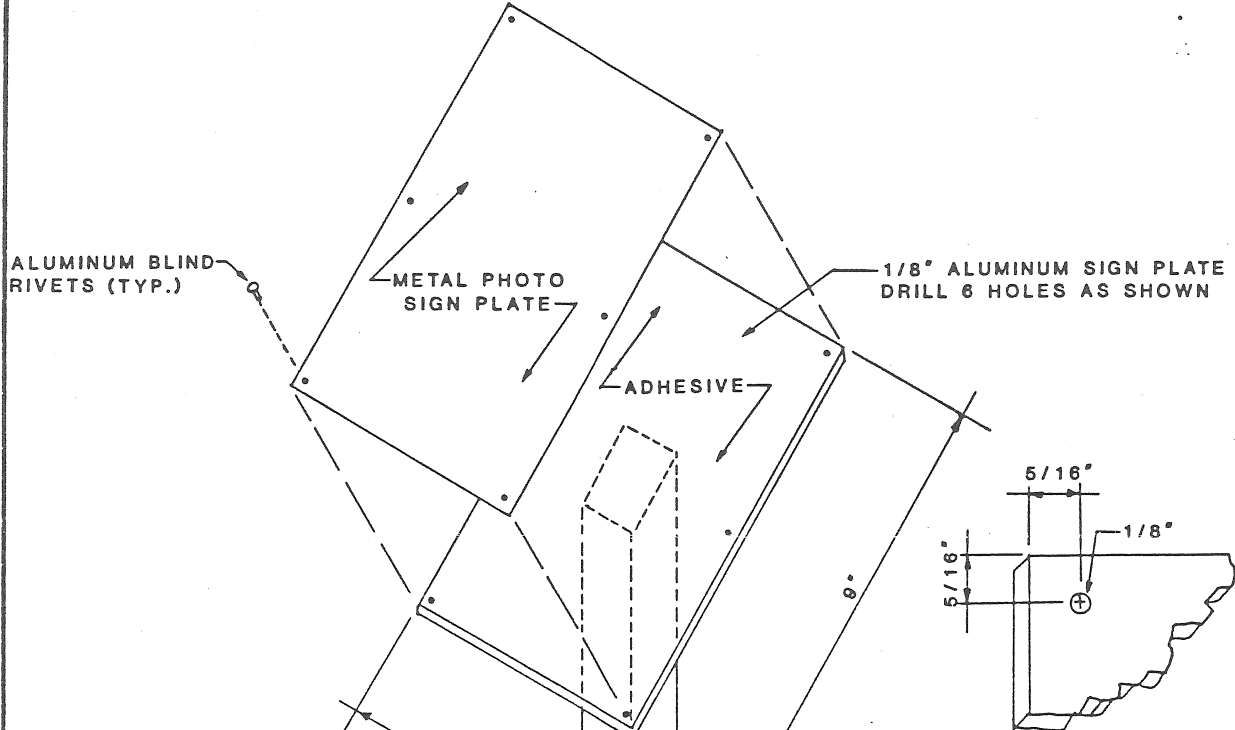
DRILLING DETAIL
NOT TO SCALE

6' LENGTH OF 1 3/4" ALUMINUM SQUARE TUBING ONE END CUT AT 45° AND WELDED TO PLATE

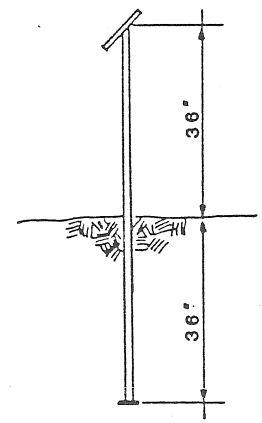
INSTALLATION DETAIL
NOT TO SCALE

SCRAP PIECE OF ALUMINUM PLATE 6" X 6" WELDED TO TUBING

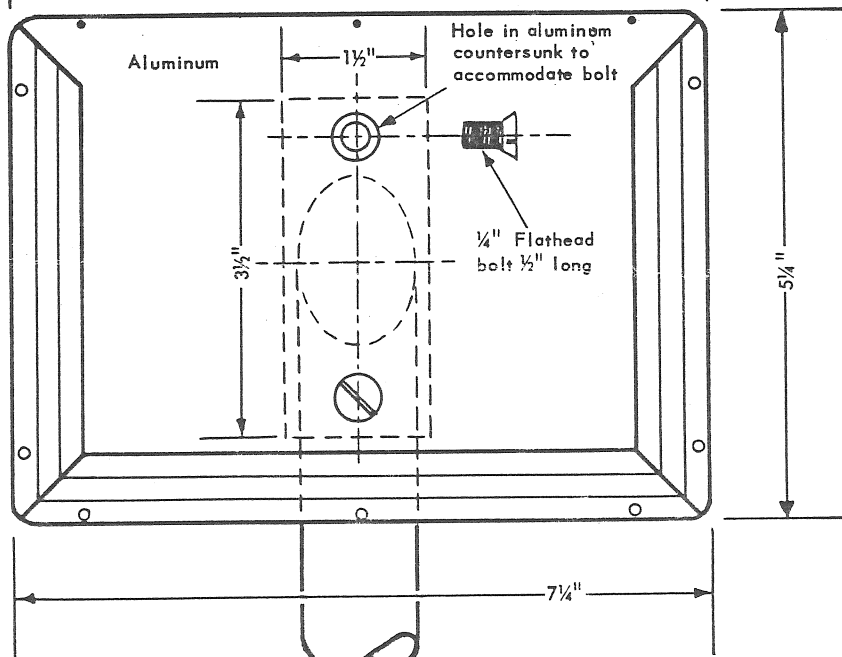
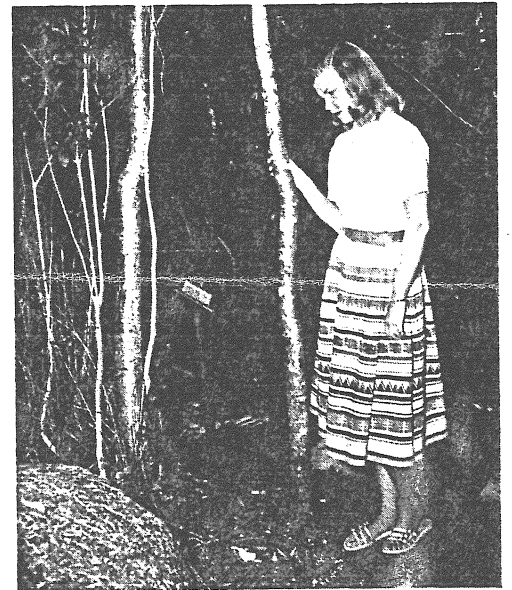
An attractive trailside label holder designed and built to resist weather damage and vandalism.

The steel pipe post, set 18 inches in the ground, is filled with concrete. A steel rod welded crosswise near the bottom end of the post will serve as a toggle and make unauthorized removal difficult.

May be fabricated in park mechanical shops, or purchased on the open market for less than \$10 in quantity lots.

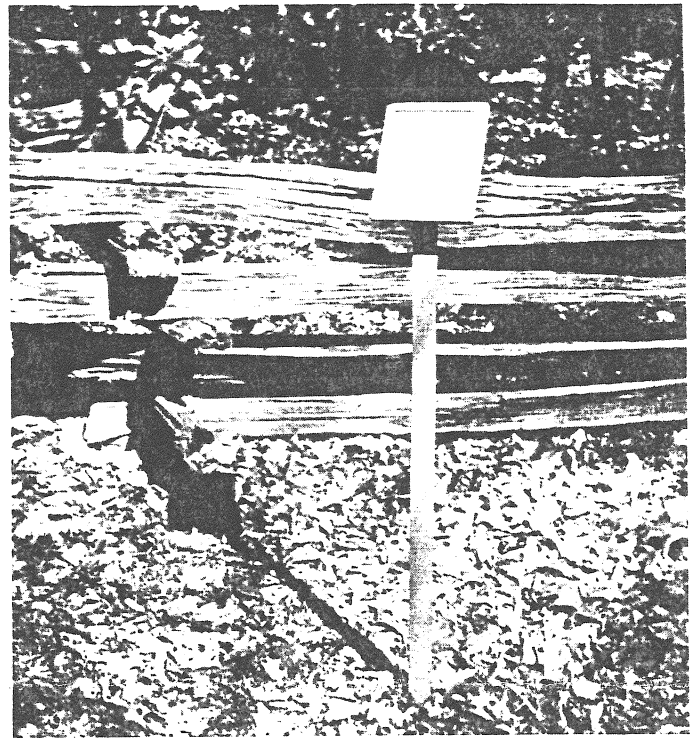
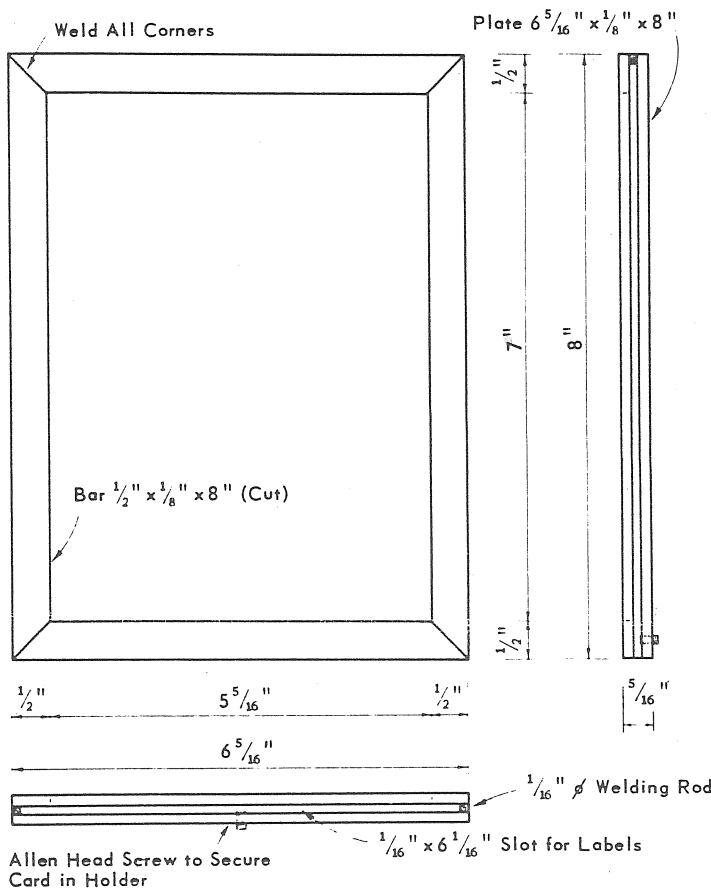
A simple, easily placed trailside marker which could be fabricated in most park shops.

Note anchor bar near the foot of the upright, placed to discourage unauthorized removal. Labels used in this holder are printed on cards and then laminated in plastic. All metal parts of this marker should be treated with rust preventive.
