# Phelps Brook Watershed and Walden Woods Pond

Windsor, Connecticut

Eastern Connecticut  
Environmental Review Team  
Report

**Environmental Review Team Report**

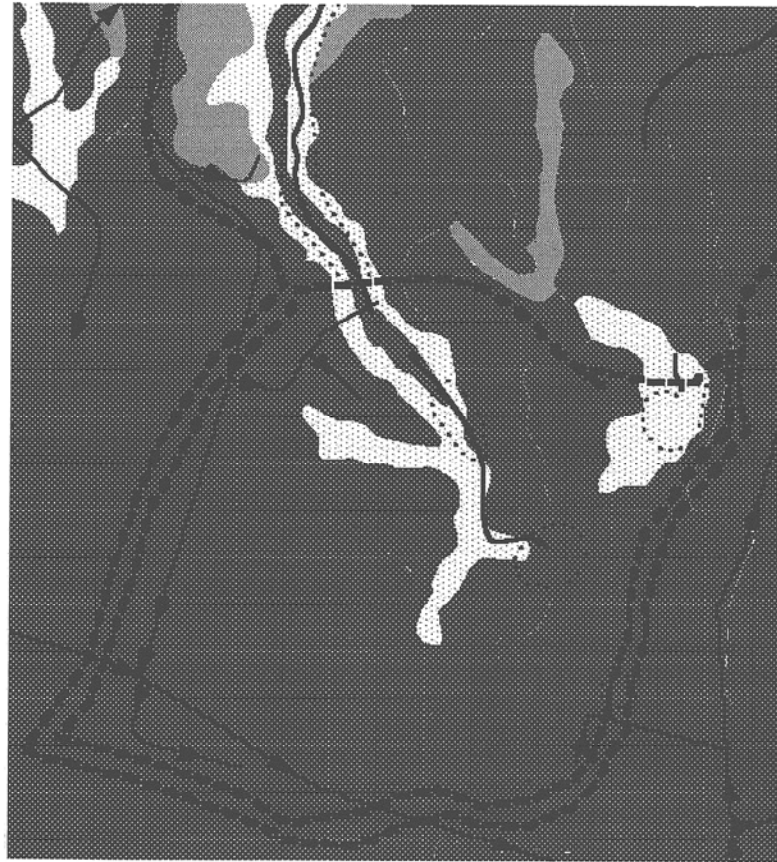
Figure 8

## Phelps Brook Study Area Slopes
