# **Aquarion Water Company Surplus Property Acquisition**

**Woodbury, Connecticut**

## **King's Mark Environmental Review Team Report**

**April 2013**

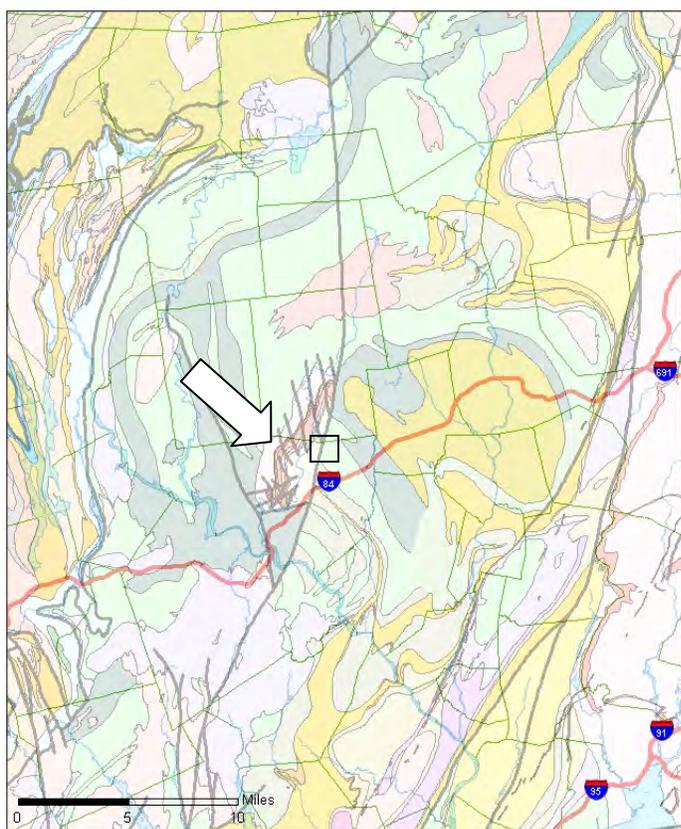
**Figure 1a. Generalized bedrock geologic map of western uplands showing Mesozoic Pomperaug Basin (arrow). Small box approximate location of Figure 1b. Western uplands shown as area of swirled color pattern in western 90% of map. Central lowlands shown in muted yellow and pink colors along eastern border of map. Pomperaug Basin shown in same muted yellow and pink colors. Lite-gray lines are faults, brittle fractures that are mostly Mesozoic age and younger. Map from Rodgers, 1985.**

Woodbury (and Southbury also) is part of the western uplands of Connecticut (Bell, 1985; Figure 1a), a Paleozoic metamorphic province, but upon which a sedimentary basin developed in Mesozoic time (Figure 1b). The eastern side of the sedimentary basin is fault

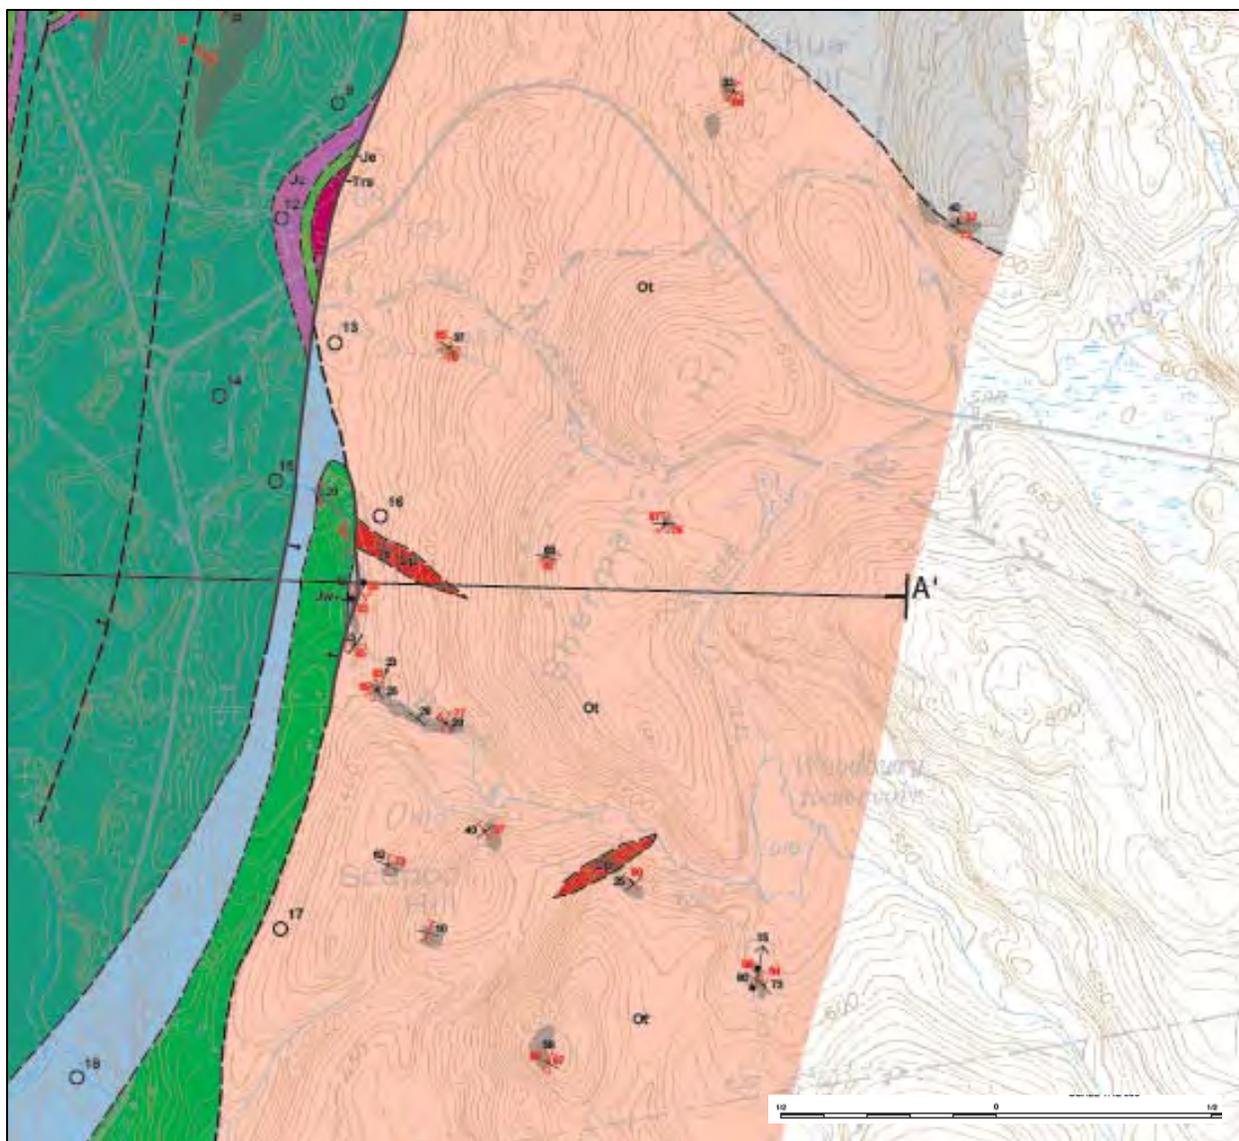
Figure 1b. Bedrock geologic map of the area on a topographic base (C.I.=10ft; scale: largest division = one mile). Woodbury Reservoir located just below the center of the map. Paleozoic metamorphic formations on the eastern  $\frac{3}{4}$  of the map area are separated from Mesozoic sedimentary and volcanic rocks by a major fault (faults are delineated by heavy dashed and solid lines running roughly north-northeast across map. Area shaded pale red and lite- gray (Ot, Taine Mountain Formation) are underlain by Paleozoic metamorphic rocks. Areas shaded red (Dp) are Paleozoic igneous rocks (pegmatite). Areas of various shades of green are different Mesozoic basalt flows and areas of blue, purple and dark read are different Mesozoic sedimentary formations. Map (from Burton, 2006), was constructed (in cooperation with the *Pomperaug River Watershed Coalition* ) at a scale of 1:12000.

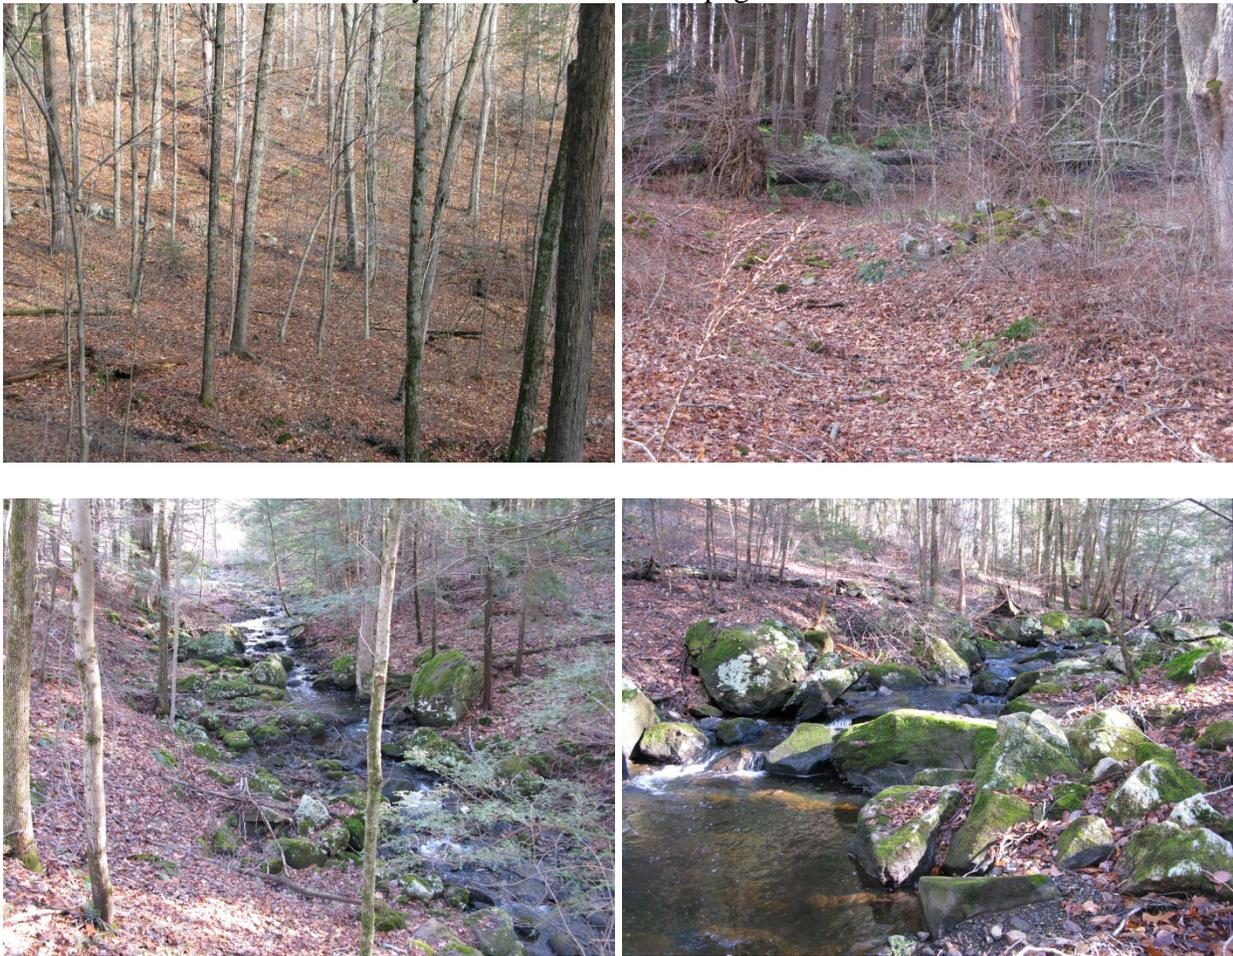
**Figure 2.** a. Moderate to gentle slopes in the middle part of the parcel. The impoundment is out of the picture to the right. South Brook can be seen running through the mid part of the picture. b. Steep to moderate slopes on the east side of southerly most spur of Sherman Mountain. Note outcrops of Taine Mountain Formation. c. Boulder strewn bed of South Brook immediately below Woodbury Reservoir dam. d. Steep slopes on sides of South Brook near the western boundary of the lower parcel.

The topography of the Aquarion and open space parcels is moderately rugged with hill slopes ranging from gentle to steep (Figure 2). The topographic map looks as though there should be some low cliffs locally, especially on the south and east sides of Sherman Hill; none however, were seen during the field observations. A perennial stream, South Brook, traverses the area roughly in a southwesterly direction to its confluence with the Pomperaug River just west of the parcels. The highest elevation on the southern parcel is about 680 feet (the northern parcel, however, reaches an elevation of about 750 feet); the lowest elevation, approximately 420 ft, is where South Brook leaves the parcels. The relief on the parcels is greater than 300 feet.

South Brook (Figure 2c, d) flows generally south and westward through the parcels. The brook's gradient averages roughly 100 ft./mile. It flows through a valley with gentle to moderate slopes at the northern part of the parcel. The valley opens up in the middle portion of the parcel where a small impoundment, Woodbury Reservoir, was been created for water supply. The southern part of the parcel is a rather deep, steep-sided valley. The steepest gradient of the stream is found in the southern part of the parcel where it is almost 400 ft./mi. The watershed area for South Brook, of course, extends well beyond the bounds of any of the parcels.

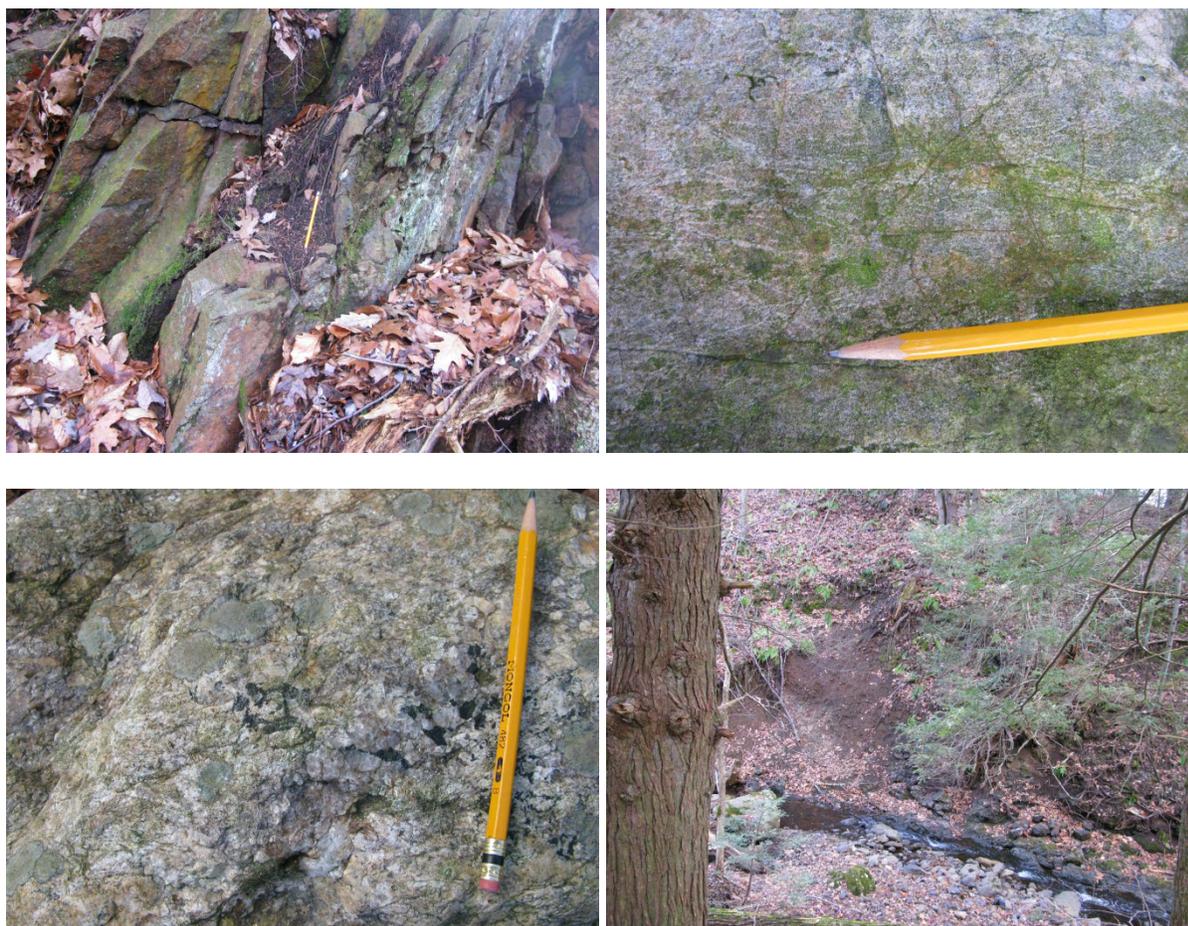
**Figure 3. Rocks exposed on parcels. a. and b. Taine Mountain Formation is composed of fine grained biotite gneiss and gray granofels. Rocks that contain enough biotite tend to weather rusty; more feldspar rich granofels is gray colored. a. Prominent fractures are high angle and dip (tilt) toward the east-northeast. Compositional layering (foliation) is subtle but may be seen on the shoulder protruding closest to the camera as a slightly lighter gray layer that dips northeast (into the picture/away from the observer) at a relatively low angle. b. Gray granofels with indistinct foliation. c. Intrusive, unfoliated pegmatite-body composed of coarse-grained feldspar and quartz. d. Bedrock outcrops at bottom of stream are rubby basalt, probably basalt breccia formed at the top of a lava flow. The outcrops were not examined. Outcrop located near west end of trail (near the trail head on Middle Quarter Road. It was identified as the South Brook Basalt by Burton, 2006 (Figure 1b).**

*Mesozoic rocks.* Plate tectonic processes reversed themselves about 225 m.y. ago and the huge continent began to stretch and break up. This stretching caused the Earth's crust to sag in numerous places along what is now the eastern Seaboard, but notably in the Hartford-Springfield-New Haven area and the Pomperaug Valley. The sags produced low topographic areas that allowed the accumulation of sediments (gravel, sand and mud) deposited by streams and in lakes. In addition, when the stretching became sufficiently great, deep fractures developed which eventually reached the mantle. Basaltic magma (molten rock) generated in the mantle then oozed up the fractures and formed several lava flows (Figure 3d) that also filled the depressions (sags).

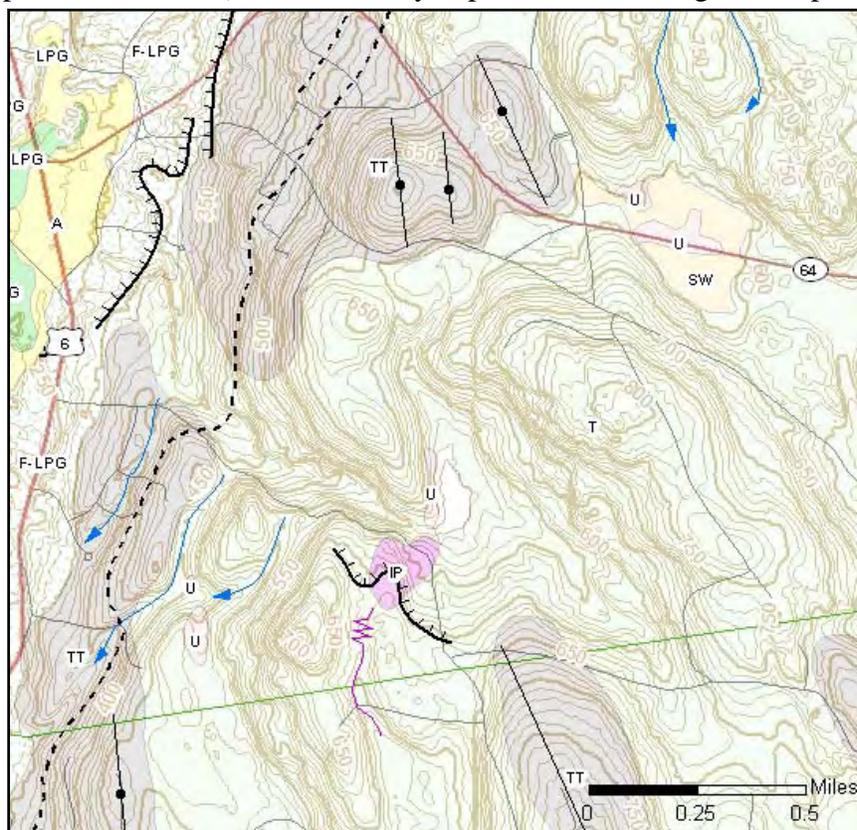
**Figure 4. Map of area showing Quaternary deposits. Glacial till (pale green area) covers most of surface. Some areas of thick till (gray area) are oblong hills referred to as drumlins. Long black line drawn through some drumlins indicates the inferred direction of ice flow. Areas on map colored yellow, green or pink are sand and gravel deposits formed by modern streams (yellow) or glacial melt-water streams (green and pink). Blue lines with arrow are identified melt-water channels from the last ice age.**

flows (compact or basal till). The rest of the debris is left behind when the ice melts at the end of the ice age (referred to as melt-out till or ablation till). Glacial till covers more than 95% of the ground surface on the parcels (Figure 4): rock exposures are rare.

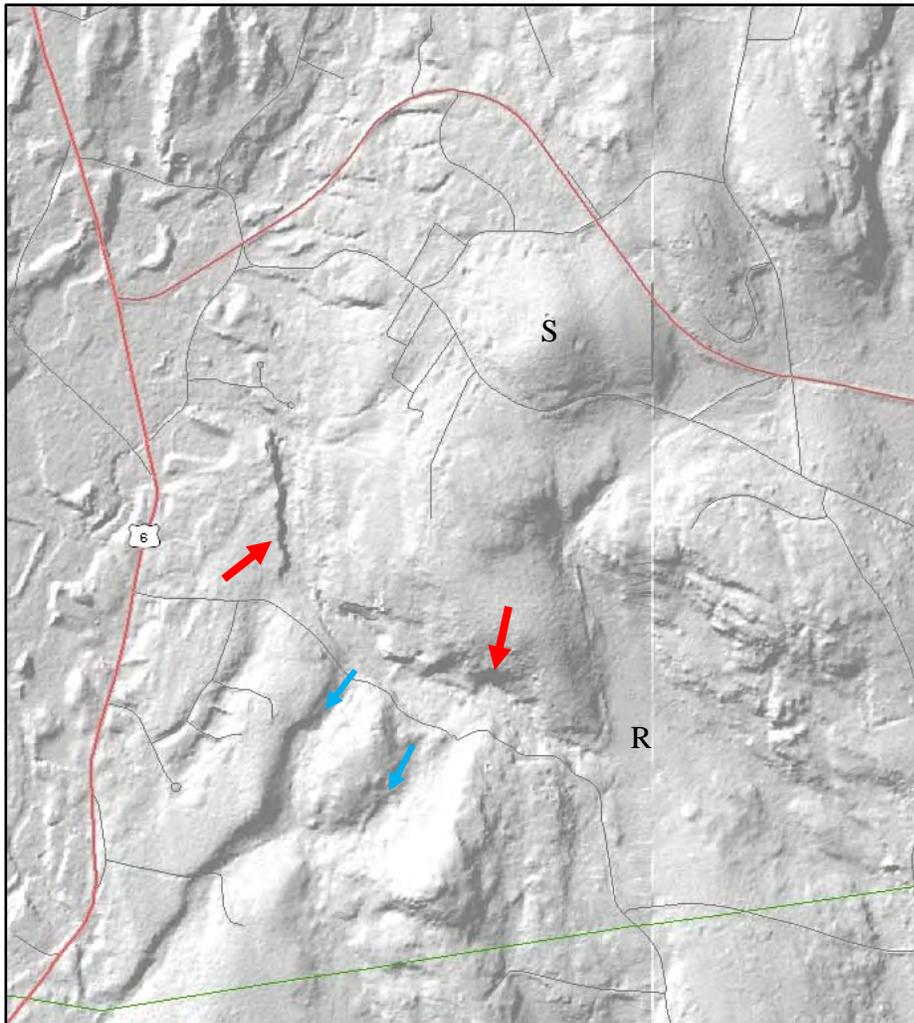
**Figure 5. Hill-shaded relief map showing valley of South Brook. (red arrows). Over-steepened slopes, indicated by shadows on valley sides, and erosion scars (red arrows) attest to former significant river flow in South Brook. Blue arrows show melt-water channels cut during end of last ice age (compare with Figure 4). Note smooth hills just north of South Brook (Sherman Hills, marked “S” on the map). These are mapped as drumlins. The two eastern most are slightly elongate in a south-southeasterly direction, the inferred direction of local ice movement. “R” is Woodbury Reservoir.**

South Brook flows through a channel formed by melt-water from an ice age that occurred before the last ice age. Its oversteepened slopes and erosion scars (Figure 5) below the reservoir attest to past undercutting by a river. The valley bottom, however, is filled with glacial till. The till must have been deposited after the valley erosion (that is the evidence for the valley erosion being older than the last ice age). In addition, Mesozoic basalt and sandstone glacial erratics appear to be concentrated (compared to the abundance on the surrounding valley sides) in the lower reach of South Brook (Figure 2c, d). The erratics presumably were on top of the

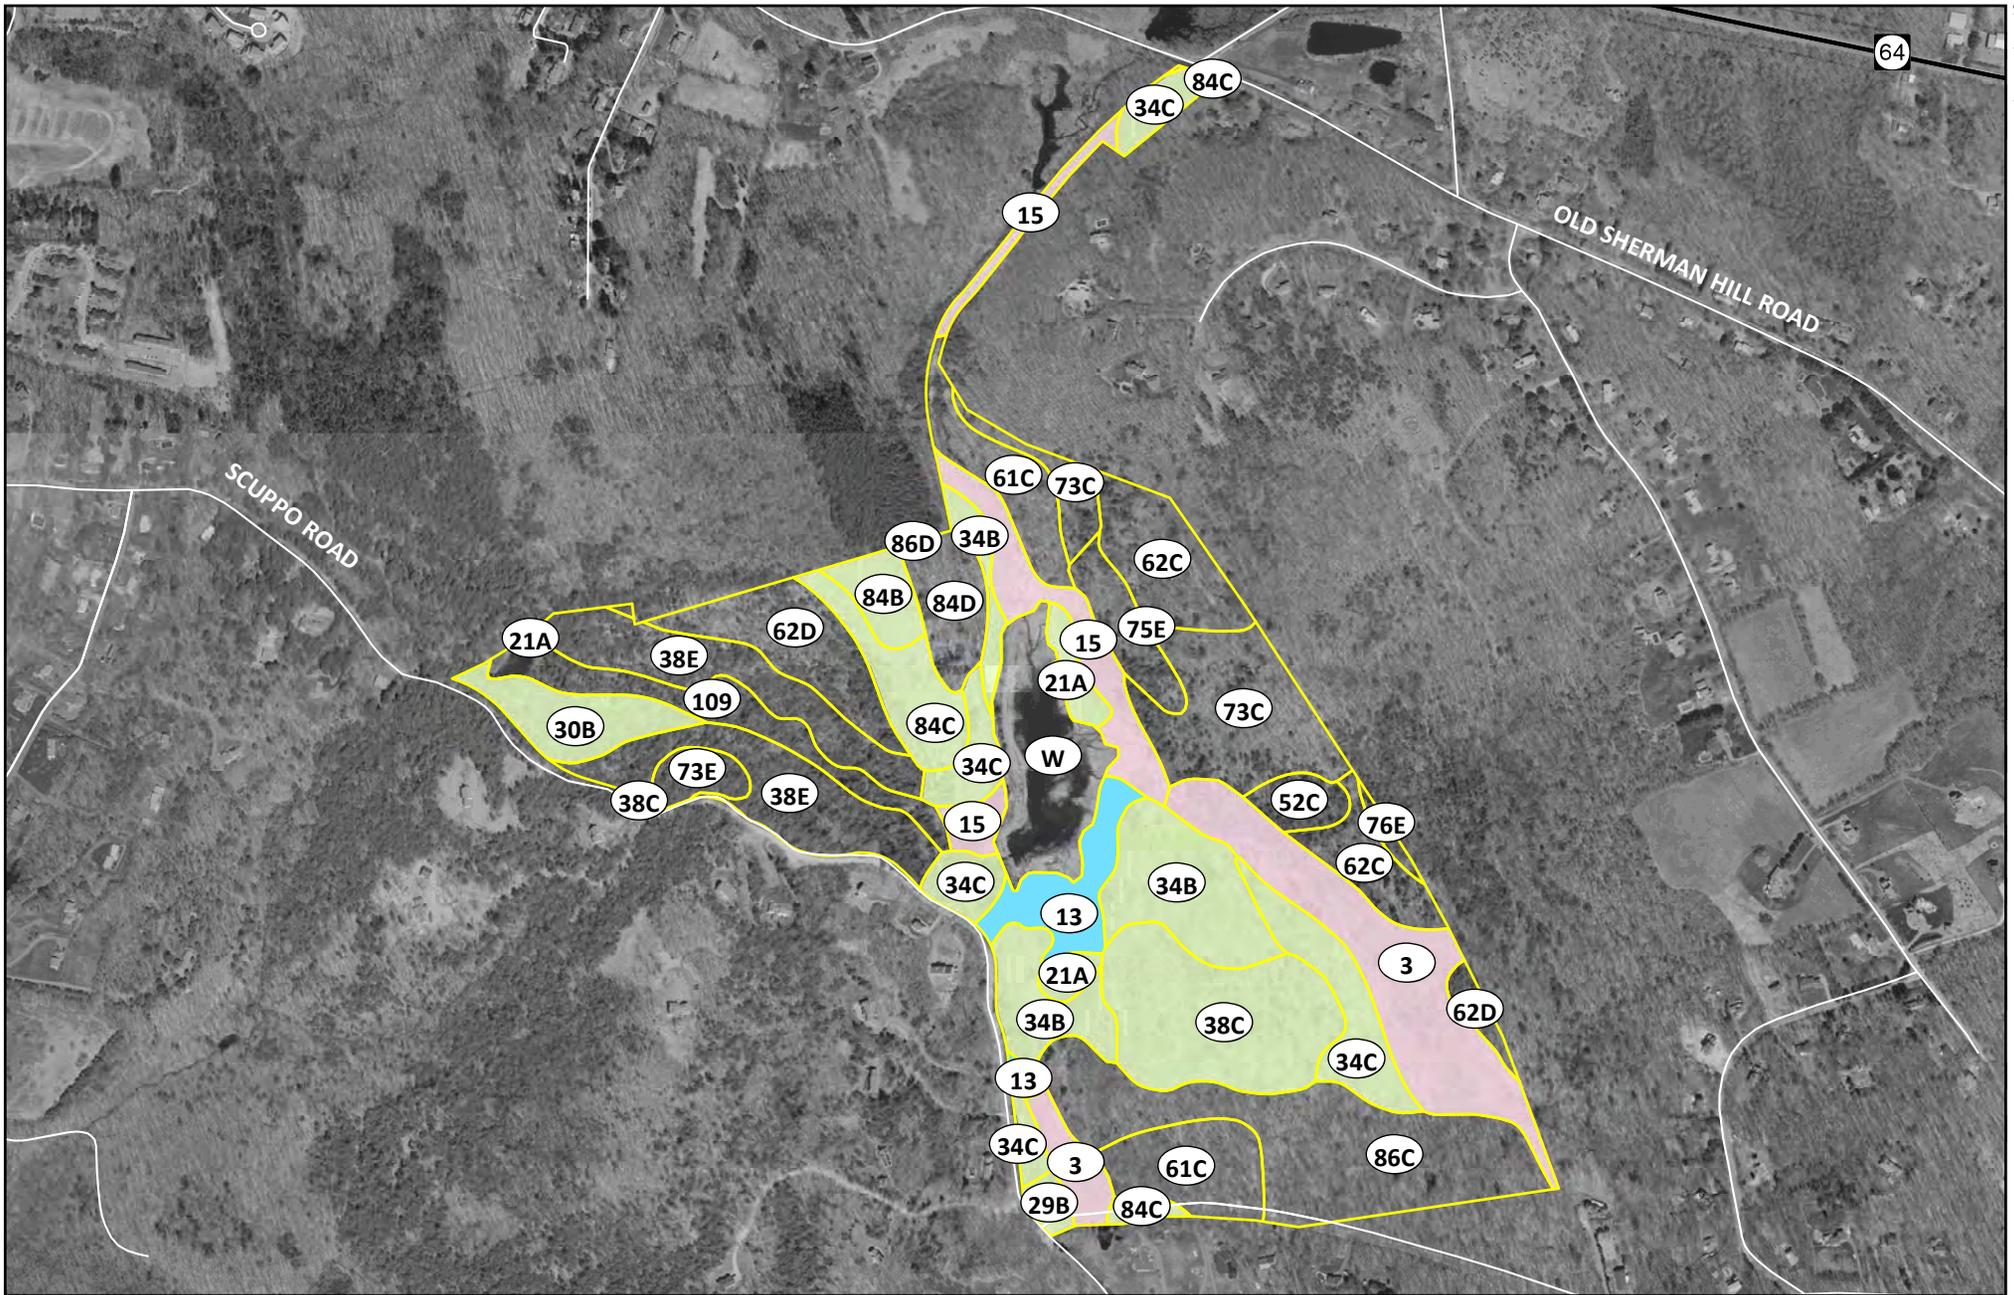
**Aquarion Water Company Surplus Property Acquisition  
Southern Parcel  
SOIL UNITS**

farmland soil
	wetland soil
	both farmland & wetland soil

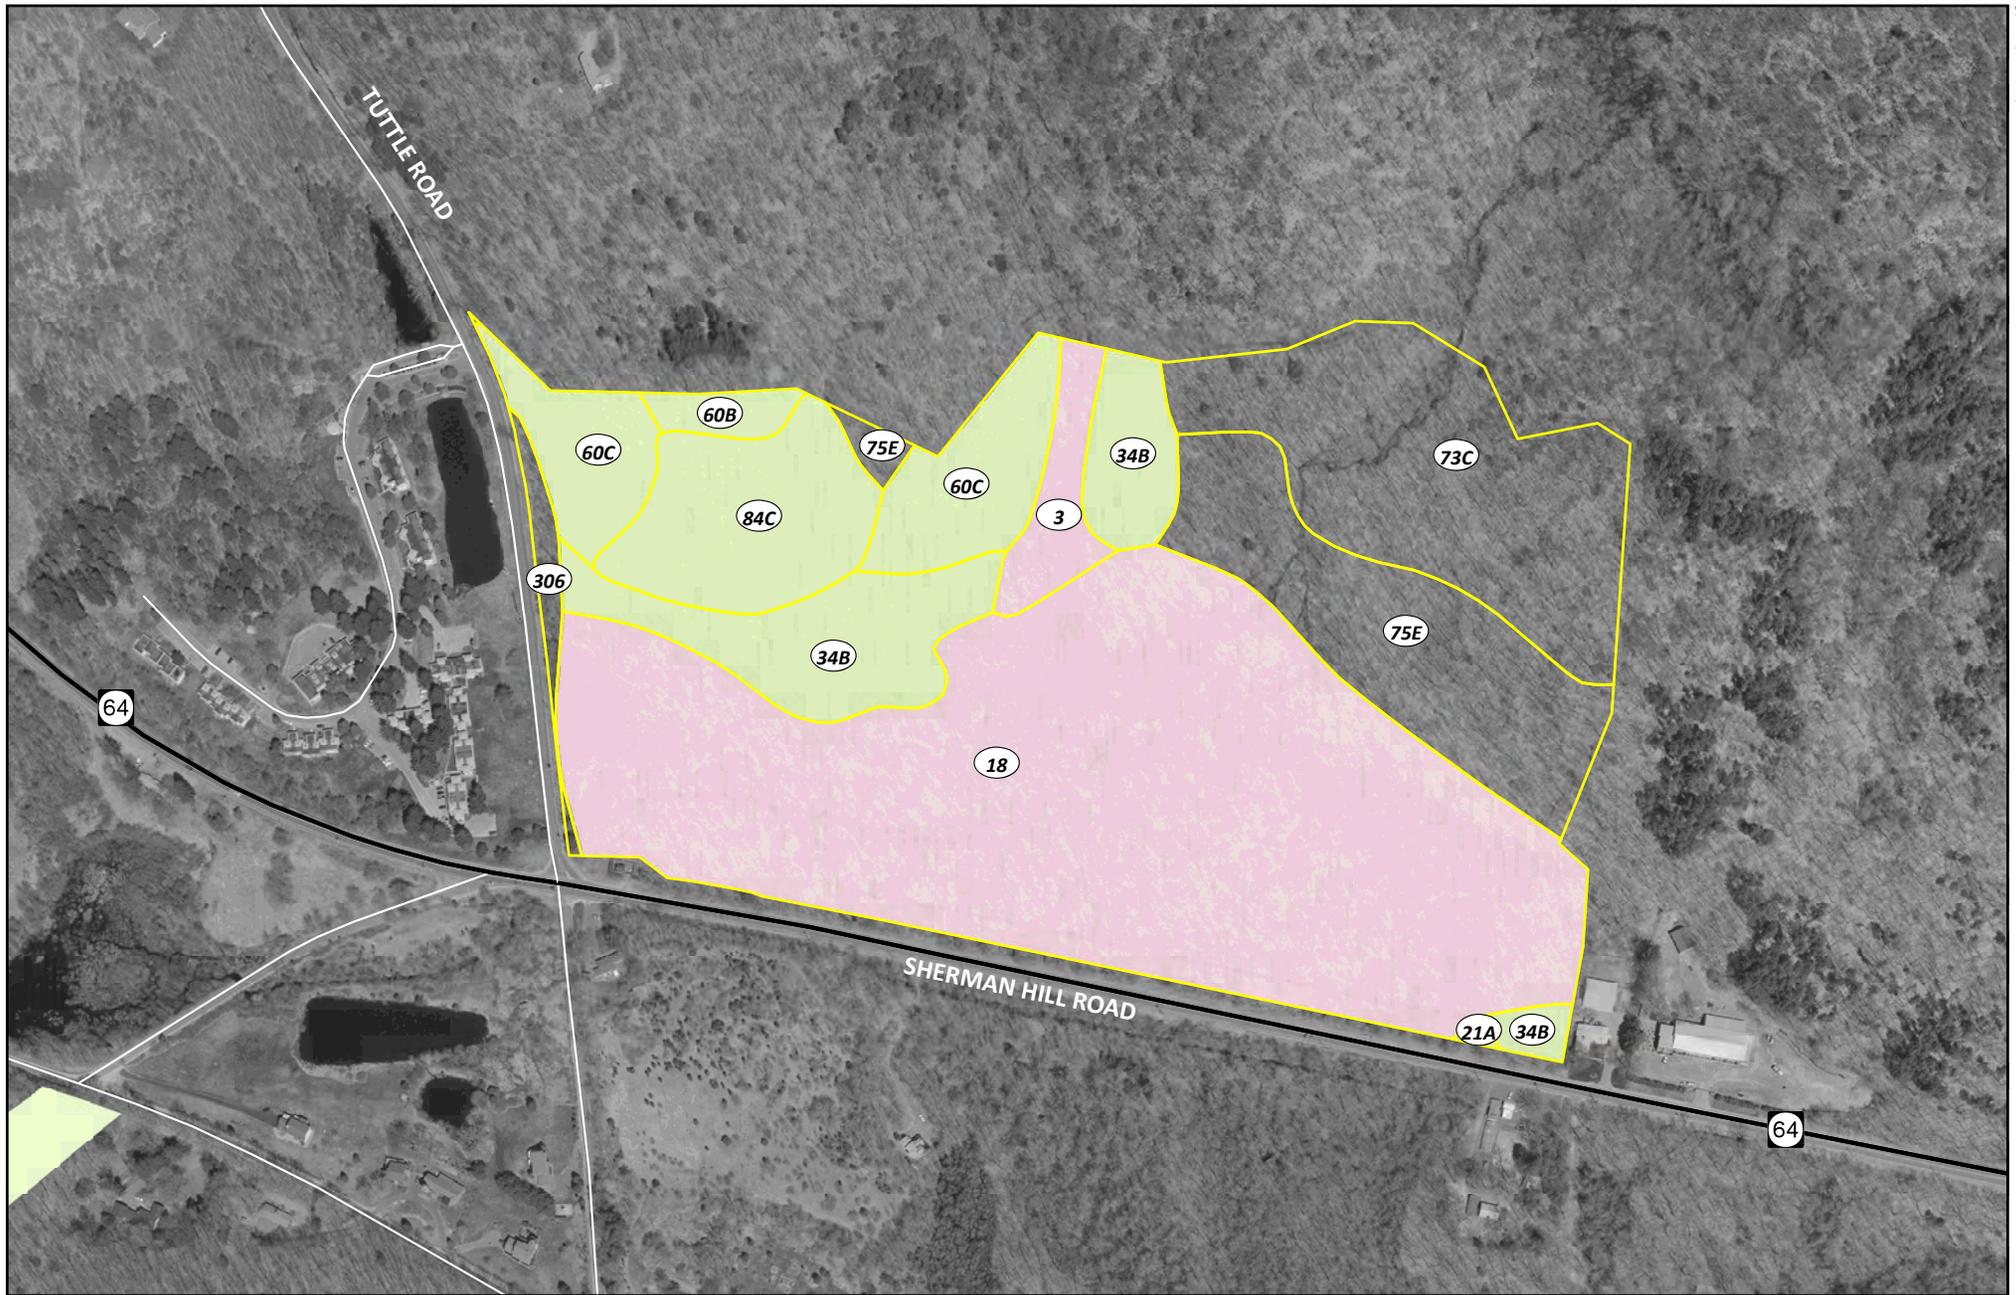
**Aquarion Water Company Surplus Property Acquisition  
Northern Parcel  
SOIL UNITS**

- CT farmland soils
- CT wetland soils

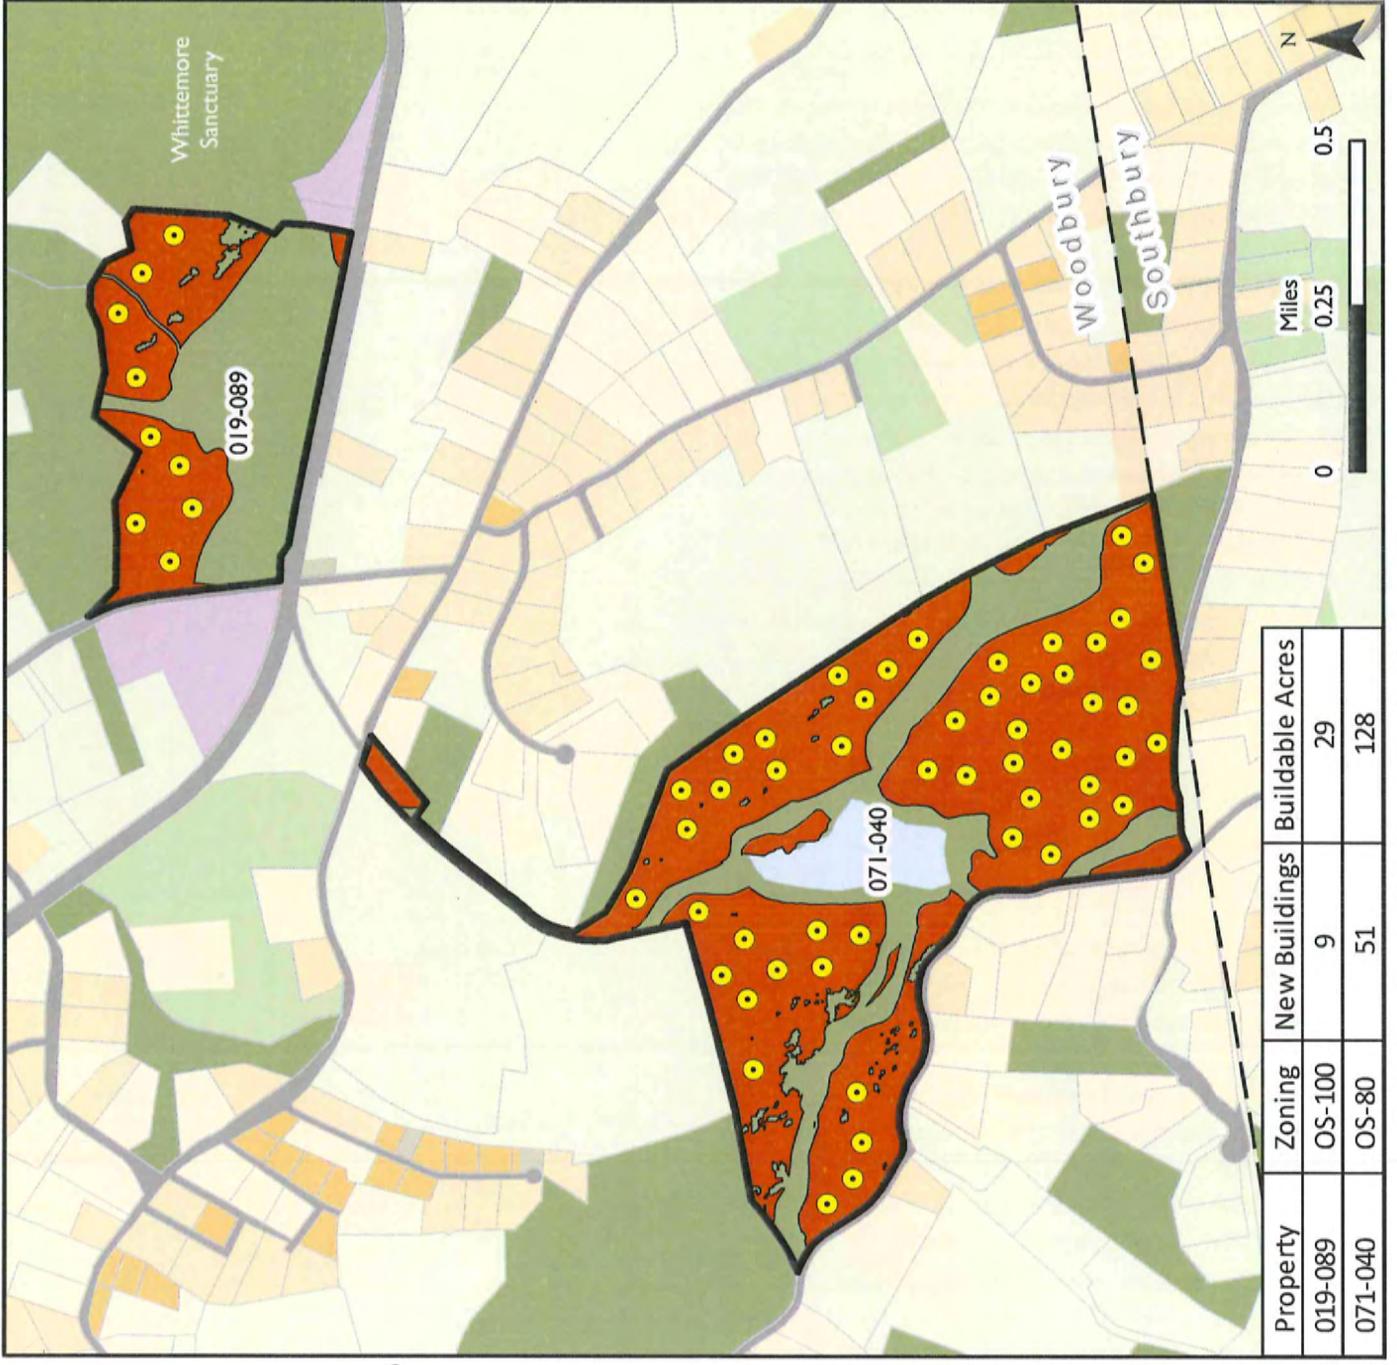
Figure 1. Build-Out Analysis

Source: Existing Land Use, Developable Land - COGCNV; Build-out Buildings from Community VIZ analysis

- New Buildings
- Developable Land
- Existing Land Use**
- Agriculture
- Commercial
- Urban Medium
- Residential 3 (1 to 2 Dwelling Units per Acre)
- Residential 4 (0.5 to 1 Dwelling Units per Acre)
- Residential 5 (Less than 0.5 Dwelling Units per Acre)
- Recreational or Open Space
- Right Of Way
- Undeveloped Land
- Water
- Aquarion Properties
- Town Boundary
- Parcels

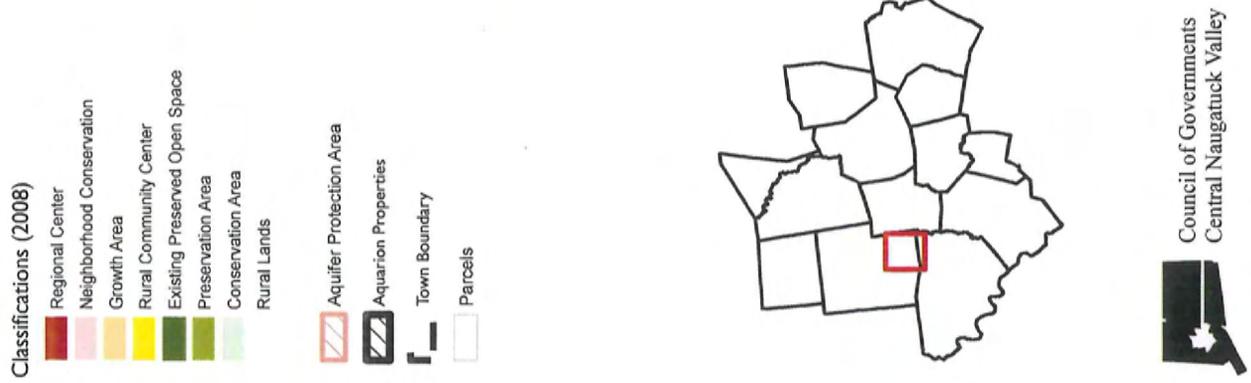
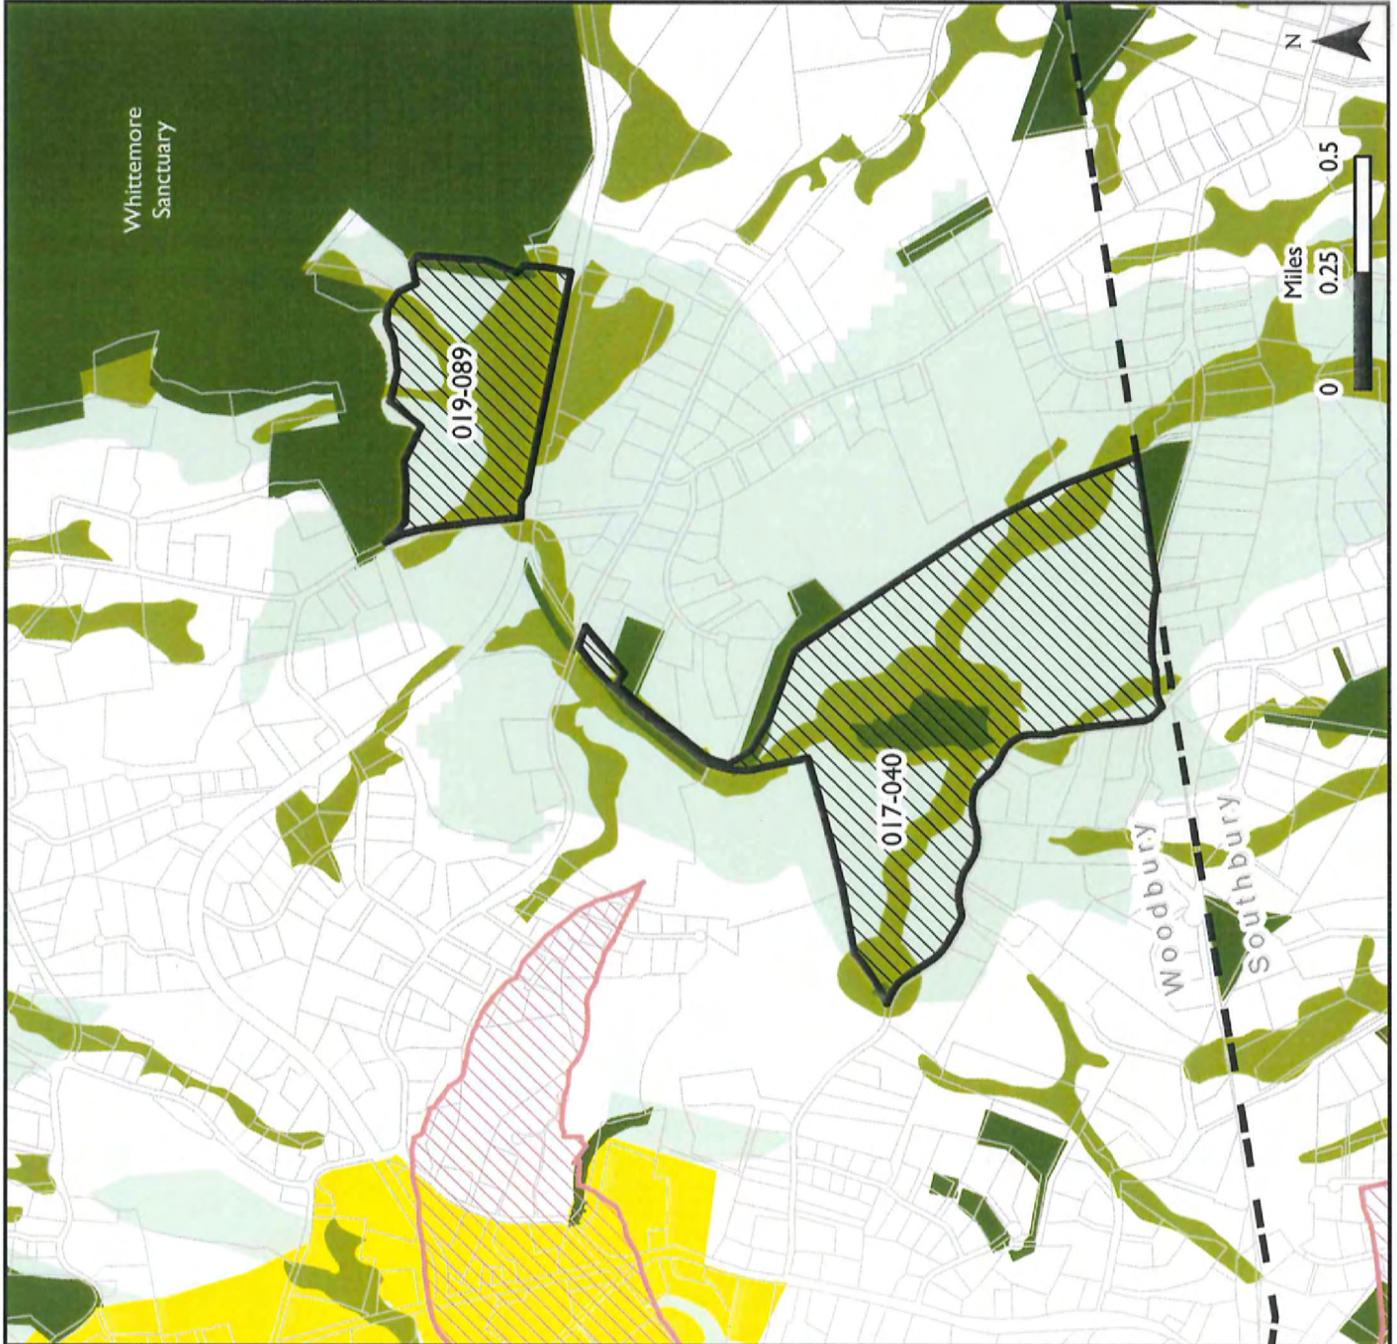
Figure 2. 2008 State POCD Guide Map

Source: Classifications - Office of Policy and Management; Parcels - COGCNV; Aquifer Protection Area - CT DEEP

The *State Plan of Conservation and Development (POCD): 2005-2010* guide map (Figure 2) identifies the land in both properties as either “Conservation Areas” (57%), “Preservation Areas” (37%), or “Open Space” (6%). Conservation of natural resources and limited development are recommended in these areas. However, in the draft *State Plan of Conservation and Development: 2013-2018* guide map (Figure 3) only 46% of the land is considered “Priority Conservation Areas.” The remaining 54% is classified as “Balanced Growth Areas,” land that meets the criteria of both development and conservation areas. One of the drawbacks of the draft plan is that it uses census blocks to calculate “Priority Development Areas.” Census blocks are larger in rural areas which over-generalize development factors that may or may not be relevant. Because of this, the draft state plan classifies much of the Woodbury Reservoir property with neighboring residential developments, resulting in a “Balanced Growth” designation. COGCNV's *Regional Plan: 2008* and Woodbury's *POCD: 2009* classify the properties as existing open space. The discrepancies between these plans can be explained by their handling of

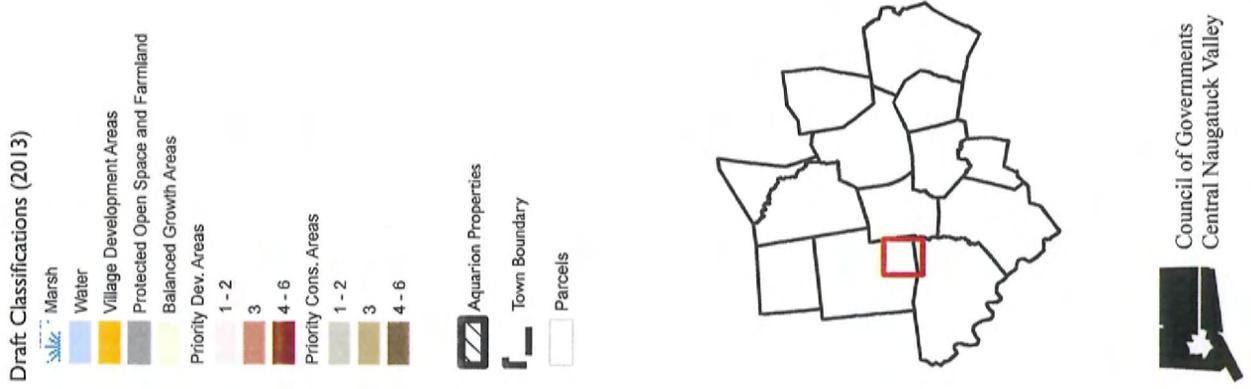
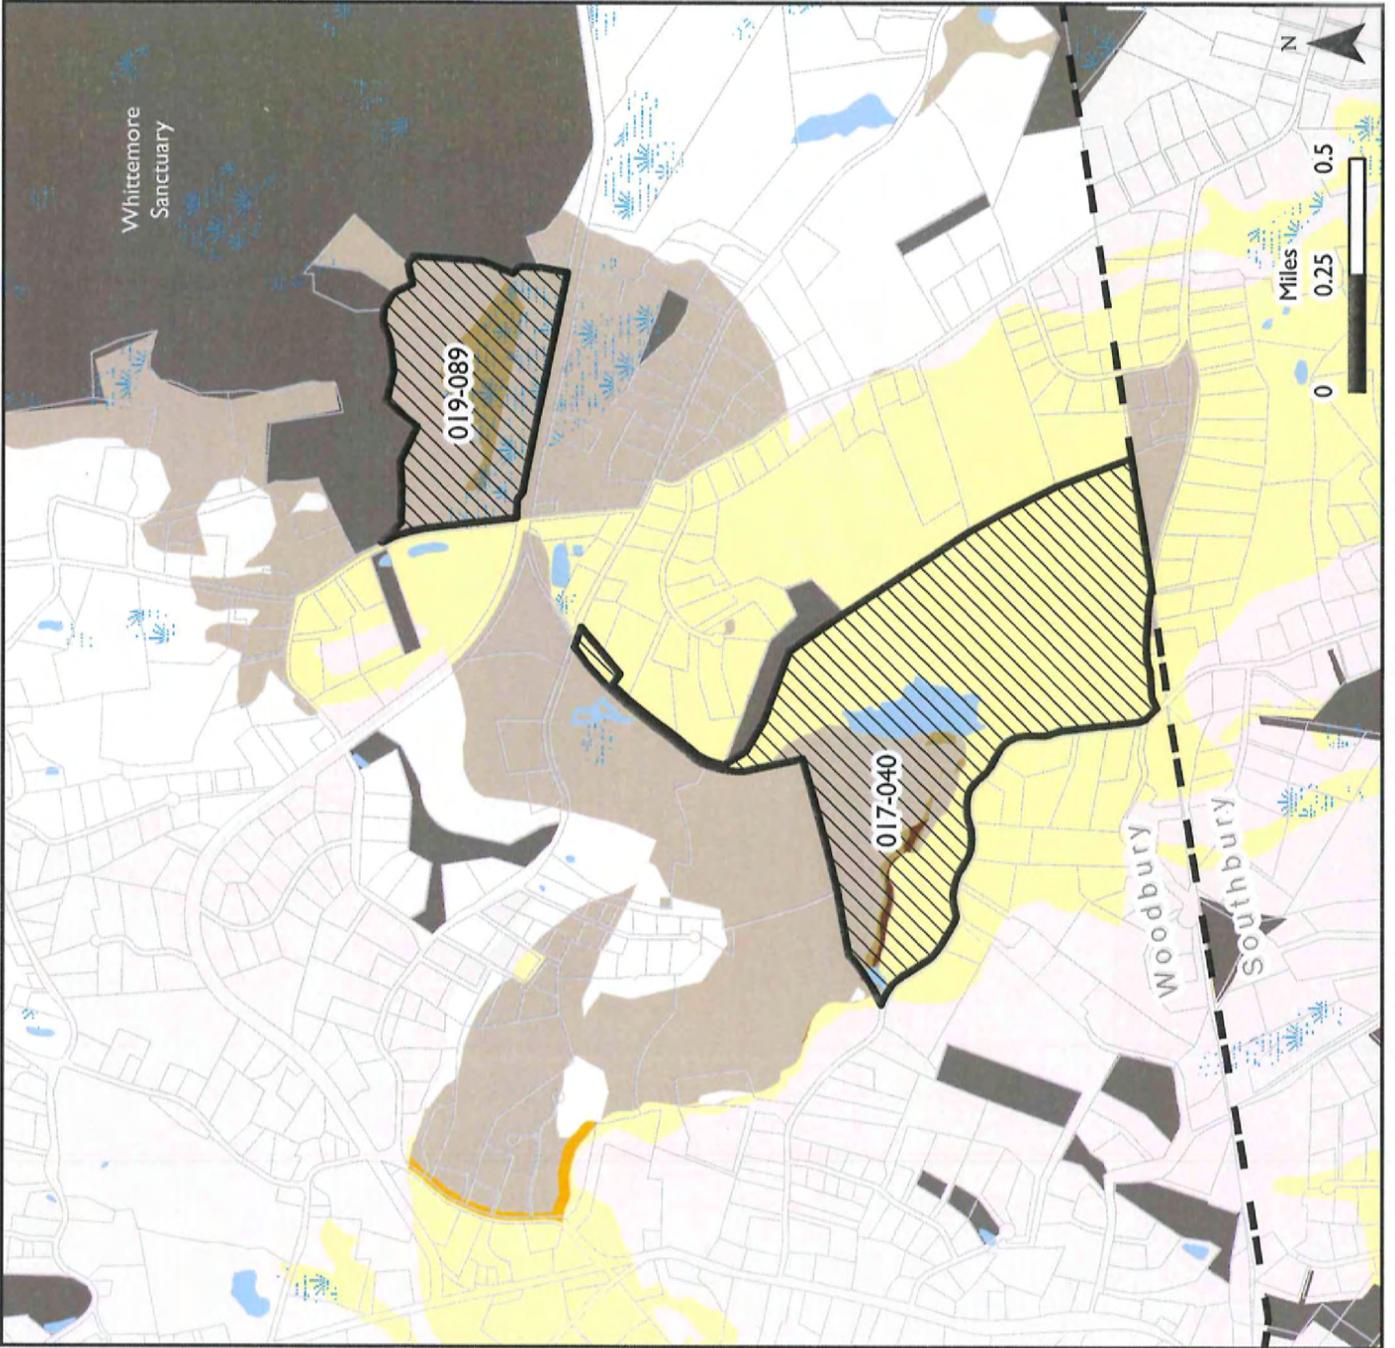
Figure 3. 2013 Draft POCD Guide Map

Source: Classifications - Office of Policy and Management; Parcels - COGCNV; Aquifer Protection Area - CT DEEP

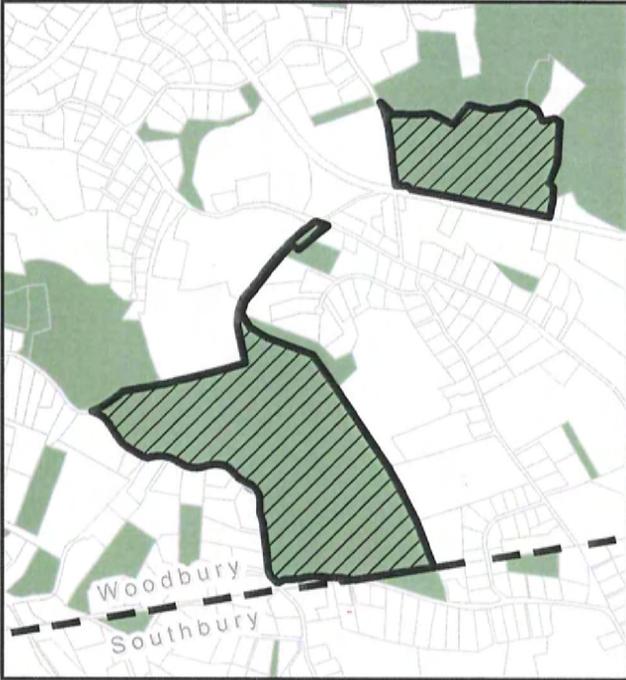
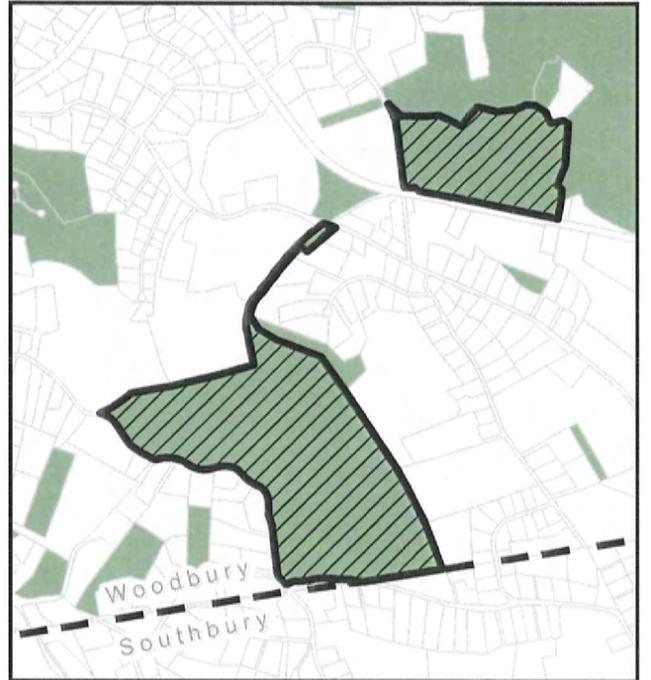
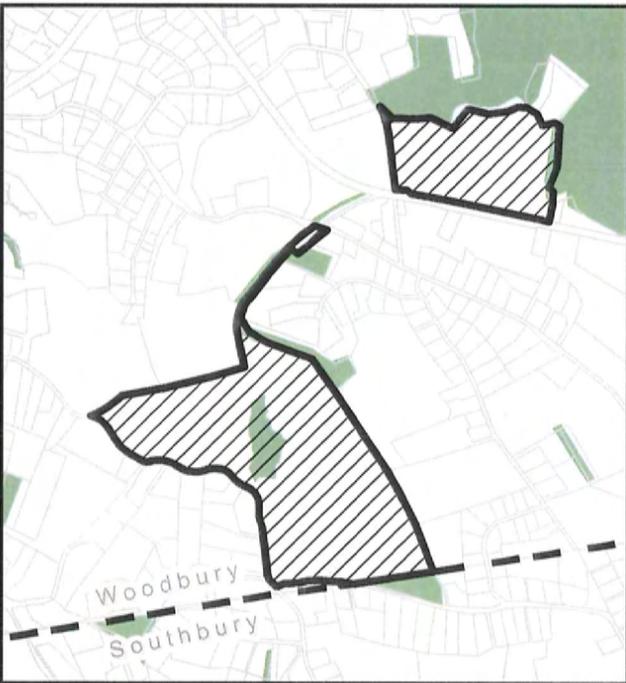
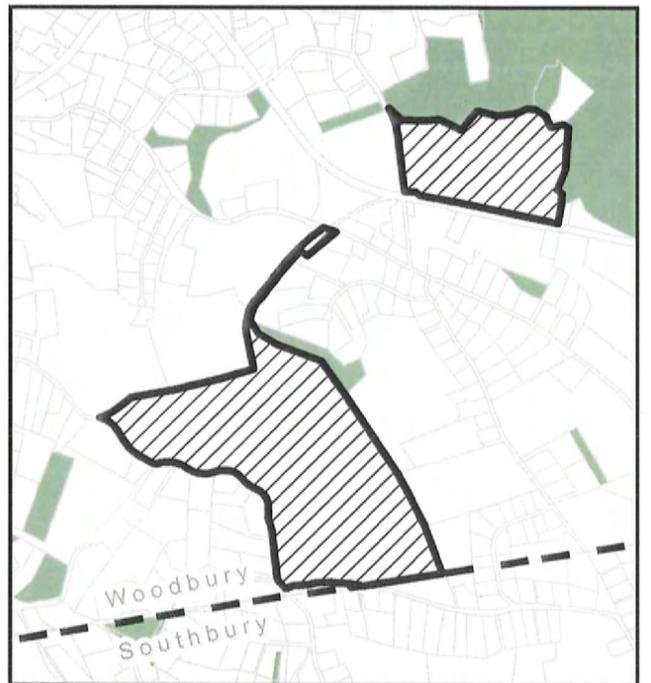
Figure 4. Local, State, and Regional Plans of Conservation and Development:  
Protected Open Space \*

COGCNV Regional Plan: 2008

Town of Woodbury POCD: 2009

State POCD: 2005-2010

Draft State POCD: 2013

Class I and Class II water supply lands, which are classified as open space in the regional and local plans, but not in the state plans (Figure 4). COGCNV finds the acquisition of these properties to be in compliance with its *Regional Plan*.
