# **Aquarion Water Company Surplus Property Acquisition**

**Woodbury, Connecticut**

## **King's Mark Environmental Review Team Report**

**April 2013**

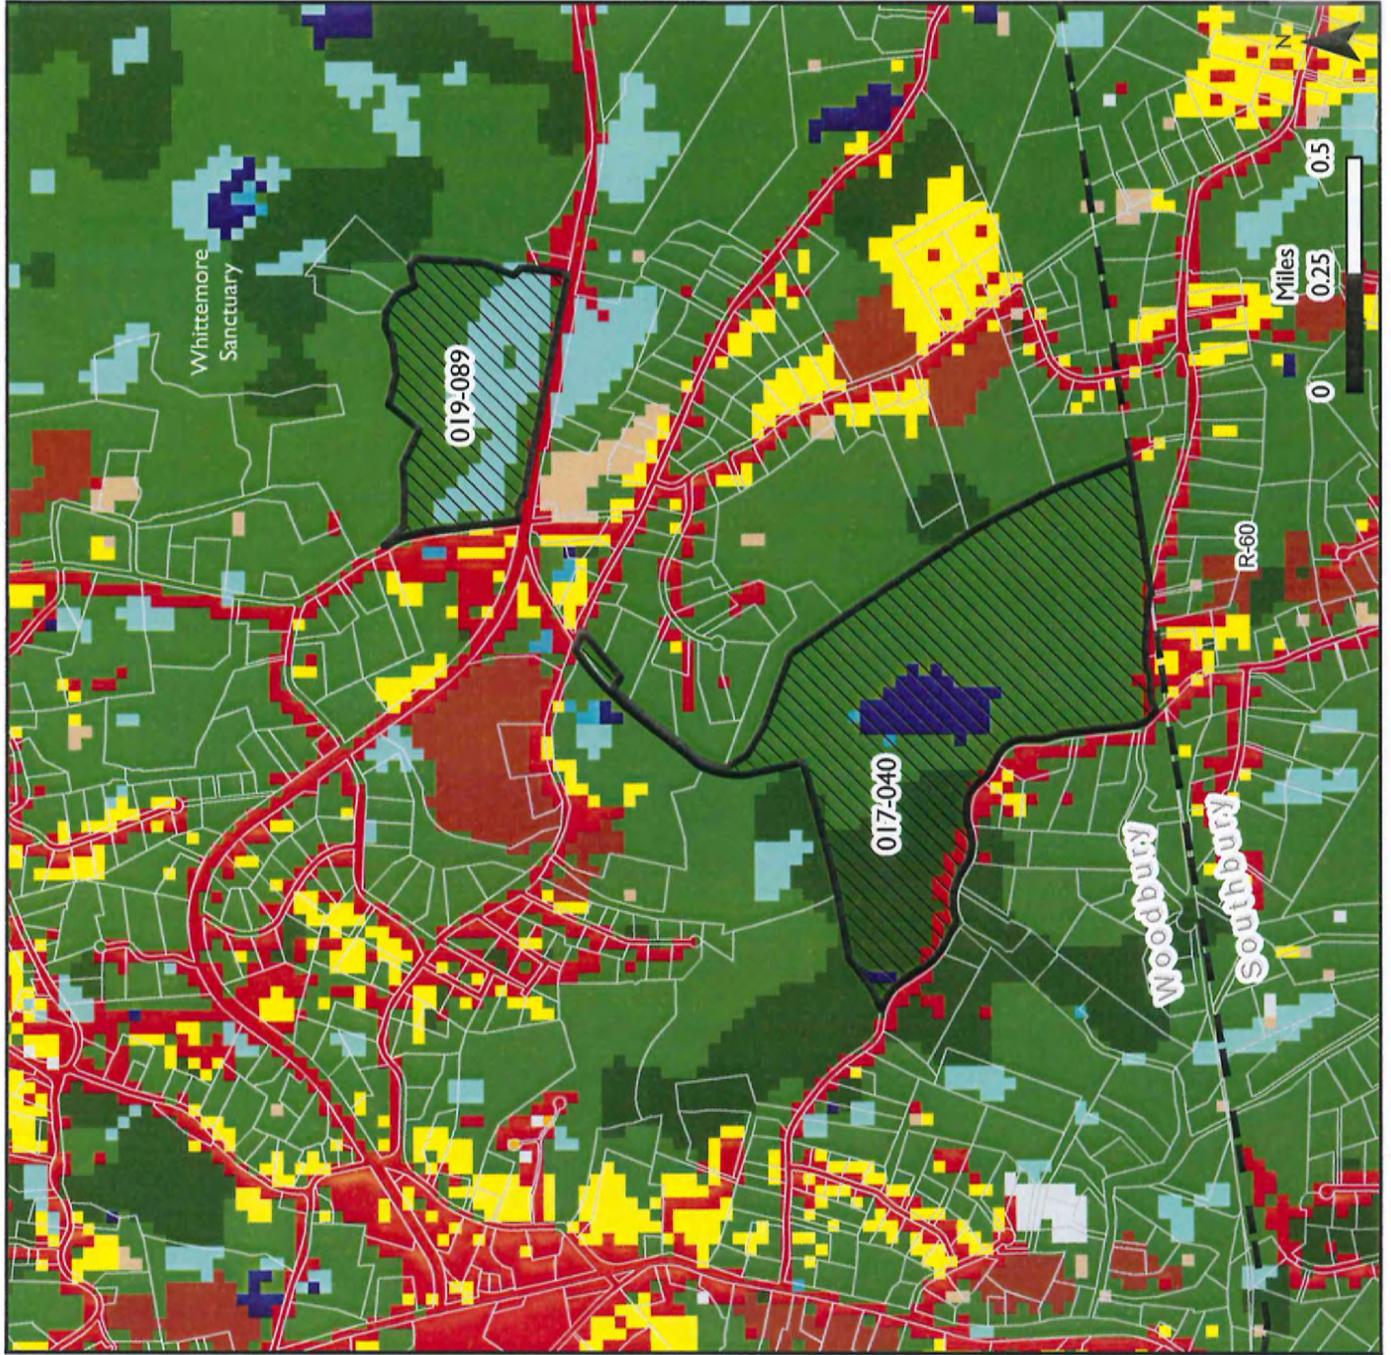
Figure 5. Land Cover: 2006

Source: Land Use Category Data - UConn Center for Land Use Education and Research (CLEAR), 2006 Land Cover dataset

- Land Use Category
- Agriculture
- Barren Land
- Coniferous Forest
- Deciduous Forest
- Developed
- Forested Wetland
- Non-forested Wetland
- Other Grasses
- Tidal Wetland
- Turf & Grass
- Utility ROWs
- Water
- Aquation Properties
- Town Boundary
- Parcels

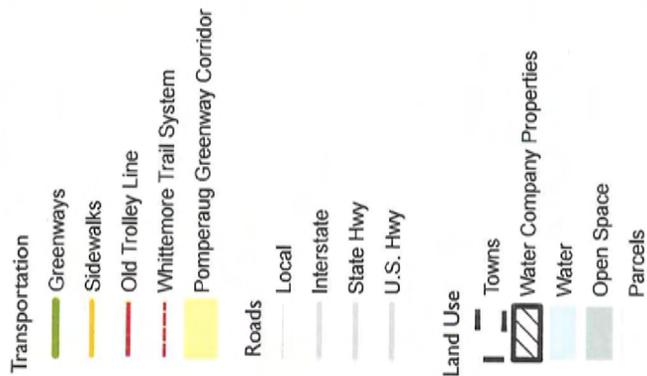
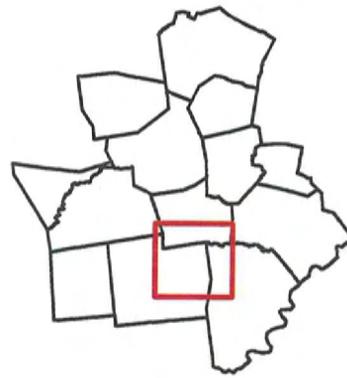
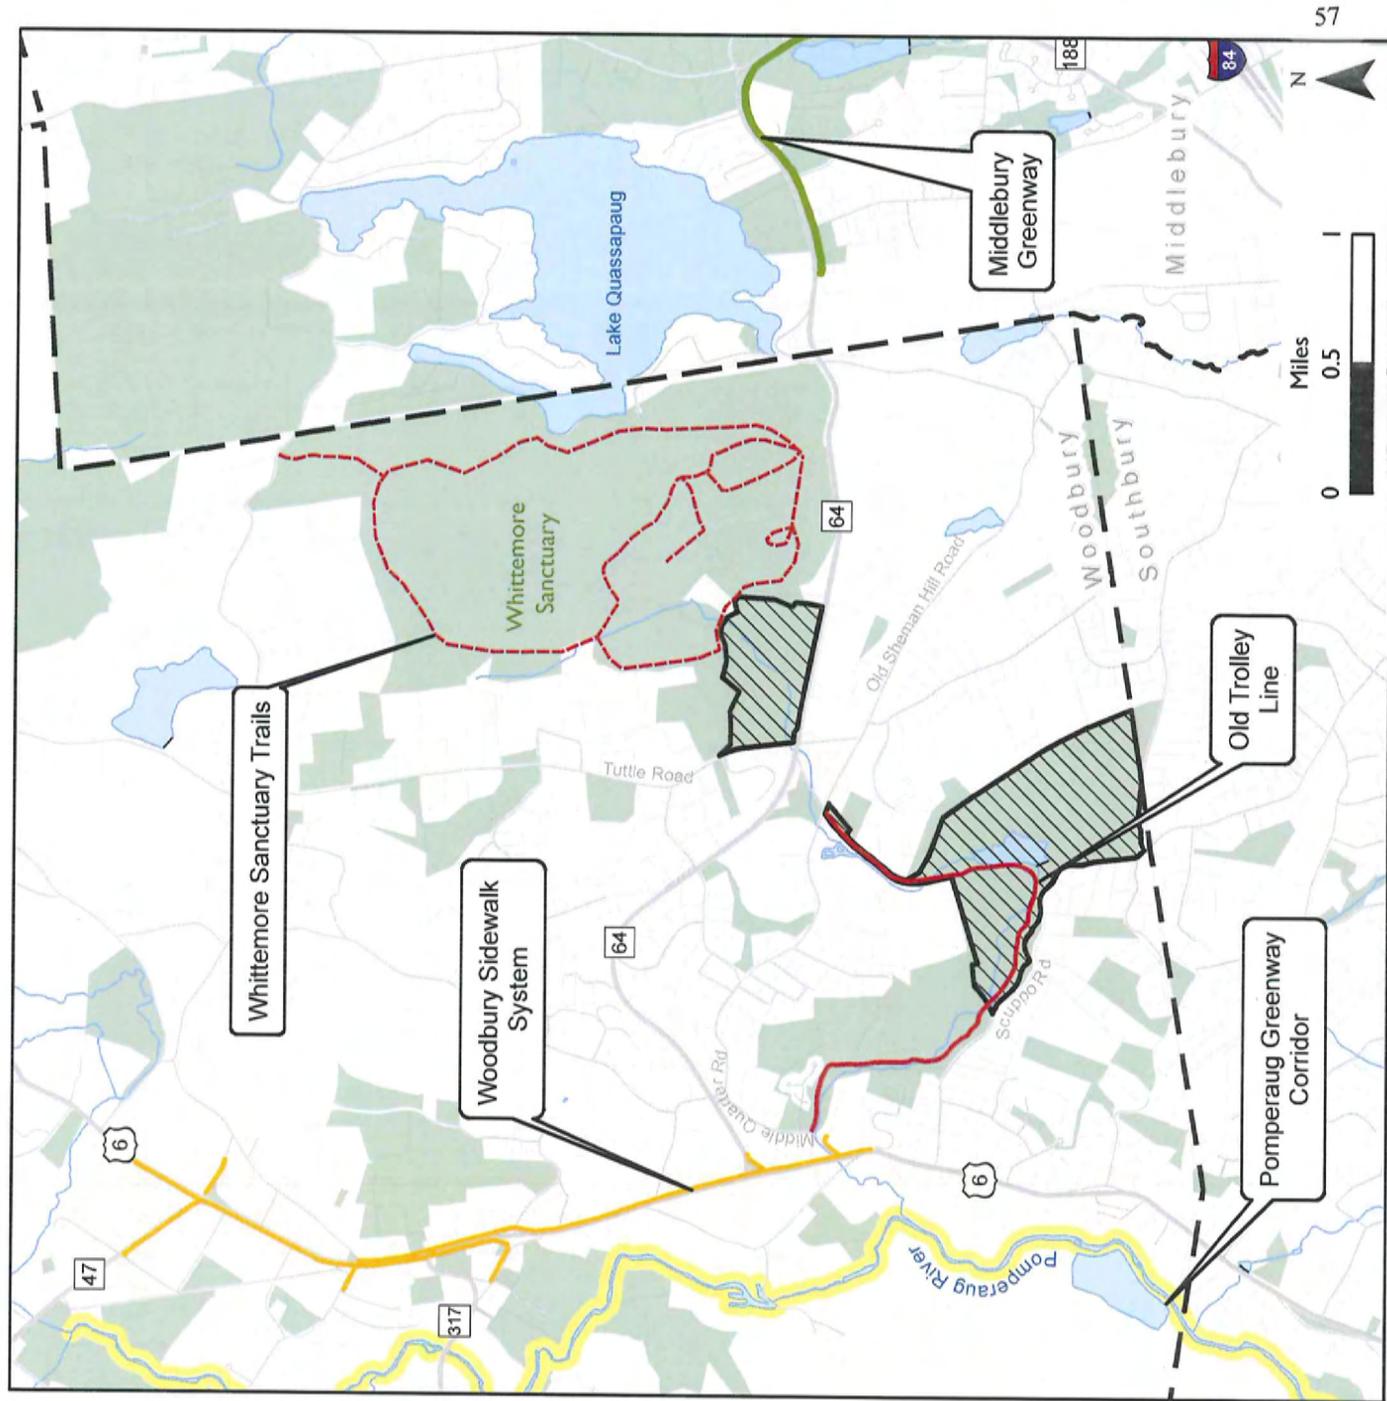
Figure 6. Area Trails, Greenways, and Sidewalks

Source: Town of Woodbury - Parcels; Town of Southbury - Parcels; COGCNV - Open Space, Transportation; CT DEEP - Roads, Water

Connections between the Woodbury Reservoir property and the Main Street sidewalks would be via the old trolley bed, which continues through three nearby parcels before ending at Middle Quarter Road. Two of these parcels are town owned (086-001 and 086-001C), while the third is privately owned (102-048). The two town parcels are part of the town's existing open space and the privately owned parcel (Southbrook development) has conservation restrictions. Route 6 between Middle Quarter Road and Route 64, near the end of the trolley bed, was listed as a high hazard location for pedestrians in COGCNV's 2009 *Pedestrian and Bicycle Safety in the CNVR* report. Pedestrians and bicyclists are likely to use this stretch of roadway to access the trolley bed trail. The location saw an ADT of 13,100 vehicles per day in 2011. Sidewalks only exist on the east side of Route 6 and numerous commercial driveways — none of which have crosswalks — interrupt the sidewalk system. A map showing the trail, sidewalk, and greenway system in the study area can be seen in Figure 6.

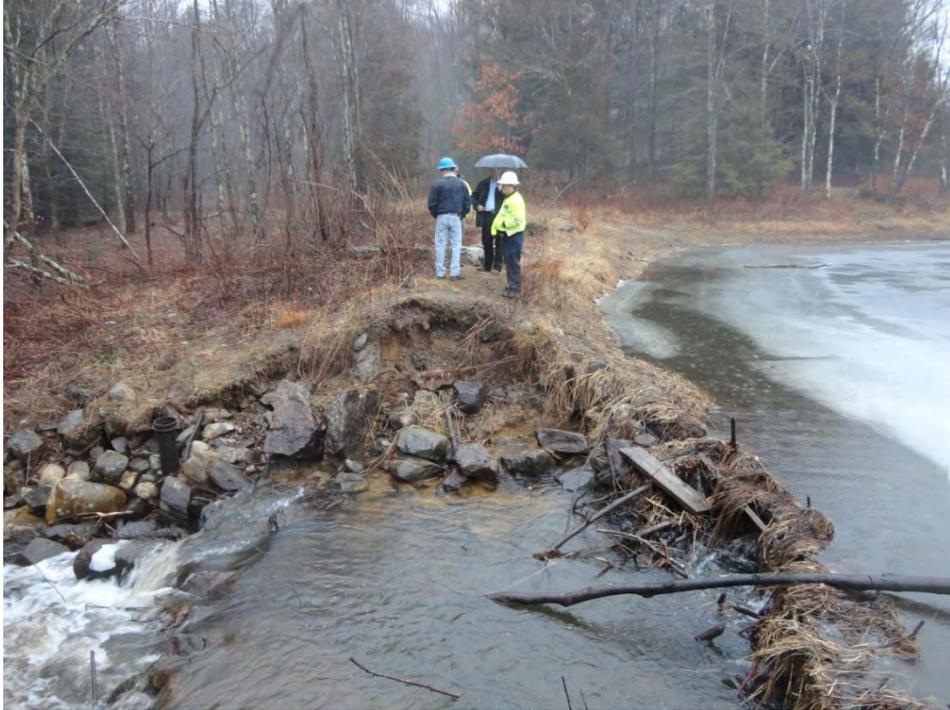
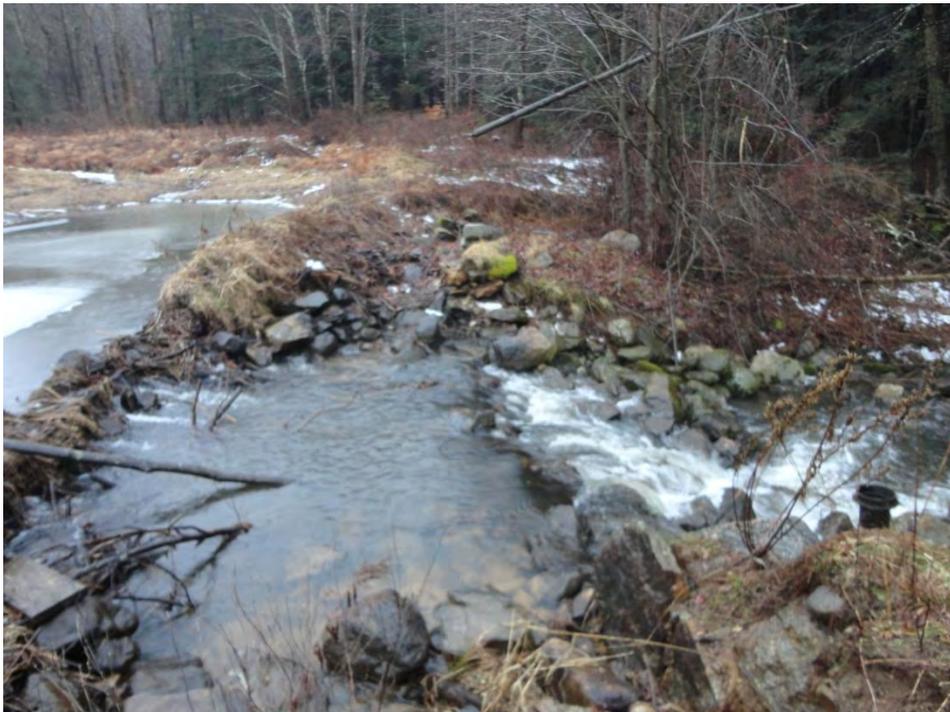
UNITED WATER CONNECTICUT  
WOODBURY RESERVOIR DAM  
WOODBURY, CT

PLAN  
SCALE: 1" = 20'

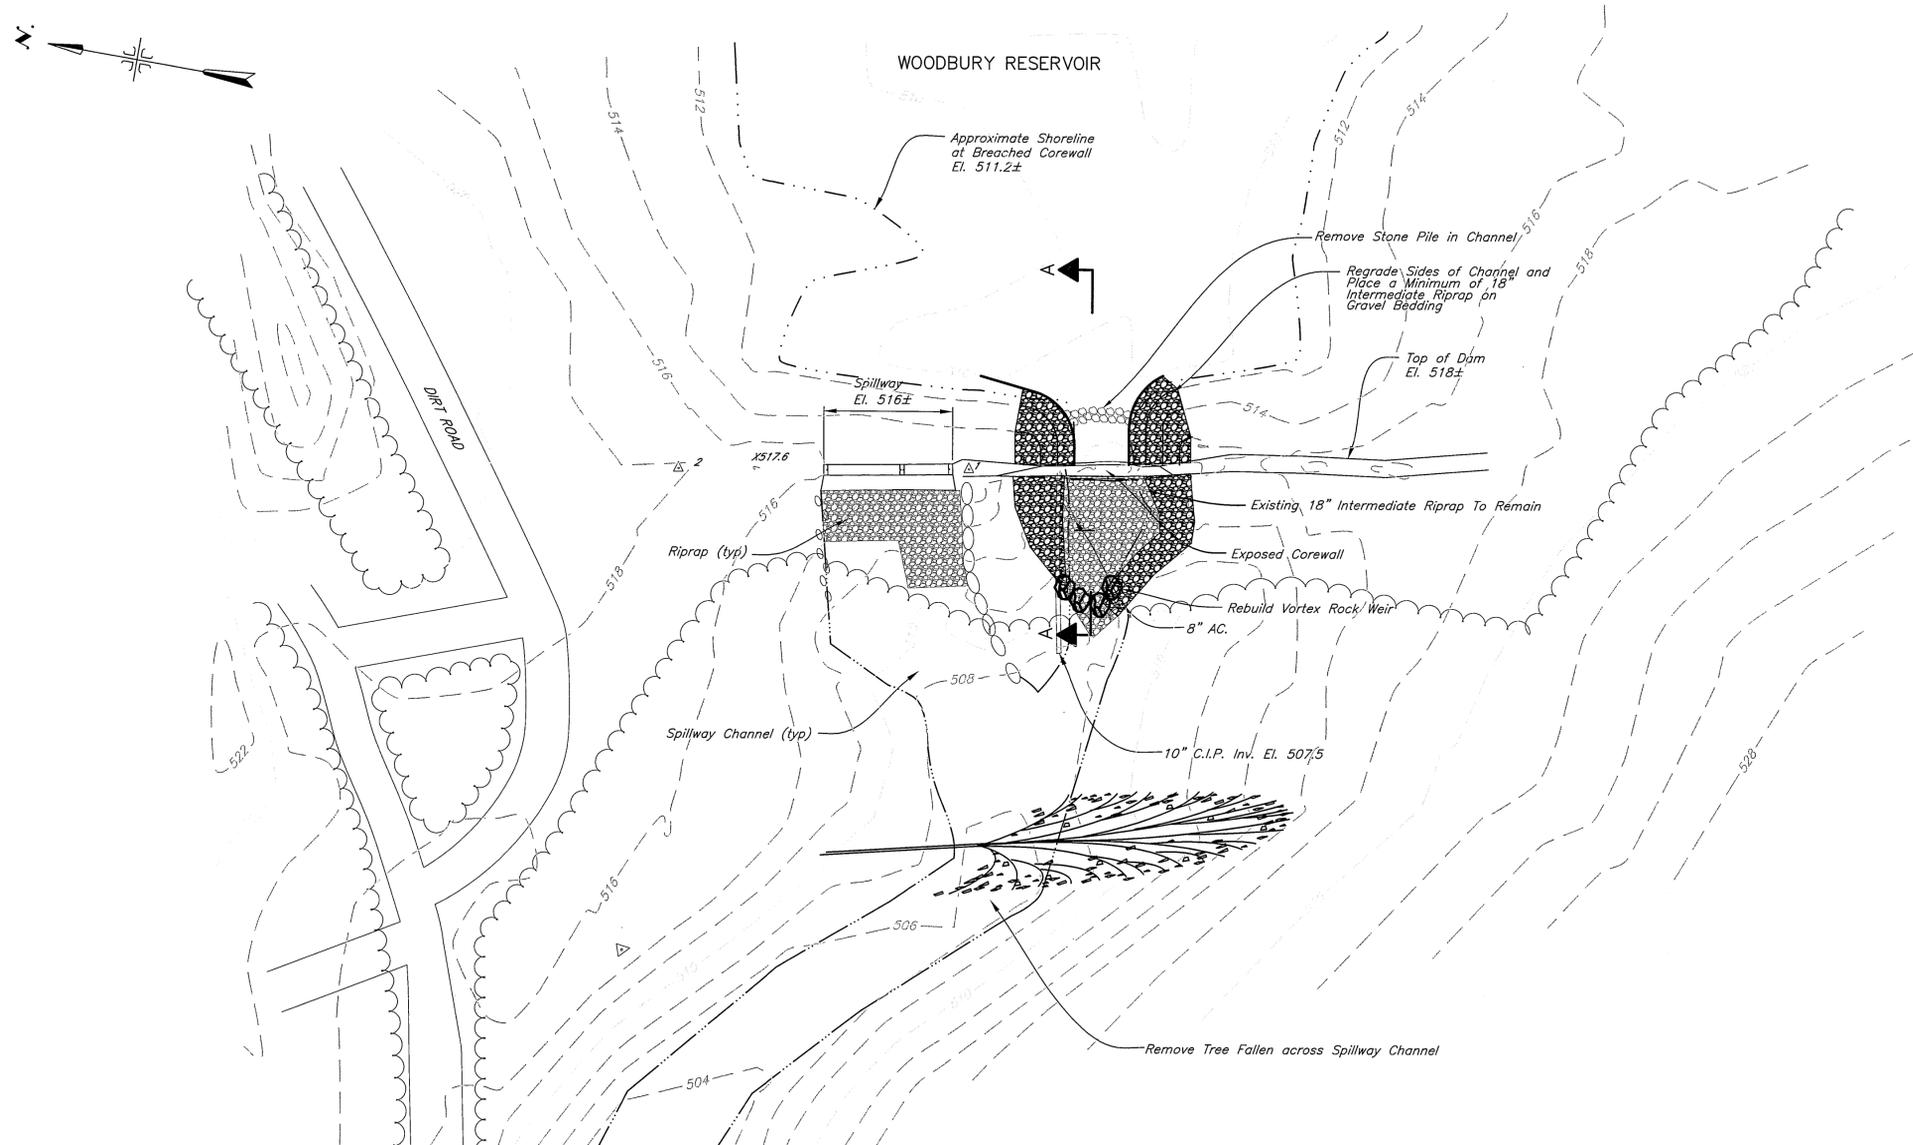
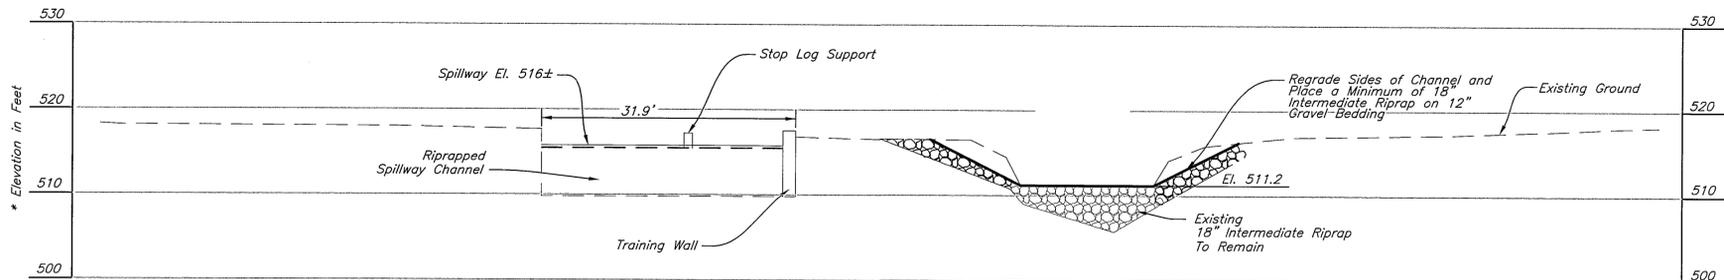
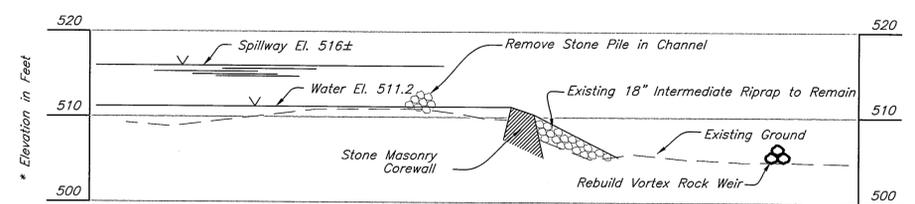
- NOTES:
1. Riprap Placed in Streambed to be Compacted and Filled with Gravel Bedding.
  2. Riprap Placed on Slopes Shall be Covered with 6" Topsoil and Seeded to Within 2 Feet of Water Level.

ELEVATION  
SCALE: 1" = 10'

SECTION A-A  
SCALE: 1" = 10' HORIZ. AND VERT.
