NATURAL RESOURCES INVENTORY

0 KATE DOWNING ROAD
PLAINFIELD, CONNECTICUT

OCTOBER 2023

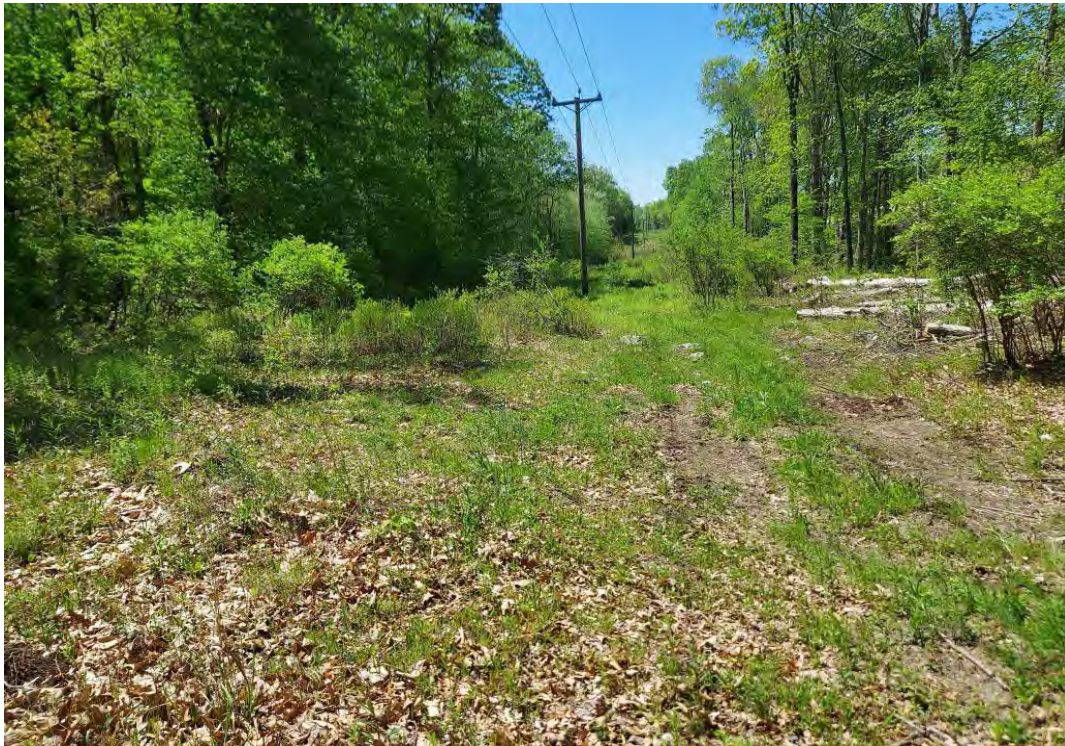
Figure 1. The Team's point of entry to the site via a utility corridor west of Interstate 395. J. Pillo.

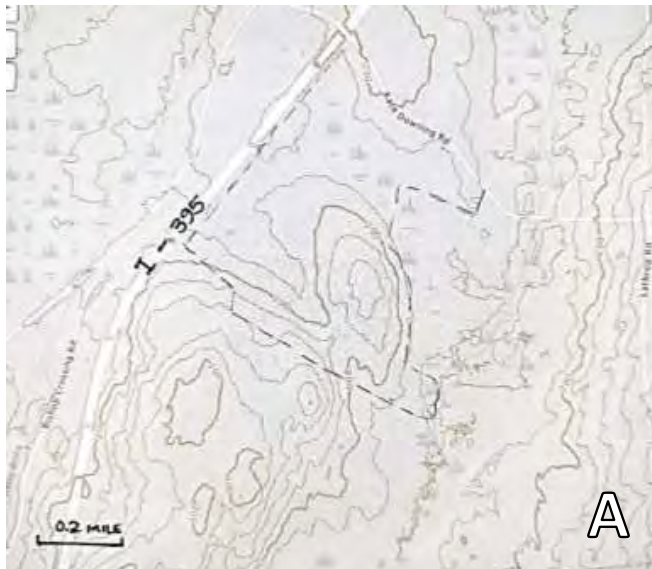
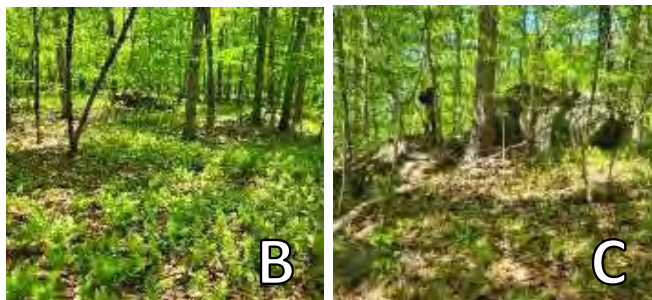
Figure 1.

A. Topographic map showing the Kate Downing Road parcel. Parcel boundary approximate and northern boundary is not defined on this map. Mill Brook flows in the valley to the east of parcel. Note Lathrop Road along eastern margin of map; a major terrane boundary is located just west of Lathrop Road. Contour interval is 20 feet. Map from CTECO website.

B. Typical gentle slope terrain is present over much of the parcel. Note glacial erratic in distance. Erratic is about 4 feet long.

C. Glacial erratic in eastern part of parcel. Note steeper slope on left (east) side of photo. Team member to left of erratic is about 6 feet in height.

Quinebaug gneiss are the only rocks seen in the areas of gentle topography (Figure 1B). The slopes along the eastern-most portions of the drop off into the valley of Mill Brook and are moderate to locally steep (Figure 1C). In the steep areas rock outcrops may be found. Those steeper slopes produce more scenic views of the forest, streams and, locally, a pond.

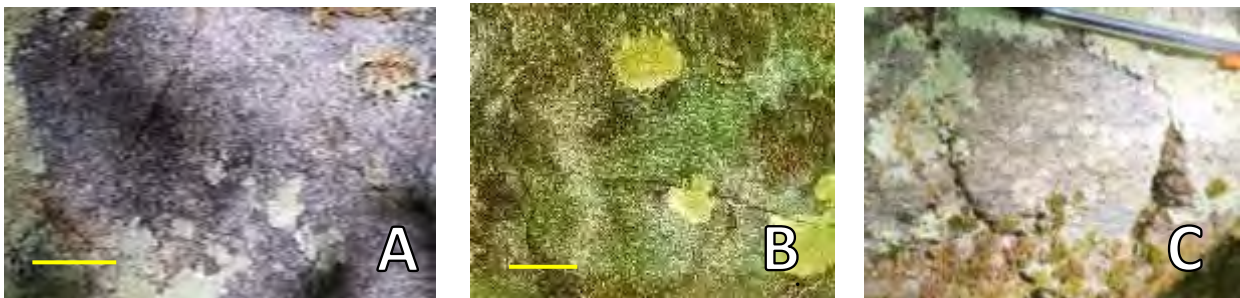
Figure 3. A & B. Fine-grained dark gray cataclasite. Light mineral grains in A. are quartz, those in B. are plagioclase. C. blastomylonite. Larger grains are composed of microcline and are deformed into augen (almond shaped).

The rocks that crop out on the eastern slopes of the parcel are dense gray and dark gray rocks that appear granulated (Figure 3). The mineral composition of these rocks requires microscopic examination, and this report relies on Dixon's 1965 description. The cataclasites consist of interlayered fine- to very fine-grained biotite, +/- hornblende, epidote, quartz, and plagioclase granulite (Figure 3A, B.) and lighter gray biotite, epidote, microcline and plagioclase blastomylonite (Figure 3C).

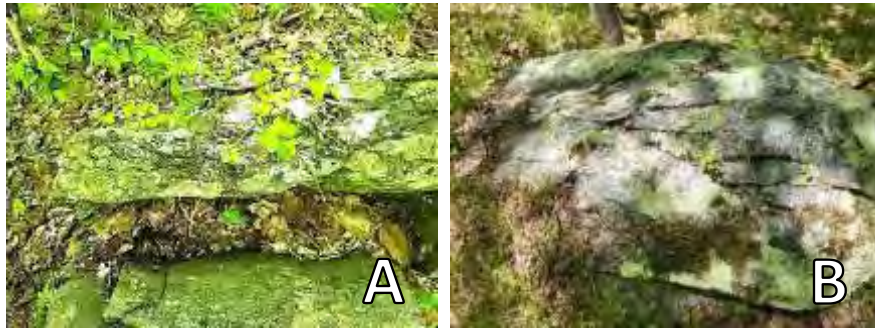
Figure 4. A. Biotite- plagioclase gneiss lenses separated by biotite rich shear zones. Poison ivy leaves at top of outcrop are about 1 inch for scale.

B. Gneiss with large quartz-filled fracture on lower left. Outcrop is about 3.5 feet long.

Few outcrops are found on the gentle slopes of the western part of the parcel. Those rocks are part of the Quinebaug formation. They consist of well-layered light- to dark-gray, and even greenish-gray, gneisses that are medium- to fine-grained (Figure 4). Shear zones consisting mainly of biotite (Figure 4A) are prominent in most outcrops. It is these rocks that Dixon suggests were crushed and transformed into cataclasite in the fault zone.

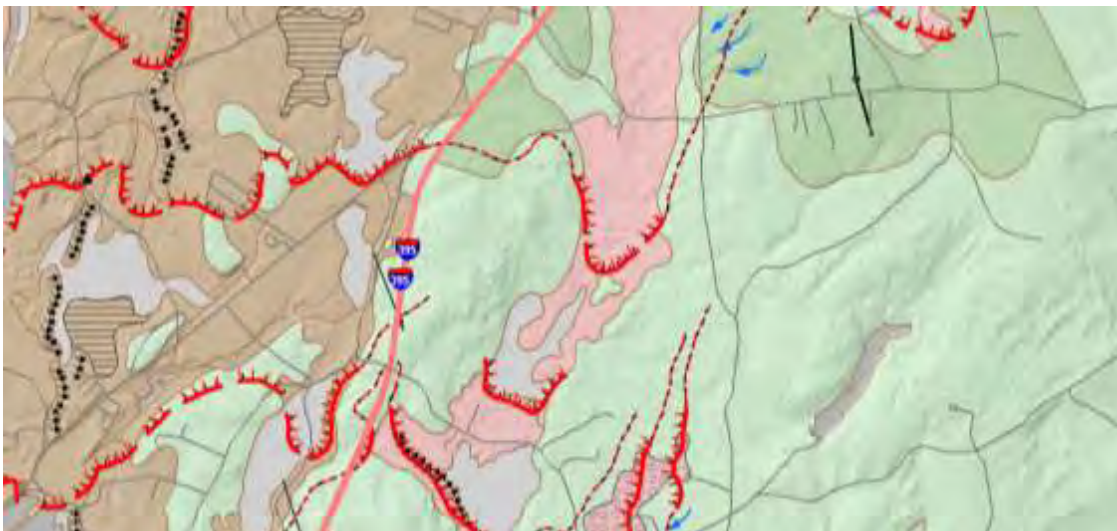
Figure 5. Map of glacial deposits in the Kate Downing Road parcel area. Red lines indicate successive locations of the ice front as it melted back. Light grayish-green and darker grayish green areas covered by glacial till; pink, brown, and bluish-gray colors indicate area covered by sand and gravel deposited by different meltwater stream systems. Map from Stone and others, 2005.

The more recent (approximately 20,000 years ago) geologic history involved the great ice sheets, glaciers, that covered Connecticut. The ice was more than a mile thick over Plainfield at the height of the last Ice-Age. The ice didn't just sit there, it flowed, moving toward the south-southeast in this part of the world. As the ice flowed it eroded the underlying bedrock and carried the erosional debris along with it. The glacier extended as far south as Long Island before it began melting. As the ice melted, glacial soils were deposited on the hillsides and sand and gravel were deposited (from meltwater streams and rivers) in the valleys. The melting occurred in pulses related to global climatic variations. During warmer pulses the front (southern end) of the glacier melted away leaving distinctive deposits. During the colder pulses, the southern end stood in one place for a number of years, leaving a different set of distinctive deposits, most easily interpreted by the meltwater stream deposits in valley bottoms. Glacial geologists thus can map the retreat of the glacier (Figure 5). The ice melted in the Plainfield area about 16,500 years ago.

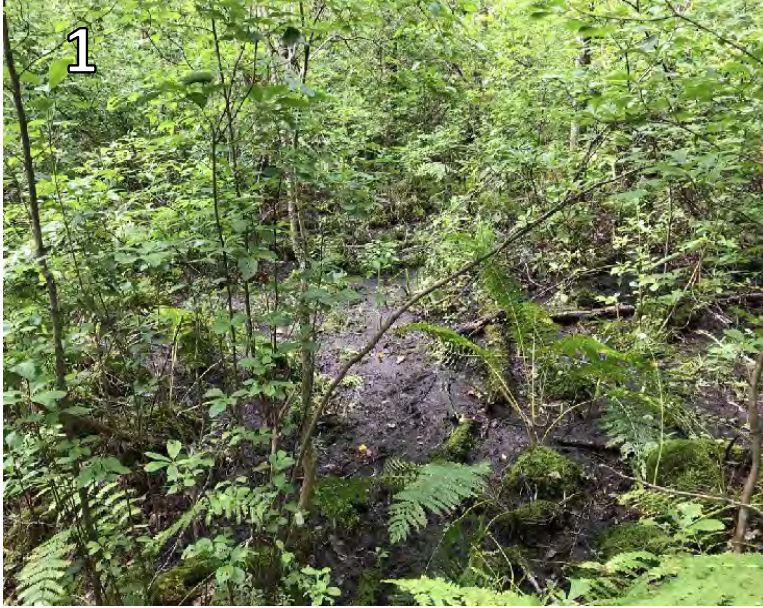
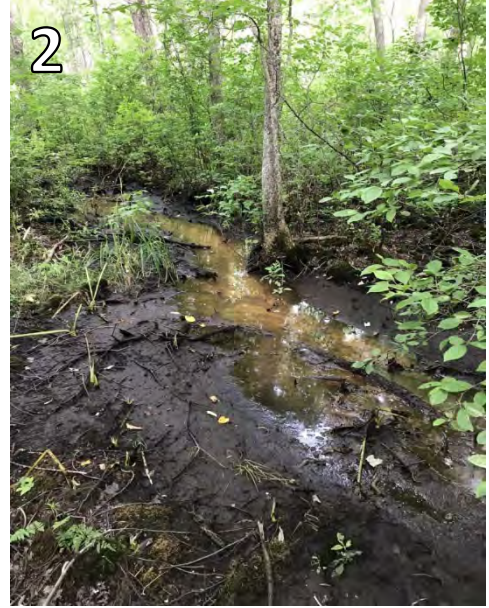
Photos. Photo 1. Extremely dense vegetation in deciduous wooded swamp. Photo 2. Headwaters stream channel in center of deciduous wooded swamp. 0 Kate Downing Road Plainfield, CT 8/24/23. E. Pawlak.

The dominant wetland type on the property (PFO1E) is known colloquially as a “deciduous wooded swamp”. These swamps occur as broad, very densely vegetated (Photo 1) corridors that span the property, trending in a southeast direction. The microtopography in the swamps is very strongly expressed due to widespread seasonal flooding in the early portion of the growing season. Many trees and shrubs are found growing on raised hummocks. The topography of the swamp is nearly level. The dominant vegetation in the swamps is red maple, sweet pepperbush, spicebush, cinnamon fern and skunk cabbage. There are very few invasive plants growing in the swamps.

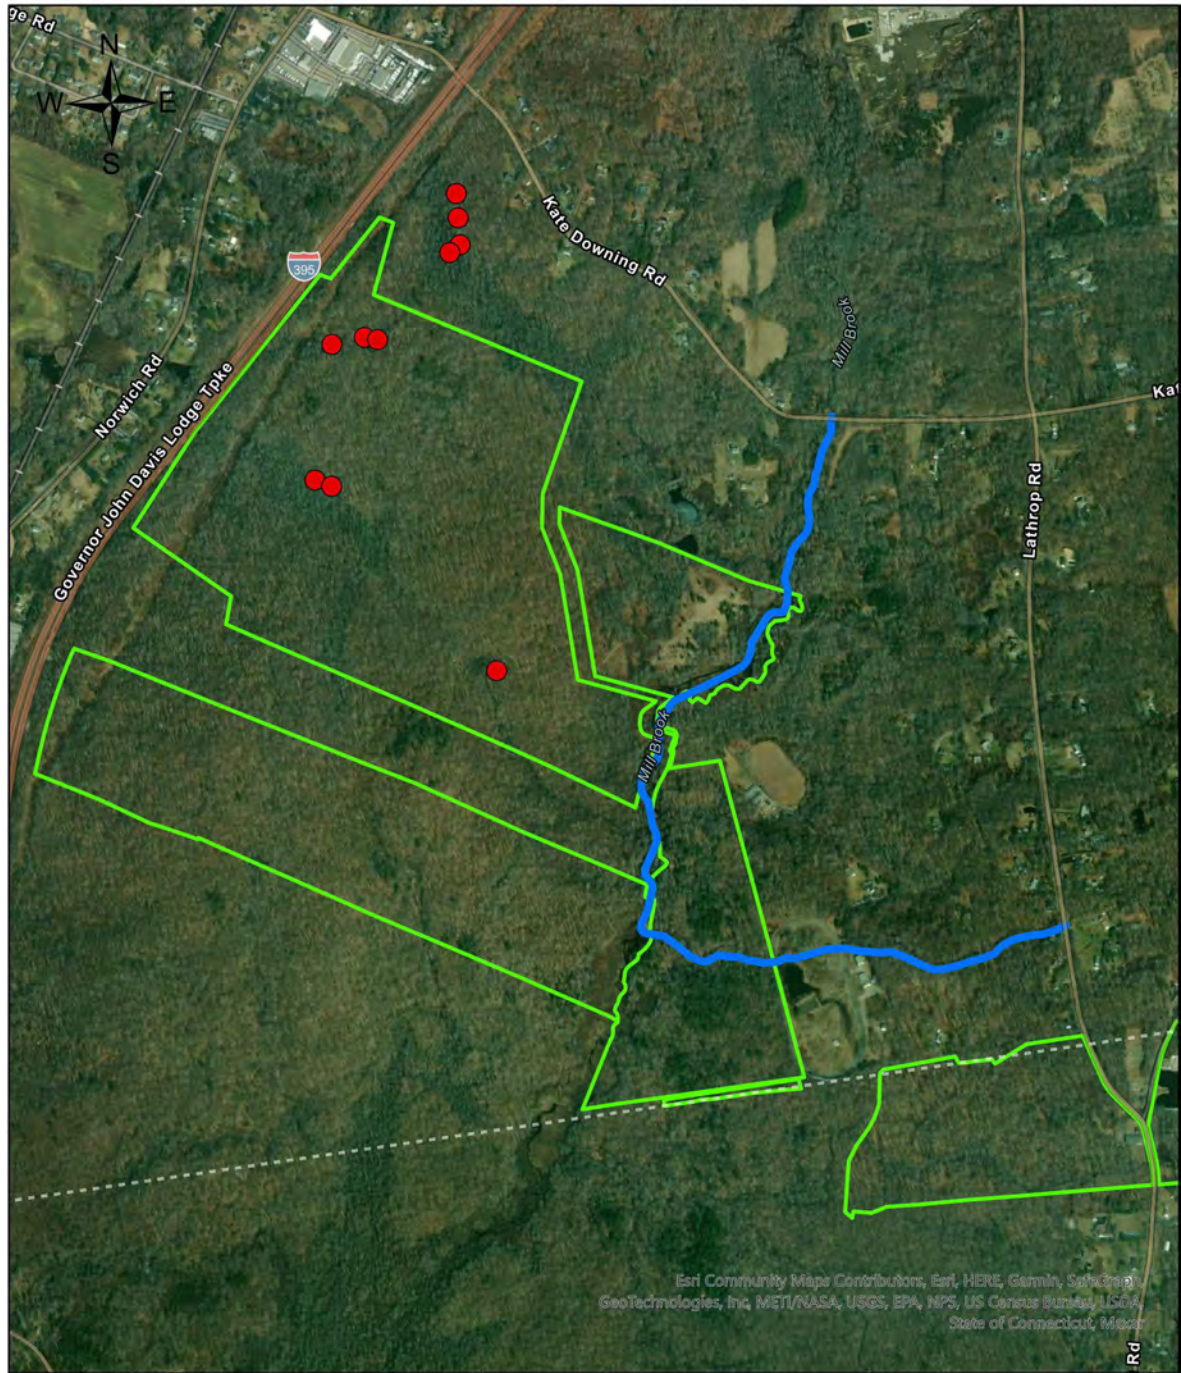
Minnow Trap Locations

Figure 1. Non-baited minnow trap locations in cryptic pools located within the greater wetland complex.

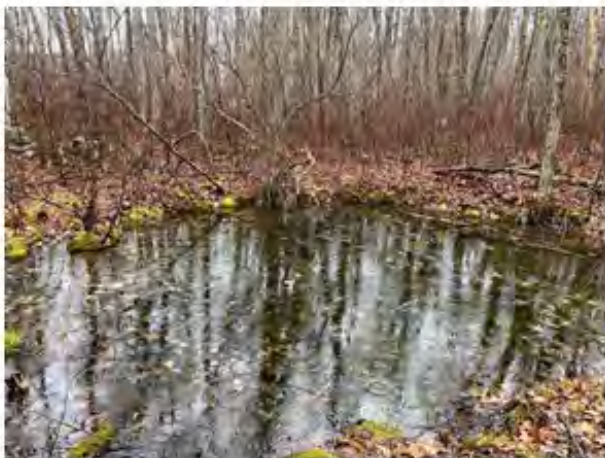
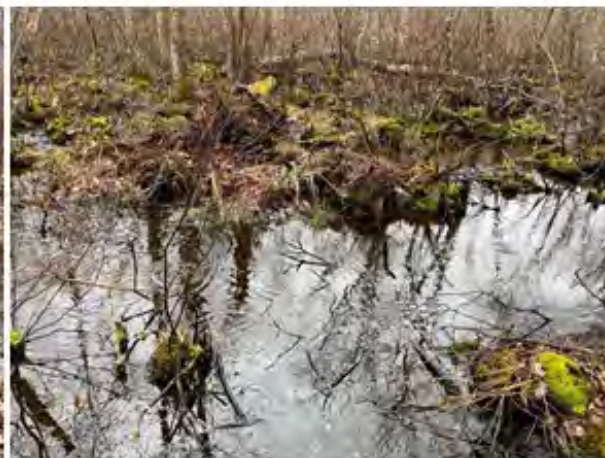
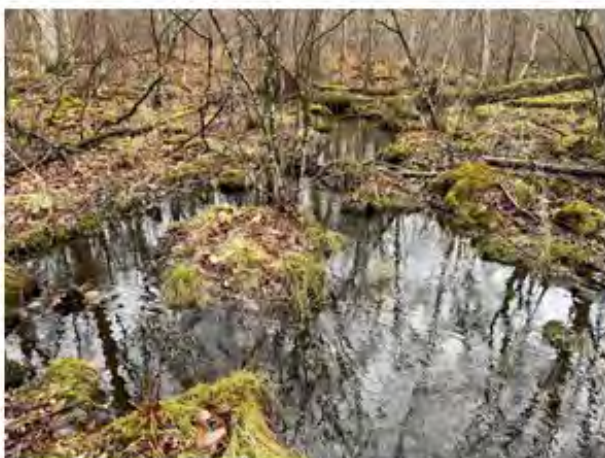
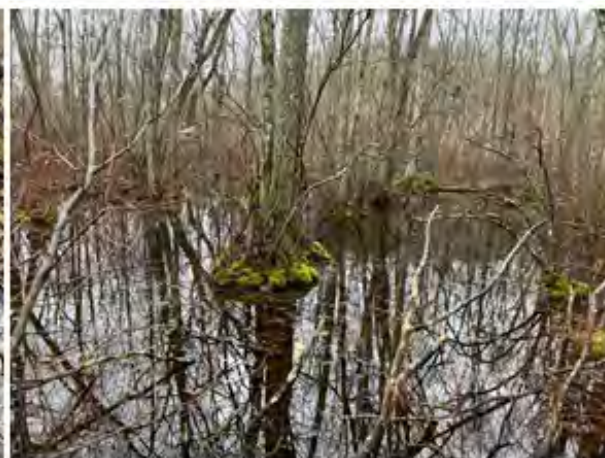
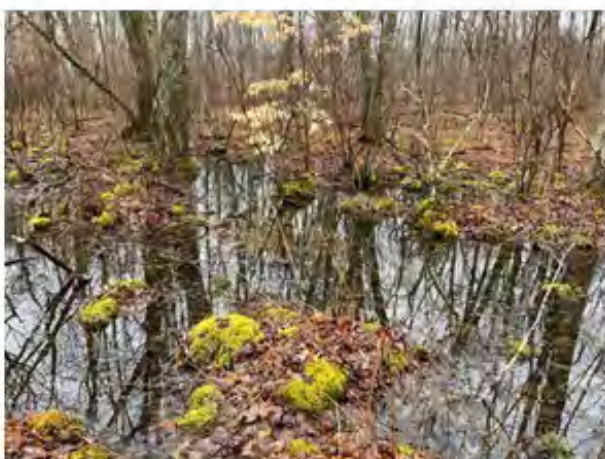
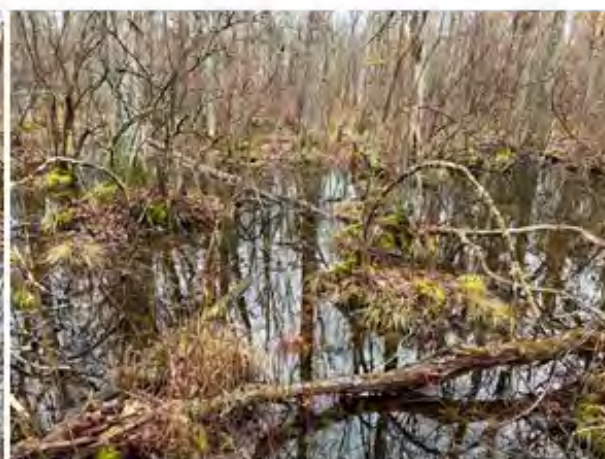
Figure 2. Representative Cryptic Vernal Pools Photos. D. Quinn.

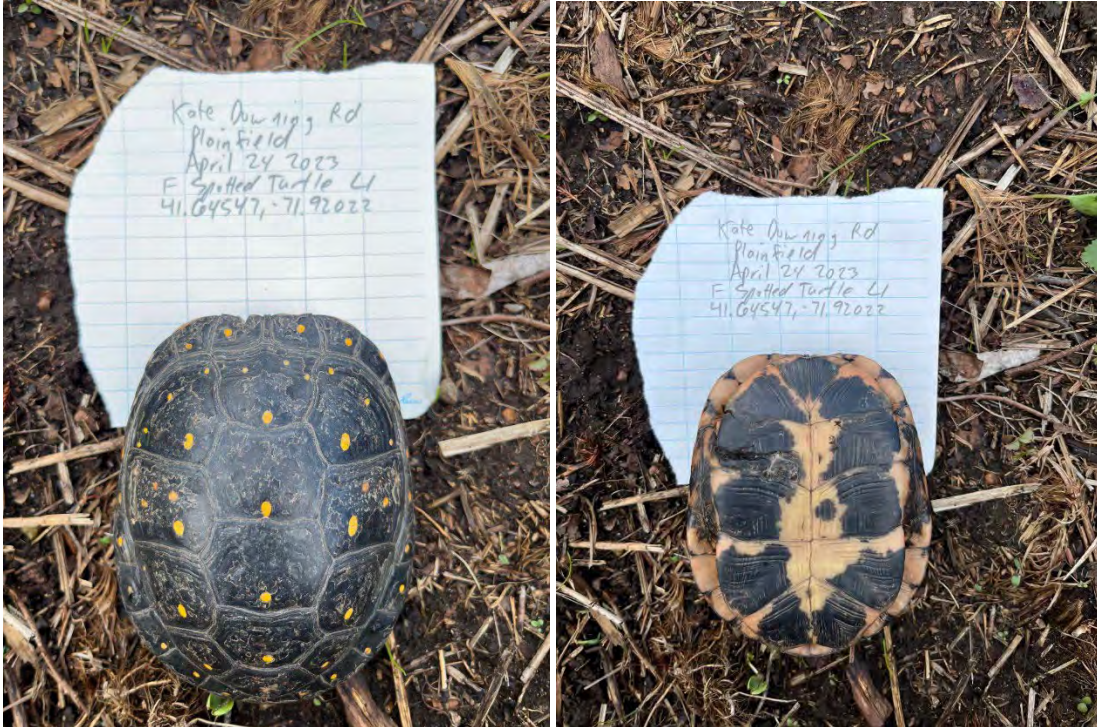
Spotted turtle observed actively moving through field.

Shell damage to right side of plastron (healed), 25% worn, 12+ annuli.

Figure 4. Adult spotted during observed during field surveys.

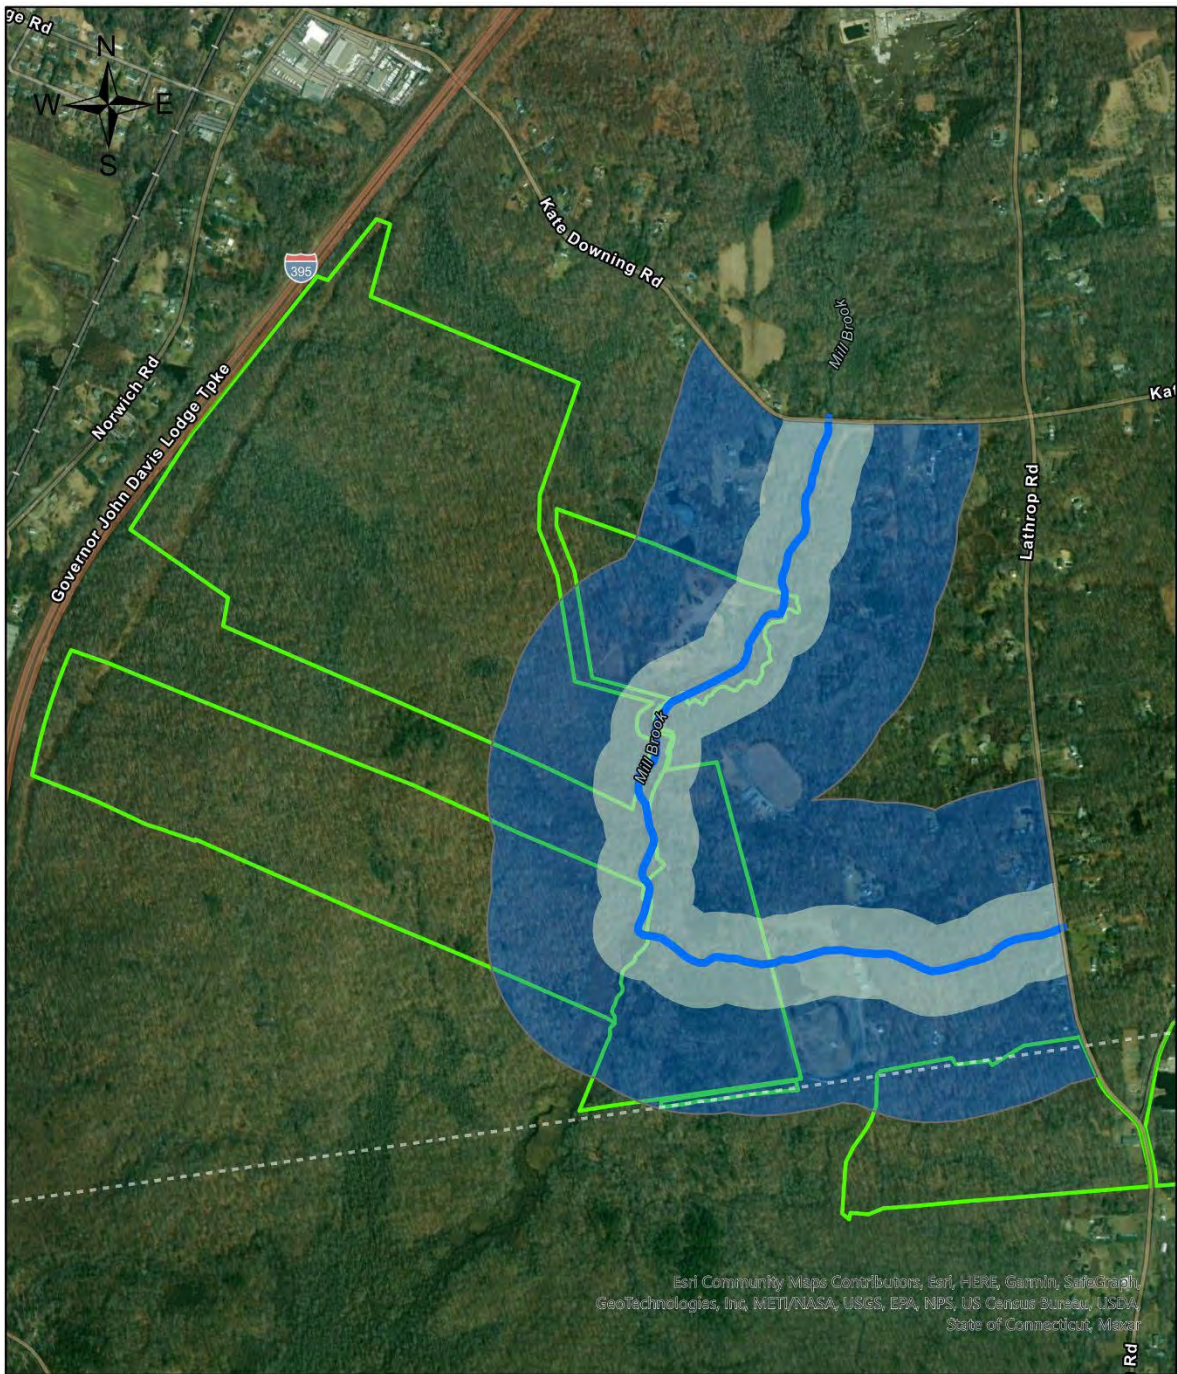
Wood Turtle Conservation Zones

Figure 6. Recommended wood turtle conservation zones.

Due to their connection to riparian systems, coupled with the vulnerability of these systems to direct and indirect impacts at a watershed scale, a “watershed-based approach” to mapping and conservation is warranted. Mapping of Scale Level Hydrography Lines were chosen to help guide conservation and management decisions focusing on “management zones” as recommended by the Northeast Wood Turtle Working Group in Status and Conservation of the Wood Turtle in the Northeastern United States (Jones and Willey 2015). Within mapped areas, conservation and management decisions can be guided at a more local level by focusing on “management zones”. These include – (Zone 1): Riverine (instream); (Zone 2): 300 feet from the edges of the river primarily encompassing the floodplain habitat; and (Zone 3): 1,000 extending beyond the boundary of Zone 2 primarily encompassing upland habitats (Figure 6).

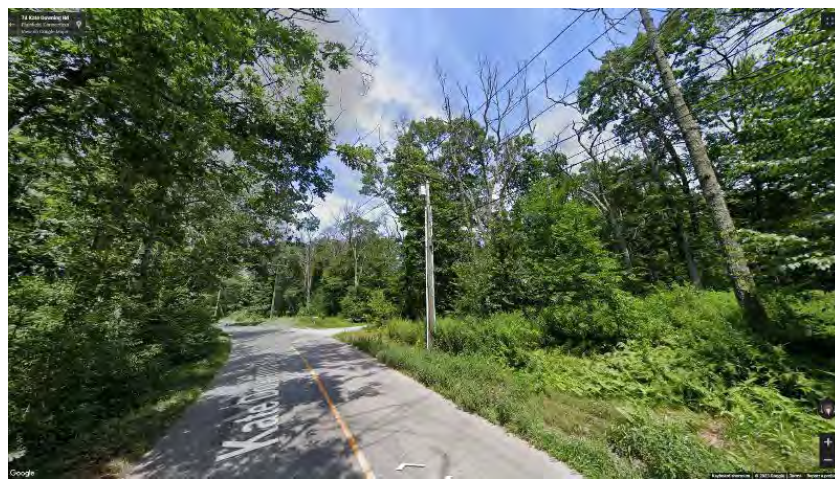
Figure 5. Google Street View from 44-foot frontage section looking west.

It is not clear if the ordinance would apply to a municipal use but generally the construction of any access point should at least meet these requirements. The narrower frontage to the east of Lot 9 may not have adequate sight line due to road geometry when driving west.
