# NATURAL RESOURCES INVENTORY

124 SQUANTUCK ROAD  
SEYMOUR, CONNECTICUT

APRIL 2025

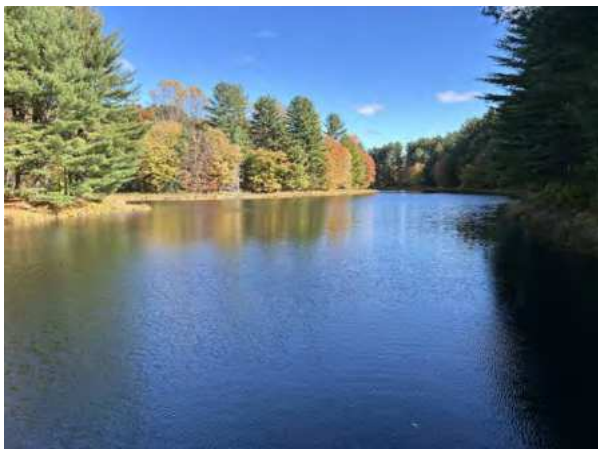
*Photo 1: Great Hill Reservoir. Edward Pawlak.*

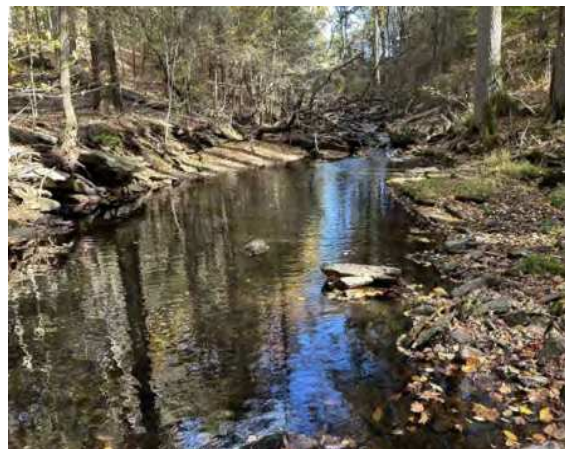
*Photo 2: Fourmile Brook, deep run below a riffle segment.  
Edward Pawlak.*

Fourmile Brook is a perennial watercourse contained within a moderately sloping rocky channel. It extends on the subject property from the Great Hill Reservoir dam to its confluence with the Housatonic River. The brook is characterized by two instream habitat types: deep runs (Photo 2) and shallow riffles (Photo 5). There are numerous large boulders (Photo 5) and small flat rocks in the channel (Photo 7).

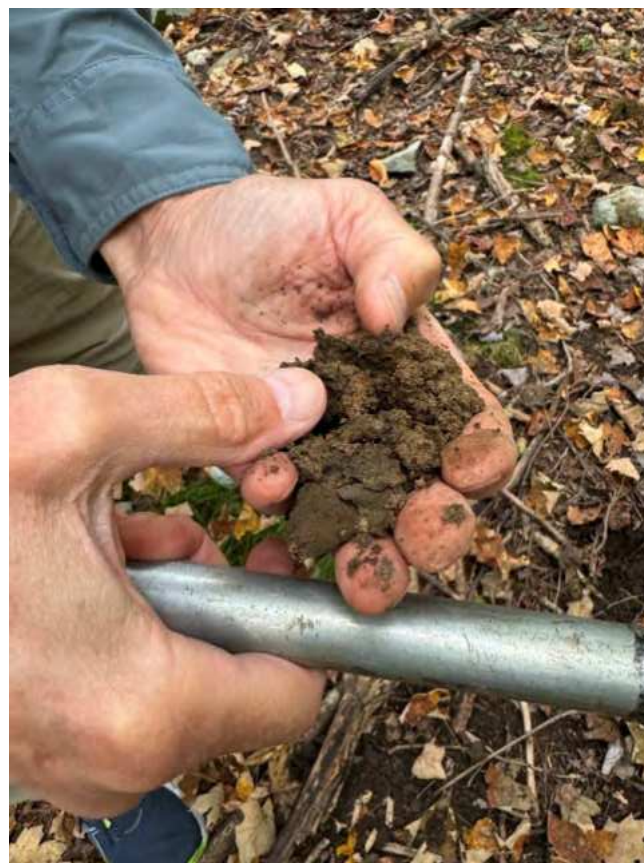
*Photo 3: Visual and textural inspection of a soil sample*

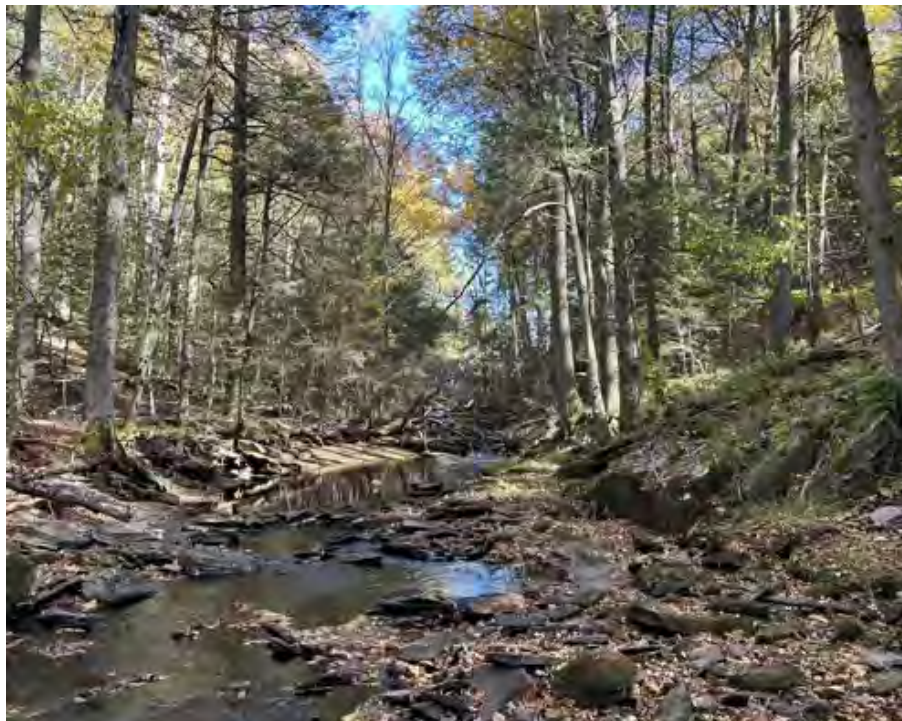
*Photo 5: Large wooded riparian zone to Fourmile Brook, note numerous boulders in channel. Edward Pawlak.*

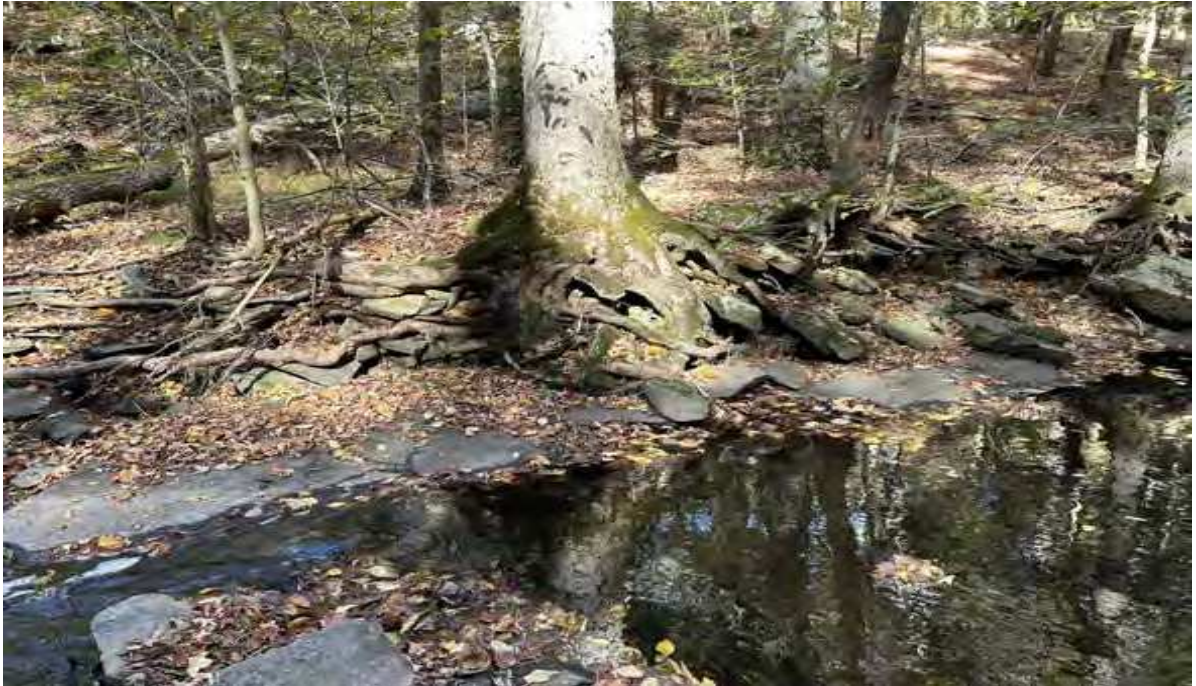
The channel banks are wooded (Photo 5) and mostly stable, although in some areas erosion has exposed bankside tree roots (Photo 8) that continue to hold the channel soils in place. Numerous areas with waterlogged soils that were discharging groundwater to the brook were observed (Photo 10). Because of the steep slopes that border the channel, there is limited opportunity for a floodplain to develop. However, a flat bench on the eastern side of the channel contains a side channel (Photo 8) that contained no flow when inspected, but the presence of waterborne debris and scouring indicates that it periodically receives an overflow from the main channel.

*Photo 6: Localized bank erosion has exposed tree roots, which continue to stabilize the bank of Fourmile Brook. Edward Pawlak.*

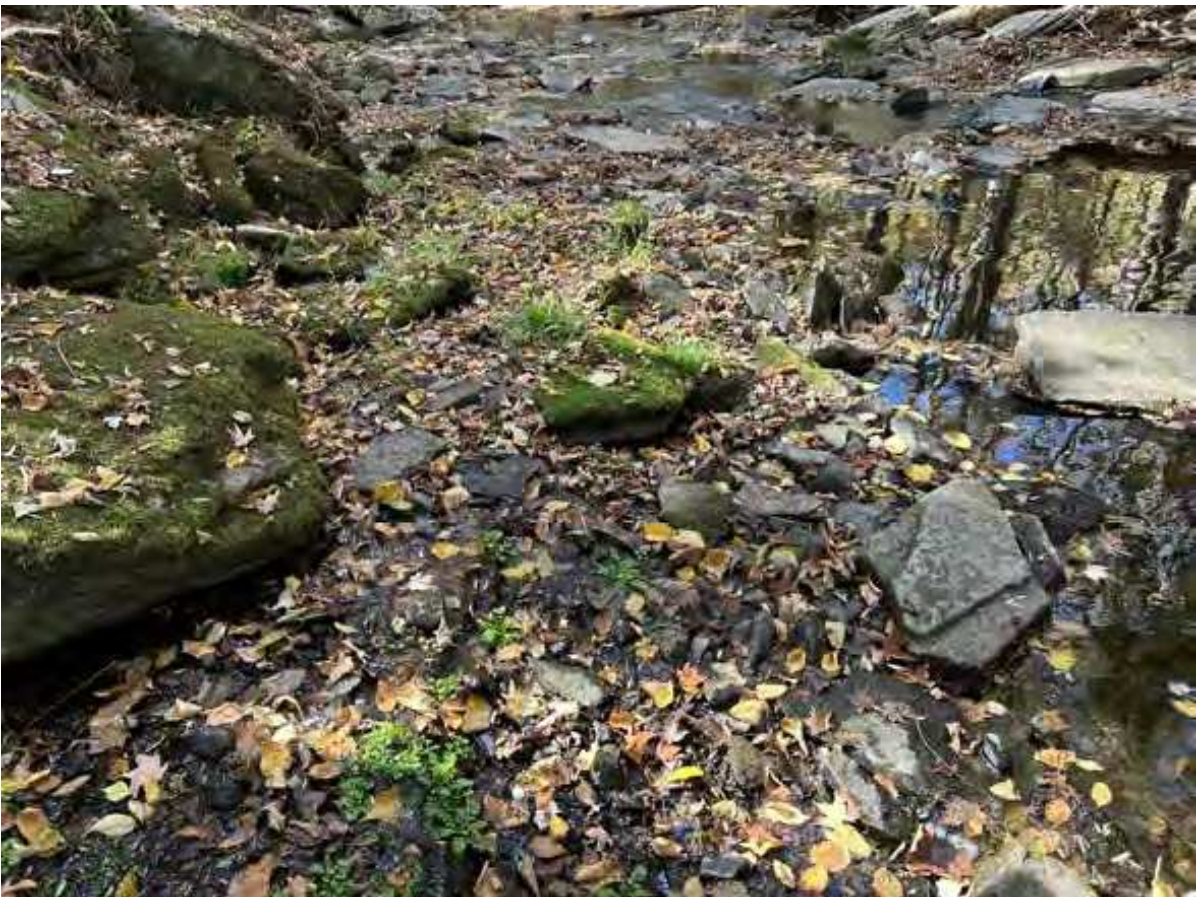
*Photo 7: There are numerous flat rocks in and adjacent to Fourmile Brook channel. Edward Pawlak.*

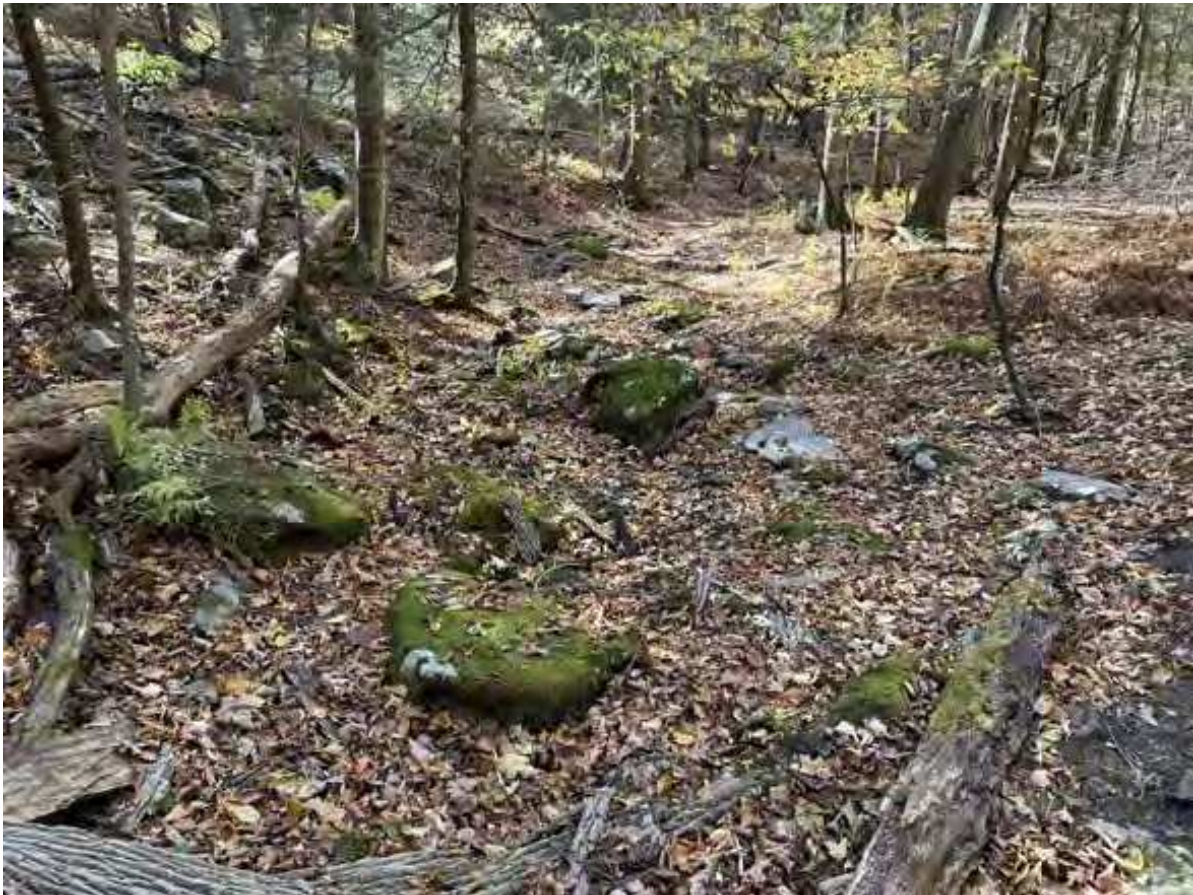
*Photo 8: Dry floodplain side channel adjacent to main channel: waterborne debris and scouring are evidence of occasional flow. Edward Pawlak.*

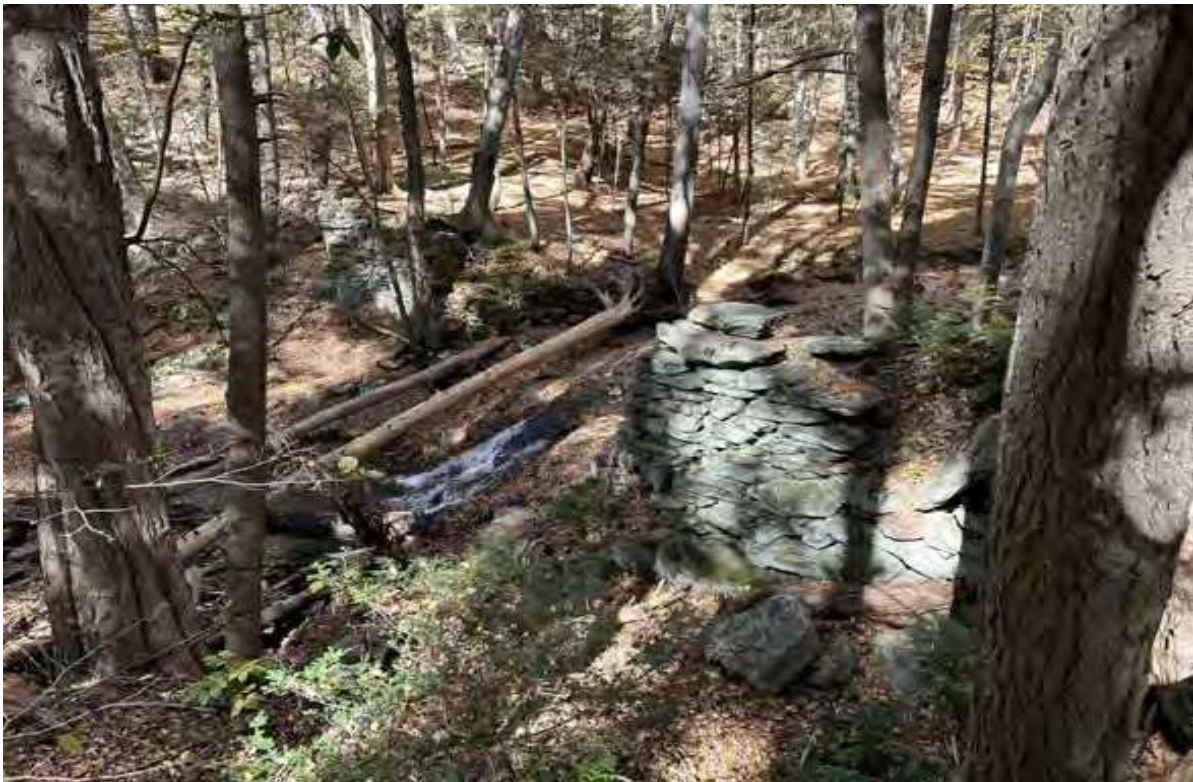
*Photo 9: The remains of a stone dam partially spans the Fourmile Brook channel. Edward Pawlak.*

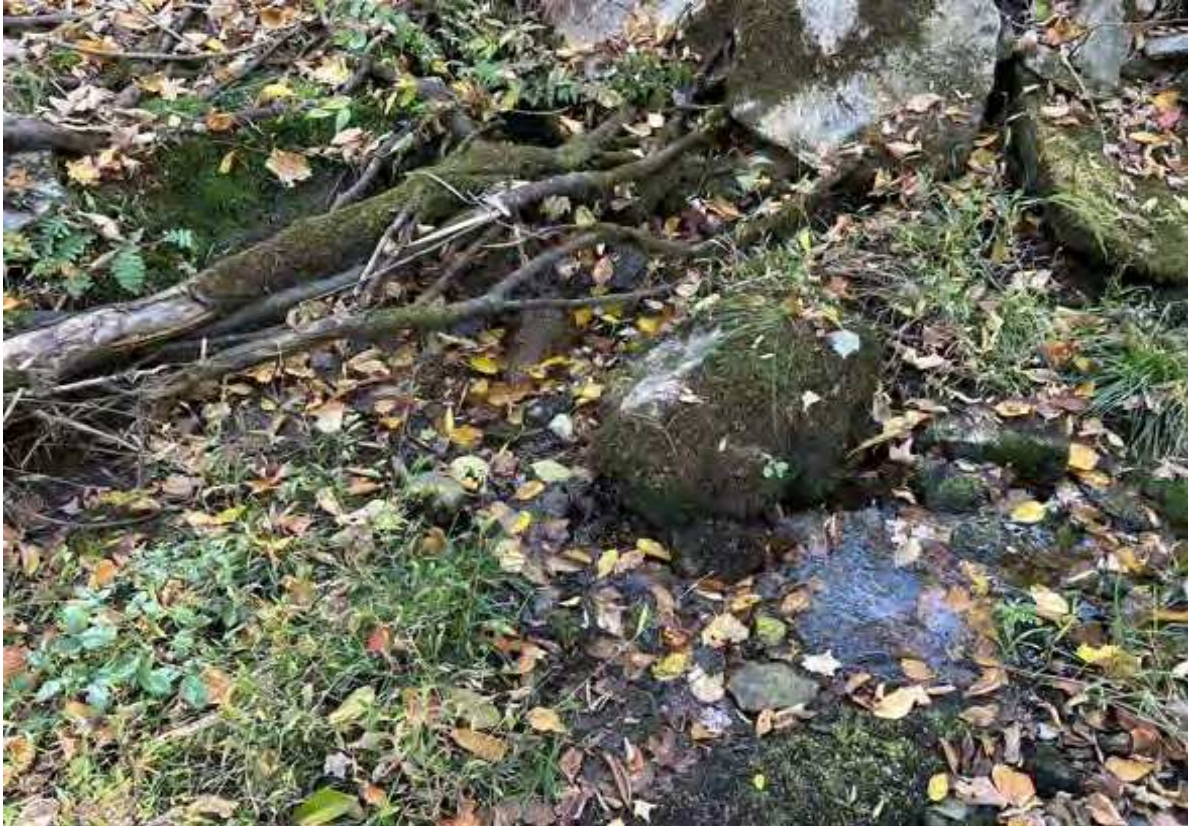
*Photo 10: There are numerous areas of groundwater discharge adjacent to the Fourmile Brook channel. Edward Pawlak.*

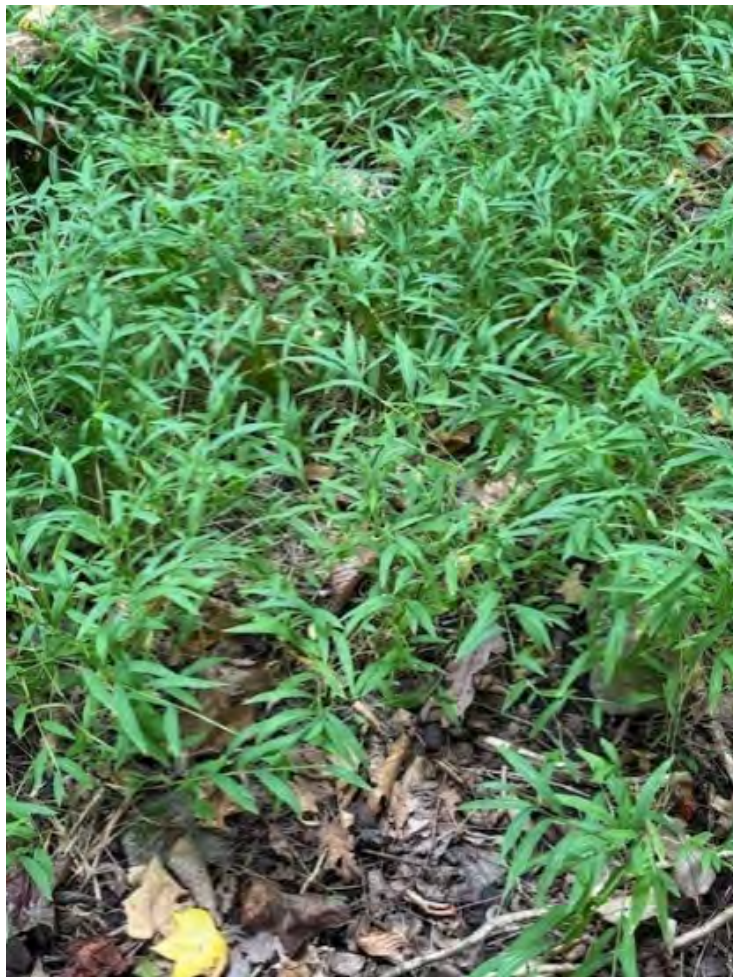
*Photo 11: Invasive Japanese stilt grass photographed on site*

Very few invasive flora were observed on the portions of the property that were inspected. There are patches of invasive Japanese stilt grass within the riparian floodplain of Fourmile Brook. However, for the most part the flora are dominated by native species. Although Japanese stilt grass is not dominant on the property, this invasive species is capable of spreading rapidly once it gains a foothold. It is recommended that measures to eradicate the relatively small patches of this invasive species be explored.

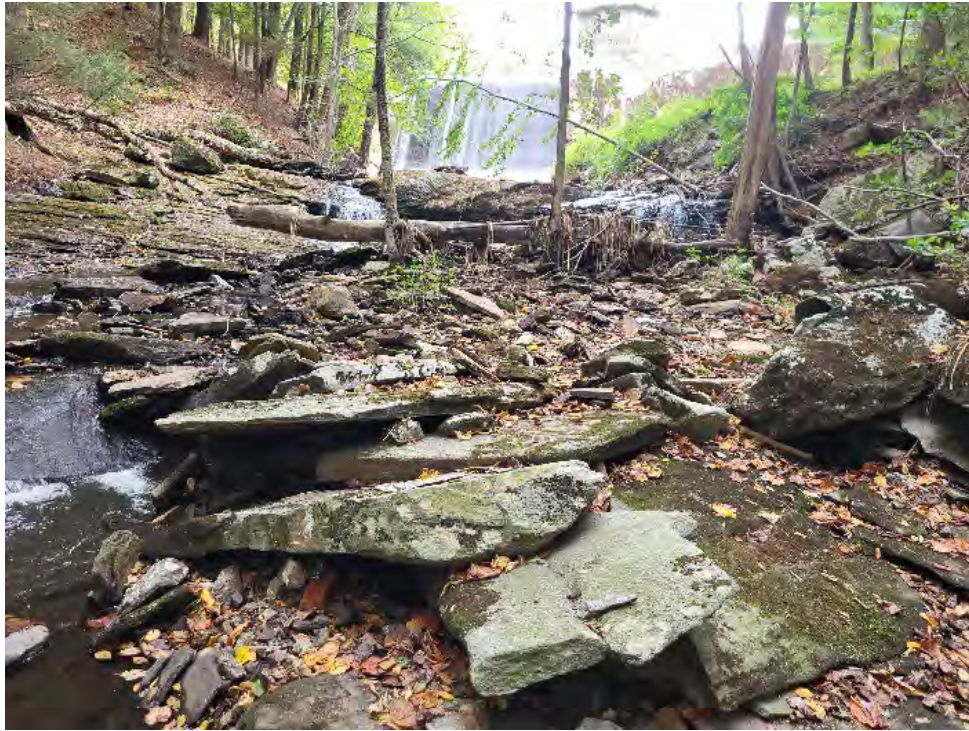
Figure 4. Bedrock exposure below dam at slight change in slope of longitudinal profile. Steepening of profile here is accompanied by rapids and low waterfalls. Slabby weathering felsic gneiss layers are interfoliate (layered) with poorly resistant biotite schist

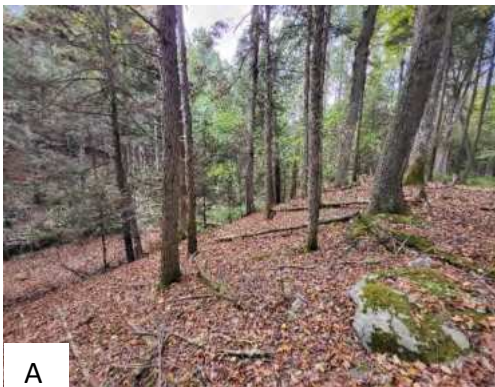
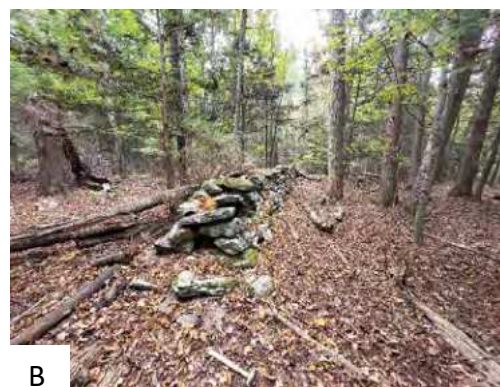
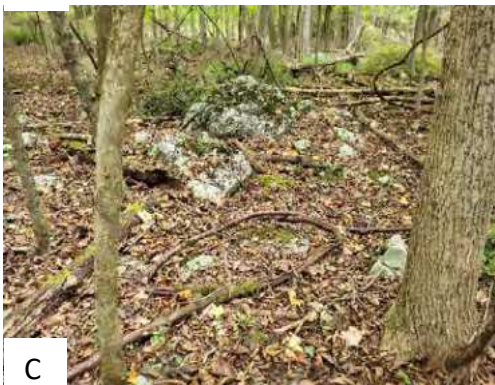
Figure 5.

A small terrace is seen on the topographic map by spread-out contour lines is clearly seen in the field (Figure 5) and likely was exploited for farm activities. Land cleared of rocks and the presence of stone fences suggest that crop farming once took place on the terrace. The fence likely was constructed with stones removed from the field and was intended to prevent livestock from entering the enclosed field.

C. Left side of fence is rocky and bouldery. That area may have been used for grazing.

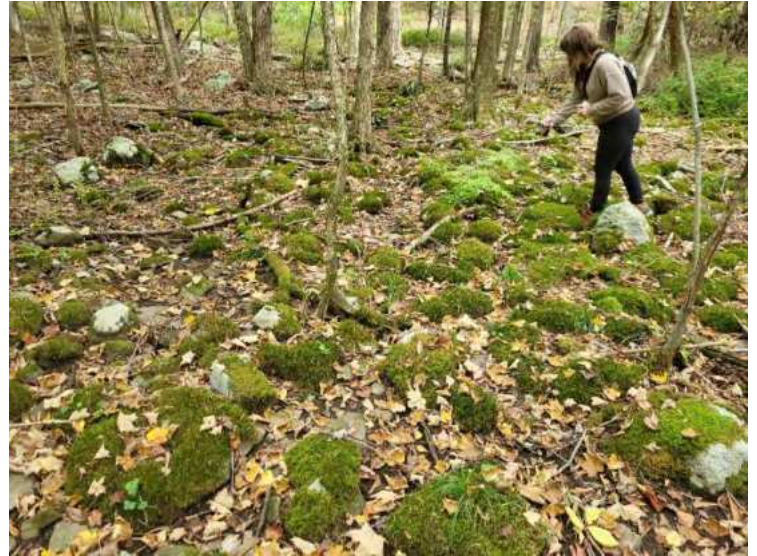
An intermittent spring feeds an intermittent stream on the terrace east of the stone fence. The intermittent stream is clearly delineated by a linear array of rounded cobbles oriented perpendicular to the slope of the terrace (Figure 6). The spring and stream were not flowing at the time of the site visit, but leaf piles in the up-hill side of cobbles attest recent former flow, perhaps during the unusual deluge that afflicted the area in August. Whether or not the spring actively discharged during that event is not known but stream-flow sufficient to move leaves is evident. Discussion of rounded cobbles in the streambed is given in later section.

*Figure 6. Rounded cobbles in the bed of an intermittent stream that was fed by an intermittent spring upstream. Note the edge of the cobble-field is sharply defined on the left side of the illustration. It is similarly sharply defined on the other side (behind the scientist pictured)*

The distribution of rounded cobbles in the stream-bed (described under the topography discussion of this report, see Figure 6) is curious. The cobble field has sharply defined edges along the length of the stream-bed. Notice that the size of the cobbles indicates that the water from which they were deposited was flowing at a high velocity. Water flow at a velocity high enough to move and round the cobbles would surely have been deeper than the current stream banks can hold. That implies that something existed exactly parallel to the current stream bed that confined water flow at a depth and velocity necessary to result in rounded cobbles along its bed. This suggests the current intermittent stream, and probably the spring also, are the

result of an antecedent stream that flowed in this exact area during the end of the last Ice Age when there was ice present to confine water flow at a higher velocity and volume than the current stream is capable of doing. During the melting of the last Ice Age glacier, I suggest a crack or crevasse developed over this area into which meltwater flowed, transporting cobbles and other debris eroded by the glacier during the height of the Ice Age. The spring exists because the crevasse deposits are more porous than surrounding glacial till that covers most of the area. Today it discharges, intermittently, onto the antecedent stream bed over which the current intermittent stream flows.

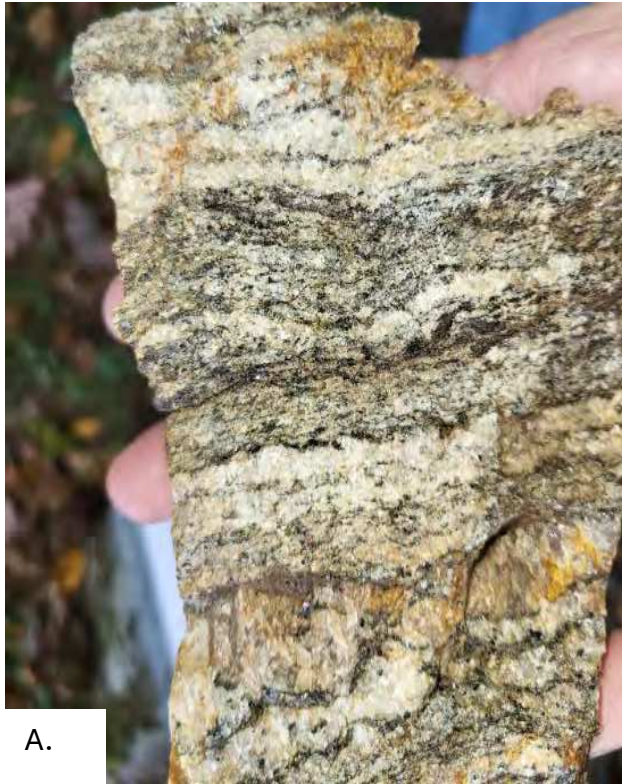
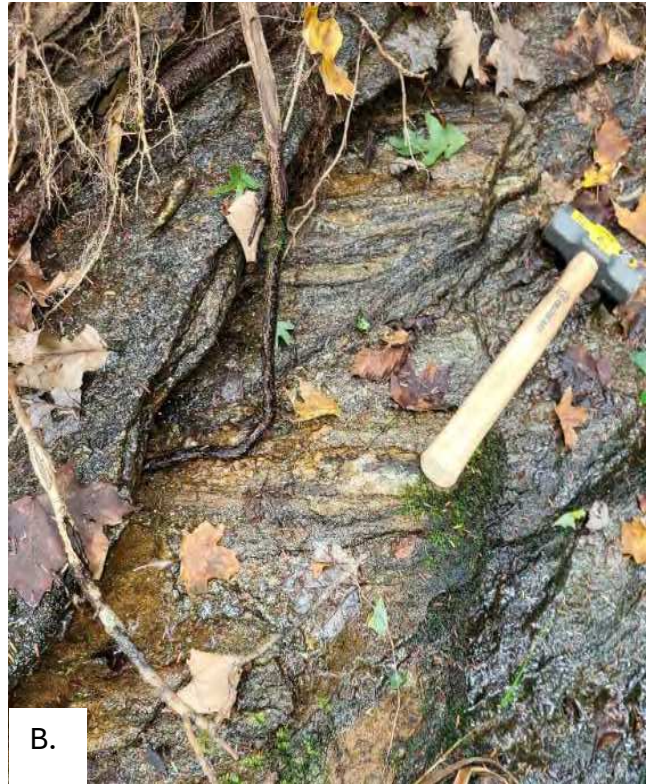
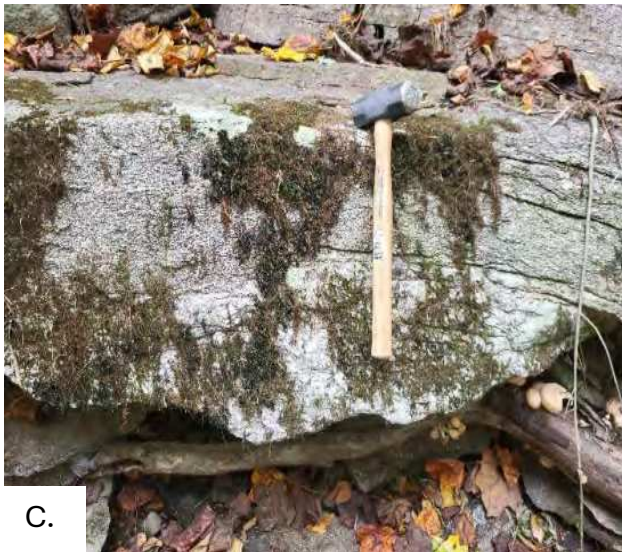
*Figure 7.*

The rocks in the Seymour area (see map at end of report) formed over 400 million years ago originally as sedimentary and volcanic layers on the edge of the ancient North American continent. They later were metamorphosed to the schists and gneisses during the various mountain building events that formed the Appalachian Mountain chain (Coleman, 2004). Most of the metamorphism occurred approximately 340 million years ago during what geologists call the Acadian event. They are described in Carr (1960) as belonging to the Hartland Formation and by Crowley (1968) as part of the Collinsville Formation. Rodgers (1985) mapped them as Collinsville formation. The specific rocks in the reaches of the valley of Four Mile Brook west and north of Route 188 are interlayered mica schist and felsic gneiss (Figure 7). The felsic gneiss consists of plagioclase feldspar, quartz and both muscovite and biotite mica although biotite is a minor constituent (Figure 7A). The felsic rocks are interlayered with biotite rich schist (Figure 7B) that contains plagioclase and minor hornblende locally. The felsic gneisses generally are thicker than the biotite schist layers. Some felsic layers show evidence for folding and other more resistant to erosion deformation during the metamorphic events. Non-foliated pegmatite locally intrudes the felsic gneiss (Figure 7C).

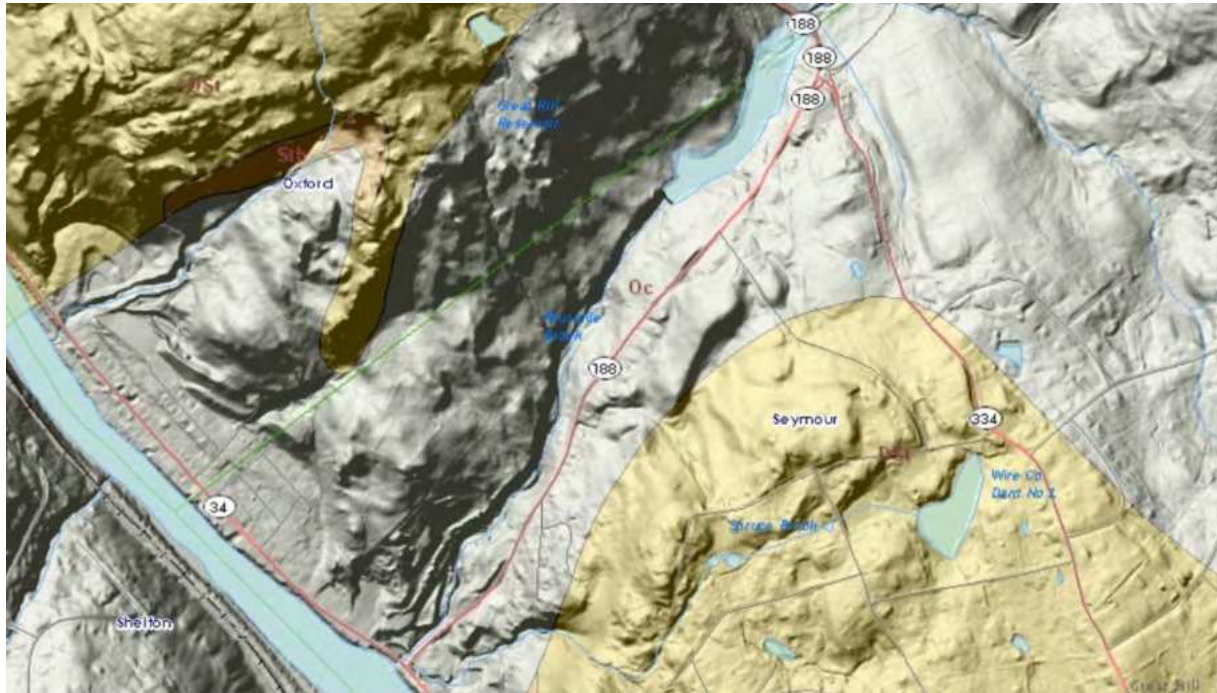
Map 1. Bedrock map showing Four Mile Brook between CT Route 34 and 188. Map base is Lidar image. Areas colored yellow are underlain by a mica schist called *The Straits Schist* by geologists. The gray area is underlain by rocks of the *Collinsville Formation*. Map from Rodgers, 1985.

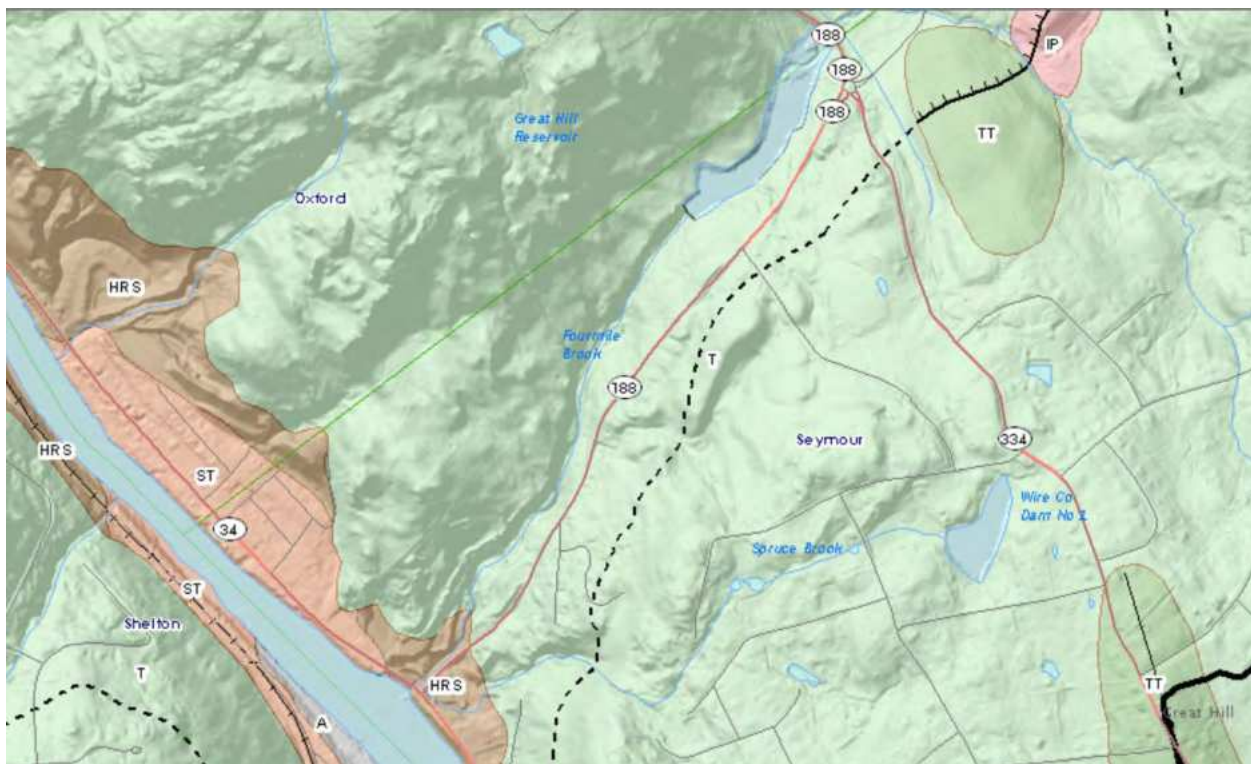
Map 2. Quaternary geology (Stone and others, 2005) of Four Mile Brook area between CT Route 34 and 188. Green color denotes area covered by till generally less than 15 feet thick, grayish green areas covered by thicker till. Black dashed line indicates southern edge of ice sheet when melting stopped for a couple of years and melt-back temporarily stopped. These areas generally have increased numbers of boulders.

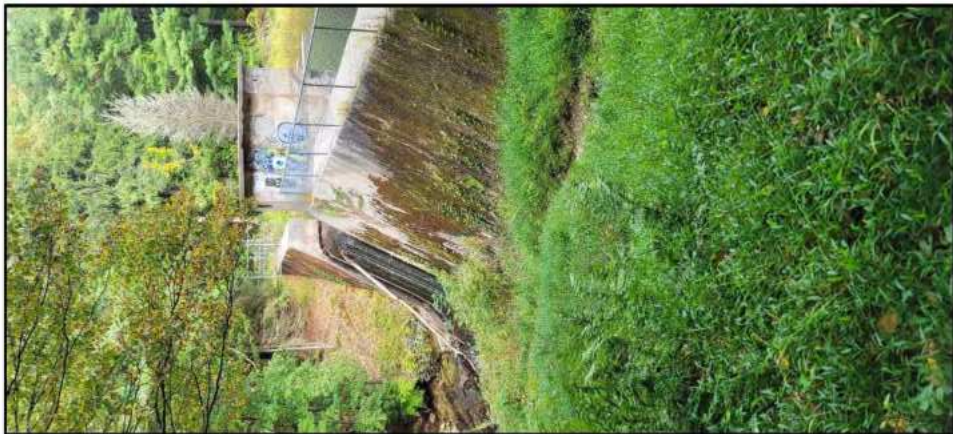
**Photo 1** – Dam with spillway.

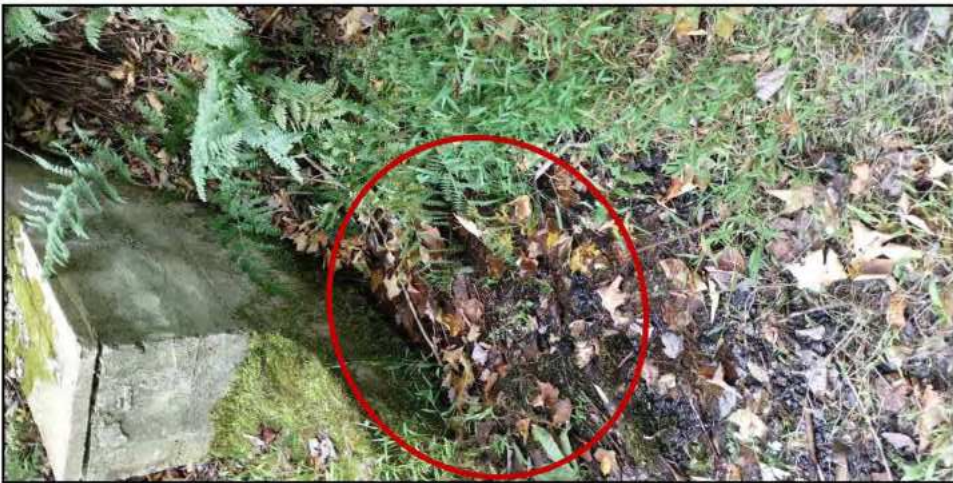
**Photo 2** – Seep just downstream of dam.

All outfalls from drainage of Squantuck Road/ Route 188 should be located and stabilized. There are 17 different outfalls maintained by CT DOT that drain onto the property. It's imperative that outfalls are properly armored to disperse stormflows to prevent erosion. The channels found on site could be the result of unarmored outfalls above. All outfalls should be inspected. Several seeps were noted (Photos 2 & 11), but many of the intermittent streams could be stormwater fed.

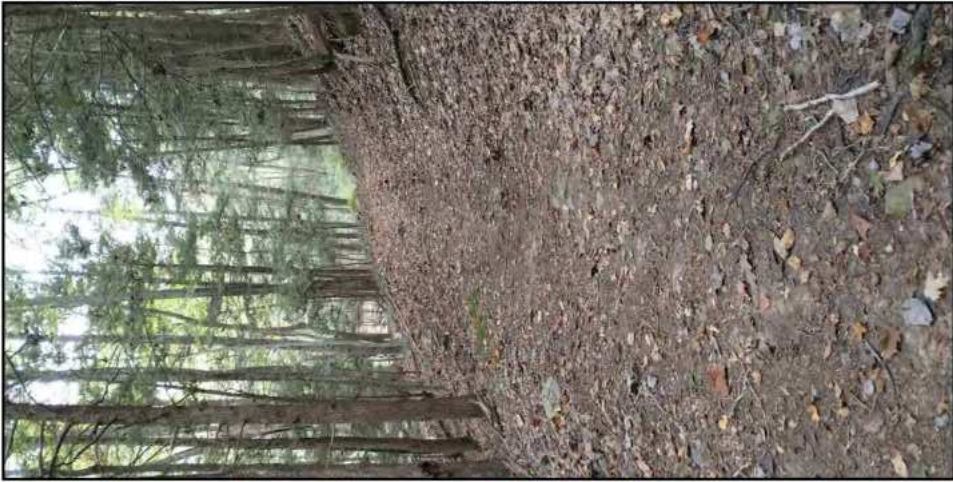
**Photo 3** – Looking northward on access road.

Several areas of erosion were noted along the access road. Additionally, some sections of the access road were muddy due to the presence of nearby seeps. As this access road is utilized as a trail and a wider trail system is developed, it is essential to ensure that erosion does not increase from additional use. Not only will sediment deposit from increasing erosion affect the water quality of the Four Mile Brook but could also become a public safety concern. Control measures could include: Turnout Installations, Waterbar Installations, Infiltration Steps, Micro-Catchment and Vegetation, Utilizing Snag Trees, Erosion Control Blankets, Rock Mulch Rundown.

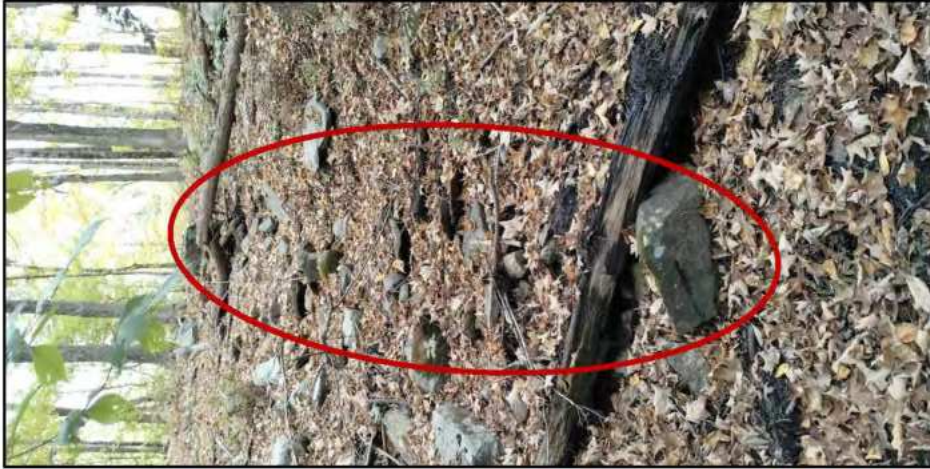
**Photo 6** – Intermittent stream with erosion (3).

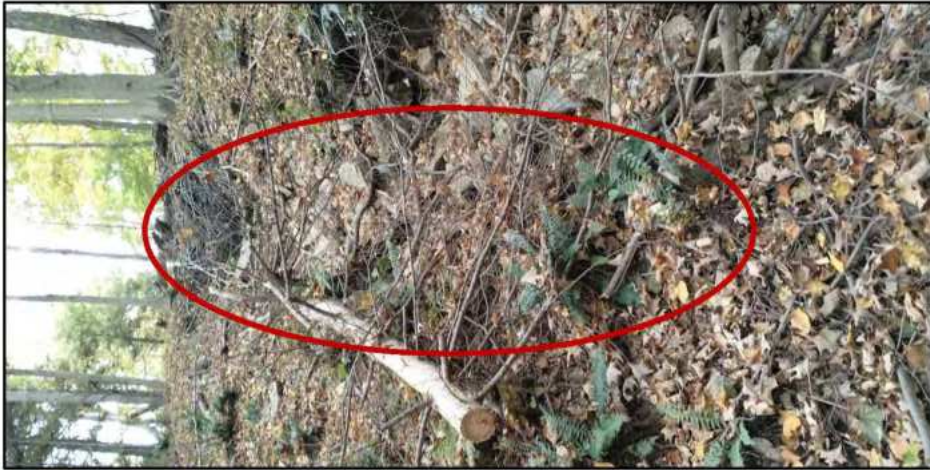
**Photo 5** – Intermittent stream with erosion (2).

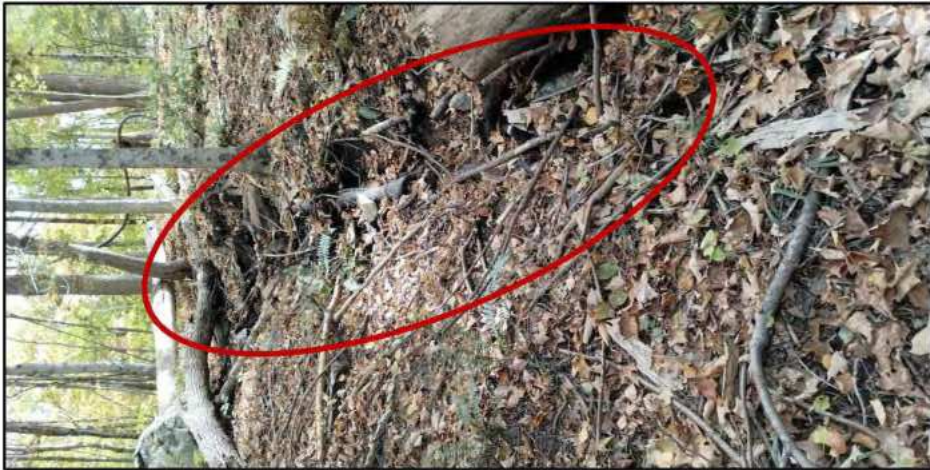
**Photo 4** – Intermittent stream with erosion (1).

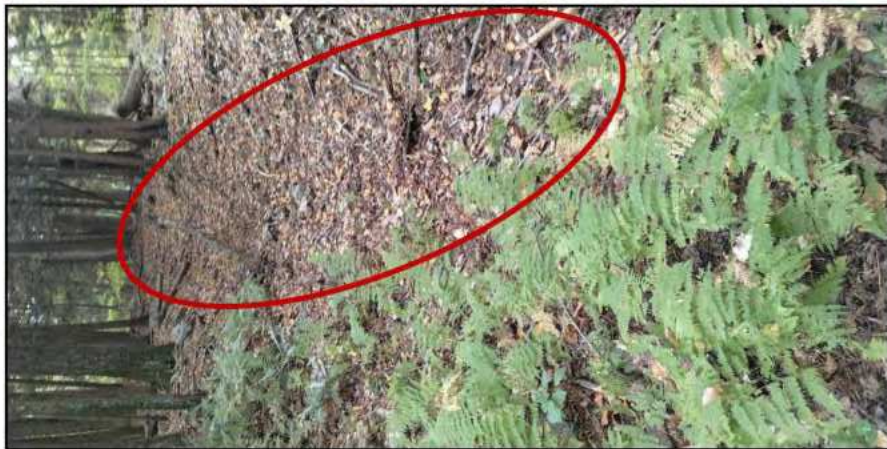
**Photo 7** – Intermittent stream on eastern slope.

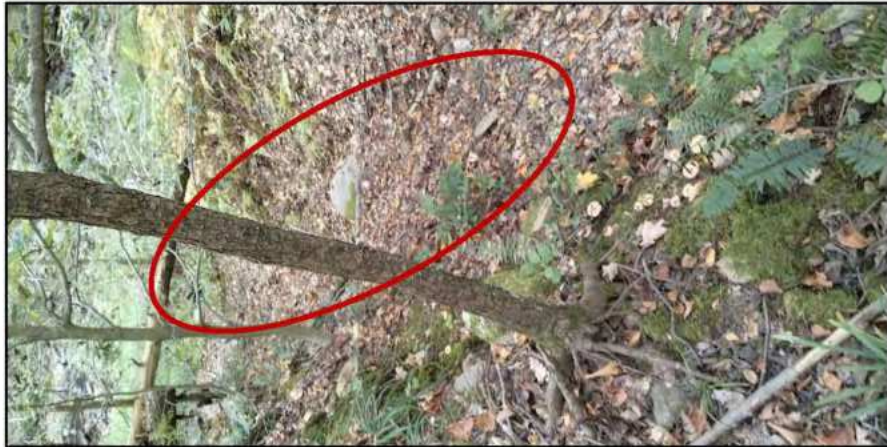
**Photo 8** – Intermittent stream on western side.

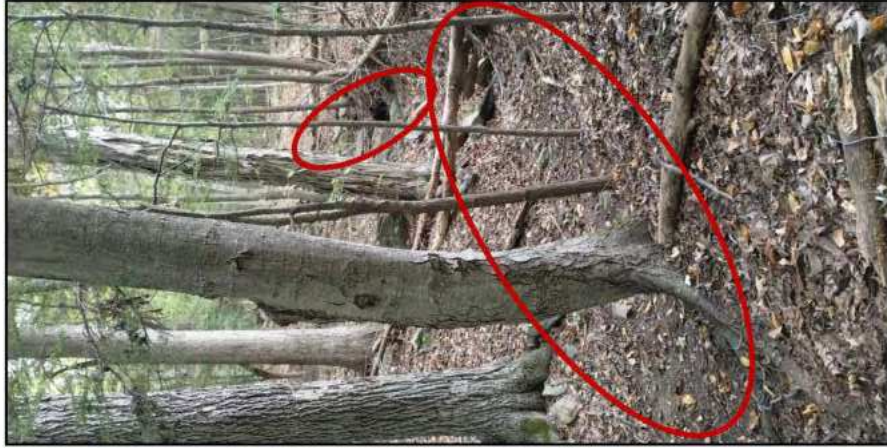
**Photo 9** – Intermittent stream in southern section.

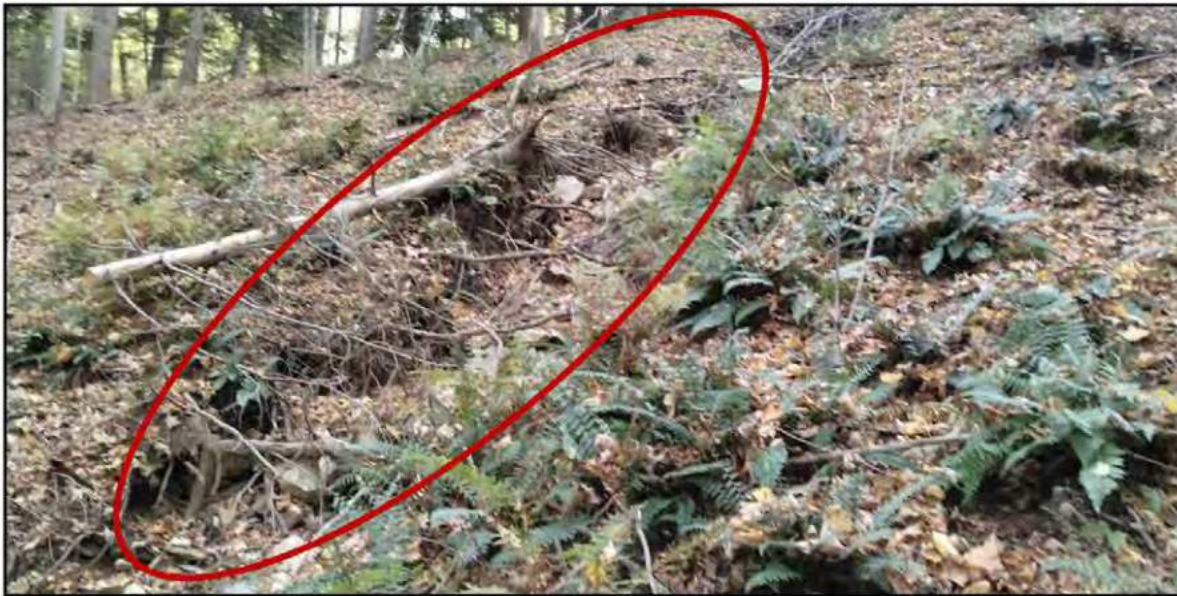
During the site visit, SWCD noted several areas of erosion along the access road (Photos 4, 5, 6, 10 & 12). Additionally, some sections of the access road were muddy due to the presence of nearby seeps (Photo 13). As this access road is utilized as a trail and a wider trail system is developed, it is essential to ensure that erosion does not increase from additional use. Not only will sediment deposition from increasing erosion affect the water quality of the Four Mile Brook but could also become a public safety concern.

**Photo 10** – Intermittent stream with erosion on eastern slope parallel to access road (4).

Turn outs are essentially lined ditches that redirect storm flows. They should be located approximately every 50 feet along the access road to ensure each turnout only handles a small amount of stormflow. Due to the steep slopes, we recommend placing 3"-6" angular stone riprap over non-woven geotextile fabric to line the turn out structures. Regular maintenance and periodic monitoring are essential to ensure that sediment doesn't build up and that stones do not shift to cause channelization.

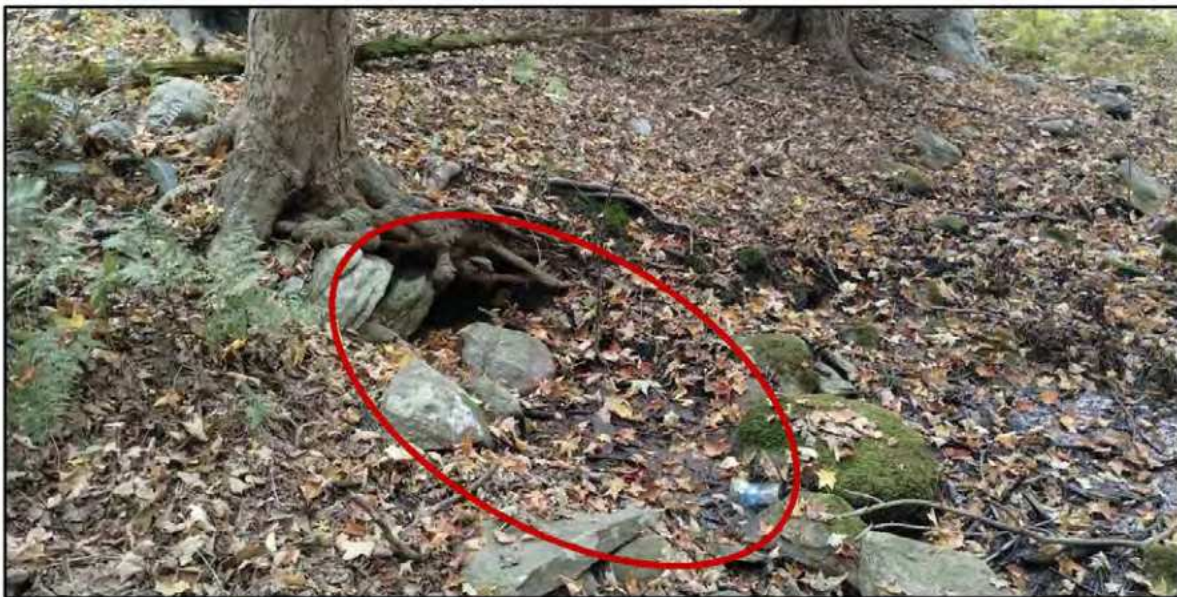
**Photo 11** – Seep located beneath tree on eastern slope parallel to access road.

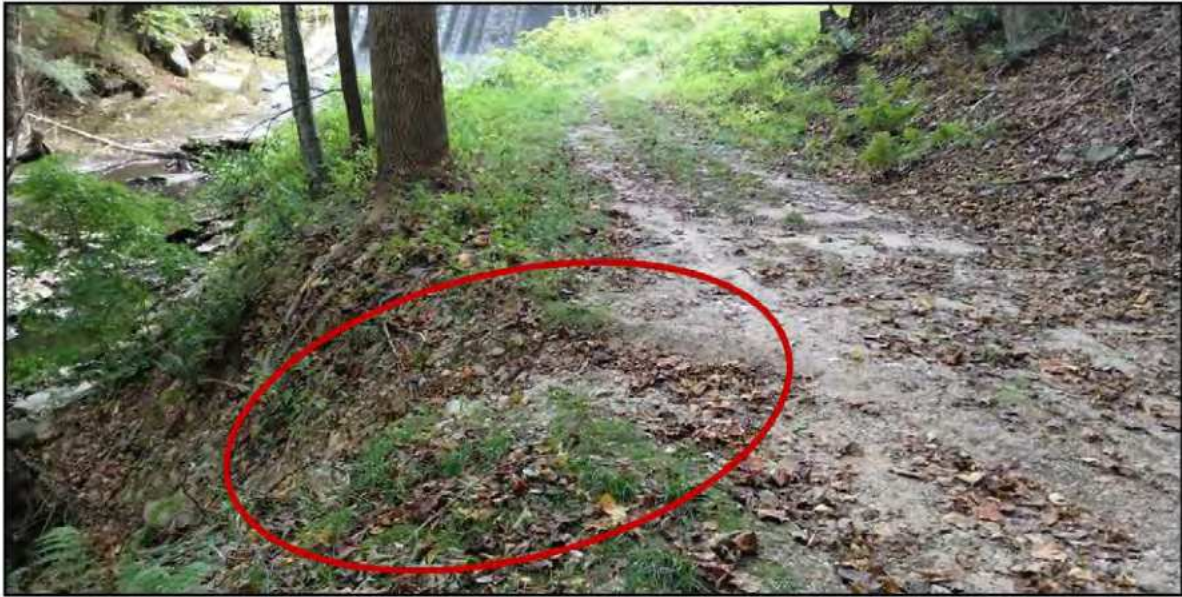
**Photo 12** – Erosion on access road. Looking northward towards the dam.

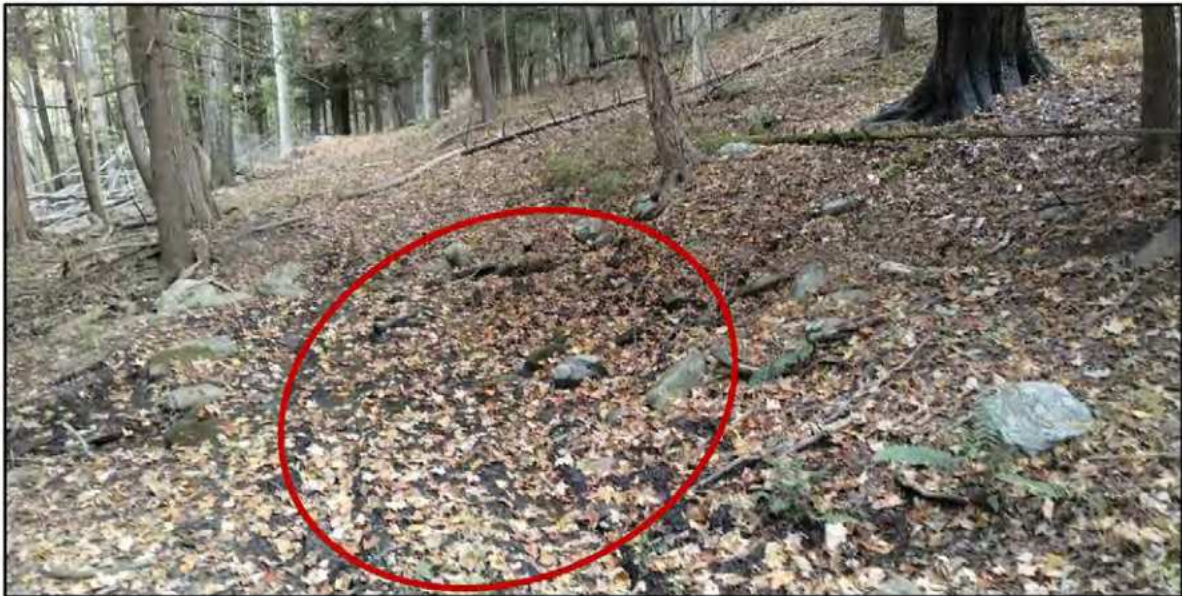
**Photo 13** – Nearby seep makes trail muddy. Stabilization is needed to protect soil & water quality and to keep trail accessible by visitors.

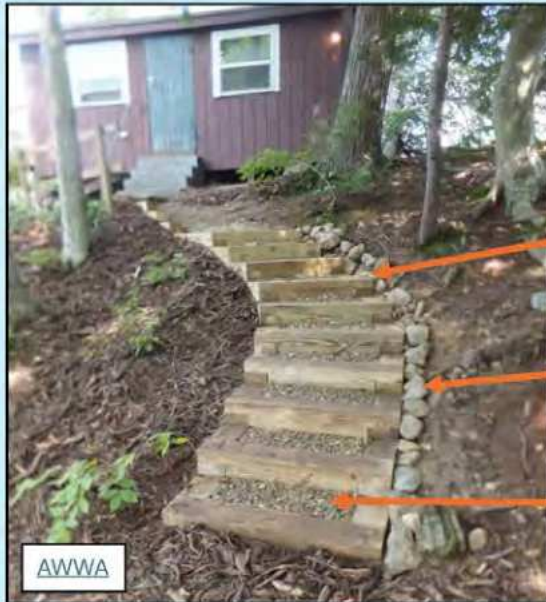
- Infiltration Steps: Alternatively, install infiltration steps to create access to the river. Maine's Acton Wakefield Watersheds Alliance (AWWA) created a great detailed [installation guide](#). Infiltration steps consist of framed steps (made of rot resistant wood, pressure treated wood, or composite). See the [SWCD's comparison guide](#) to help choose the best material. Side timbers on the steps are not necessary but can be used for more stability. Soil is excavated out from each step, geotextile material laid down, and pea stone and crushed stone are used to fill in each step.

Example of infiltration steps with side timbers.

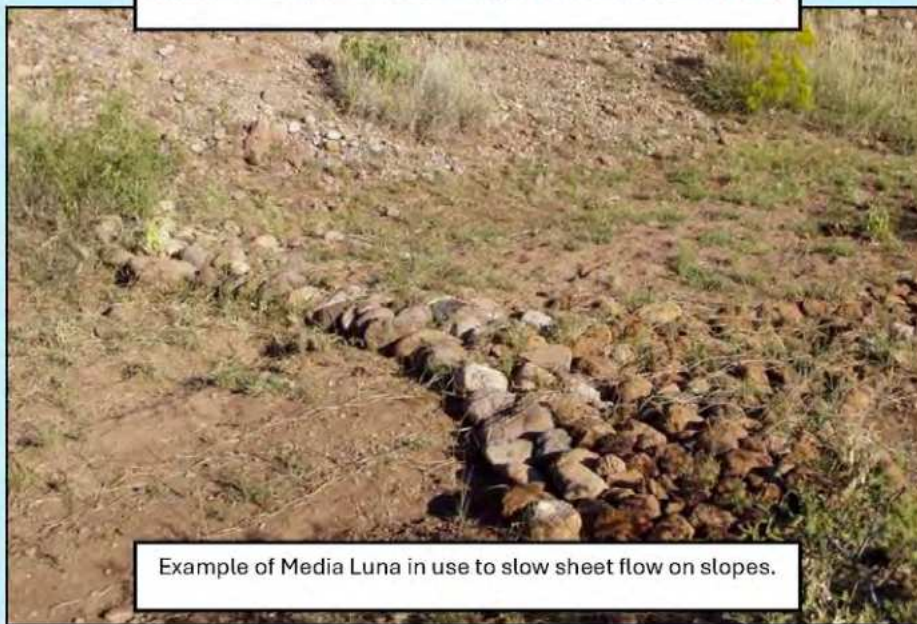
Example of Media Luna in use to slow sheet flow on slopes.
