# NATURAL RESOURCES INVENTORY

124 SQUANTUCK ROAD  
SEYMOUR, CONNECTICUT

APRIL 2025

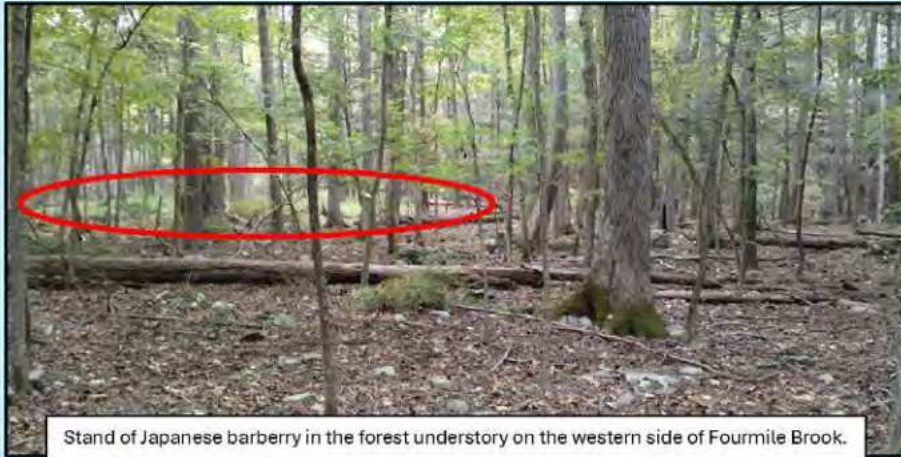
Stand of Japanese barberry in the forest understory on the western side of Fourmile Brook.

To control this invasive, which often forms dense patches, utilize a combination of multiple removal methods. Hand pull or use a weed wrench to remove. Refer to <https://cipwg.uconn.edu/japanese-barberry/> for more information about removal.

Alternatively, use directed flame of a propane torch or controlled burning. Once the plants have been initially cut, and resprouts have appeared, a propane torch can be directed at the crown of each plant. Two torch treatments per year can be effective – once before leaf out (March-June) and a follow up (July-August). Avoid using propane torches during dry, fire prone conditions to prevent wildfire. Follow detailed instructions and guidance by the [CT Agricultural Experiment Station](#).

Another option is to use herbicides. The cut stump application method has less negative environmental impact compared to foliar spraying. Cut and apply a systemic herbicide, like triclopyr, to the fresh stumps. Please consult a licensed pesticide applicator if deciding to use chemical removal, it is necessary because it's a municipally owned property.

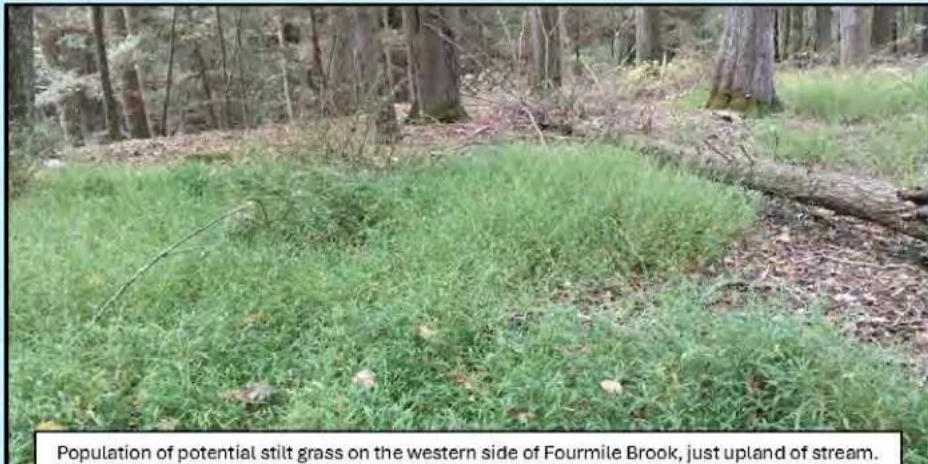
Population of potential stilt grass on the western side of Fourmile Brook, just upland of stream.

To control this annual invasive, hand pull in July before it sets seed. Alternatively, cut back regularly on a low setting to reduce seed production but note that seeds that are already there will remain viable for 5 years. Refer to [https://ipm.cahnr.uconn.edu/invasive\\_plants\\_japanese\\_stiltgrass/](https://ipm.cahnr.uconn.edu/invasive_plants_japanese_stiltgrass/) for more options and background.

Positively identify before removal. While out in the field, we did not check for the characteristics to ensure that the populations on the site were not the native white grass (*Leersia virginica*). Stilt grass has a silver line along the midrib of the leaf, non-hairy leaf nodes, and foliage that turns purple in the fall. White grass doesn't have the silver line, has hairy leaf nodes and foliage remains green in the fall. These resources may also help: [bplant.org](http://bplant.org) and [Wisconsin DNR](http://WisconsinDNR).

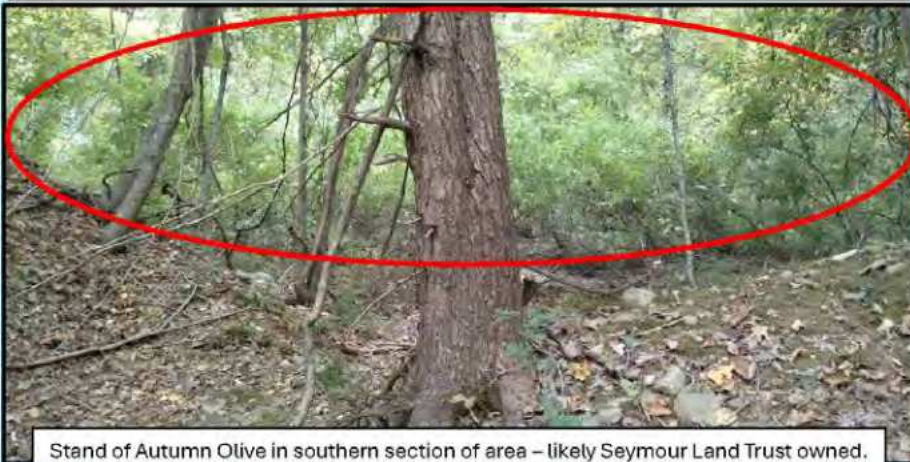
Stand of Autumn Olive in southern section of area – likely Seymour Land Trust owned.

To control this perennial invasive, cut in late September and October (cutting in spring should be avoided as it may promote new growth) and repeat for multiple years. This will deplete the plant's energy resources. For small to medium shrubs, use a digging fork or weed wrench to remove. For larger trees, girdling is an effective way to kill without cutting down the whole tree. Make a deep cut into the bark around the entire trunk about 6 inches above the ground. Refer to [https://ipm.cahnr.uconn.edu/invasive\\_plants\\_autumn\\_olive/](https://ipm.cahnr.uconn.edu/invasive_plants_autumn_olive/) for more information.

Another option is to use herbicides. The cut stump application method has less negative environmental impact compared to foliar spraying. Cut and apply a systemic herbicide, like triclopyr, to the fresh stumps. Please consult a licensed pesticide applicator if deciding to use chemical removal, it is necessary because it's a municipally owned property.

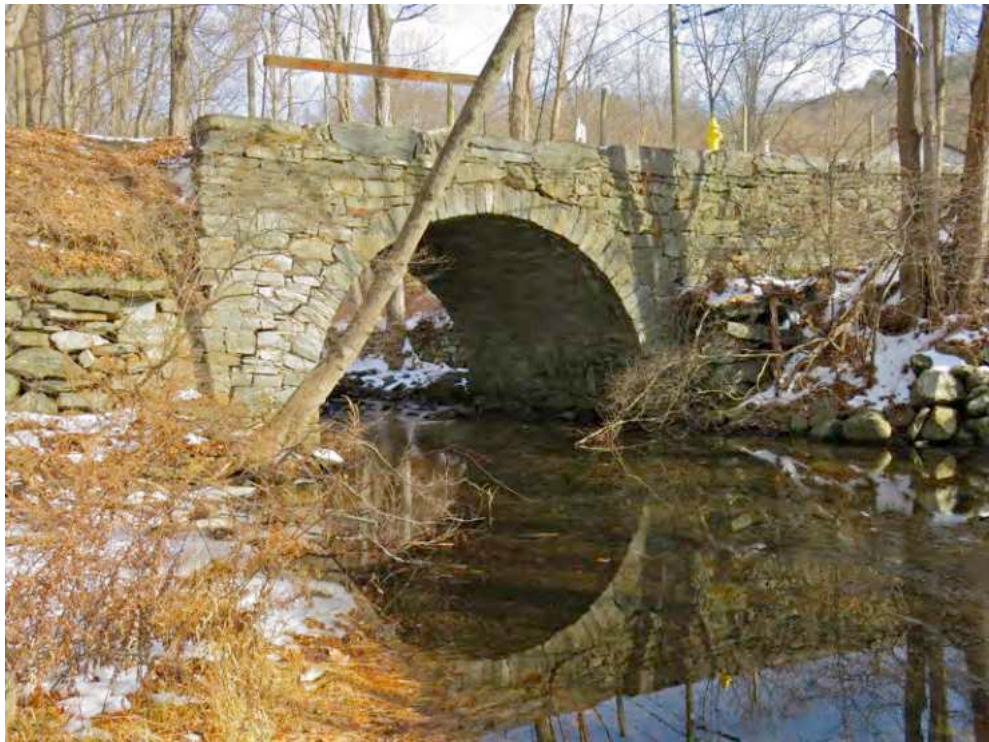
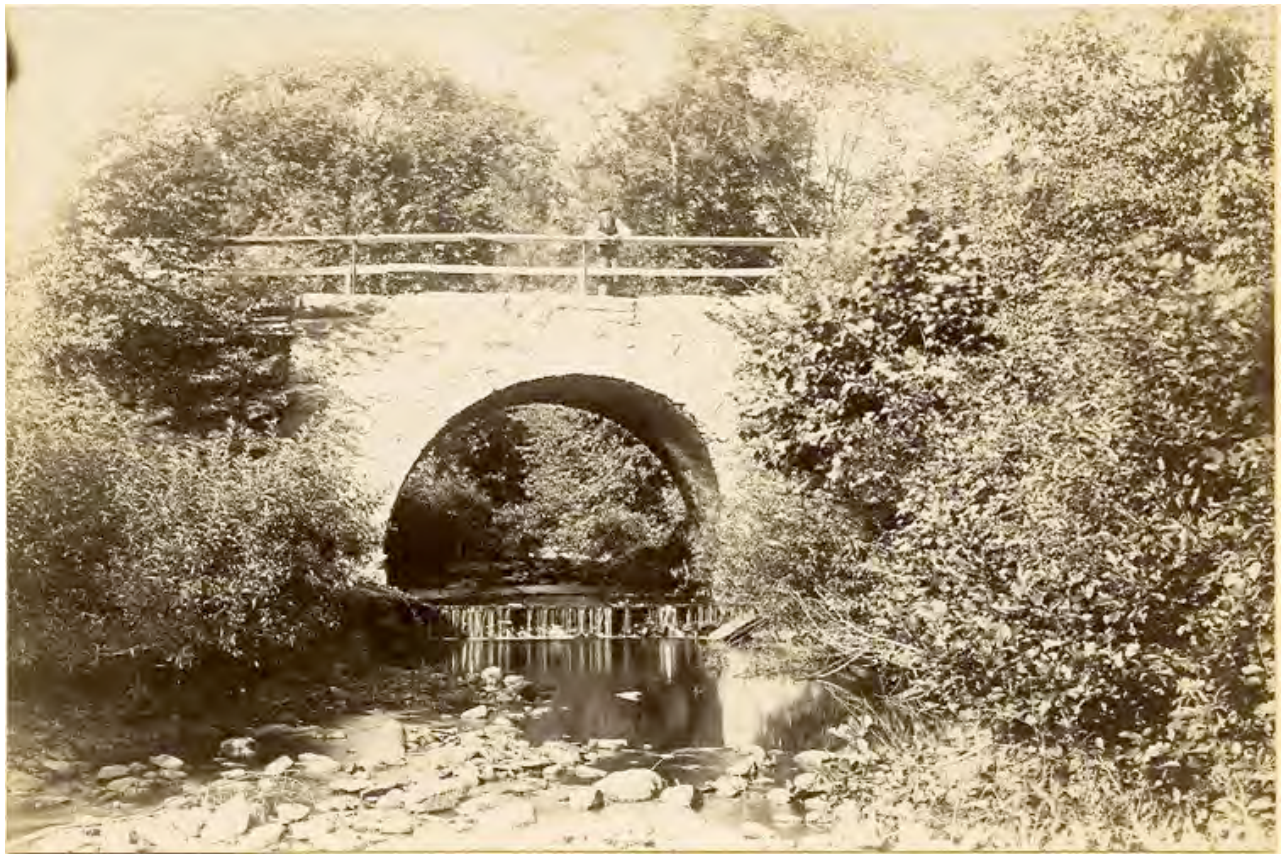
Below is a photo of the keystone bridge found at the Keith Mitchell Trailhead off today’s Route 34. This bridge originally carried ox carts, wagons and later automobiles over the Four Mile Brook. A new bridge was constructed by Connecticut Highway Department in 1935, about 100 feet downstream from the keystone bridge.

*Keystone bridge in 2012.*

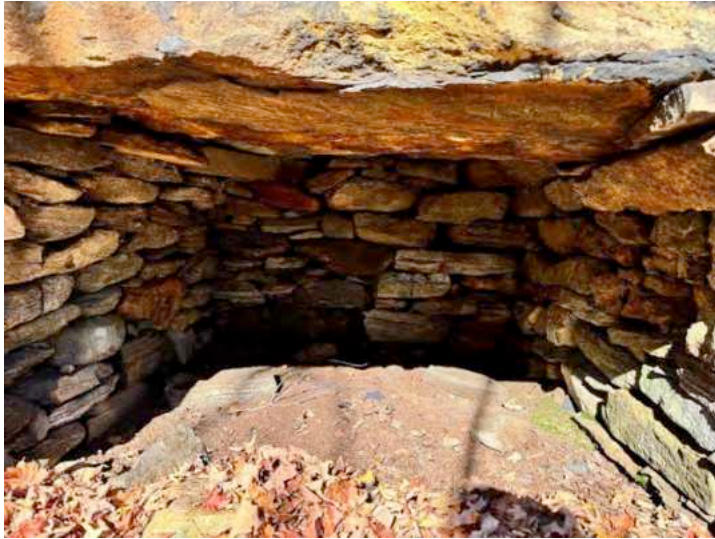
*Mysterious hole in the face of the dam.*

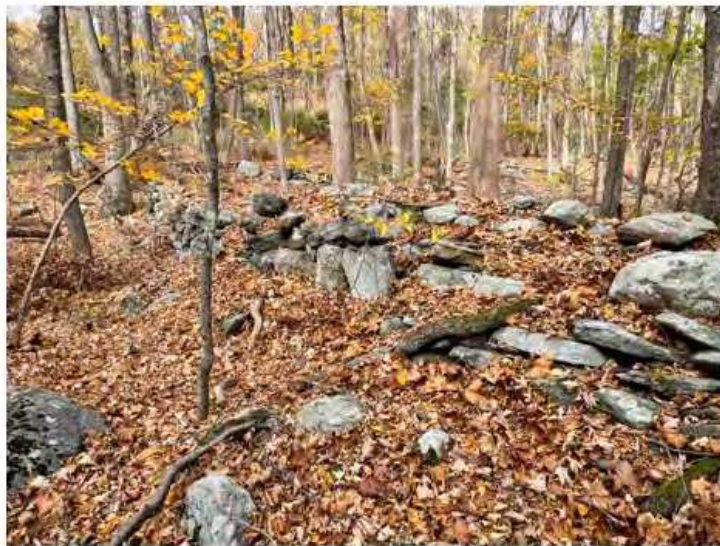
Dam 2

A small dam that served to divert water to a race for Dam #1

Remains of the race and supply pond are visible. Most of this dam has deteriorated. Remains of a zig-zag stone wall can be seen along the race. This dam may be the oldest in this area. It was used to divert water through a sluiceway to dam #1. There is also evidence that it diverted water from Four Mile Brook to the old millpond along “The Island” as indicated on the LiDAR map.

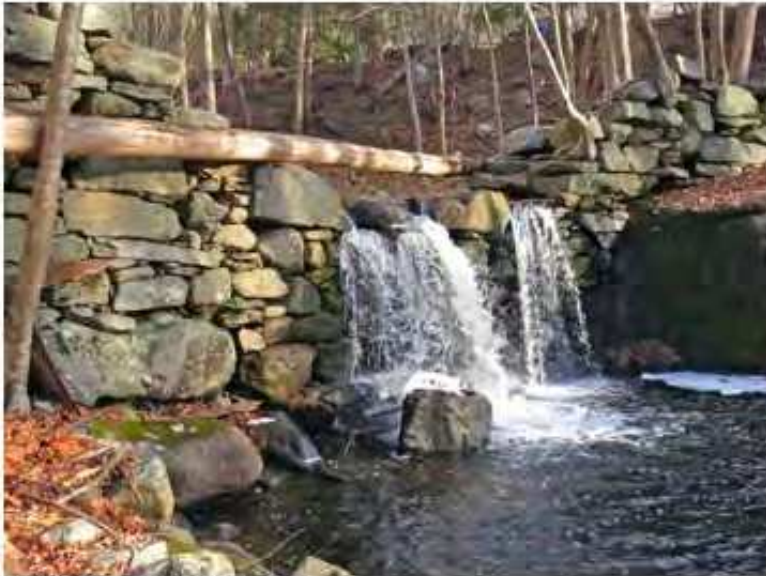
**Dam #3 – J.W. Tomlinson Sawmill**

This is a large dam partially breached with a 7-foot waterfall. An old road from Route 188 leads to this dam and mill. There are very well preserved remains of a mill foundation, wheel well, race, penstock, chimney, millpond. This was the sawmill owned by J. W. Tomlinson James Willard Tomlinson Born in January 1834 Parents: Son of James C. and Laura Tomlinson, 5<sup>th</sup> of 8 children. They resided in Wesquantuck. James C. died on June 5, 1856 and Laura on March 6, 1863. James Willard Tomlinson married Frances M. Wooster, July 23, 1864. He had two children (Sharpe). J.W. and Laura had two children: Laura born November 15, 1865 and Arthur born on April 15, 1867. J.W. Tomlinson was a “Dealer and Manufacturer of Lumber in Squantuck” from the 1868 map.

J.W. Tomlinson Saw mill

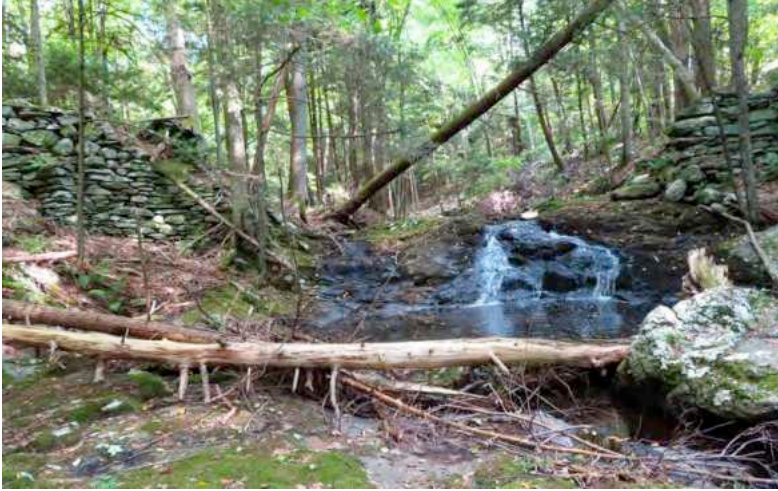
#### **Dam #4 – An unknown milldam and millpond**

I could find no mention of this dam and mill on any of the old Seymour maps and references. The early settlers of Great Hill and Squantuck may have built. There were no other streams along Great Hill Road, and they would have needed a gristmill. The Four Mile Brook. Would have met that need. The footprint of the mill appeared smaller than the first two dams.

*Breached dam*

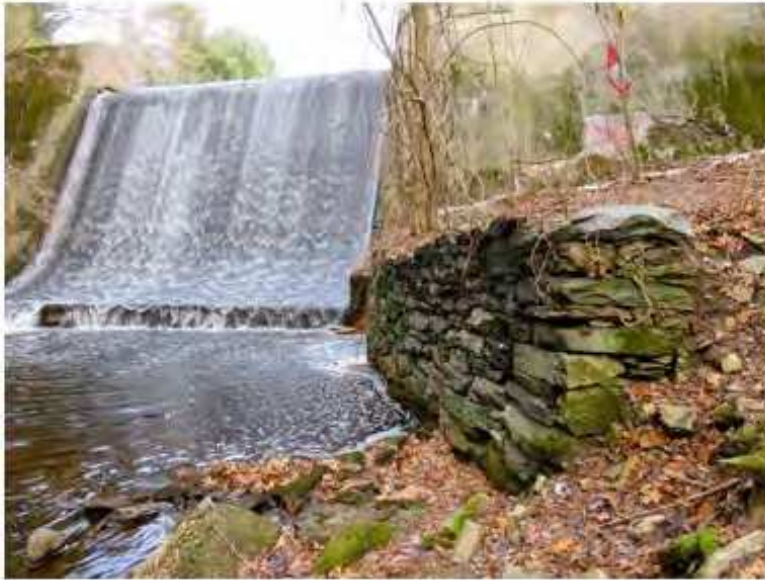
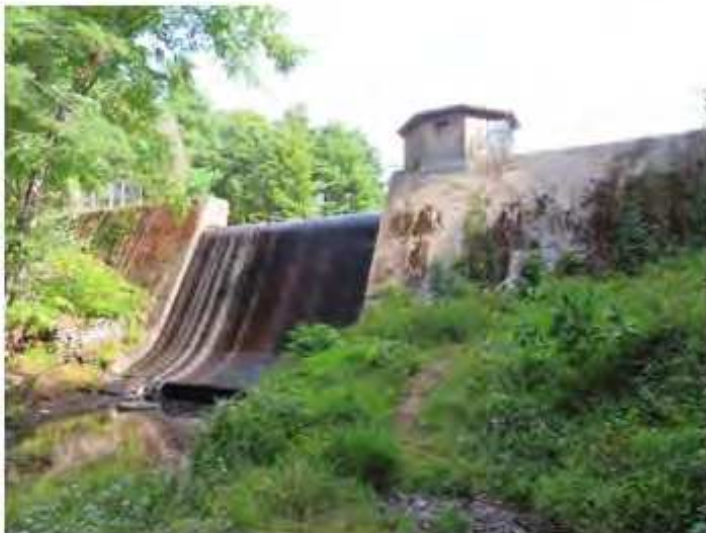
**Dam #5 – The reservoir dam**

The dam for the Great Hill Reservoir. Surface area approximately 11 acres. Part of the upper pond is owned by Oxford. The reservoir has three beaver lodges of which one may be active. The reservoir is fished and used by rowboats. People have ice fished there. Eagles and great blue herons have been seen.

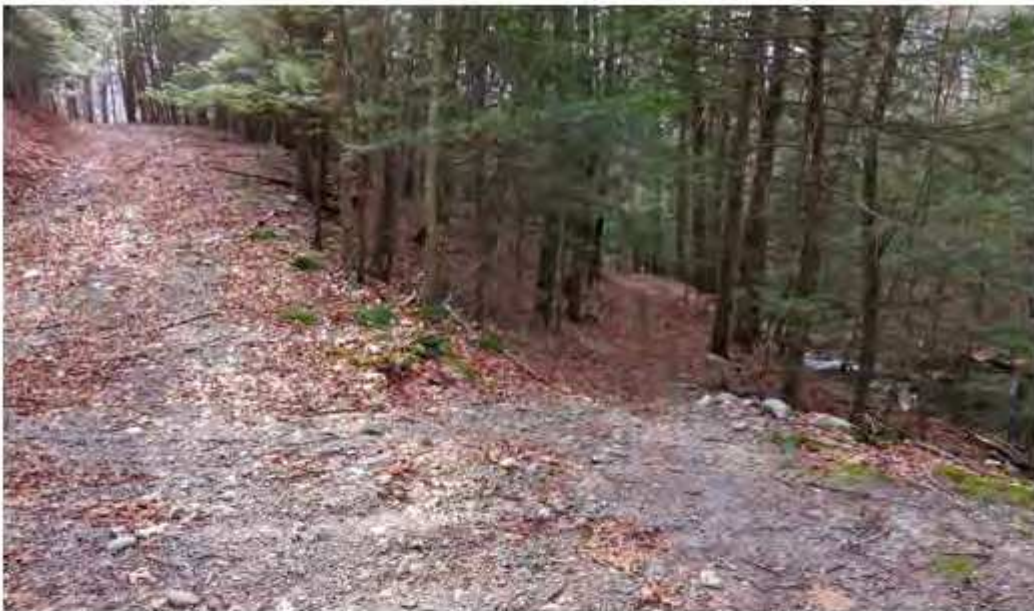
This dirt road from Rte 188 leads to the dam. The partially abandoned Hull Road coming down from upper Seymour crosses Rte 188 and meets up with the dam road. Taking a right here leads to the old road in the previous photos.

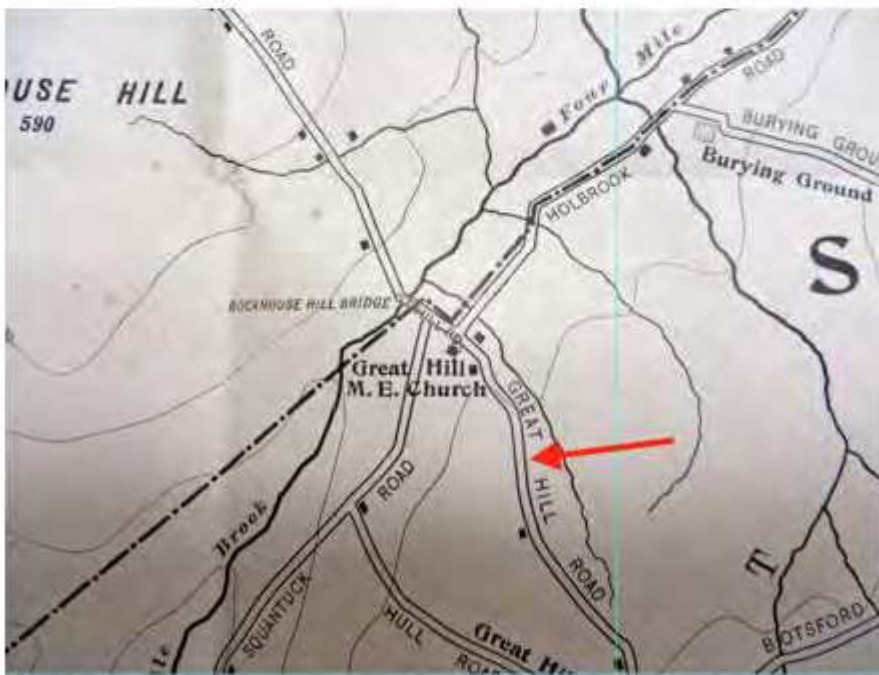
Hull Road crosses Squantuck Road and travels down to the dam. People from upper Great Hill used this road to access the Woodbury Path to Rockhouse Hill and Woodbury.
