# ENVIRONMENTAL REVIEW TEAM REPORT

## JORDAN PROPERTY ACQUISITION BROOKFIELD, CONNECTICUT

JORDAN PROPERTY ACQUISITION  
BROOKFIELD, CONNECTICUT  
JUNE, 1978

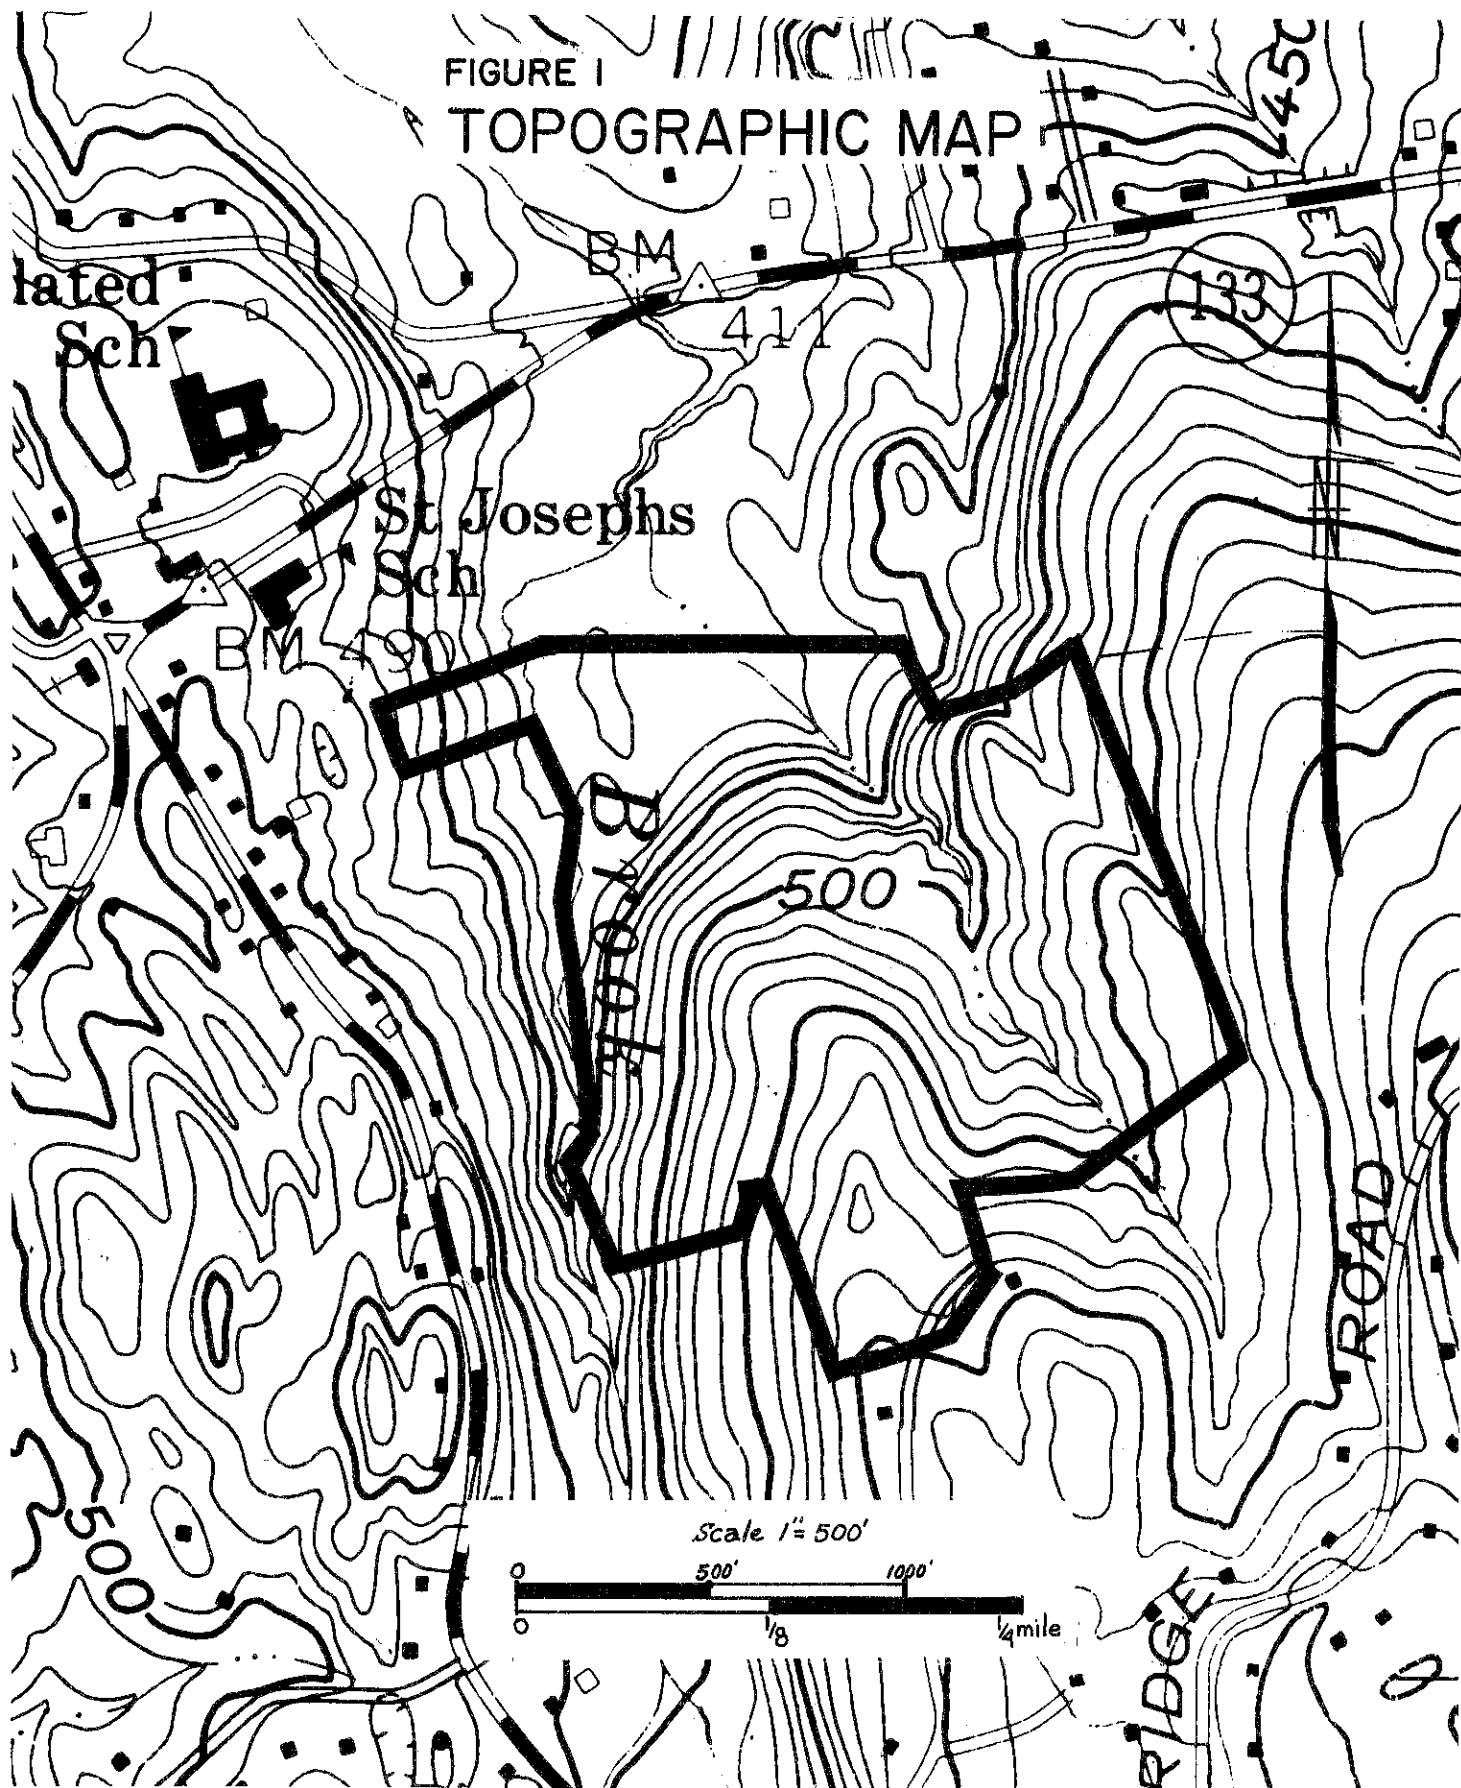
FIGURE 1

TOPOGRAPHIC MAP

The property consists of a gently rolling hilltop and steeply sloping ( $\pm 15\%$ ) north slope of varied and interesting landscape (see Figure 1). The hillside rises between the narrow flood plains of Merwin Brook and the un-named brook transversing the property to the east. In the north-western part of the site, the slope is flatter but somewhat irregular. East of the un-named brook, the land surface is knobby because of the proximity of bedrock which crops out in many places. Elevations on the property range from a low of 420 feet at the northern tip of the parcel to a high of 590 feet on the southern border.

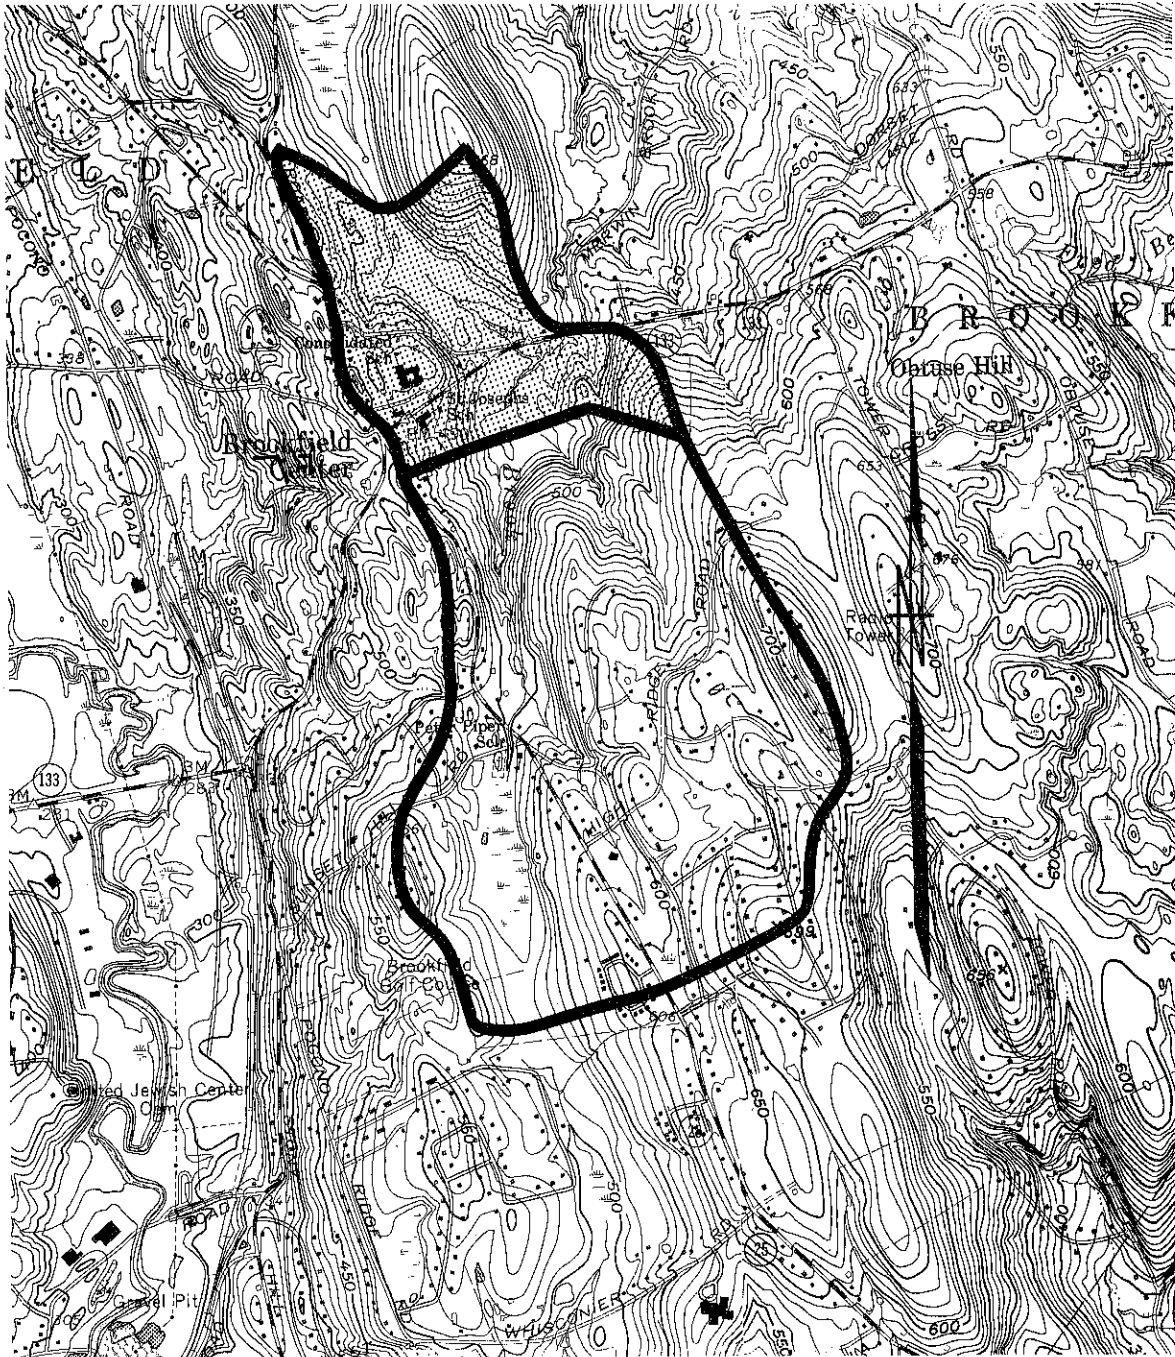
## FIGURE 2 WATERSHED MAP

Drainage area of the two brooks that flow through the Jordan Property. Non-shaded section shows drainage area to the points of exit of the two brooks from the property. Shaded section shows additional runoff supply area that contributes to Merwin Brook as far as Route 133.

Runoff from the Jordan Property flows either into Merwin Brook or an un-named brook to the east. The two brooks merge north of the property; Merwin Brook continues flowing north for about 1.7 miles and enters a cove of Lake Lillinonah (Housatonic River). The drainage area that supplies the two brooks up to the points at which they leave the property is shown in Figure 2; approximately 505 acres is contained. The additional drainage area, approximately 145 acres, that supplies Merwin Brook as far as Route 133 also is shown on that figure.

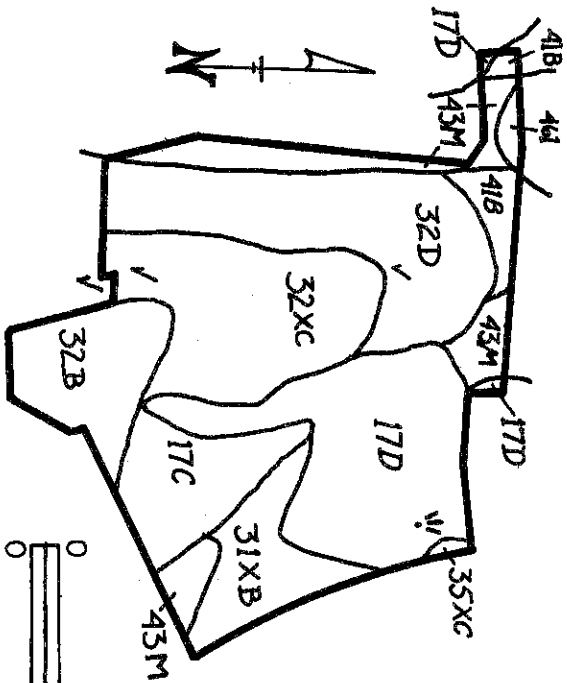
# SOILS MAP

Prepared by USDA-SCS  
1978  
Advance copy  
Subject to change.

SCALE 1" = 660'

A detailed soil survey map of the property is presented in the appendix of this report together with a description of all soils identified on the property.
