REPORT FOR  
**GRACE RICHARDSON AND HOYDEN HILL  
OPEN SPACE AREAS**

FAIRFIELD,  
CONNECTICUT

Environmental Review Team Report

**FEBRUARY 1990**

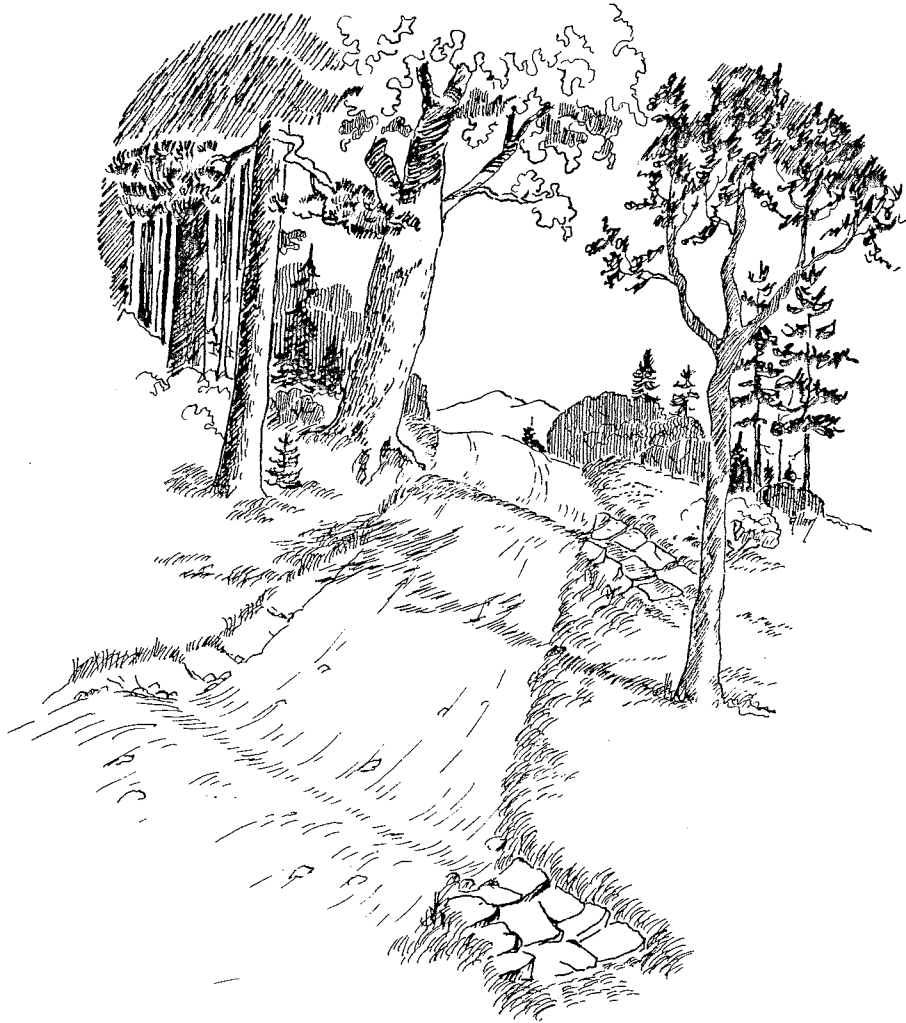
## FEATURES OF A PROTECTED ROAD

1. Water break at head of slope.
2. Water break at proper distance midslope.
3. Water break at about  $30^{\circ}$  angle down slope.
4. Riprap of stone at diversion outlet.
5. Road is outsloped.

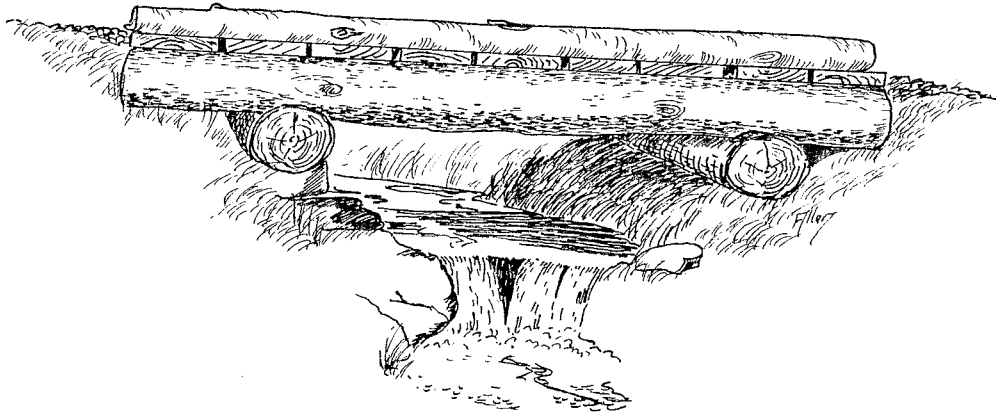
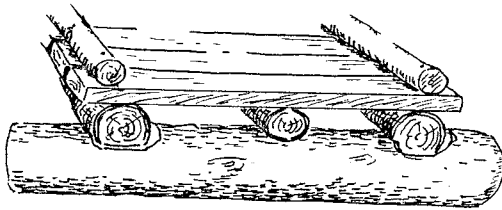
## A SIMPLE LOGGING ROAD BRIDGE DESIGN

1. Bridge streams crossings if there is a potential sediment or pollution source.
2. Use alternate road location to avoid the necessity of a bridge, if possible.
3. Bridge crossing should be located where the stream channel is straight with an unobstructed flow of water.
4. Abutments should be in a direction parallel to the stream flow and imbedded in good foundation material.
5. Locate at right angles to stream flow where approaches are reasonably level for a minimum of 50 feet from both sides.
