Mt. Hygeia Reservoir

Killingly, Connecticut

ENVIRONMENTAL

REVIEW TEAM

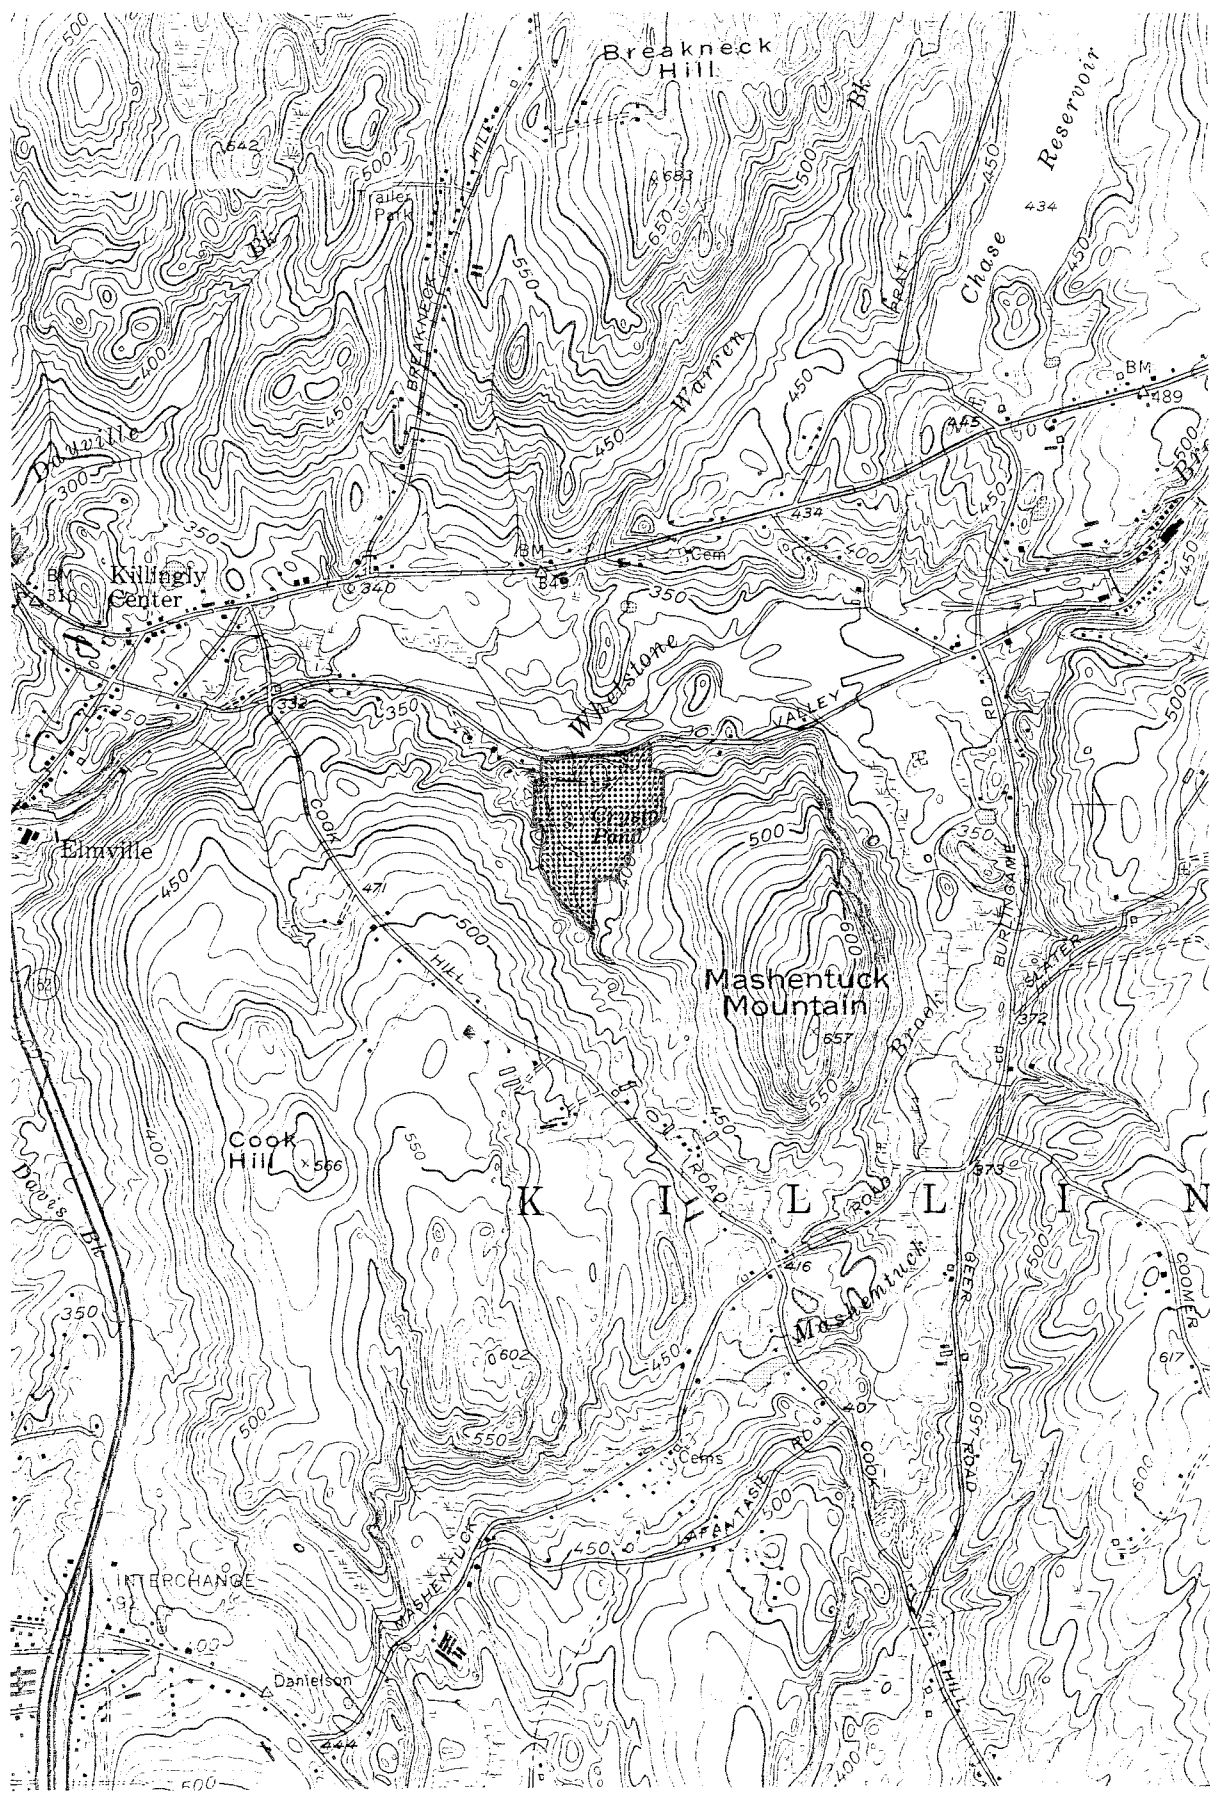
LOCATION

Scale 1" = 2000'

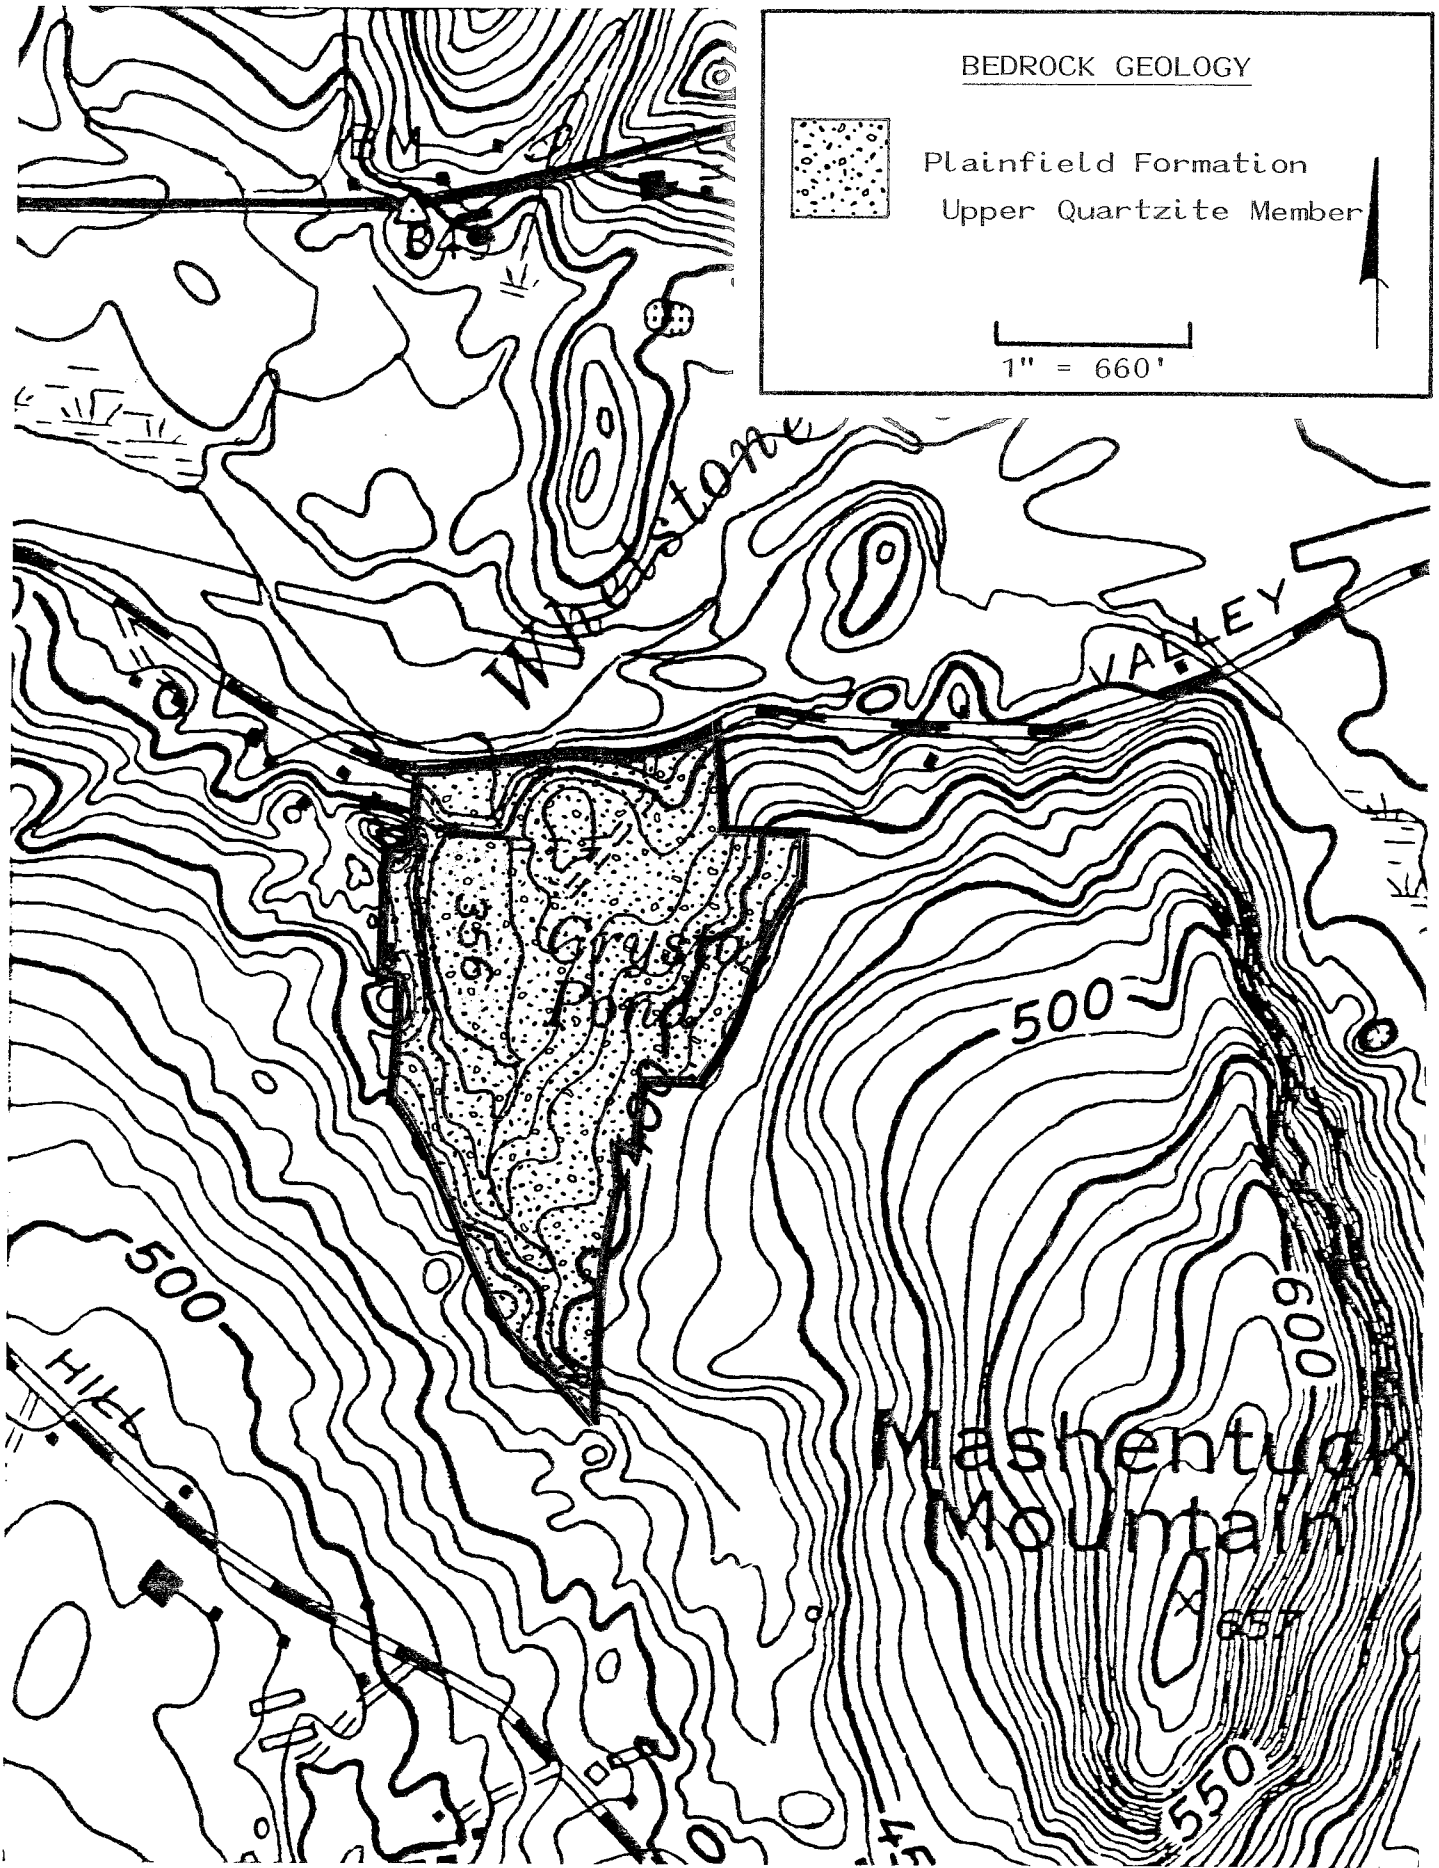
Plainfield Formation
Upper Quartzite Member

1" = 660'

The underlying bedrock is a source of domestic water to many homes in the area. A northwest/southeast trending fault zone that runs parallel to Cook Hill Road is reported south of the site. Because of its close proximity to the site, it is expected that the upper few hundred feet of the bedrock is fractured and weathered. The fault mentioned above is a structural feature that formed during the geologic past but is no longer experiencing active movement.

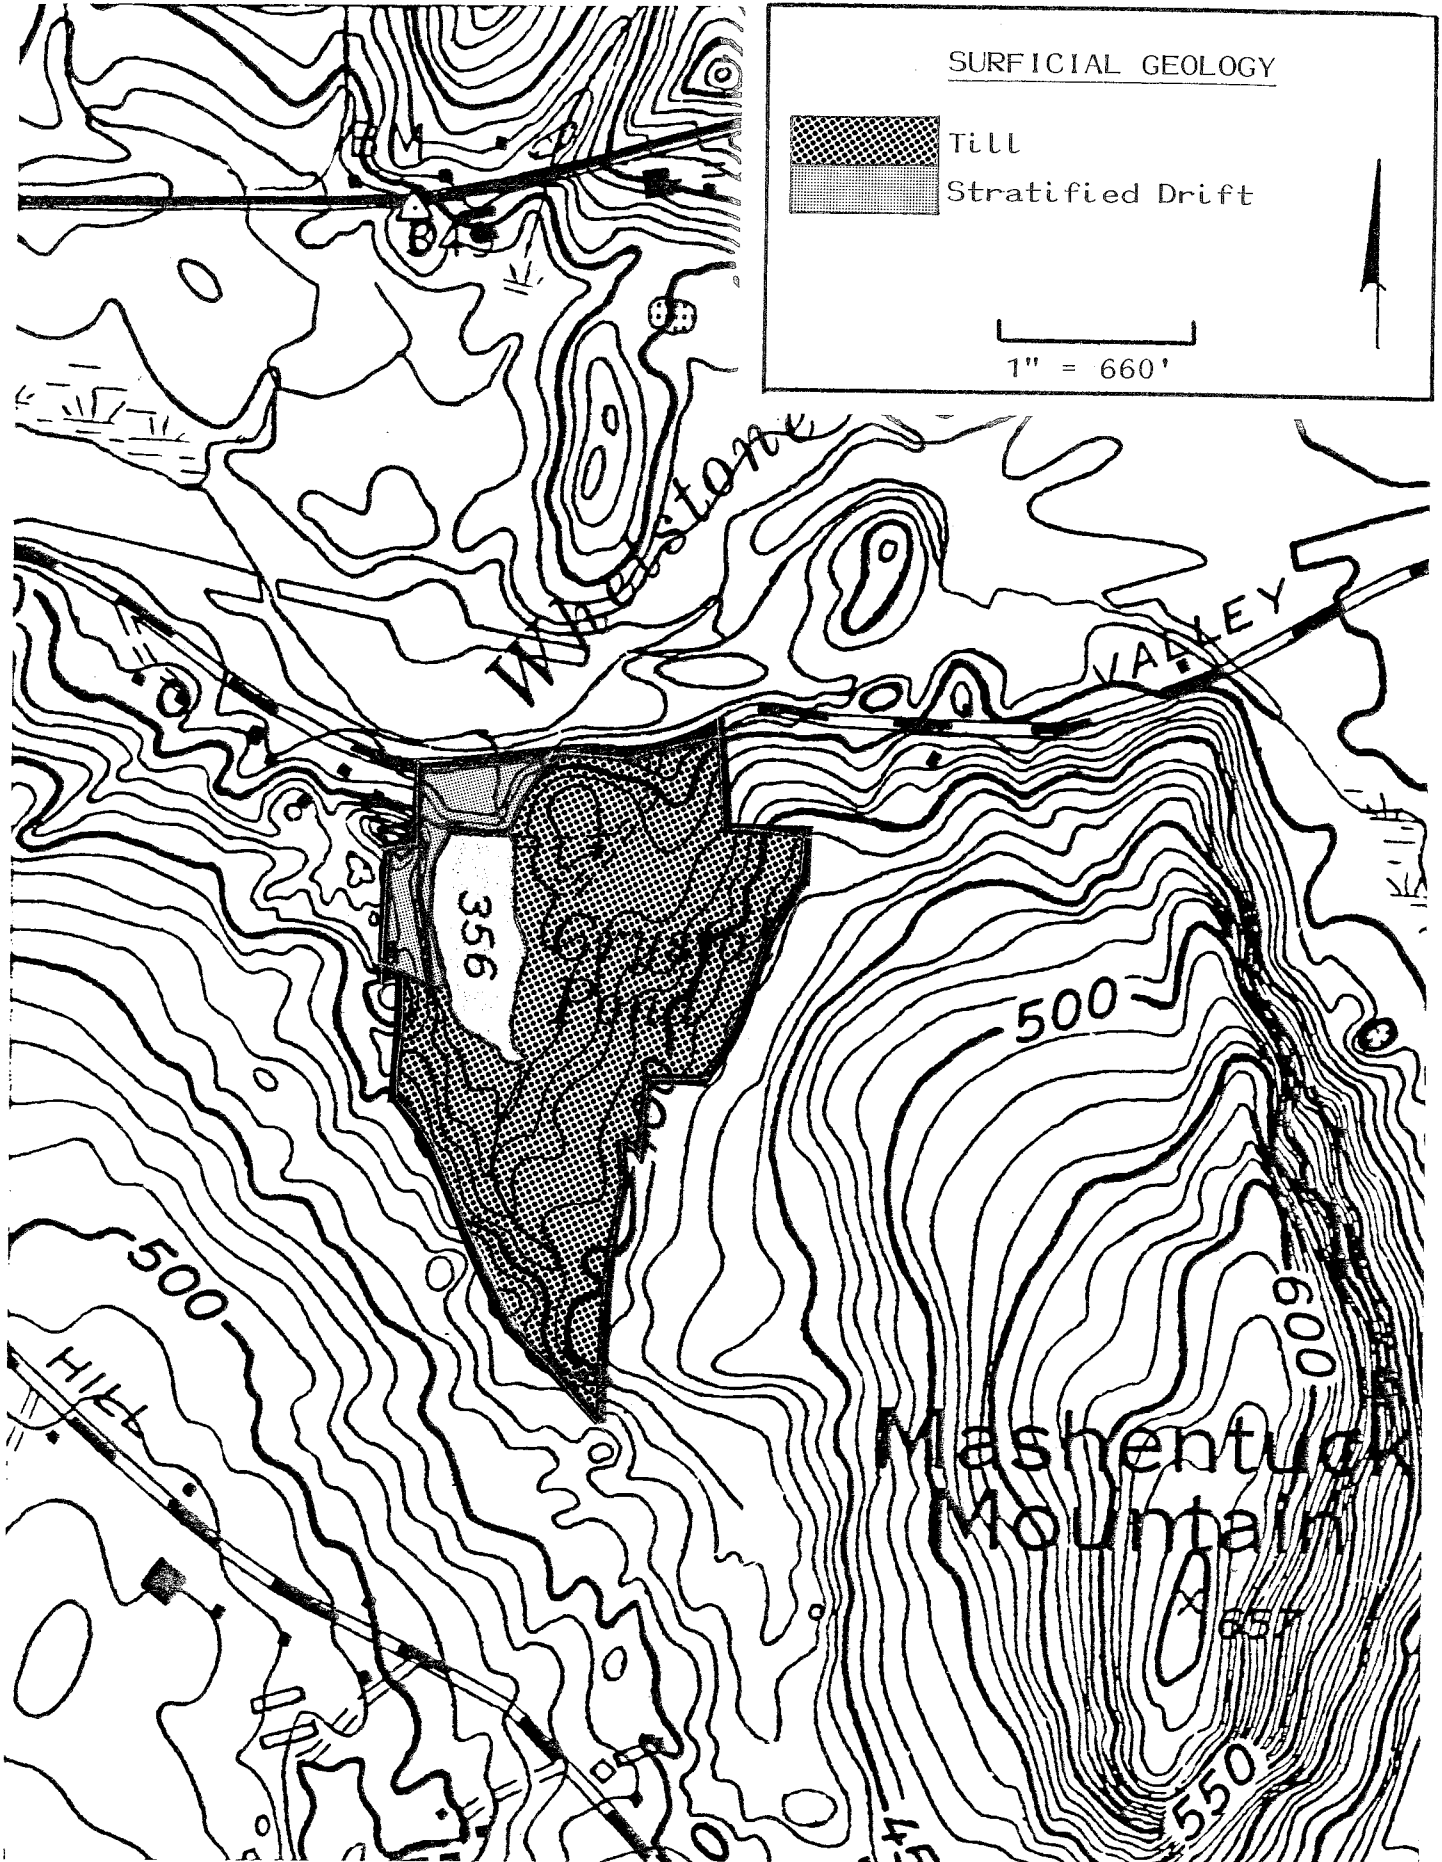
SURFICIAL GEOLOGY

Till
Stratified Drift

1" = 660'

outcrops and bulldozed pre-existing soils, incorporating the rock particles into the ice mass. These particles were then plastered against bedrock ridge and knobs by the ice as it continued its advance, or were let down gently from the ice as it began to waste away. The nonsorted accumulation of rock fragments that resulted contains a wide range of sizes and shapes and is known as till.

Based on soil data mapping the texture of the till on the parcel is mostly sandy, stony and loose. Flanking the westside of the site and north of the spillway for the reservoir, are deposits of sand and gravel. These materials, known as stratified drift, were washed out of and away from the receding ice stream by meltwater streams. Sand and gravel has been mined from this area in the past.

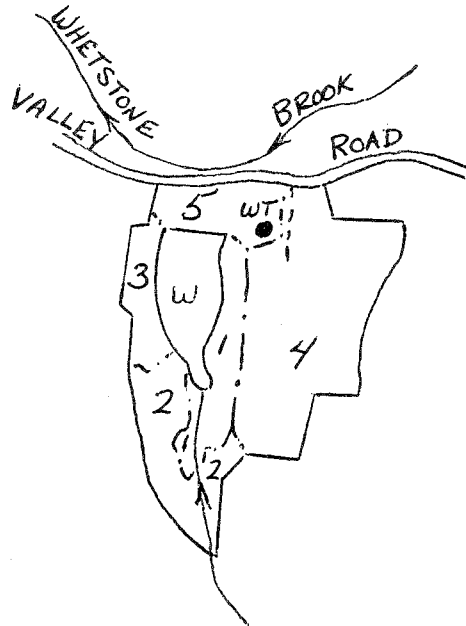
SCALE: 1" = 1000'

<u>LEGEND</u>	
	STREAM
	PUBLIC ROAD
	ACCESS ROAD
	WATER TOWER
	PROPERTY BOUNDARY
	VEGETATION TYPE BOUNDARY

VEGETATION TYPE DESCRIPTIONS*

The proposed utilization of the forested areas of the parcel for recreation development will impact the vegetation negatively dependent upon the extent of clearing, which depends upon the magnitude of development. Removal of some vegetation to open up areas proposed for passive recreation to increase sunlight and airflow must be considered. Clearing operations, where possible, should remove only the lowest quality trees and those which are a direct hazard to area users. The healthier, more vigorous trees should be retained where possible for their high shade and aesthetic value.
