**BULL HILL
TREE FARM
PONDS**

**Marlborough, Connecticut
May 1990**

*Eastern Connecticut
Environmental Review Team
Report*

**ENVIRONMENTAL REVIEW TEAM REPORT
ON**

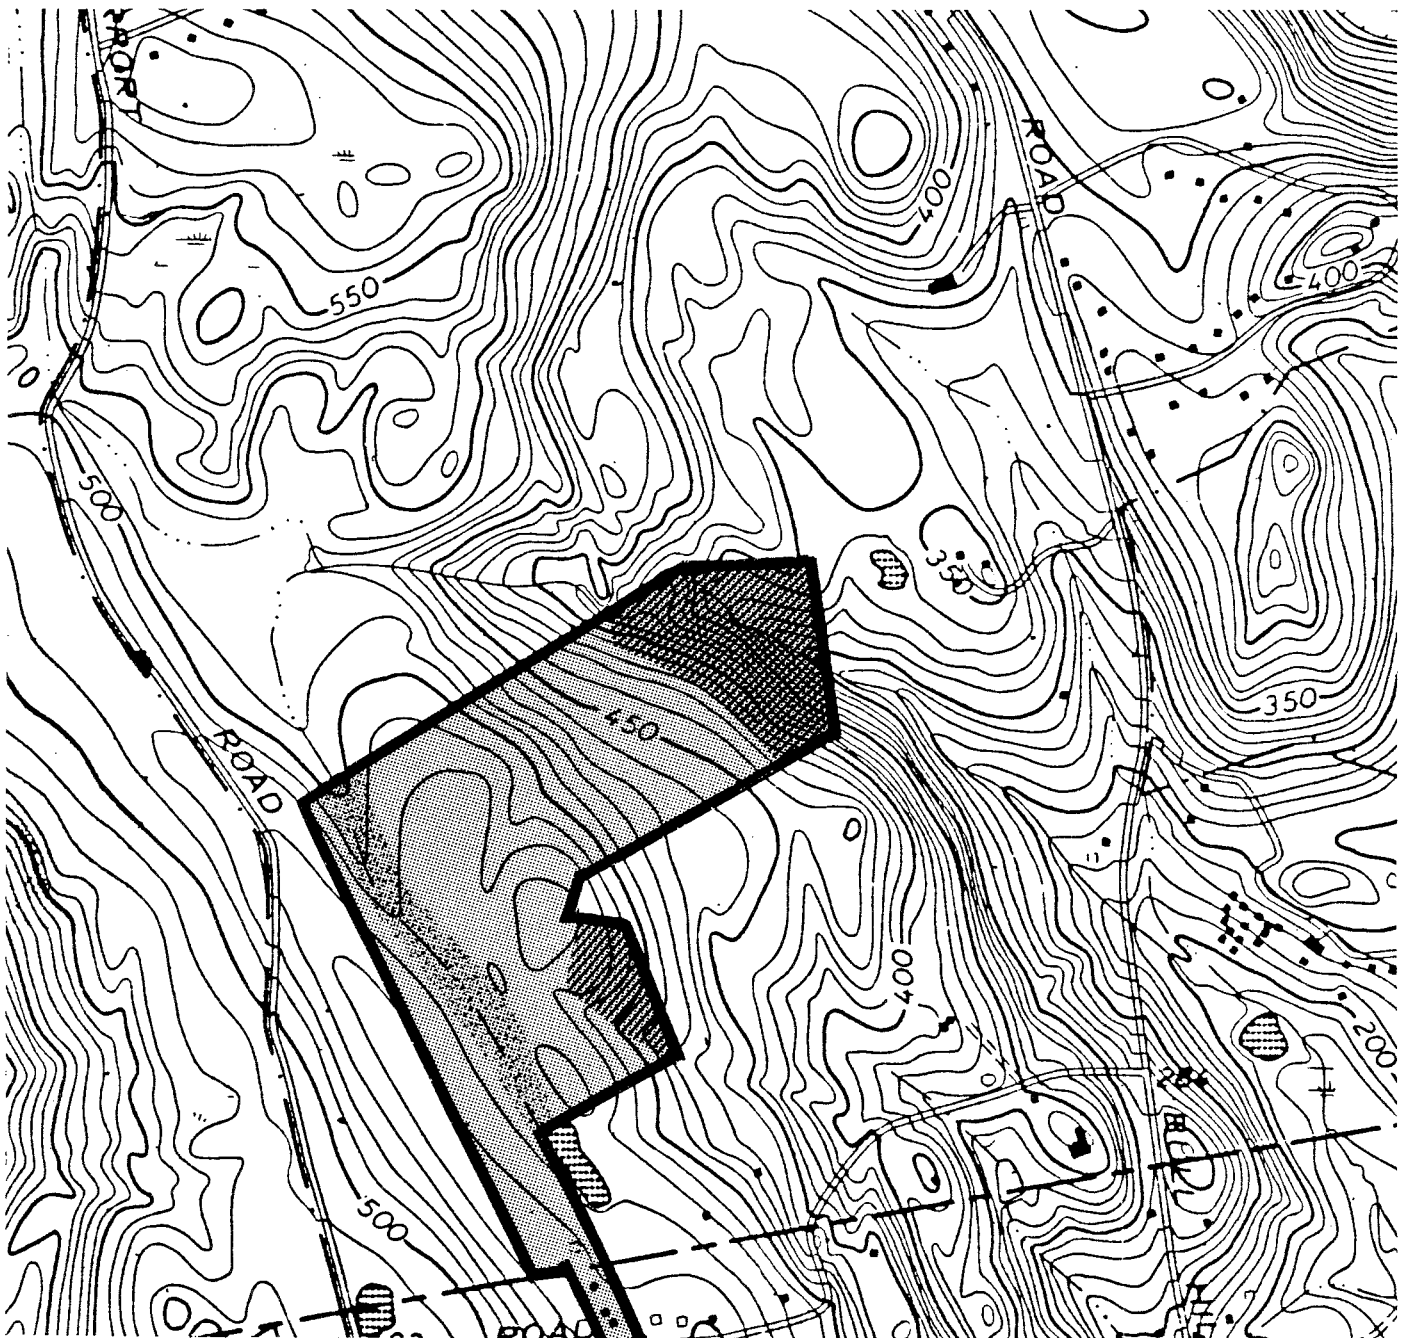
SURFICIAL GEOLOGIC MAP

Scale 1" = 1000'

Local surface material that includes mixed sand, gravel, clay, silt, variable organic matter and/or blocks and boulders.

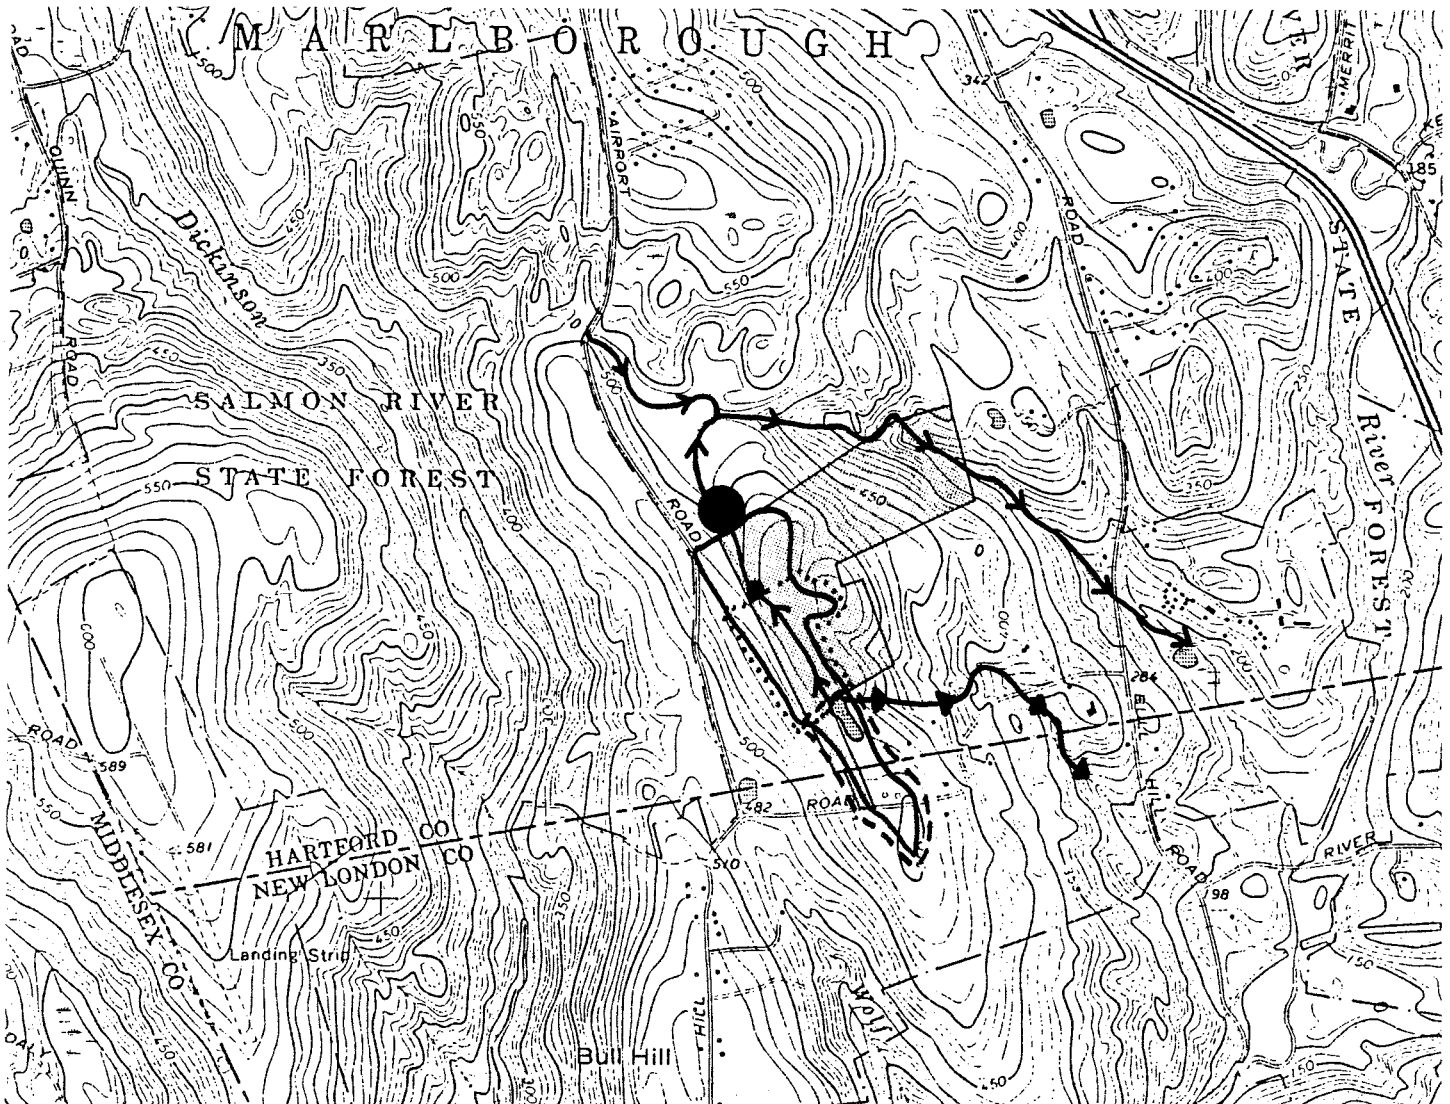
Approximate watershed boundary and respective point of outflow for the proposed ponds.
