Environmental Review Team Report

# Royal Oaks Park II

Middletown, Connecticut

July 1981

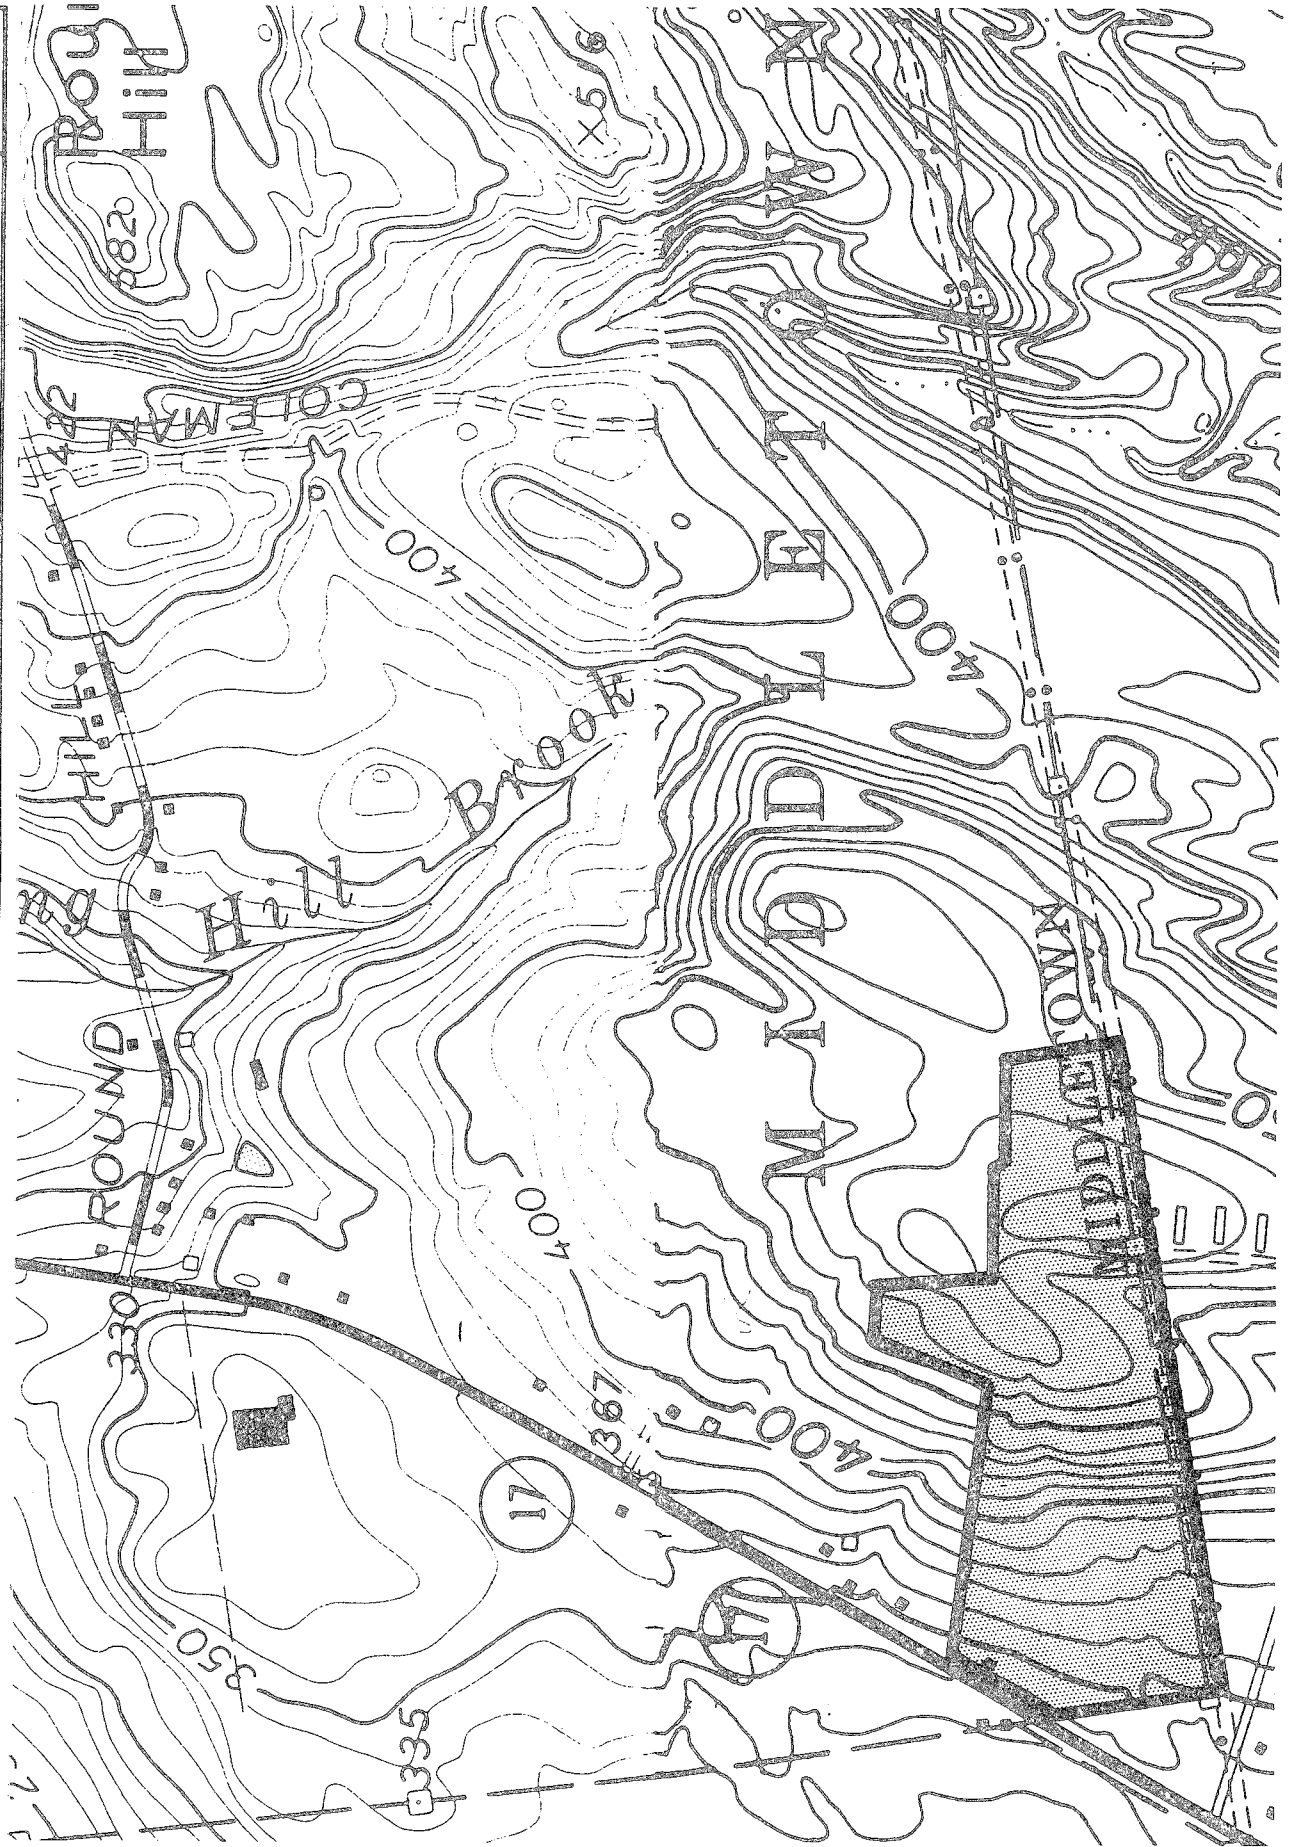
# Topography

— Site Boundary

Notable features of the site include a large, gently sloping meadow in the western portion of the property, a steeply sloping, heavily wooded area in the central section of the property and a flat, forested area on the eastern side of the property. A small pond is located in the central section of the site. Given the variety of ornamental vegetation present and its planting pattern, it is possible that this site was formerly used as a nursery. Evidence of abandoned chicken coops was also found during the field review. Soil series typical of the site range from the Hartford series to the Ludlow and Wethersfield series. Over half of the proposed site lies within the watershed of Middletown's Laurel Brook public water supply reservoir.

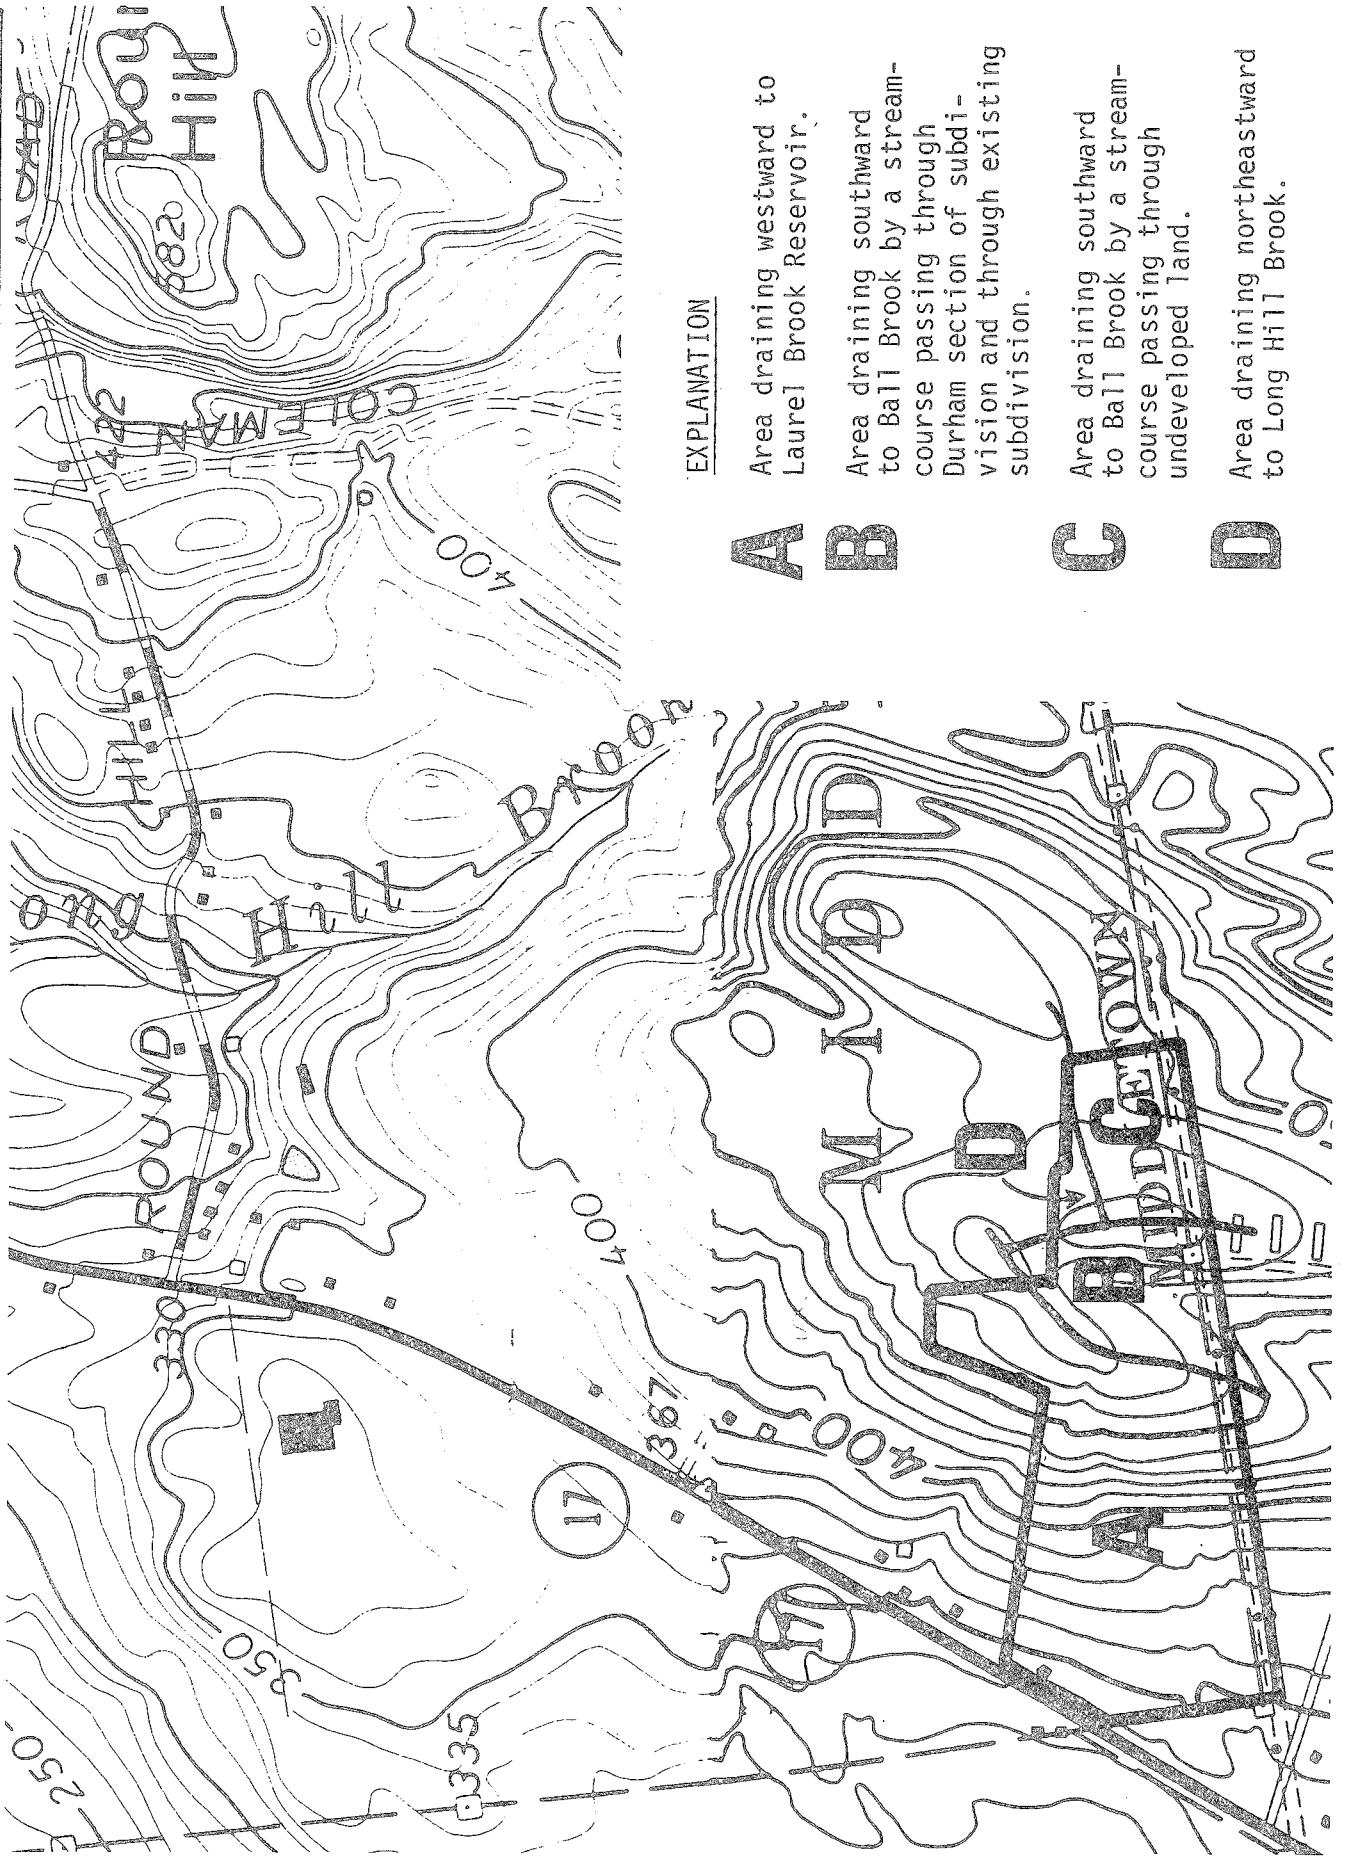
- A** Area draining westward to Laurel Brook Reservoir.
- B** Area draining southward to Ball Brook by a stream-course passing through Durham section of subdivision and through existing subdivision.
- C** Area draining southward to Ball Brook by a stream-course passing through undeveloped land.
- D** Area draining northeastward to Long Hill Brook.

The runoff increases anticipated on the other sections of the property should not cause any immediate problems for neighboring landowners since there are no residences that are both close to the site and downstream from those sections. However, all developments should be viewed in the context of the total potential for development in their drainage areas. The cumulative impact of a series of small developments may be substantial. For this reason, landowners should be encouraged to take steps to mitigate the flow of surface waters resulting from the development of their parcels. It is especially important on this site to consider measures that would reduce the flows from the largest drainage area (Area A). The eastern drainage area (Area C) is not so important, as it is quite small and relatively isolated from other easily developable areas.
