JOHN TROST SUBDIVISION

New Fairfield, Connecticut

KING'S MARK ENVIRONMENTAL REVIEW TEAM REPORT

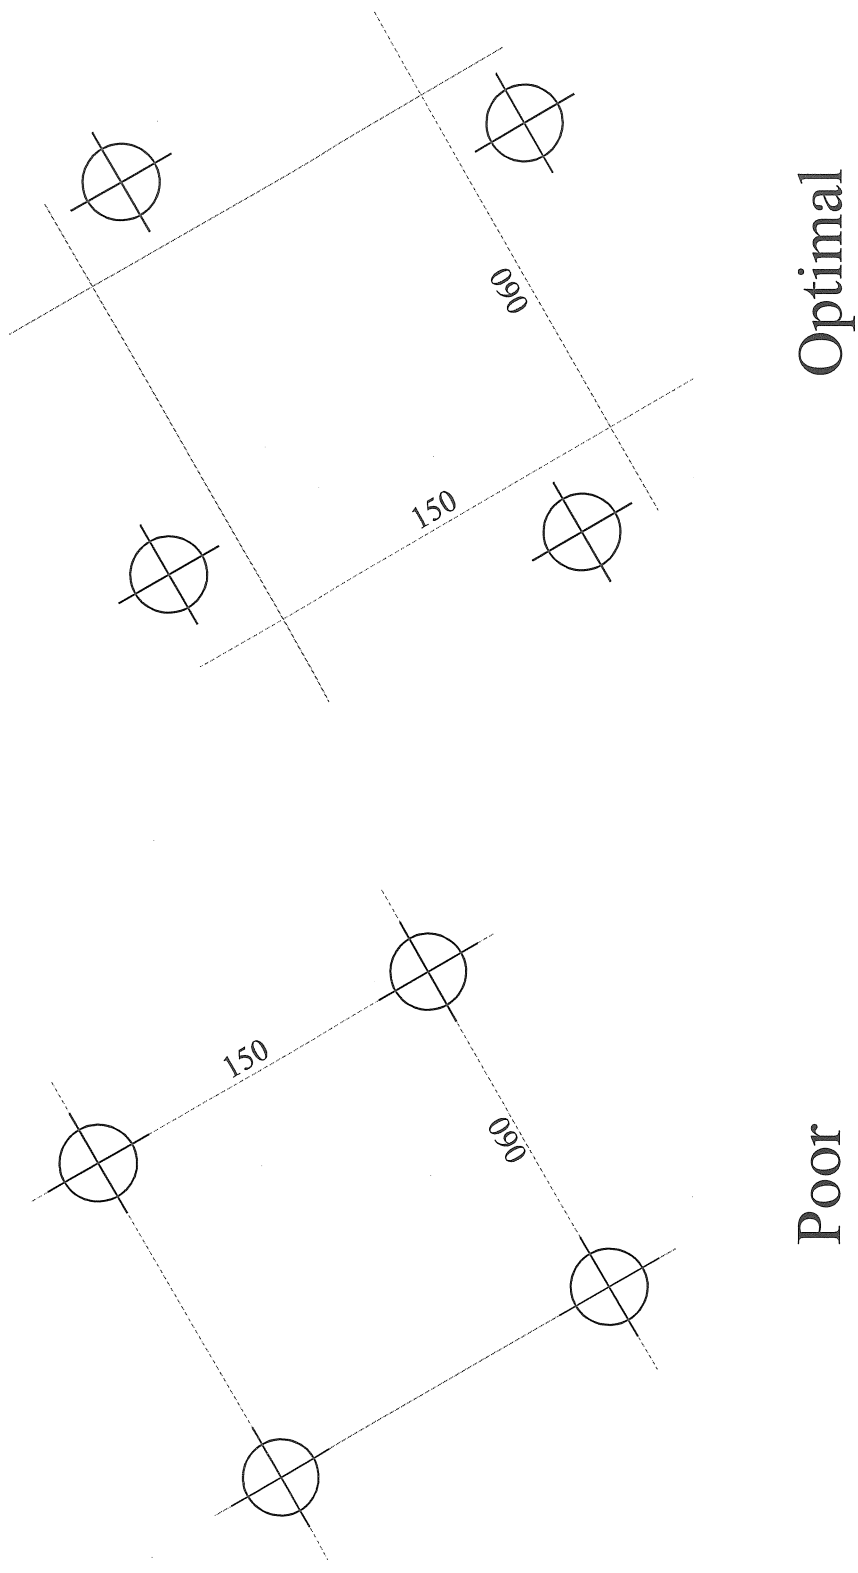
Figure 6

Siting of Wells Relative to regional Fracture Trends

Given the virtual absence of horizontal fractures and the low horizontal hydraulic conductivity that implies, it seems unlikely that wells spaced 200 to 400 feet apart would ever adversely affect one another. However, there are two situations where some interference might be seen. If the water table is high, the near surface sheeting joints could significantly enhance the horizontal connection between nearby wells. However, once the water table drops below open sheeting joints the wells would become effectively isolated from one another. Although unlikely, it is possible that two wells, a hundred feet or so apart, might intersect the **same** water bearing fracture. If heavily pumped they certainly could affect one another. However, as we know the orientation of the producing fractures, that possibility can be virtually eliminated if the new wells are sited intelligently. (See Figure 6)

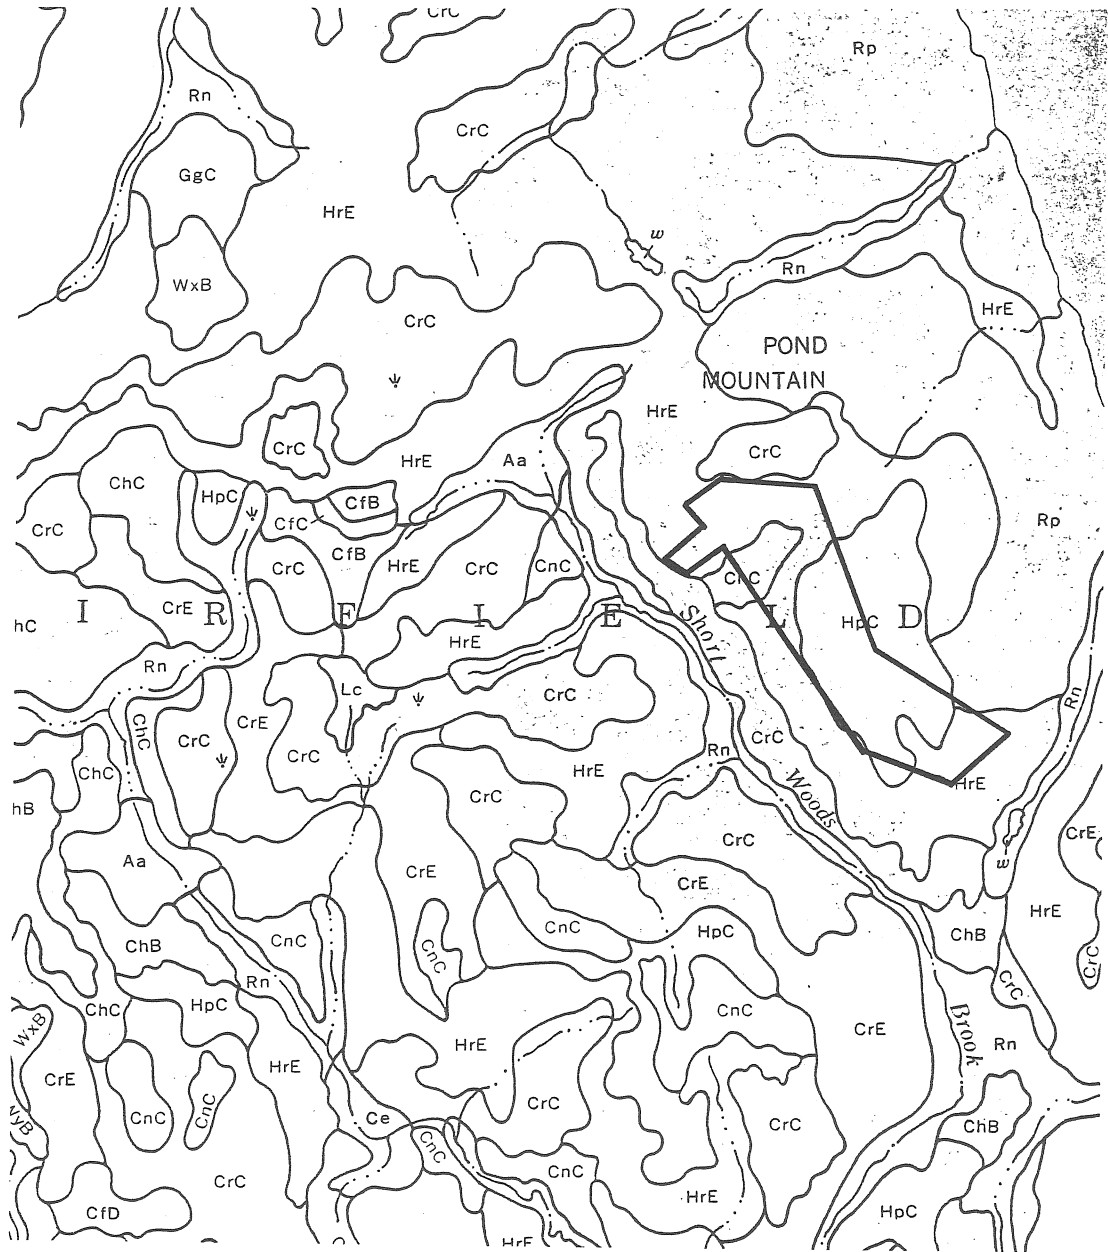
Figure 7

Soils Map

Scale 1" = 1320'

There are three (3) principle soil types found on the property:

- HrE (Hollis-Rock Outcrop-Charlton complex, 15 to 45 percent slope)
- HpC (Hollis-Charlton-Rock Outcrop complex, 3 to 15 percent slope)
- CnC (Charlton extremely stony fine sandy loam, 3 to 15 percent slope)
