# ENVIRONMENTAL REVIEW TEAM REPORT

COLONIAL HILL ESTATES  
NEWTOWN, CONNECTICUT

I. INTRODUCTION

The Town of Newtown, Connecticut is presently reviewing an application for subdivision of ± 100 acres of land in the west central portion of town. The proposed subdivision, known as "Colonial Hill Estates", would create 58 house lots of 1+ and 2+ acres in size (see Figure 1). Each lot would be serviced by an on-site well and septic system. Access to the parcel would be provided by newly constructed roads off Great Hill Road, Head of Meadow Road, and Scudder Road. Development plans indicate that ± 20.5 acres of the 100 acre site would be left in its natural condition as open space.

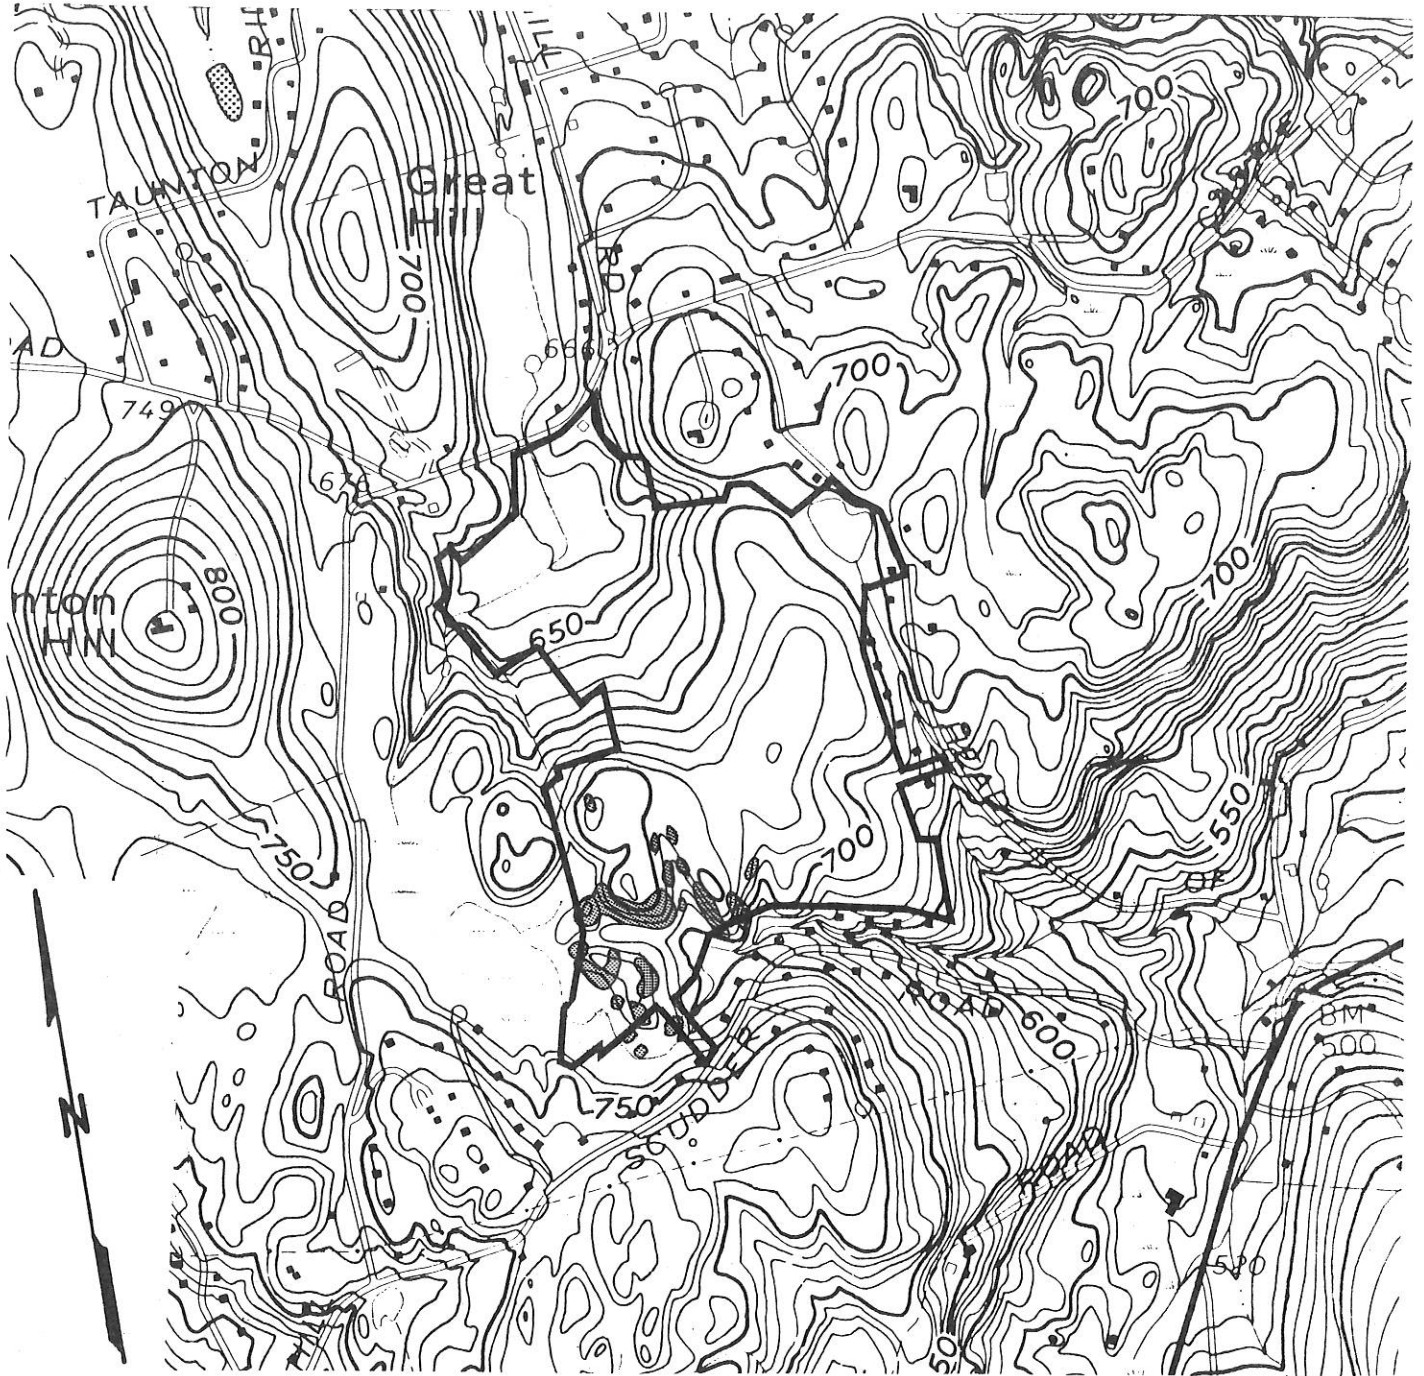
FIGURE 3.  
**BEDROCK OUTCROP MAP**  
BASED ON FIELD OBSERVATIONS ONLY

SCALE 1" = 1000'

MAPPING BY M. ZIZKA, 1979

later redeposited directly from the ice. The topmost part of the till is often sandy and relatively loose, but lower layers are typically siltier and very compact. Soils data suggests that the most compact till is commonly near the surface in the southern and eastern sections of the site, while the sandier variety is more common in the moderately sloping northwest section. The till appears to be generally thicker than 10 feet in the northern half of the site, but it is commonly thinner or absent in the southern half. The bedrock outcrop map which accompanies this report (Figure 3) gives a general indication of where the till is thinnest.

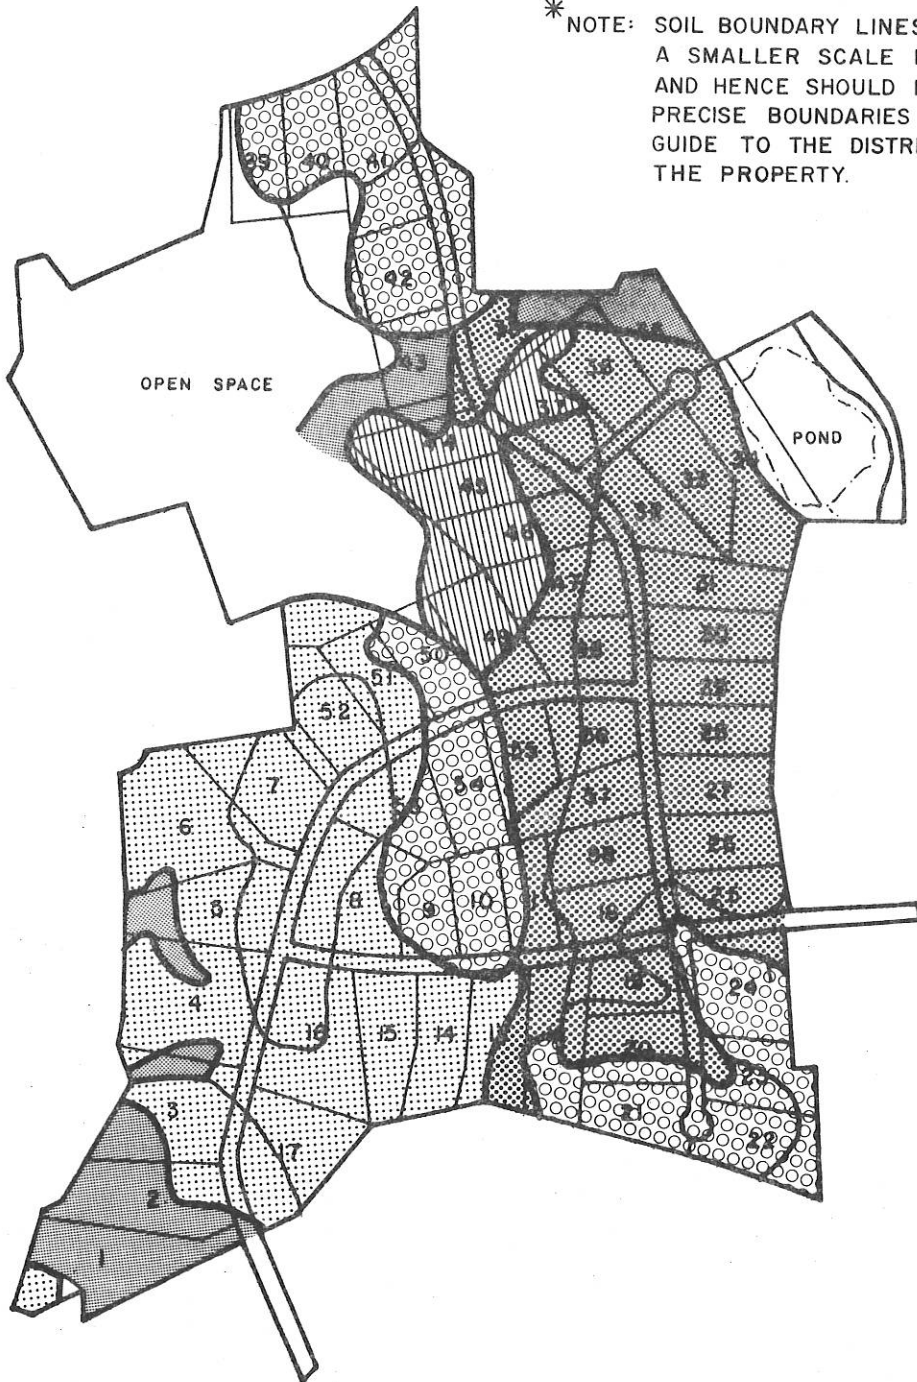
# NATURAL SOIL GROUPS AND PROPOSED LOTS\*

\*NOTE: SOIL BOUNDARY LINES WERE DERIVED FROM A SMALLER SCALE MAP (1"=1320' SCALE) AND HENCE SHOULD NOT BE VIEWED AS PRECISE BOUNDARIES BUT RATHER AS A GUIDE TO THE DISTRIBUTION OF SOILS ON THE PROPERTY.

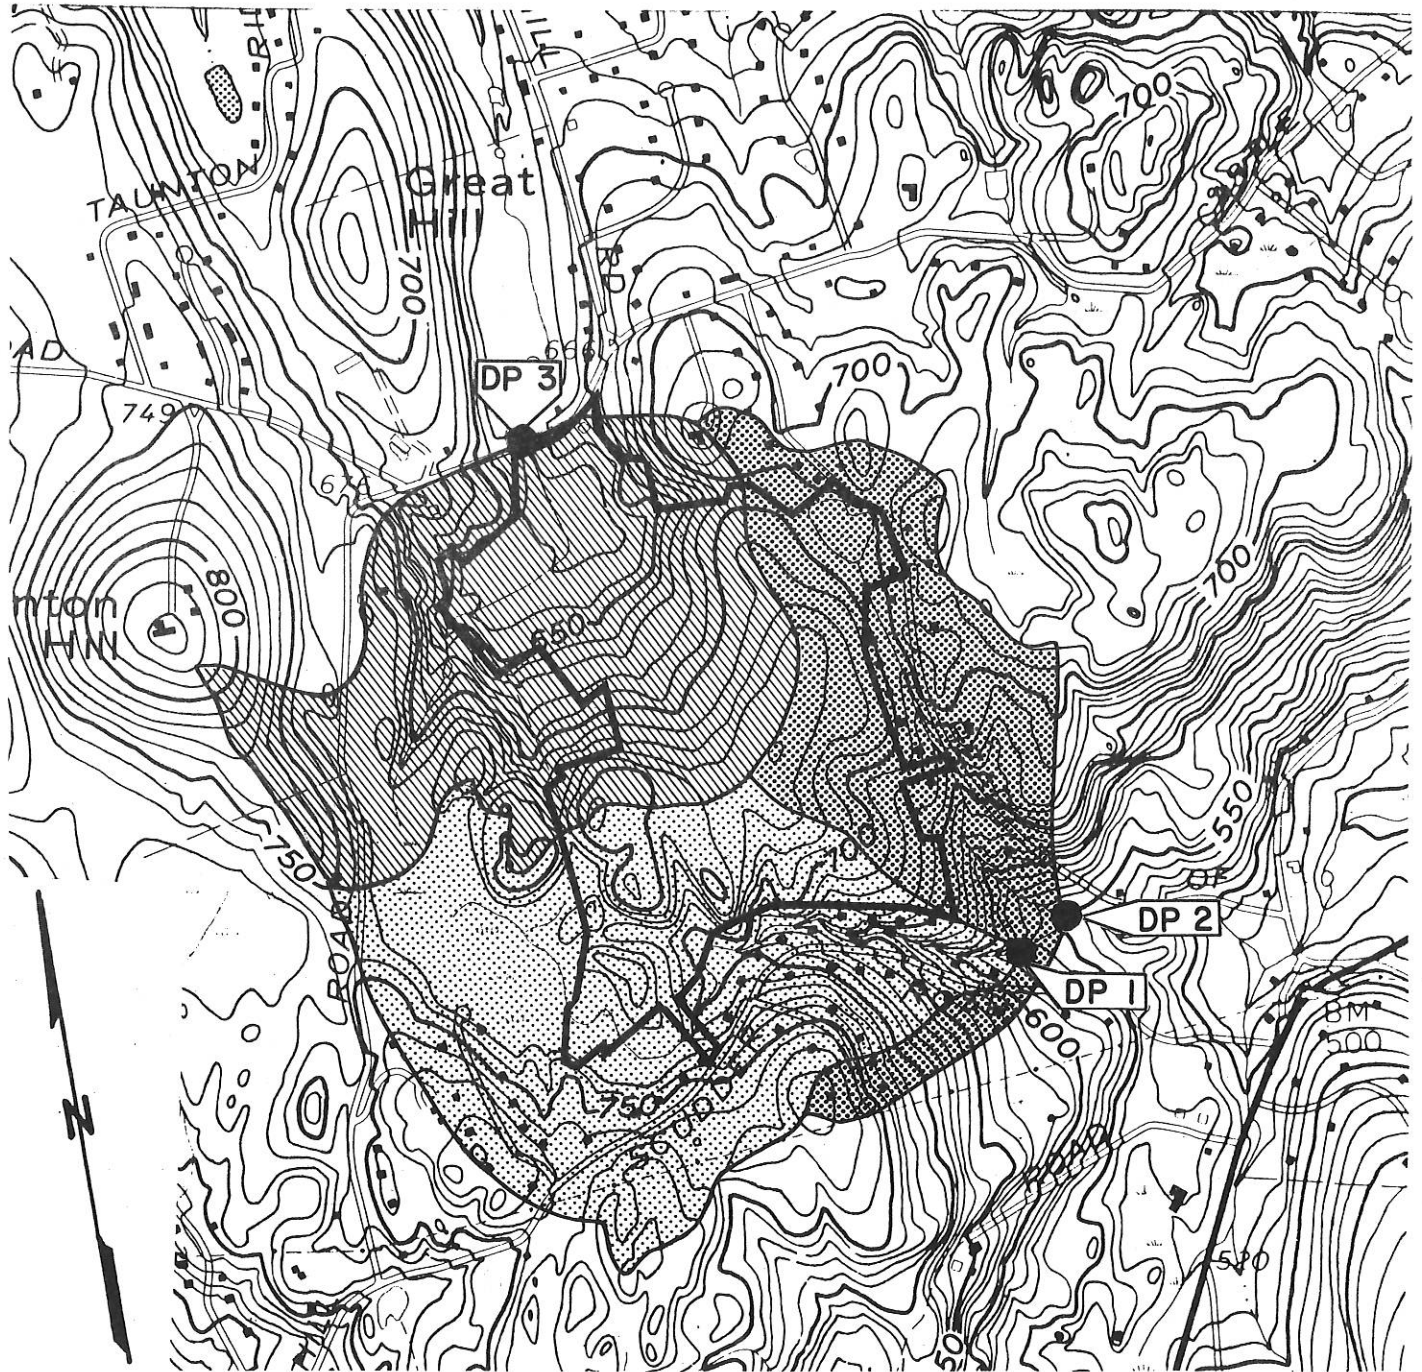
FIGURE 6.  
HYDROLOGIC DESIGN POINTS & THEIR ASSOCIATED  
WATERSHED AREAS\*

SCALE 1" = 1000'

Three hydrologic design points are shown in Figure 6, as are their associated watersheds. Table 1 shows estimated present and anticipated future peak flows at those points for the theoretical 25-year, 24-hour storm and the 50-year, 24-hour storm.\* (Although no individual design point along the brook near Head of Meadow Road was studied, it is clear that the peak flow increases in that brook would be similar to those experienced by the brook along Scudder Road.)

TABLE 1 Estimated present and anticipated future peak flows for the three design points shown in Figure 6.
