**EASTERN CONNECTICUT  
RESOURCE CONSERVATION AND DEVELOPMENT PROJECT**

ENVIRONMENTAL REVIEW TEAM REPORT  
ON  
MONO POND  
COLUMBIA, CONNECTICUT  
OCTOBER, 1975

MONO POND  
Columbia, Connecticut

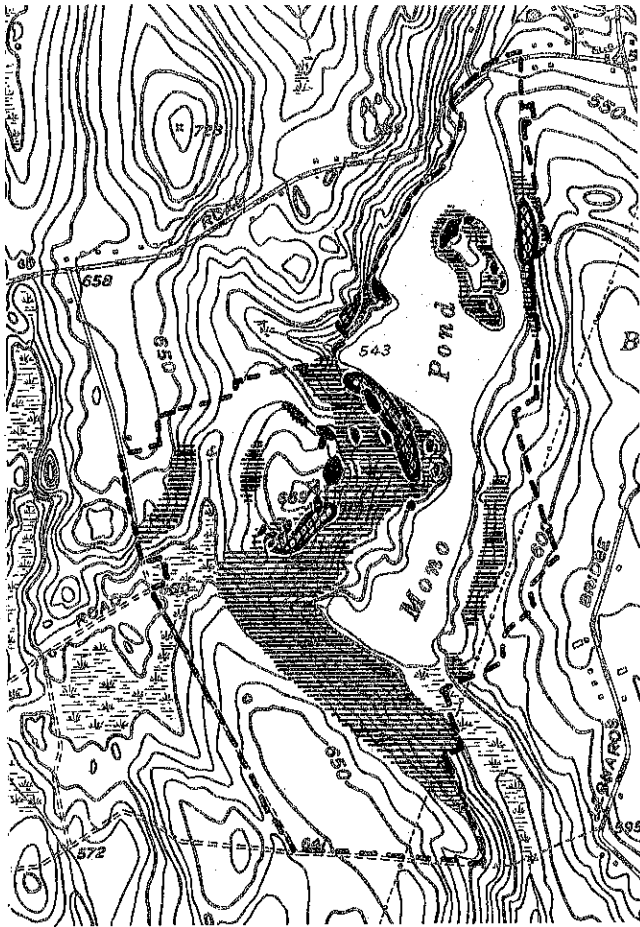
## TOPOGRAPHY

General areas of steep (greater than 15%) and moderate (8-15%) slopes are highlighted on the topography map. It should be noted that these areas of steep and moderate slopes are closest to the lake. Rock is at or near the surface in the areas where the slopes are steepest.

The Mono Pond site is underlain by gray colored gneisses and schists. The bedrock exposures or outcrops (places where bedrock is visible at the surface) are also highlighted on the topography map. The largest area of concentration of bedrock outcrops is on hill #669, on the west bank of the pond, although outcrops exist along other portions of the western bank, and on the island. (See BEDROCK GEOLOGIC MAP OF THE COLUMBIA QUADRANGLE by George Snyder, U.S.G.S. Map GQ-592, 1967 for further bedrock geology information.)

The Mono Pond property includes approximately 335 acres of land that surrounds and drains into Mono Pond. The pond itself has an area of approximately 103 acres, and there is an 11 acre steep, rocky island in the northern half of the pond. At the northern end of the pond, there is a man-made dam and spillway. The east bank of the pond is formed by a relatively smoothly sloping hillside. The western banks of the pond are more irregular in shape and slope, and a portion of the southern terminus of the pond is marshy and stream-fed. The bulk of the property extends to the west and south of the pond. (Refer to the topography map on the next page for property boundary locations.)
