ENVIRONMENTAL REVIEW TEAM REPORT

SOCHRIN PARK SEYMOUR, CONNECTICUT

FEBRUARY, 1978

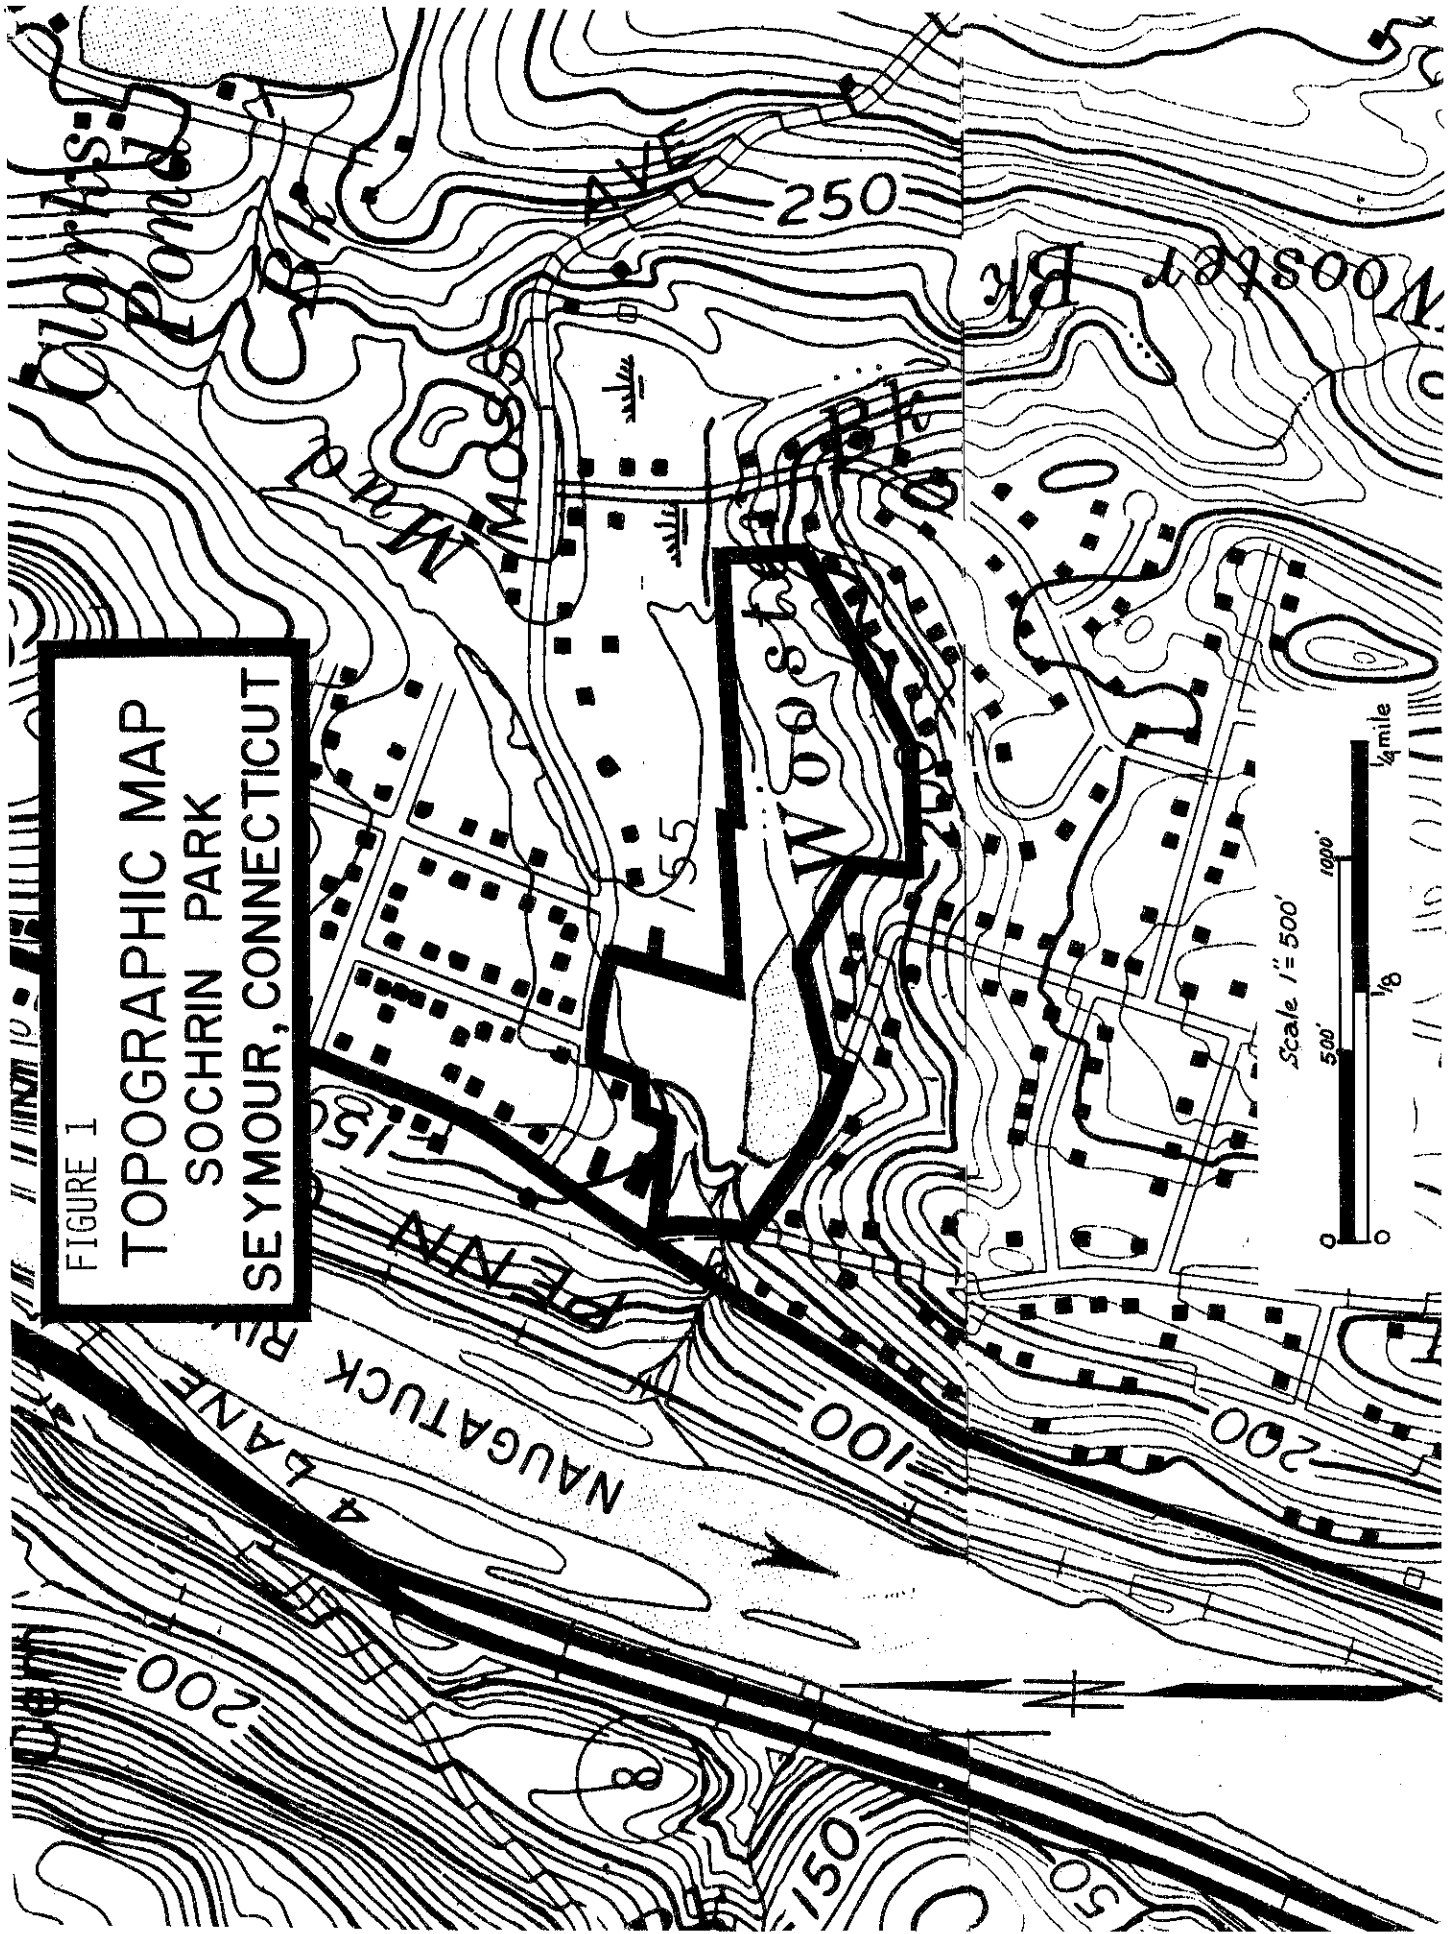
FIGURE 1
TOPOGRAPHIC MAP
SOCHRIN PARK
SEYMOUR, CONNECTICUT

The park land is relatively flat with the exception of the steep banks on the southern edge of the property (see fig. 1). The land supports a parking lot, basketball court and small playground in an open area of about three acres. In addition, there are approximately twelve acres of wooded land at the site and a shallow 2.5 acre pond impounded by an old concrete ice company dam (see fig. 2). Two brooks traverse the property. Mud Brook cuts through the northern portion of the property. Wooster Brook flows through the central portion of the tract and feeds Sochrin Pond. These two brooks merge on the western edge of the property and flow to the Naugatuck River.

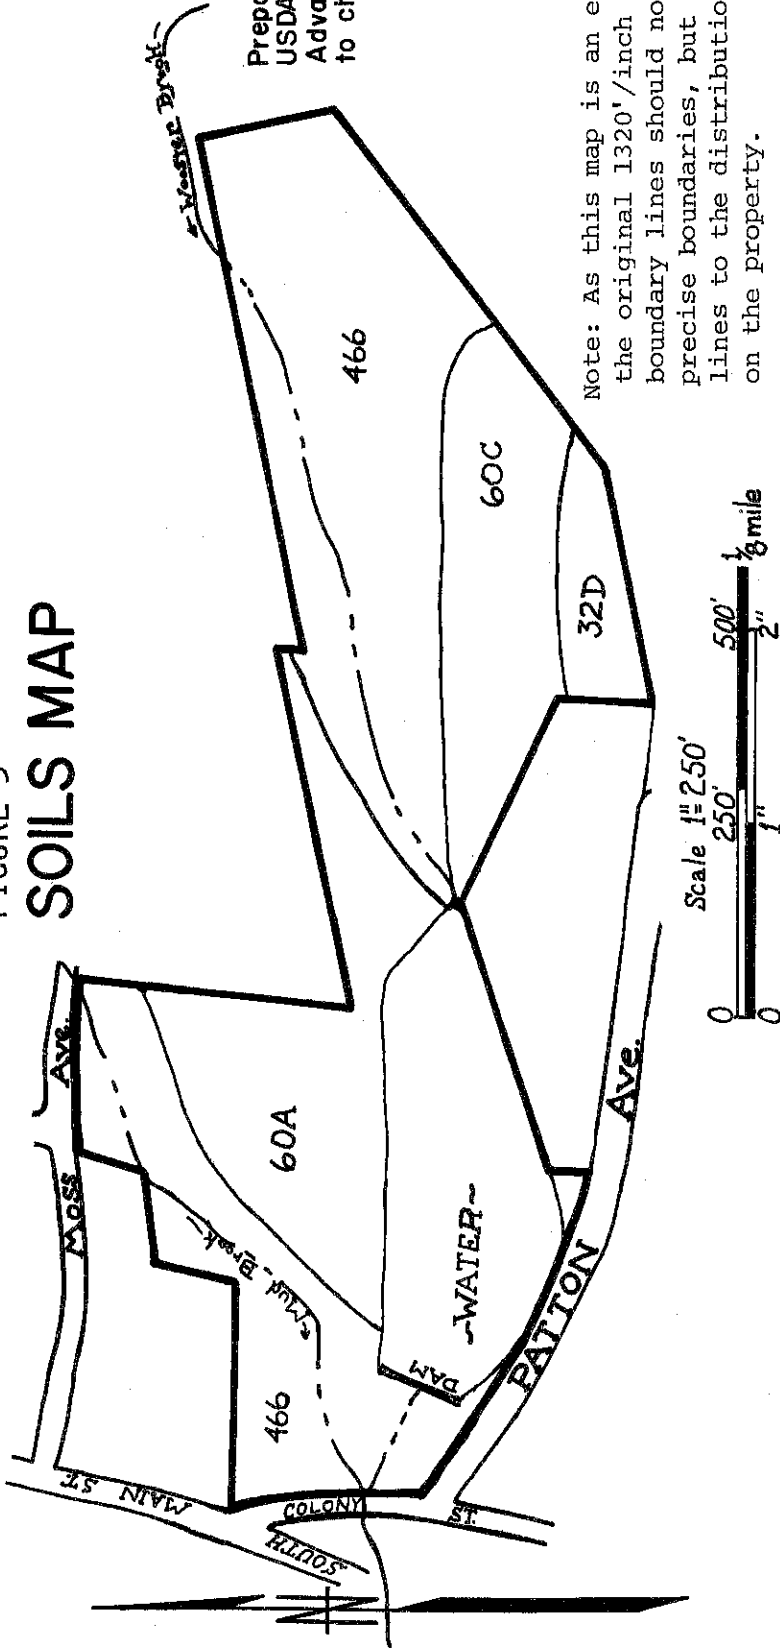
FIGURE 3 SOILS MAP

Soil Survey Maps by the U.S.D.A. Soil Conservation Service identify four soil types on the Sochrin Park property. The geographic distribution of these soils together with their limitation ratings for various land uses is presented in Figure 3.

Note: As this map is an enlargement from the original 1/320" scale, the soil boundary lines should not be viewed as precise boundaries, but rather as guide-lines to the distribution of soil types on the property.

Natural Soil Group	Mapping Symbol	Slope %	Approx. Acres	% Of Total Acres	On-Site Sewage Disposal	Buildings with Basements	Streets and Parking	Camp Areas	Picnic Areas	Play-grounds	Paths and Trails
ALA	HKA (60A)	0-3%	4.0	23.00	1	1	1	2	2	3	1
ALB	HKC (60C)	8-15%	2.0	11.00	2	2	1	2	2	3	1
A3A	WD (466)	0-3%	8.0	46.00	4	3	3	3	3	3	3
B1D	CaD (32D)	15-25	1.0	6.00	4	4	4	4	4	4	4

*Limitations: 1 - slight; 2 - moderate; 3 - severe; 4 - very severe

The limitations imposed by existing soil conditions (see fig. 3) together with the paucity of level land at the site practically precludes active recreational development at Sochrin Park. The one area with potential for active recreational development is the open land in the general location of the present parking lot (see fig. 2). Although this area is limited in size (\pm 2 acres), it is conducive to the development of some formal small court games such as tennis. Alternatively, this area would be the likely location of any artificial pool constructed.
